APPLICATION FOR DEMOLITION OF PRINCIPAL BUILDINGS

City of Madison

Building Inspection Division

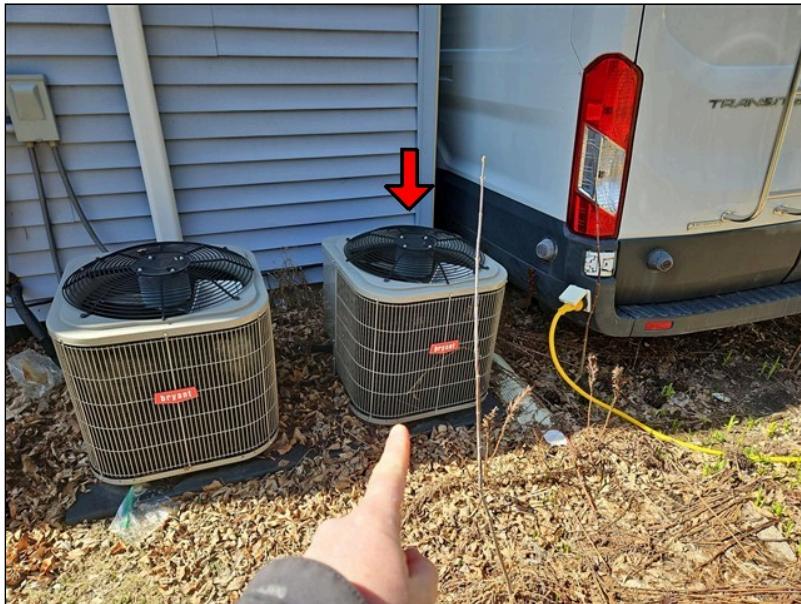
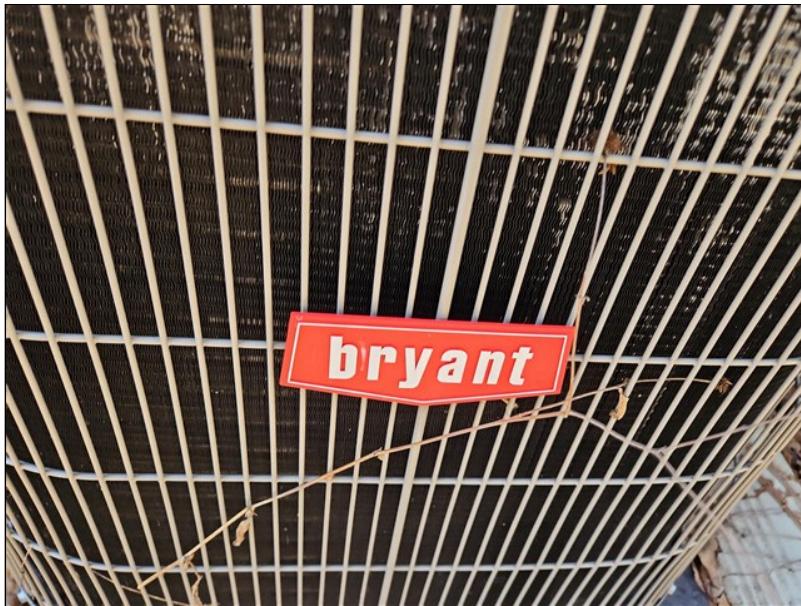
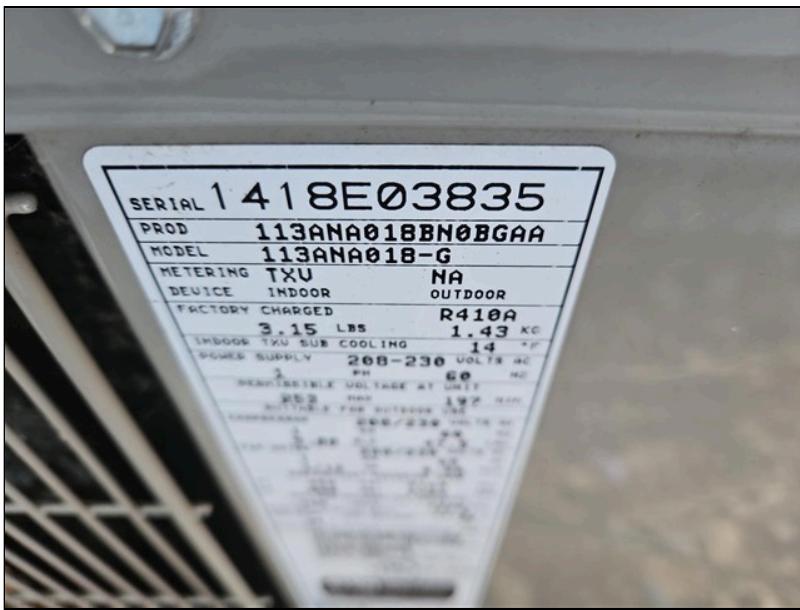
7.7 (2) Bryant AC unit - year of manufacture was 2018.

As the temperature was below 65 deg within the last 24 hours and damage can happen to the compressor if operated at low temperatures, the unit was not turned on. Physical condition was observed only.

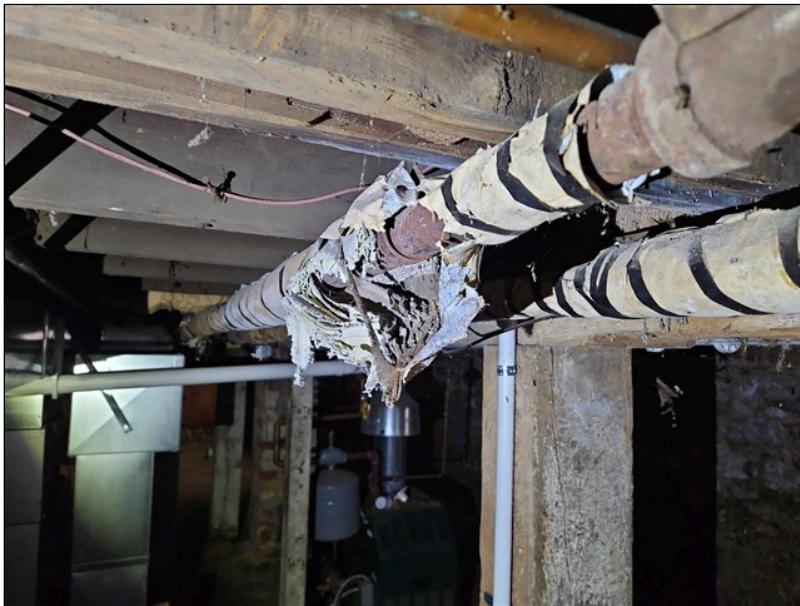
7.10 Further Evaluation: A material that has the appearance of asbestos was present on the the legacy water pipes for the radiators. Asbestos is linked to health concerns. Recommend further evaluation and addressing as necessary by a qualified professional.

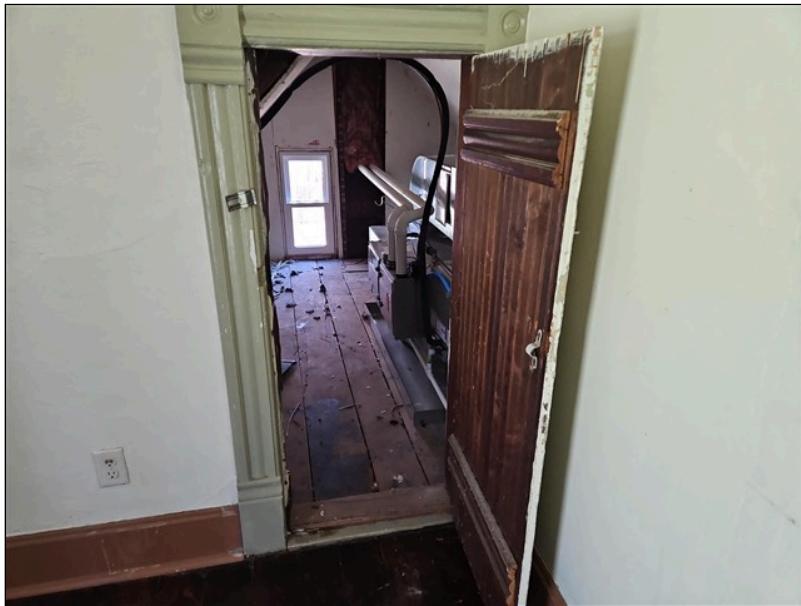
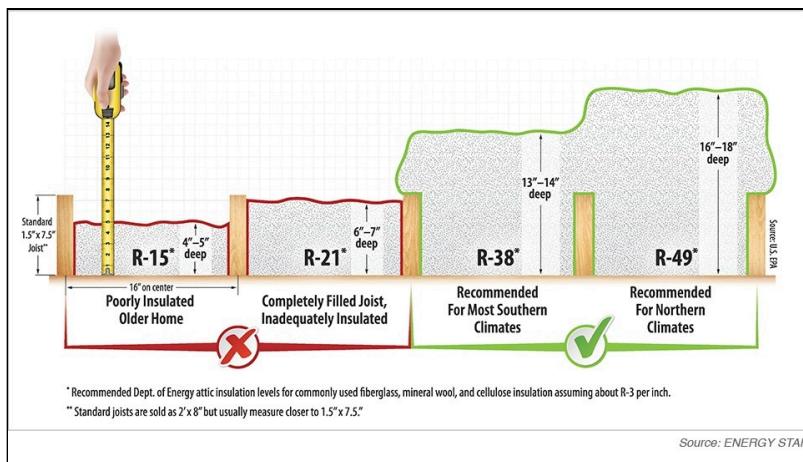
8.0 (1) Repair: An insufficient amount of insulation was installed in this attic per today's standards.

Recommend a qualified insulation specialist provide further evaluation and add insulation as necessary. Please note that adding insulation may require more ventilation and/or air sealing. All three should be evaluated together.

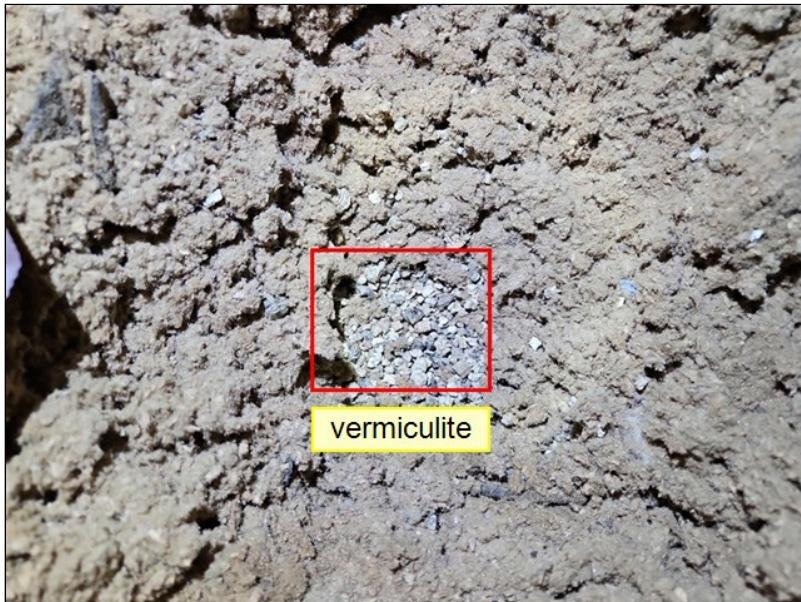
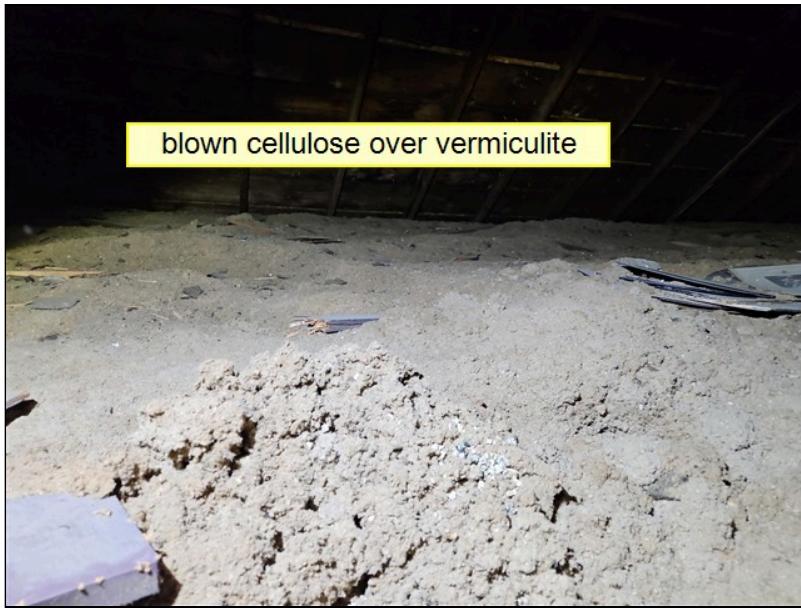
8.0 (2) Further Evaluation: Vermiculite insulation was present in the attic. Vermiculite insulation is known to contain asbestos. Testing by a qualified asbestos abatement specialist would need to be conducted to confirm the presence of asbestos with certainty.

Recommend further evaluation of the attic in these photos and the attic space with the planking on the floor and addressing as necessary by qualified asbestos abatement specialist.

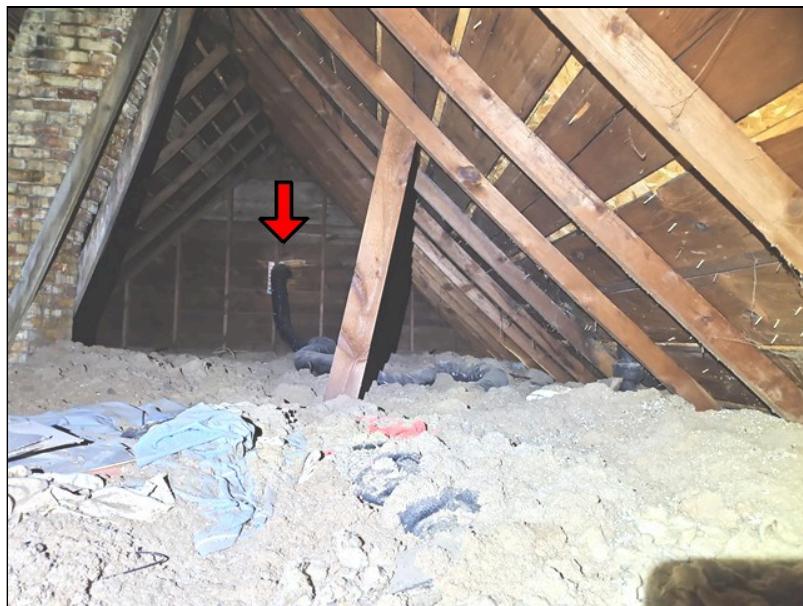
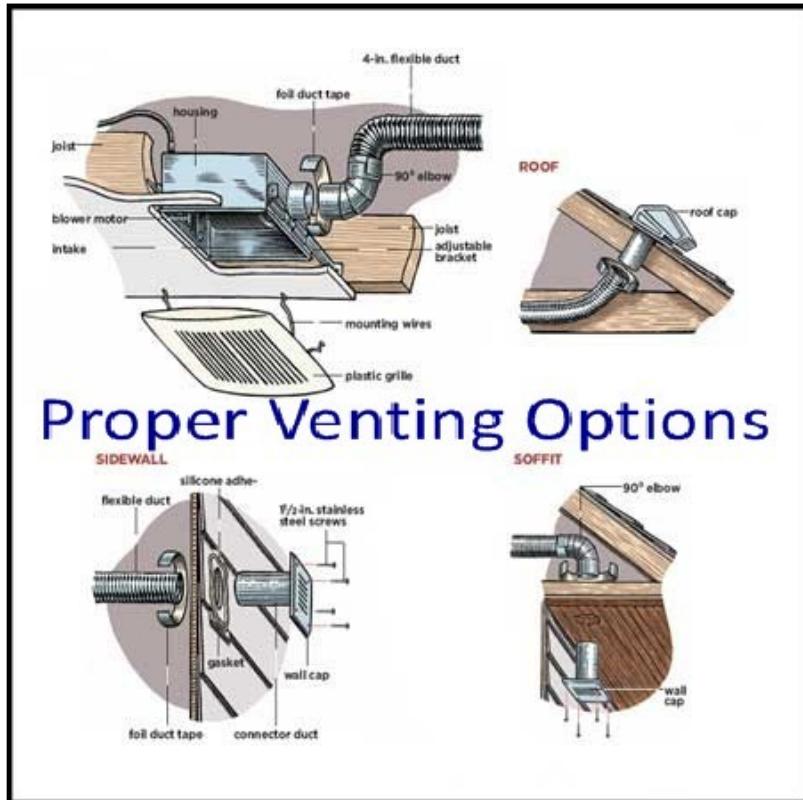
8.3 (1) Repair: A gable vent that would be used to vent the attic space was in use for the bathroom fan.

Recommend further evaluation and repair as necessary by a qualified contractor.

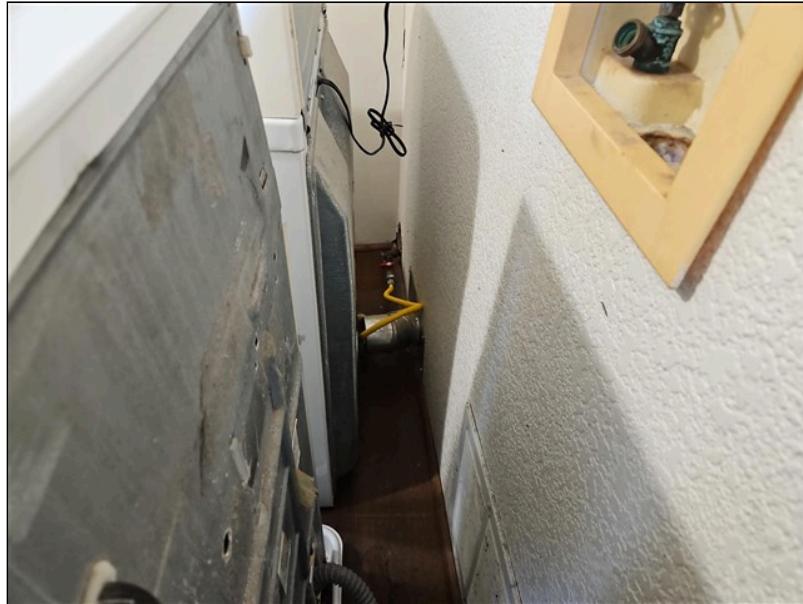
8.3 (2) Repair: The dryer vent was disengaged and not venting to the outside. This can create high levels of humidity in the home and introduce lint into the air.

Recommend further evaluation and repair as necessary by a qualified individual.

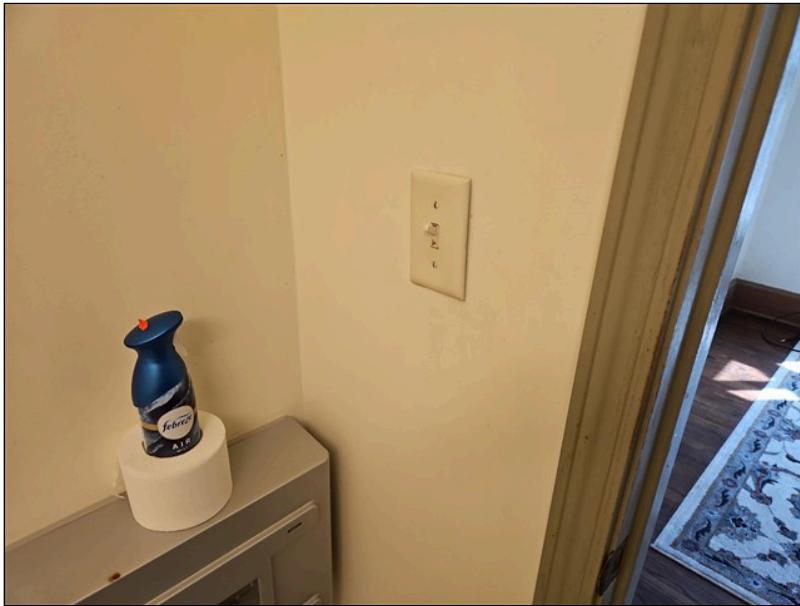
8.3 (3) Defect: Bathroom fan did not turn on with the switch on the wall.

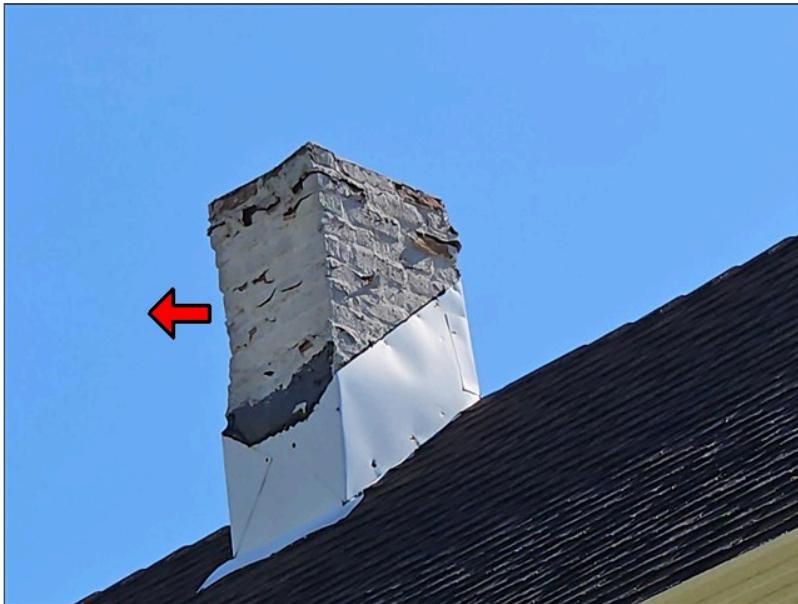
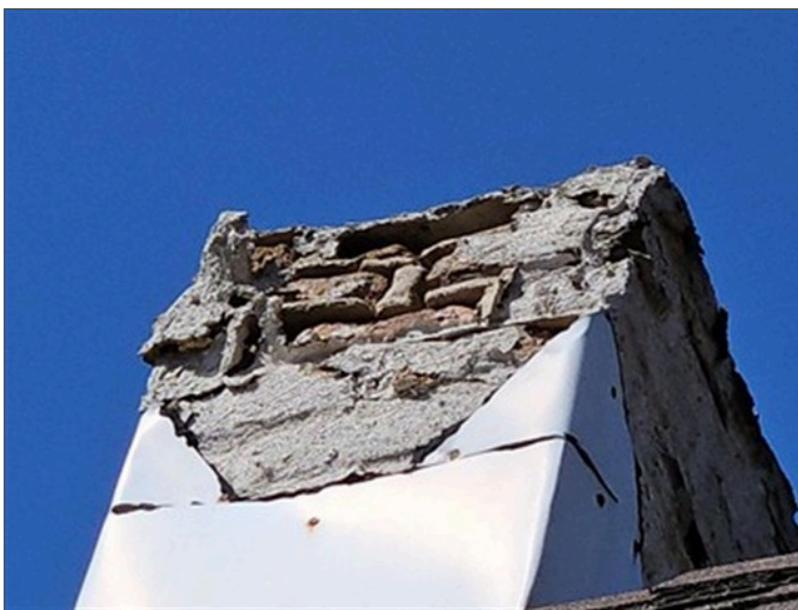
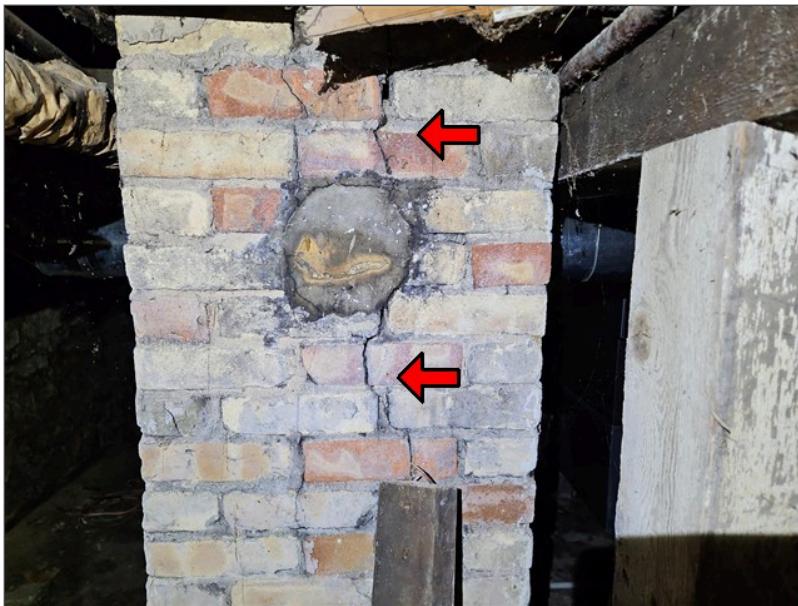
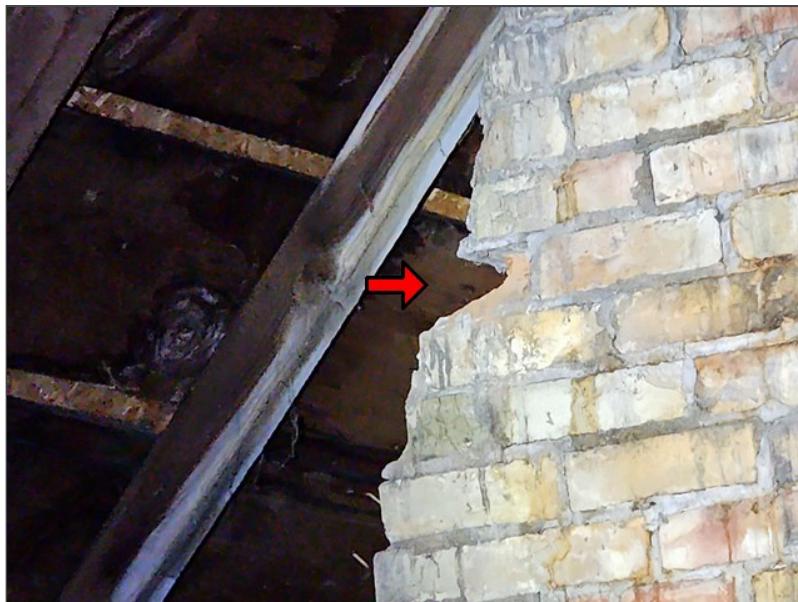
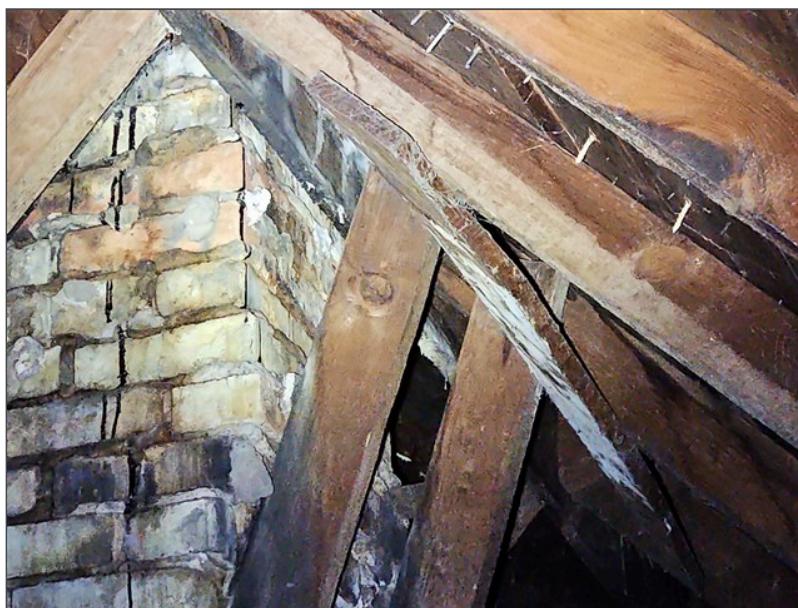
Defect: Chimney structure was deteriorated. In the basement, cracks were present. Chimney was leaning on the exterior. Moisture stains are indicative of a current or past leak in the flashing.

Please note the chimney is not venting the HVAC systems or water heater and serves no purpose.

Recommend further evaluation and repair/remove as necessary by qualified chimney contractor.

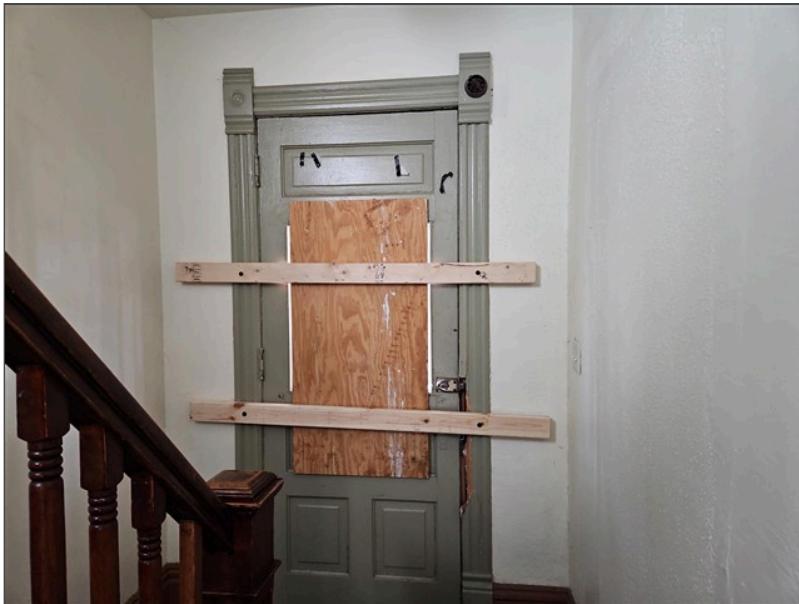
(1) **Defect:** Access to front door was blocked. There was only one exit to the exterior of the main floor.

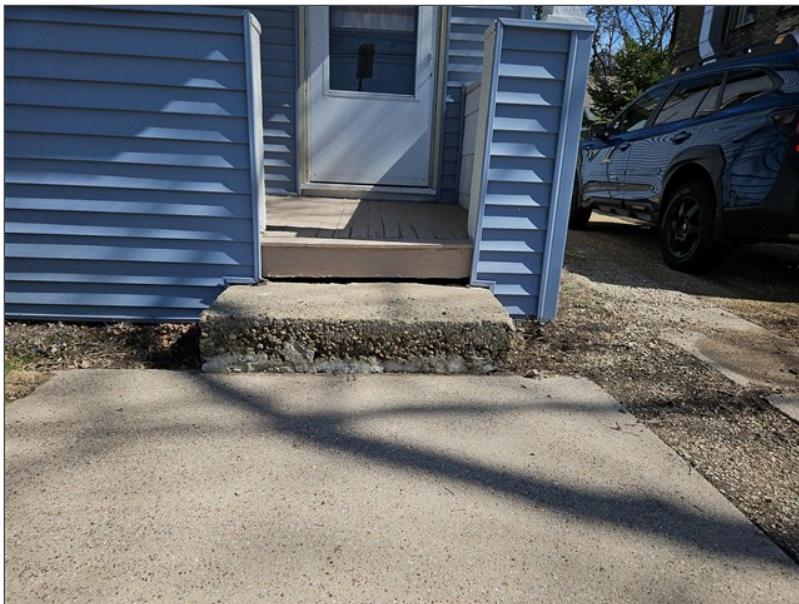
(1) **Defect:** Rise of step to rear porch was excessive. Rise of steps was inconsistent. Conditions present are a trip hazard.

Recommend further evaluation and repair as necessary by qualified contractor.

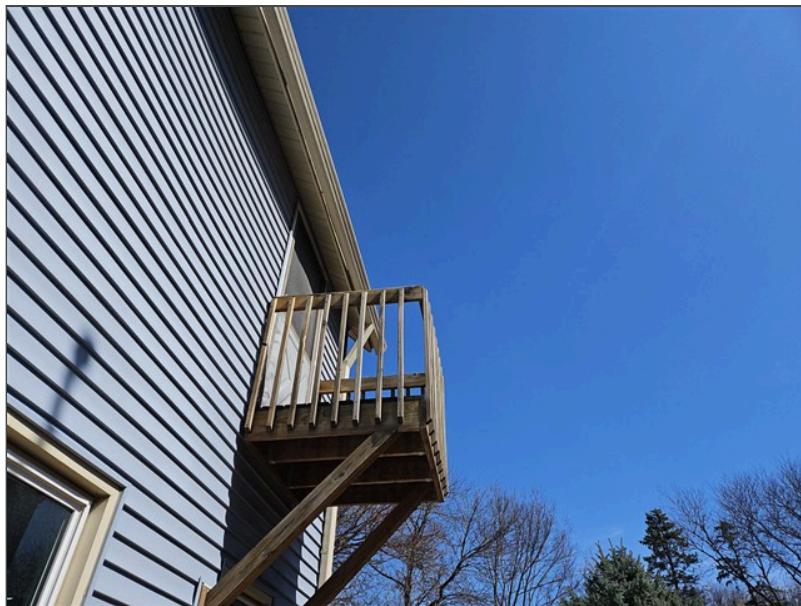
(2) **Defect:** The balusters on the guardrail on the balcony were spaced in excess of 4". This is a choking hazard for children.

Recommend further evaluation and repair as necessary by a qualified contractor.

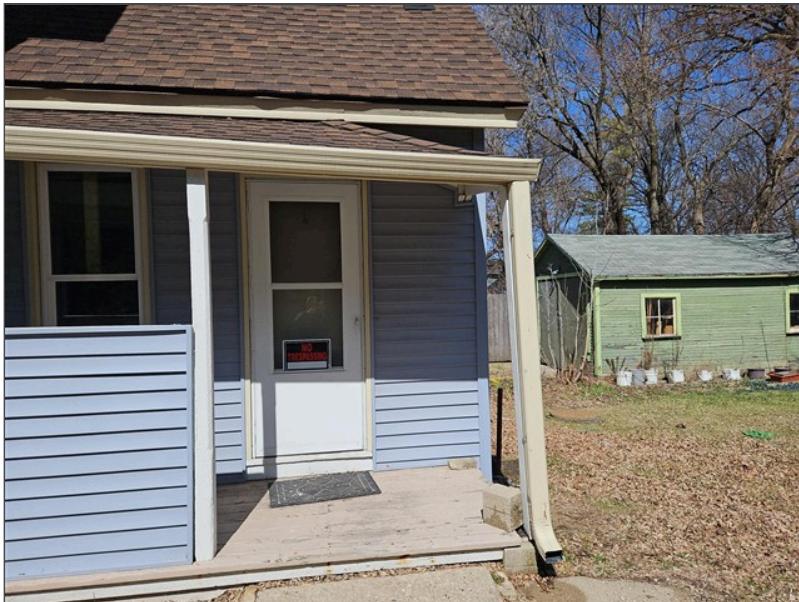
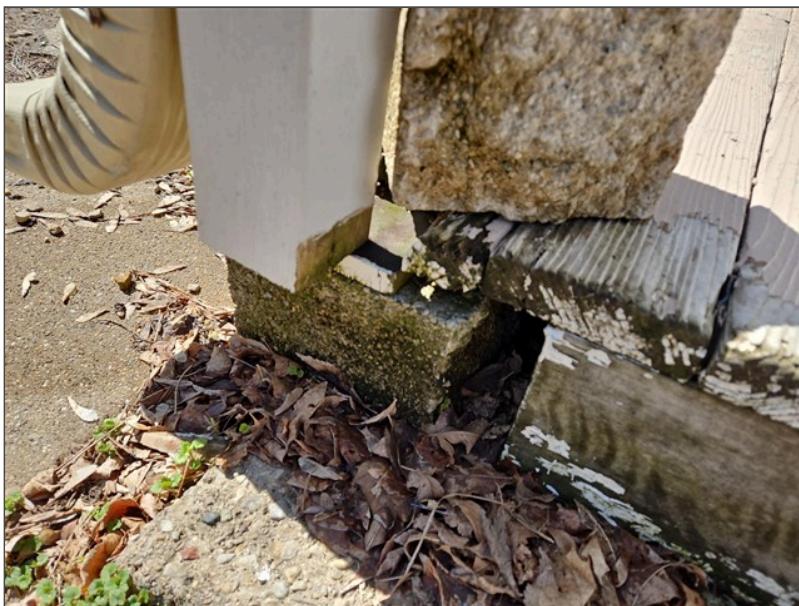
(3) **Defect:** Post supporting porch roof was not centered on footing. Footing was not set below the frost line and may move with frost heave.

Recommend further evaluation and repair as necessary by qualified contractor.

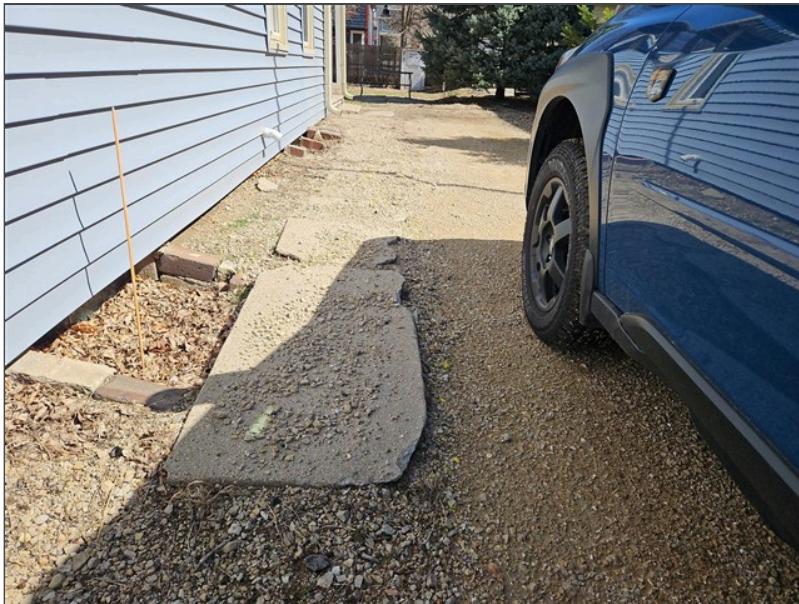
Defect: The heaving, settling and cracking of the sidewalk has created trip hazards.

Recommend further evaluation and repair/replace as necessary by a qualified contractor.

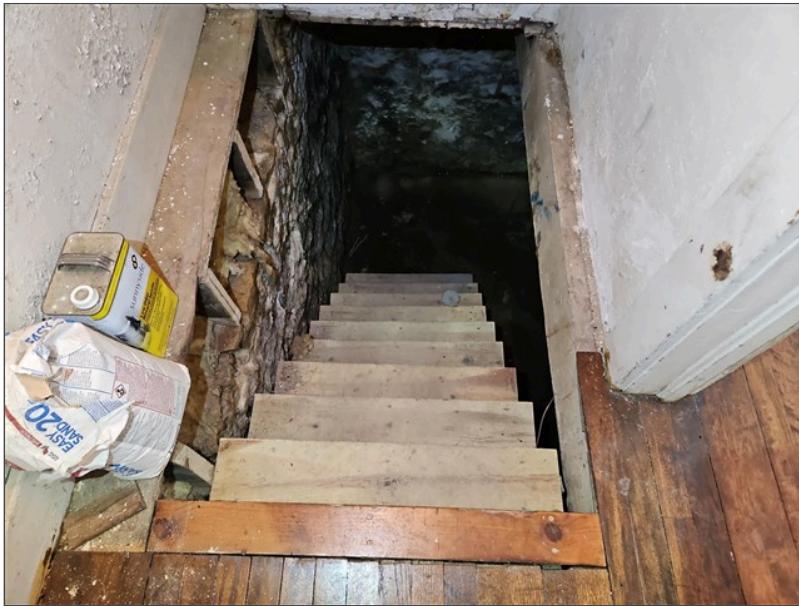
Defect: The stairs to the basement and upper level were not constructed in a manner that are consistent with today's safety standards. This can be a fall hazard.

It may not be possible to make all the changes necessary that will make the stairs meet today's standards but action can be taken to make them safer. One action can be the installation of a handrail.

Recommend further evaluation and repair by a qualified contractor.

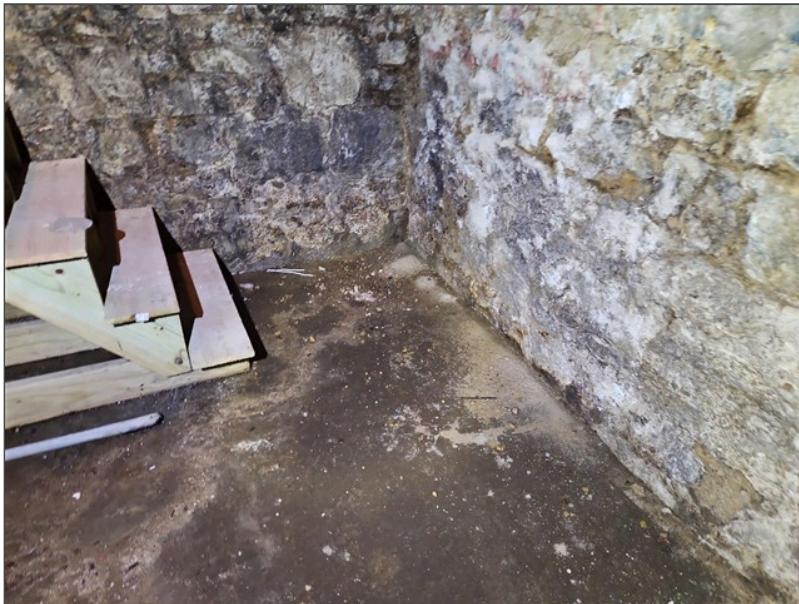
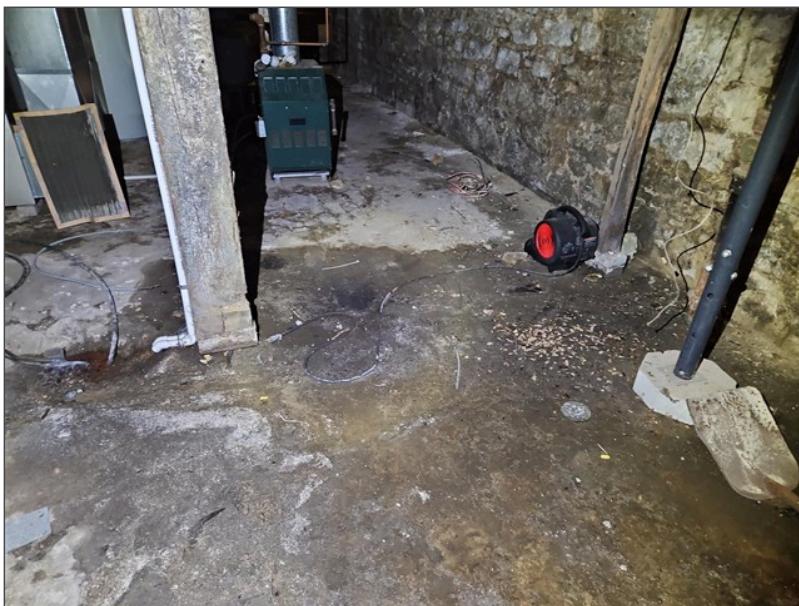
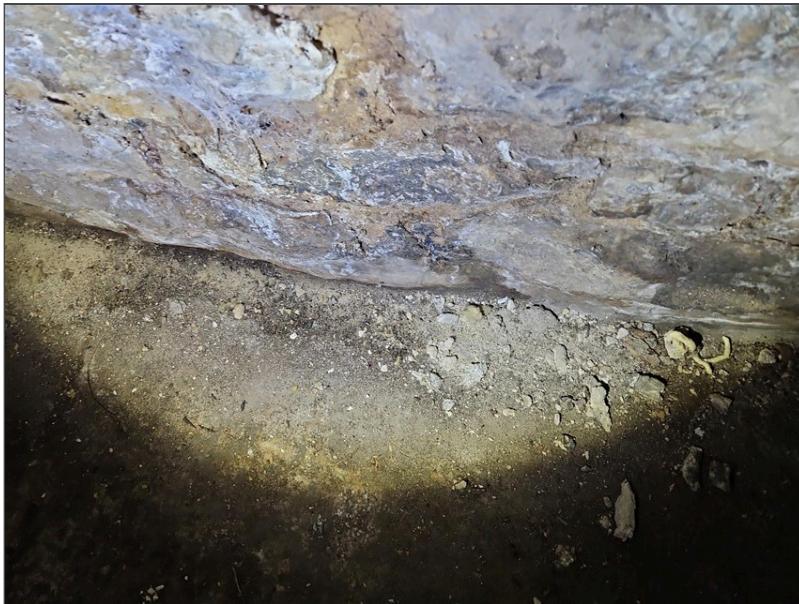
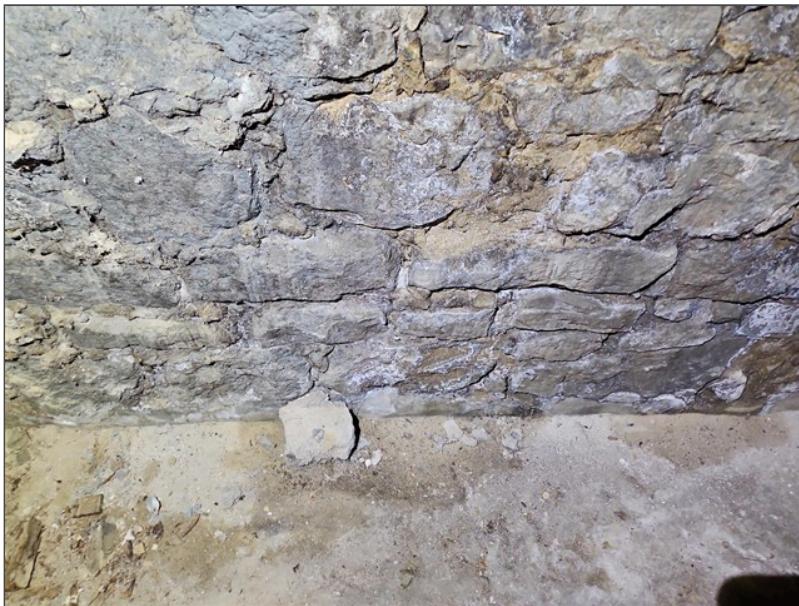
Defect: Pooling water and moisture stains were present in the basement. The mortar was deteriorated between the rocks/stones in the foundation wall in areas. The deterioration of the mortar in a rock/stone foundation wall makes it vulnerable to moisture intrusion and may result in the structural integrity of the wall being compromised.

Recommend further evaluation and repair as necessary by a qualified foundation specialist.

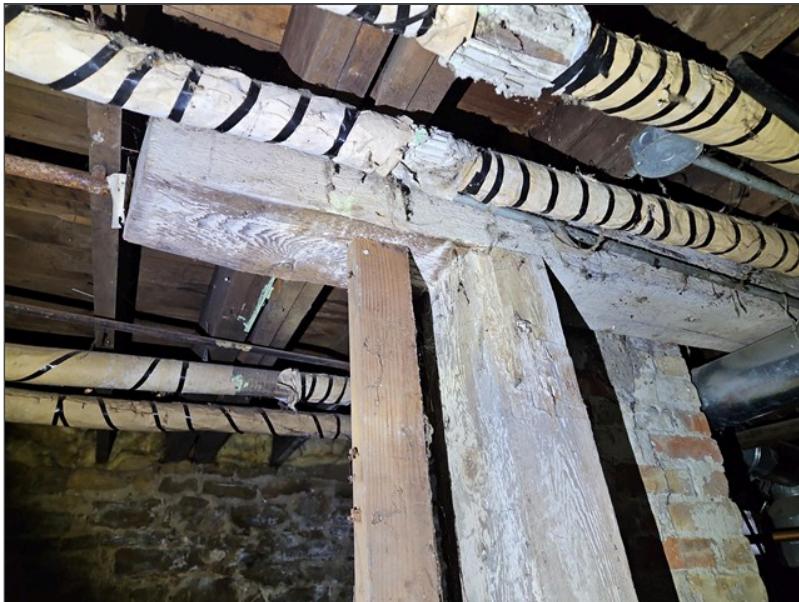
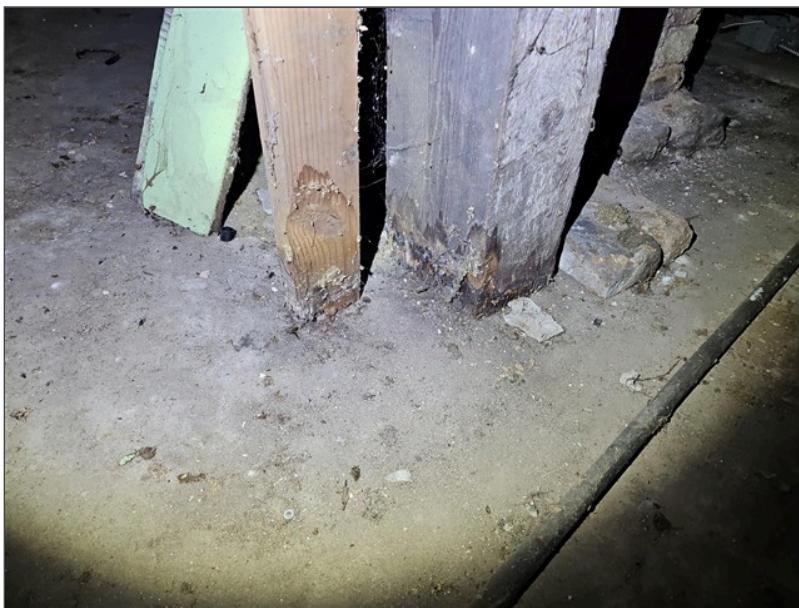
(1) **Defect:** Columns were not constructed in a manner or in a condition to adequately support the floor structure.

Recommend further evaluation and repair as necessary by a qualified professional.

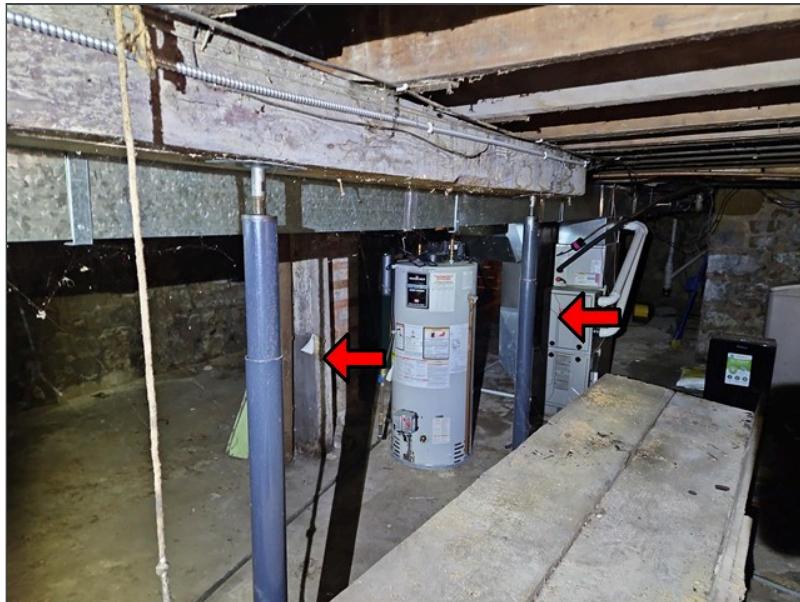
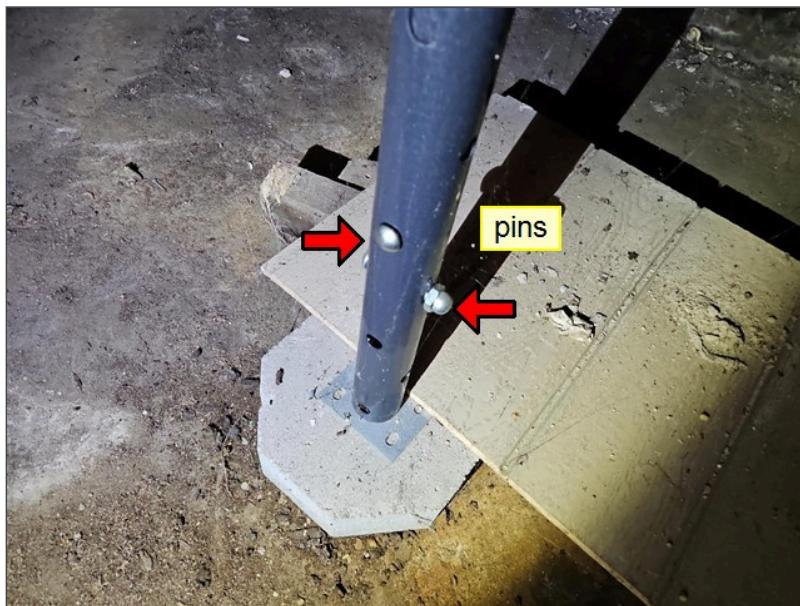
(2) **Defect:** Steel screw jacks were installed as columns supporting a main beam. Screw jacks are intended for temporary use only and not approved for permanent support. The pins only are supporting the floor structure.

Recommend further evaluation and repair as necessary by a qualified professional.

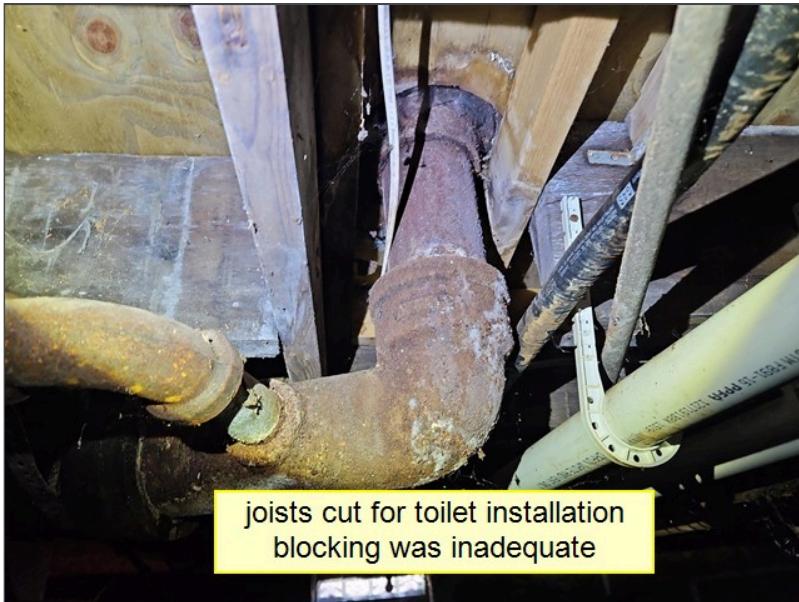
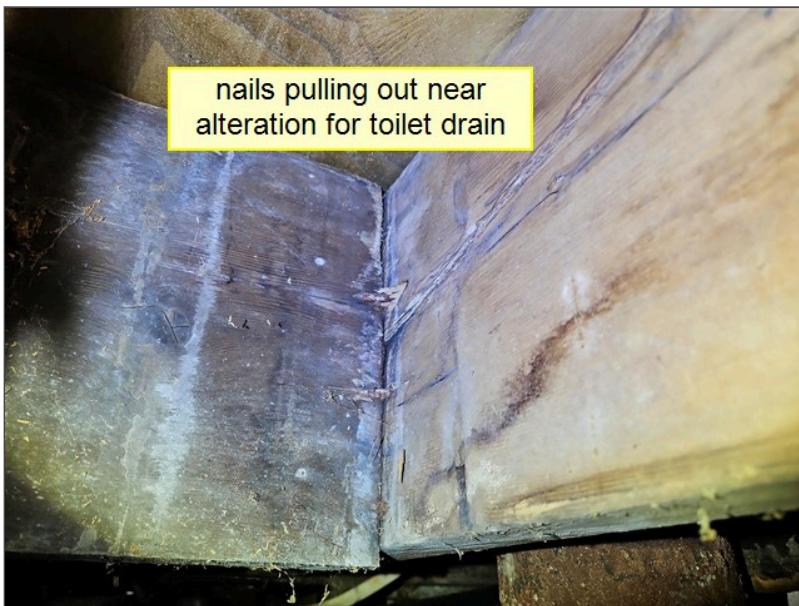
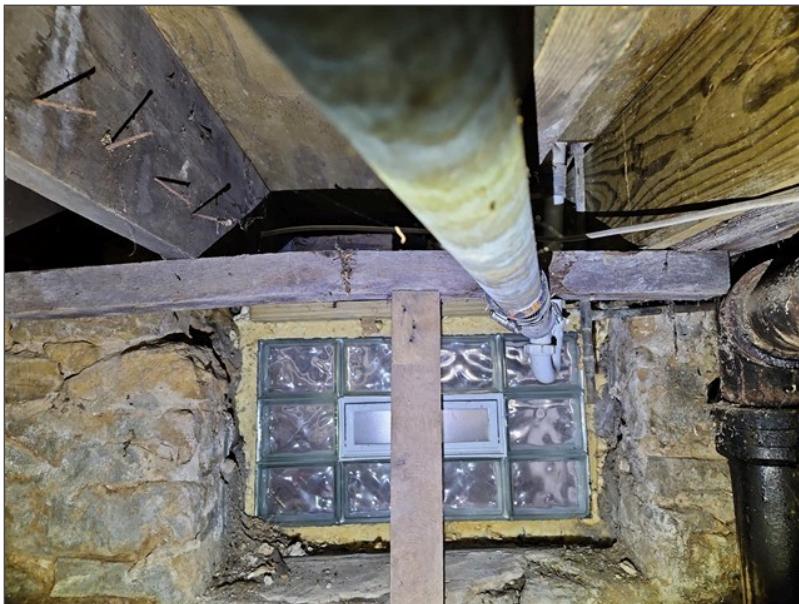
Defect: Joist(s) were altered in a manner that impact their structural integrity. Beam was sagging.

Recommend further evaluation and repair as necessary by a qualified professional.

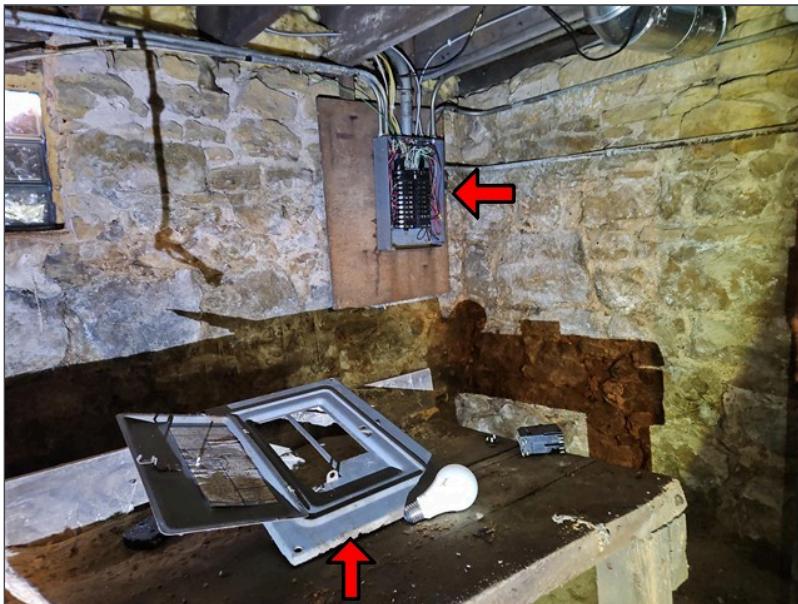
(1) **Defect:** The deadfront cover was not installed on the panel box.

Recommend further evaluation and repair as necessary by licensed electrician.

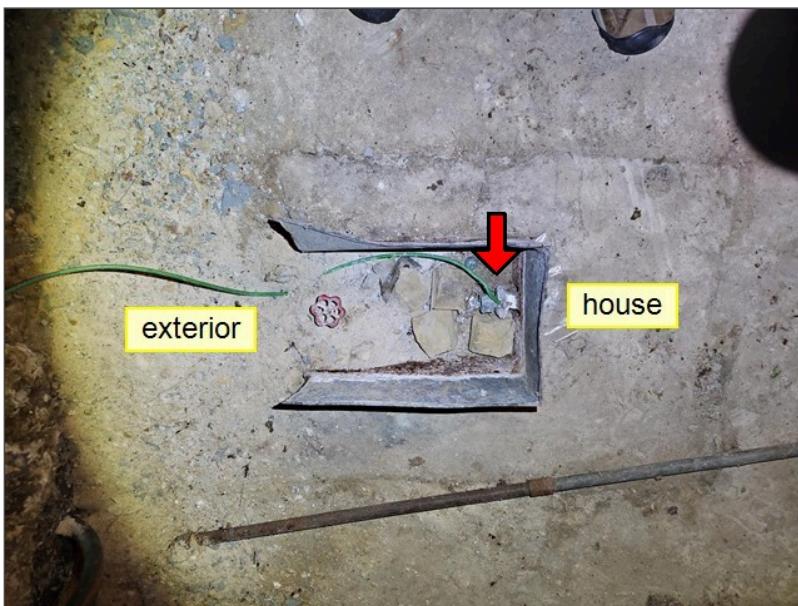
(2) **Defect:** A grounding electrode conductor (GEC) is the wire used to connect the grounding system of the home's electrical service to the grounding electrode (rod driven into the ground on the outside, main water supply pipe...).

The GEC was connected to a legacy lead water line - on the house side, not to the pipe leading to the ground outside.

Recommend connecting the clamp for the GEC to the current main water supply line by a licensed electrician.

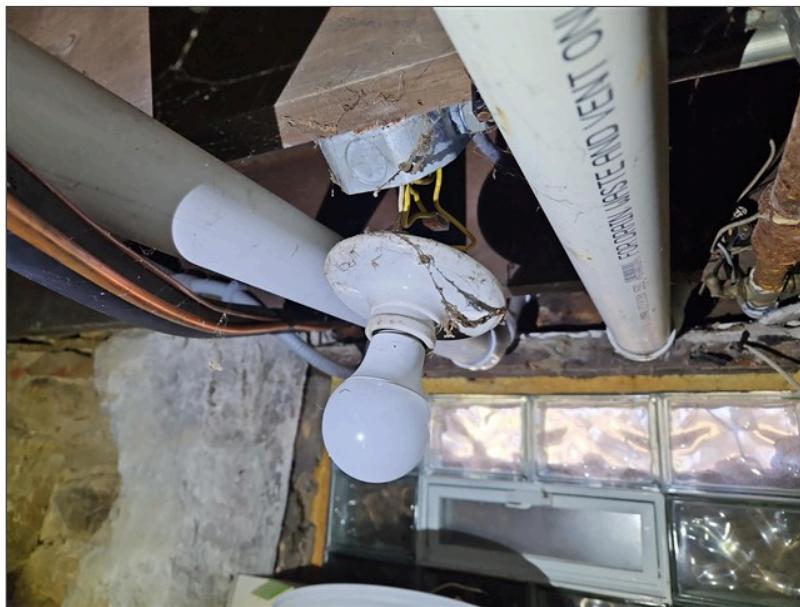
(1) **Defect:** Light fixture was not securely attached to the structure in the basement.

Recommend further evaluation and repair by a licensed electrician.
