APPLICATION FOR DEMOLITION OF PRINCIPAL BUILDINGS

City of Madison

Building Inspection Division

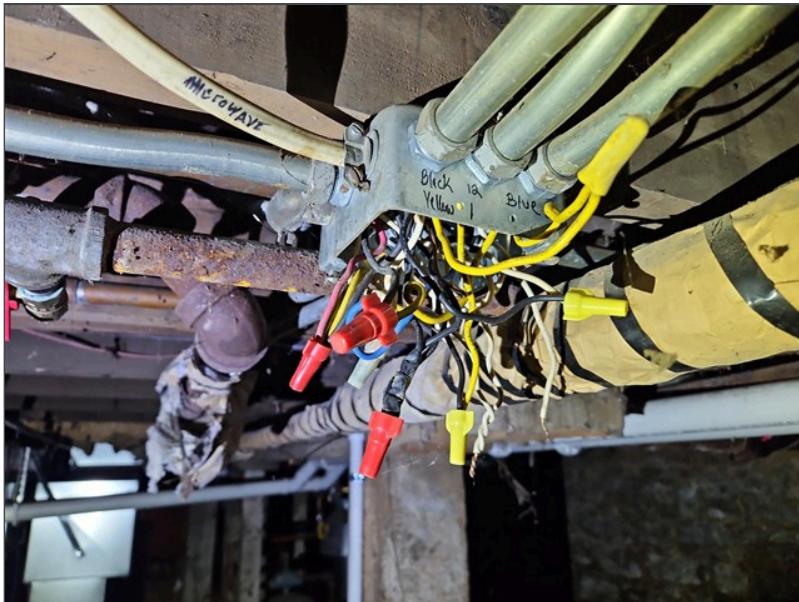
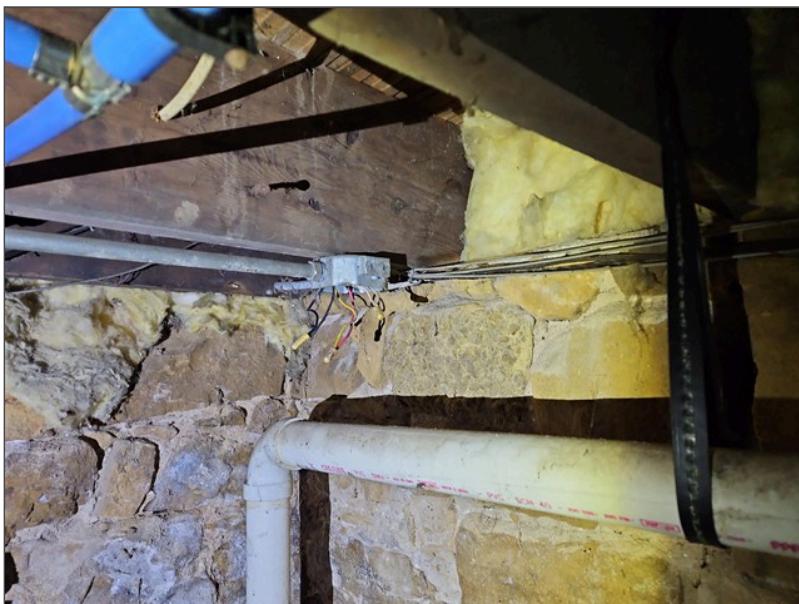
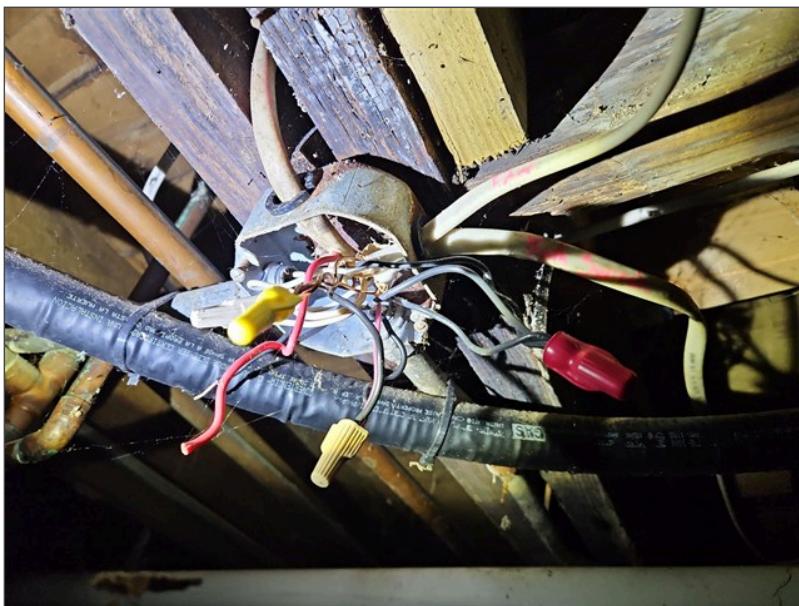
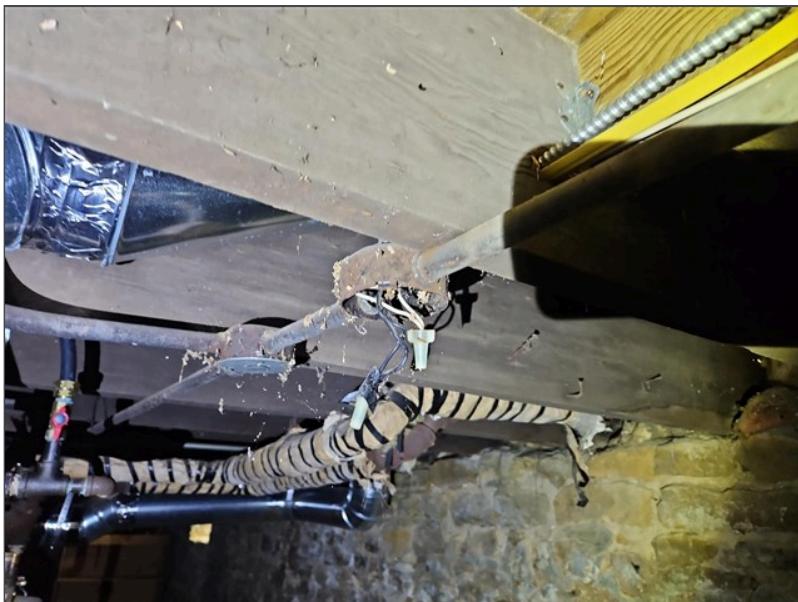
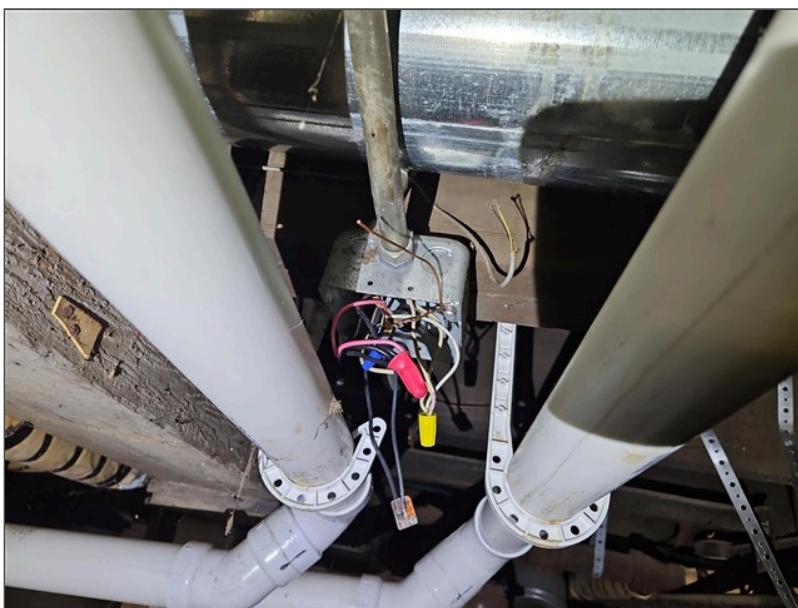
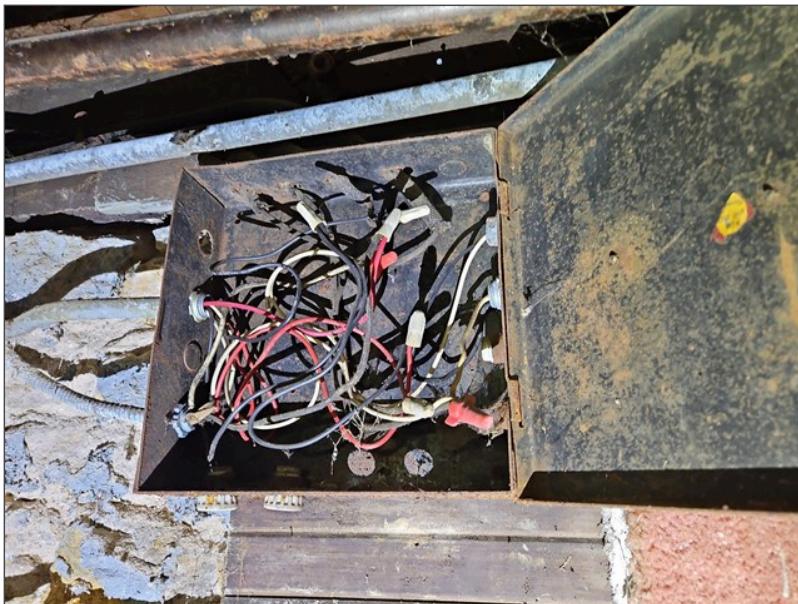
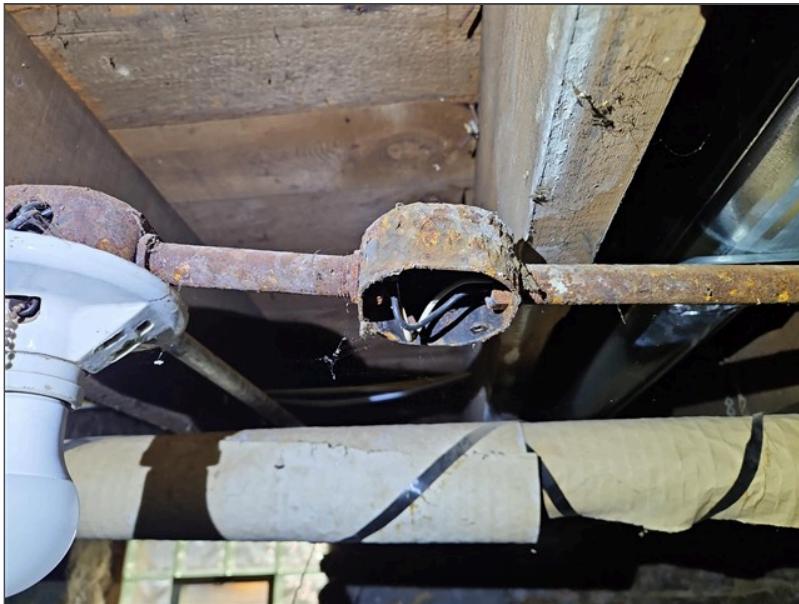
(2) **Defect:** Cover plates were missing. This condition leaves energized electrical components exposed to touch and is a shock/electrocution hazard.

Recommend further evaluation and repair as necessary by licensed electrician.

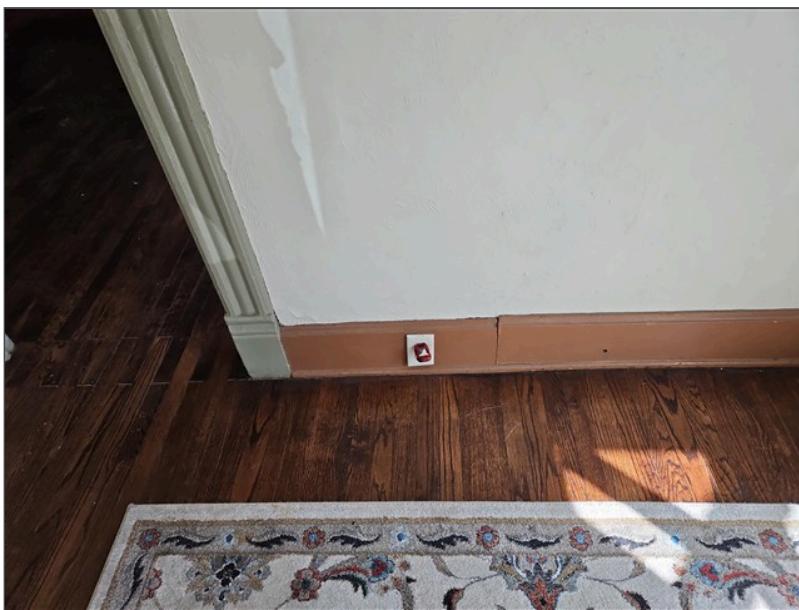
(4) **Defect:** Receptacle that was not energized was present in the dining room.

Recommend further evaluation and repair as necessary by a licensed electrician.

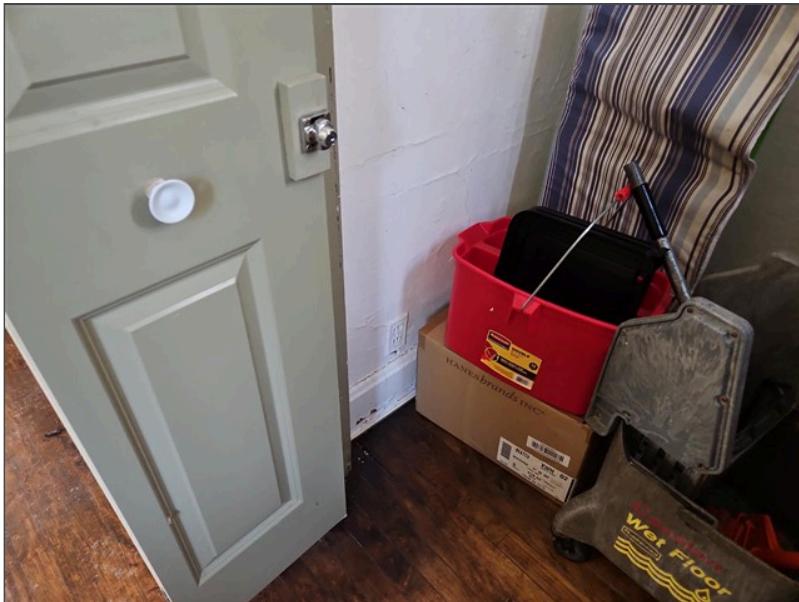
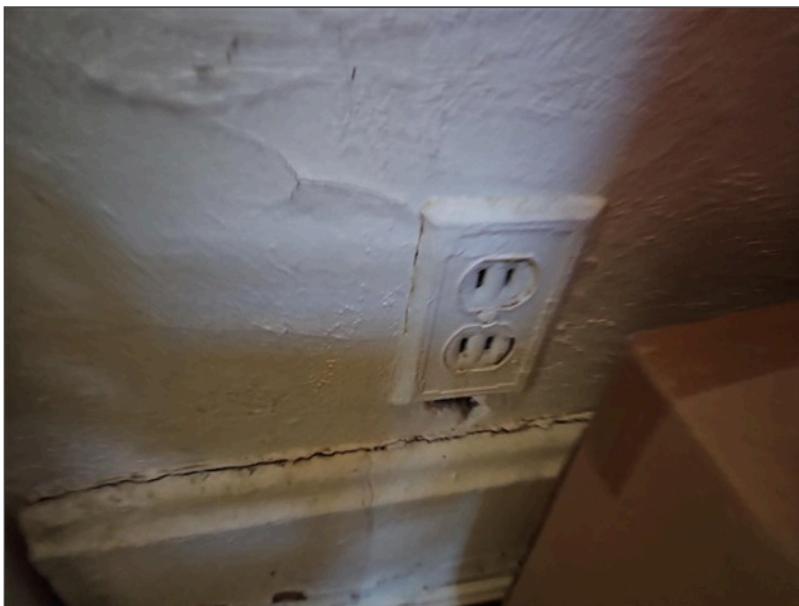
(1) **Defect:** Non-grounded, 2-prong electrical receptacles were present. The lack of a grounding conductor will limit the use of items that require a ground. If there is an electrical surge in the home, items not plugged into a grounded receptacle will be damaged. The use of grounded receptacles increases the safety of the electrical system for the occupants of the home.

Recommend updating receptacles to include a grounding system or safety disconnect such as a GFCI protected receptacle/breaker. Work should be completed by a licensed electrician.

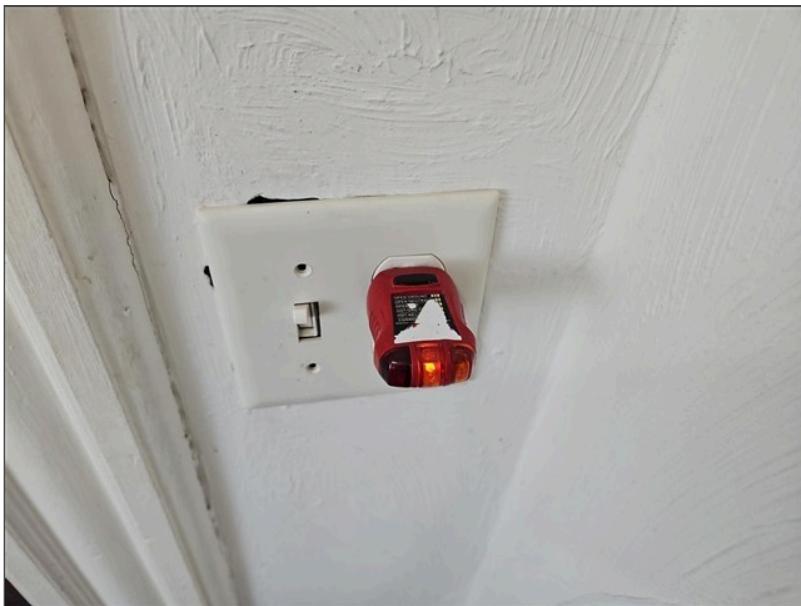
(2) **Defect:** Electrical receptacles had an open ground. There is an increased potential of electrical shock hazard as well as damage to electronics due to a power surge if a receptacle is not grounded.

Recommend further evaluation and repair as necessary by licensed electrician.

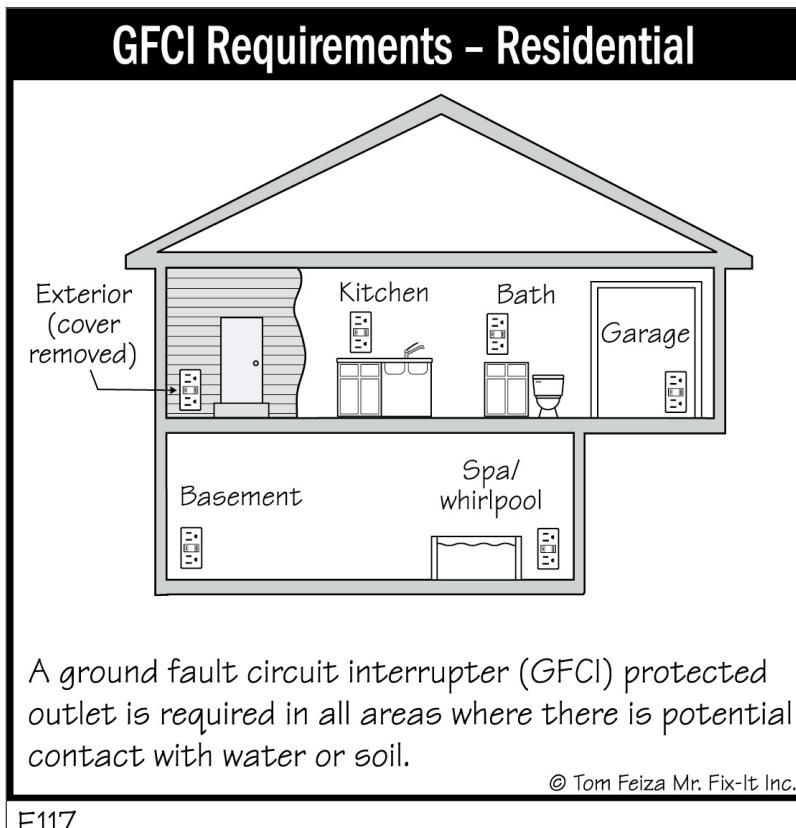
E117

(3) **Defect:** A GFCI protected receptacle monitors the flow of current in the receptacle. If it detects that current is flowing along an unintended path, such as through water or a person, it will trip. It is a safety device meant to protect the user from a shock/electrocution hazard.

GFCI protected receptacles were not installed in all required areas. The absence of GFCI protected receptacles is a shock hazard.

Recommend further evaluation and repair as necessary by a licensed electrician.

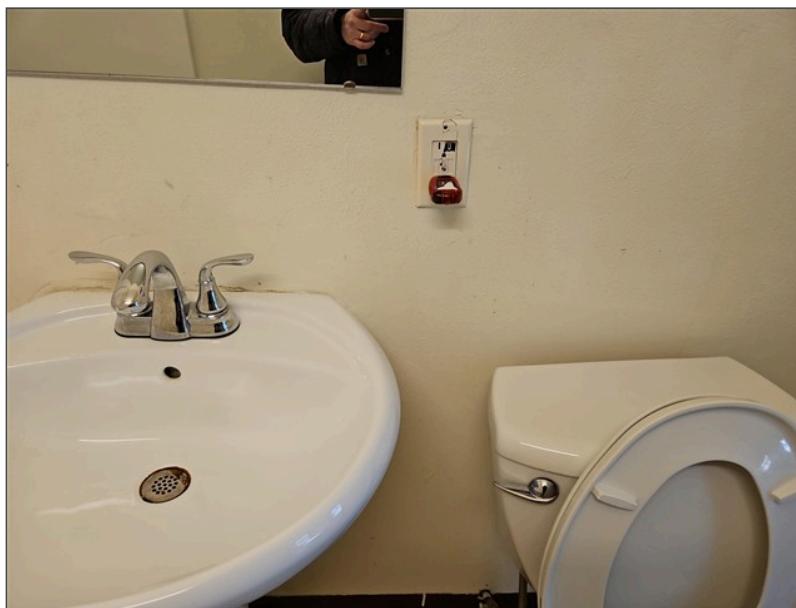
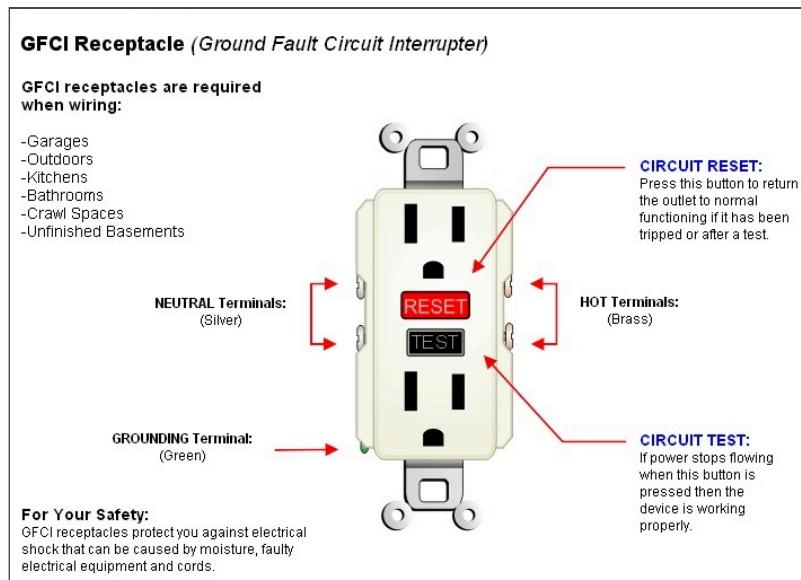
Defect: GFCI receptacle was not energized when Inspector arrived. The reset button did not energize.

Recommend further evaluation and repair as necessary by a licensed electrician.

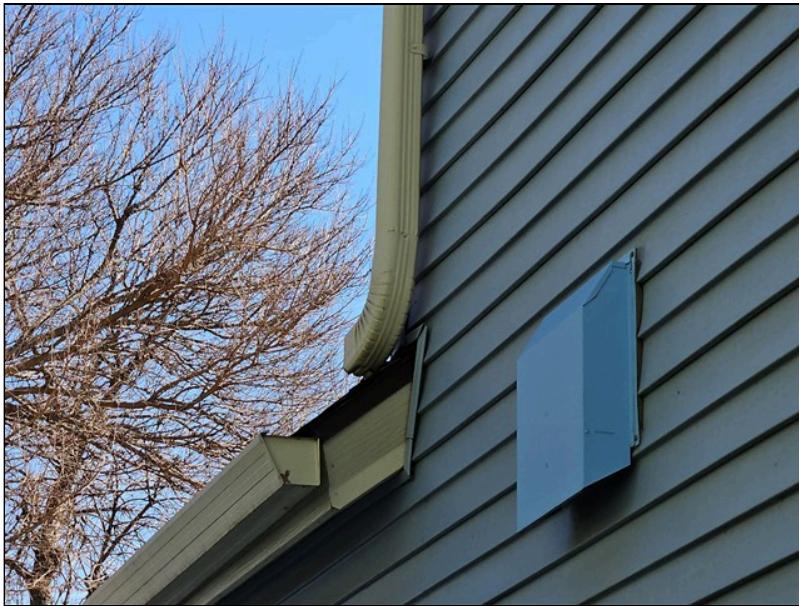
(1) **Repair:** Downspout discharged directly onto the lower roof covering. Over time the concentrated draining of water over this section of the roof can result in a reduced shingle life and/or leaking. If it is draining next to a sidewall or valley, there is the increased potential of moisture intrusion in the area.

Recommend a qualified contractor install a downspout to take water to the gutter on the lower roof.

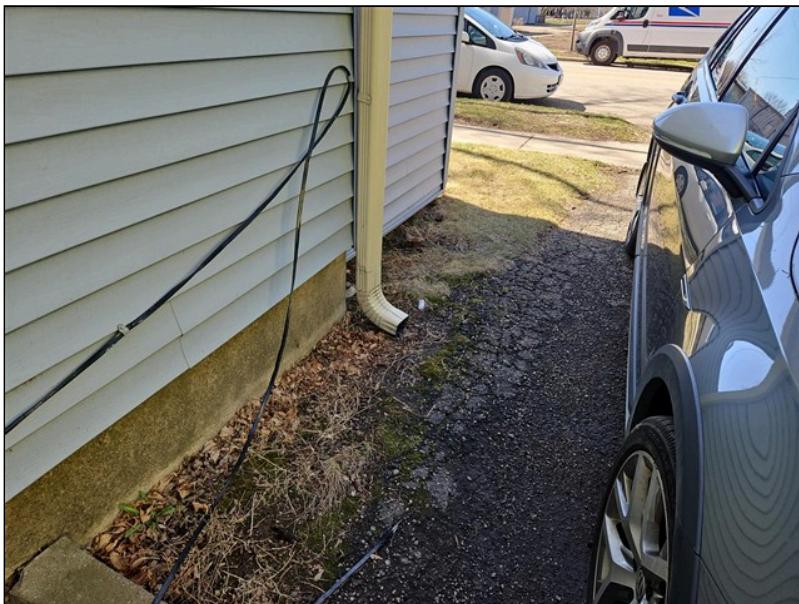
(2) **Repair:** Downspouts discharged roof drainage next to the foundation. This condition can result in excessively high moisture levels in the soil at the foundation and can cause damage to the foundation and moisture intrusion into the basement.

Recommend installation of downspout extensions to discharge roof drainage a minimum of (6) feet from the foundation.

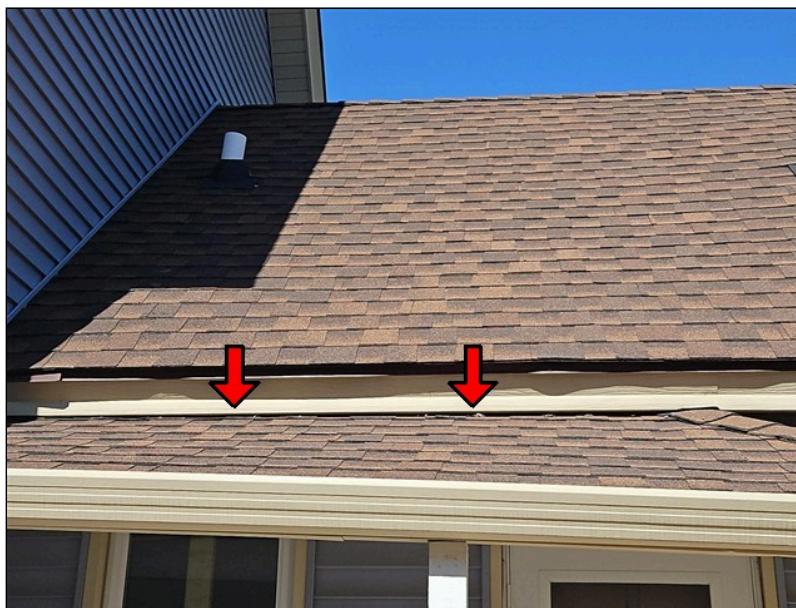
Repair: Headwall flashing was not installed in required areas. Areas are vulnerable to moisture intrusion and the resulting damage from it.

Recommend further evaluation and repair as necessary by a qualified roofing contractor.

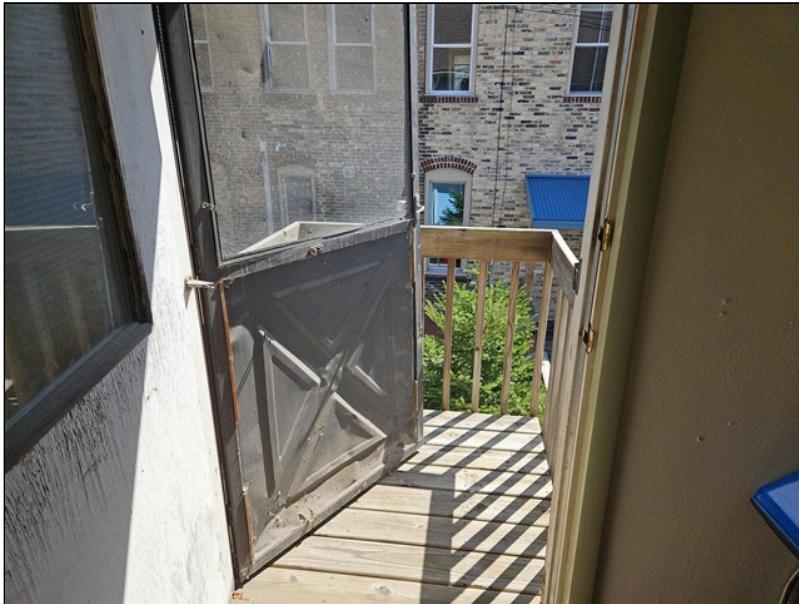
(2) **Repair:** Storm door to balcony was damaged.

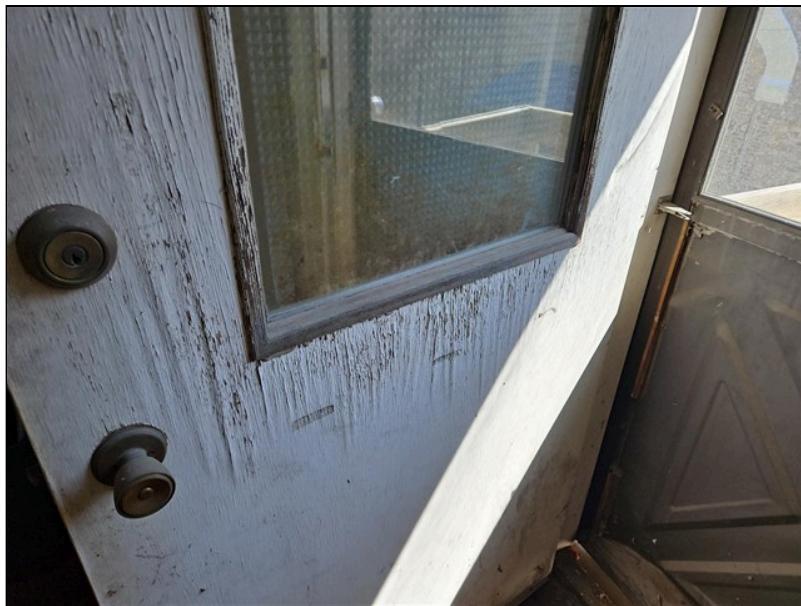
(3) **Repair:** Door to balcony was deteriorated.

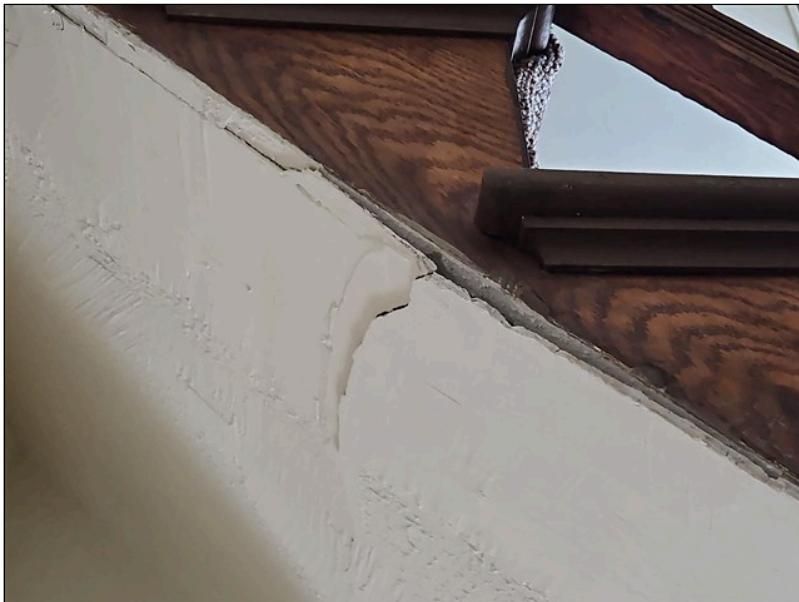
example of one location

(1) **Repair:** The plaster was disengaged/cracked in multiple locations.

Recommend further evaluation and repair as necessary by a qualified contractor.

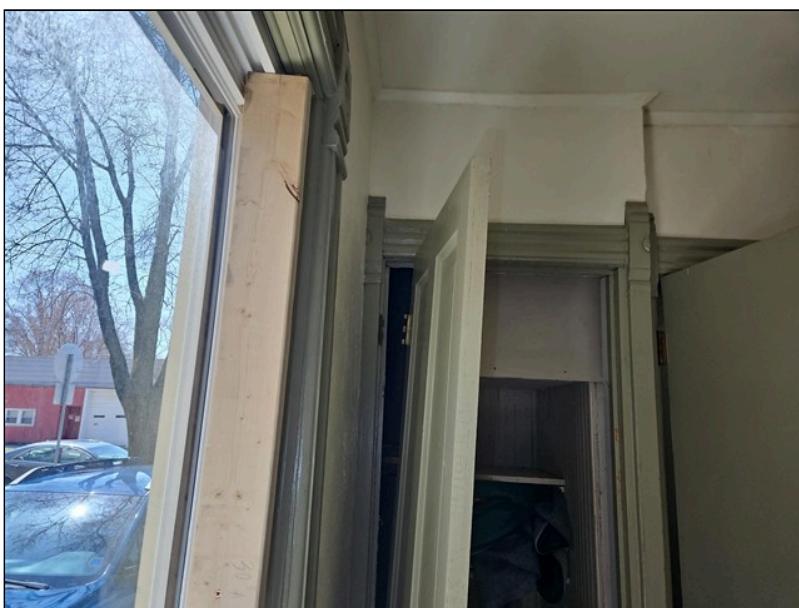
Repair: Door was not connected to the frame.

Recommend further evaluation and repair by a qualified contractor.

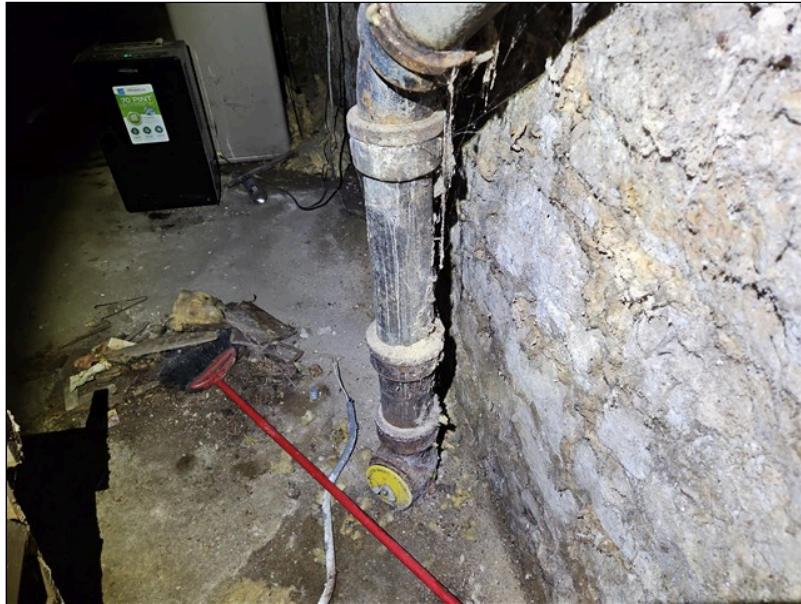
(1) **Monitor:** Cast iron and galvanized waste pipes will corrode from the inside to the outside over time and will need to be replaced eventually.

Recommend monitoring condition.

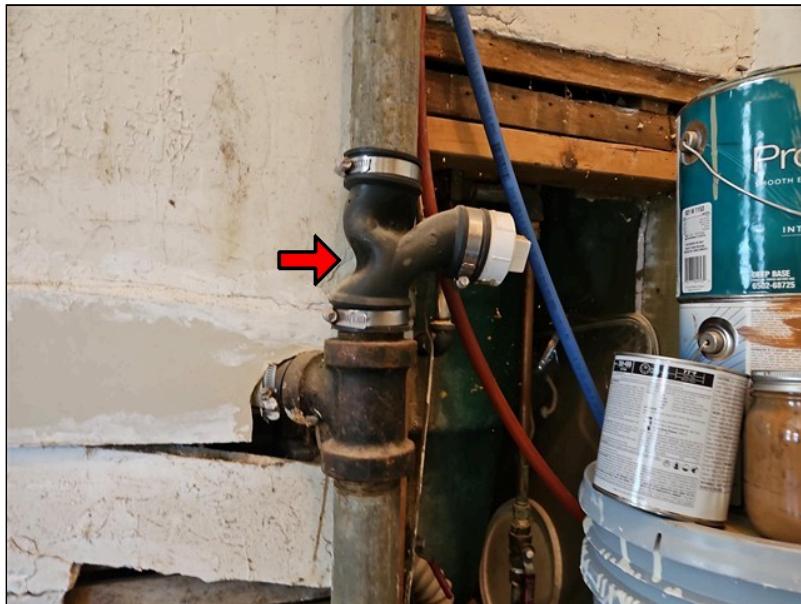
(2) **Repair:** Junction was deformed and may prevent proper drainage.

Recommend further evaluation and repair as necessary by licensed plumber.

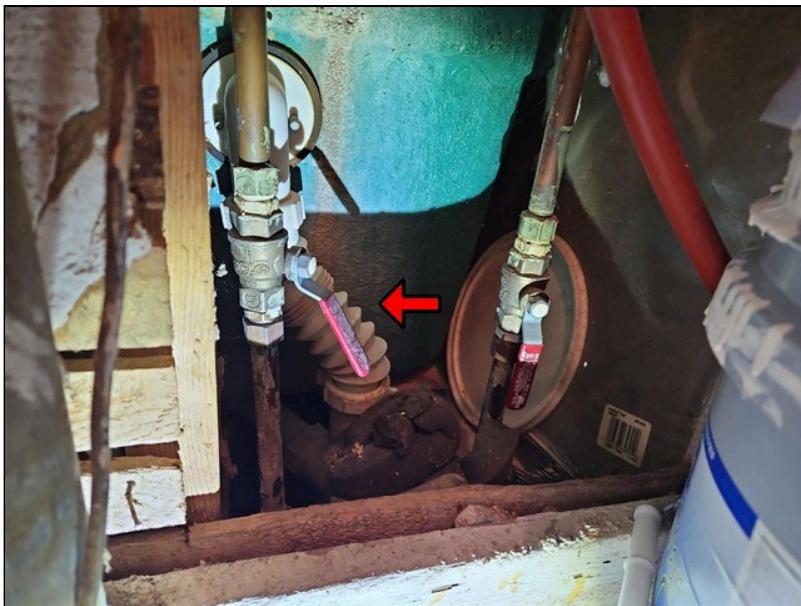
(3) **Repair:** An expandable drain line was installed under the main level shared bath tub. Expandable waste lines will trap debris making them prone to clogging.

Recommend further evaluation and repair as necessary by licensed plumber.

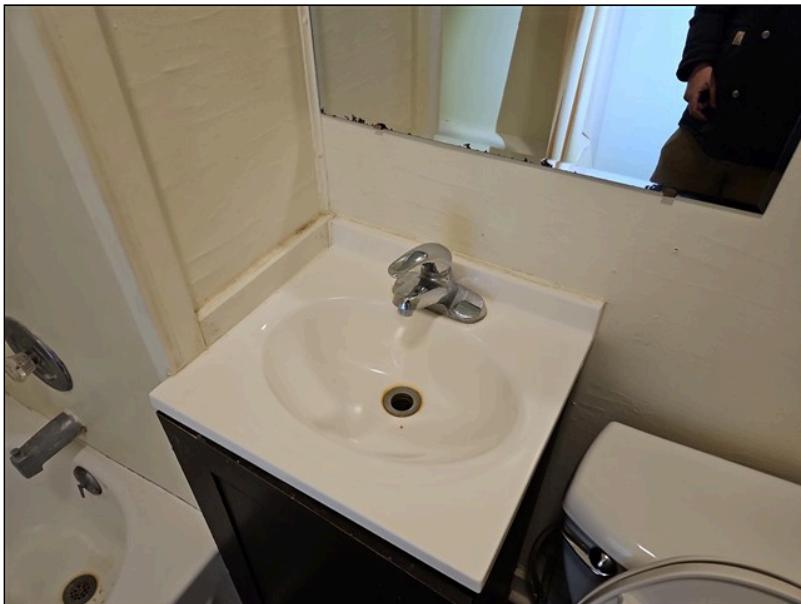
(4) **Repair:** In the upper level shared bath, the sink did not have a functional drain stopper. The sink would not hold water.

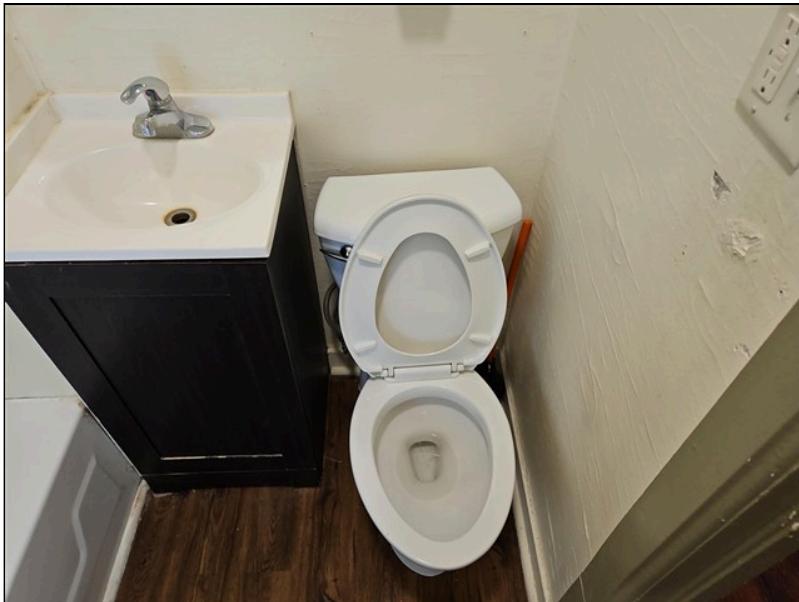
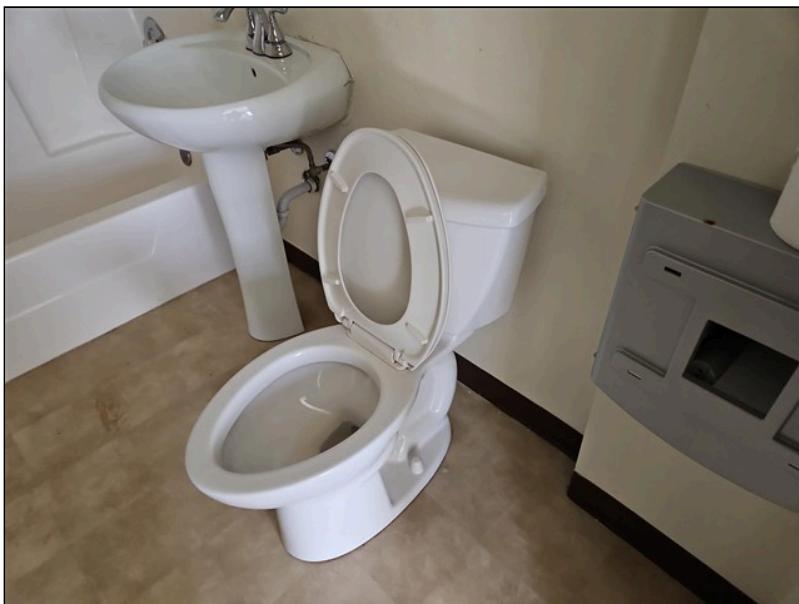
(1) **Repair:** Toilets in both bathrooms were not firmly attached to floor. This could be indicative of a worn wax ring, damaged subfloor, flange bolts needing to be tightened or other reason.

Recommend further evaluation and repair as necessary by a licensed plumber.

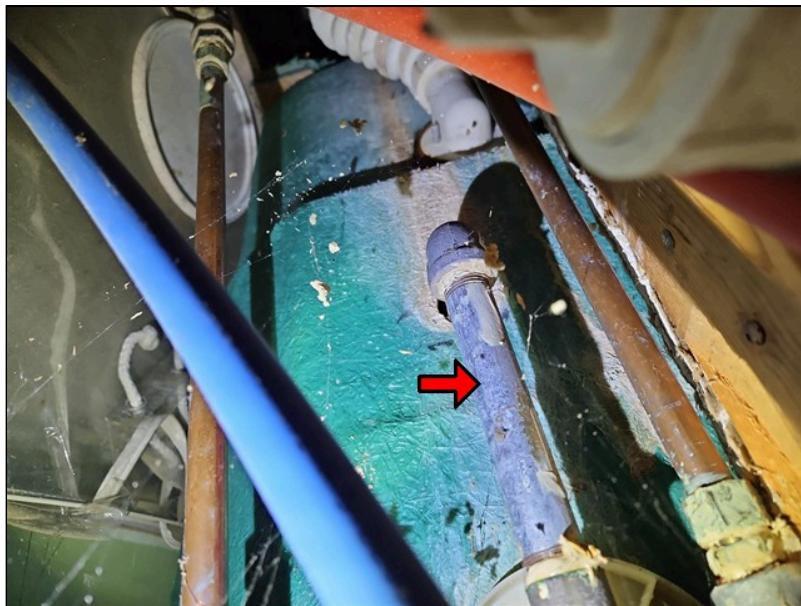
(2) **Monitor:** Galvanized steel pipe was in use for the water distribution lines. This style of pipe will rust from the inside out. The accumulation of rust/minerals on the inside of the pipe may restrict water flow. Recommend monitoring condition.

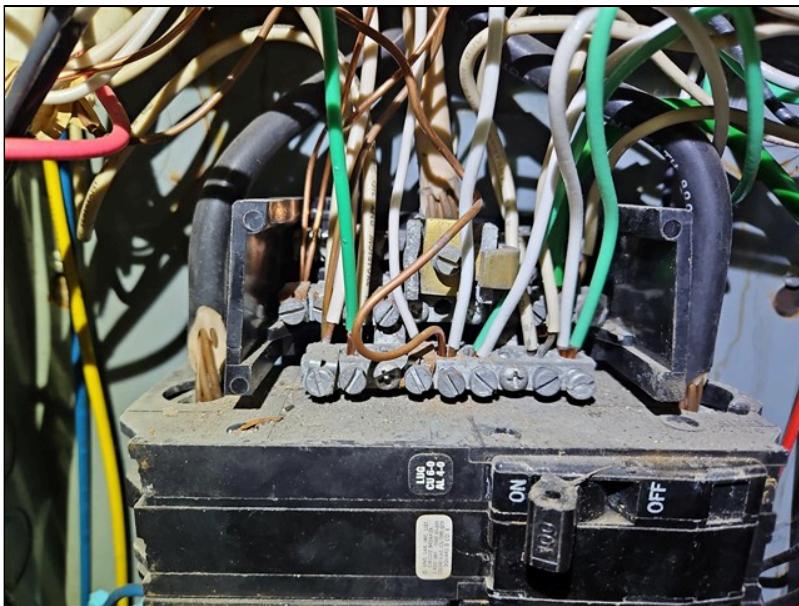
(1) **Repair:** Double lugged neutral and grounding conductors and double lugged neutral conductors were installed on the bus bar inside the main panel.

Lugs can loosen over time because of the electromagnetic force created by electrical current and the constant subtle heating and cooling of electrical circuits. A loose lug can result in arcing of the neutral wires against the bus bar and present a potential fire hazard.

Recommend further evaluation of the panel and repair as necessary by licensed electrician.

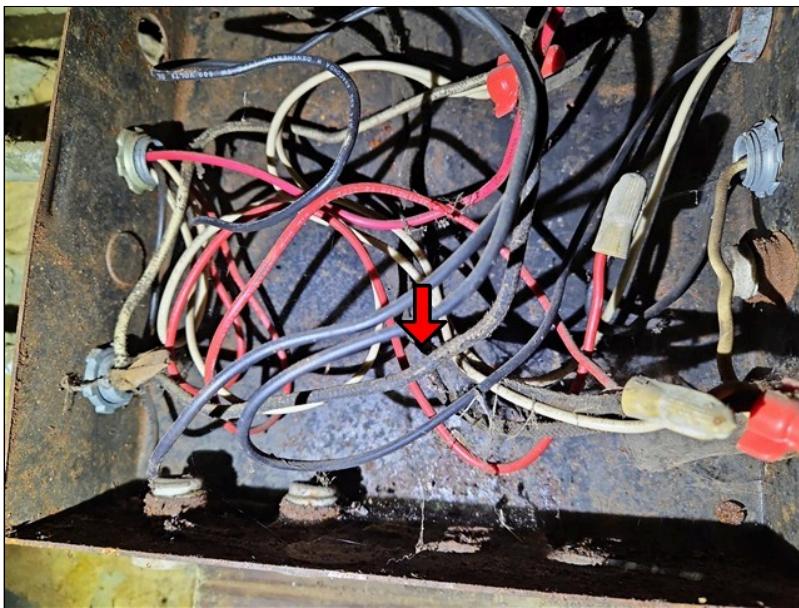
(2) **Further Evaluation:** Cloth wiring was present.

Cloth wiring is an older style, typically found in homes built before the 1960s. The cloth covering can become brittle, crack, or flake over time and exposing the wires which can be a shock and fire hazard.

Recommend further evaluation by a licensed electrician.

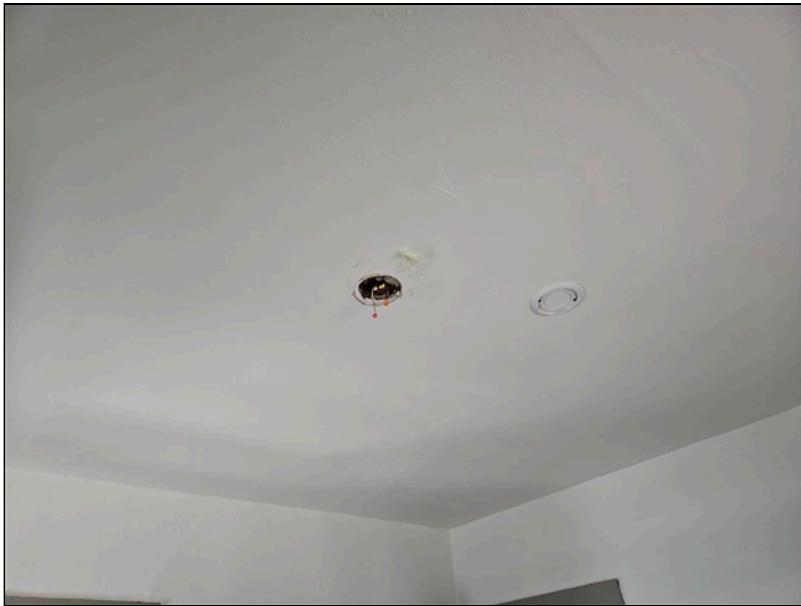
(3) **Repair:** There was no light fixture in the kitchen.

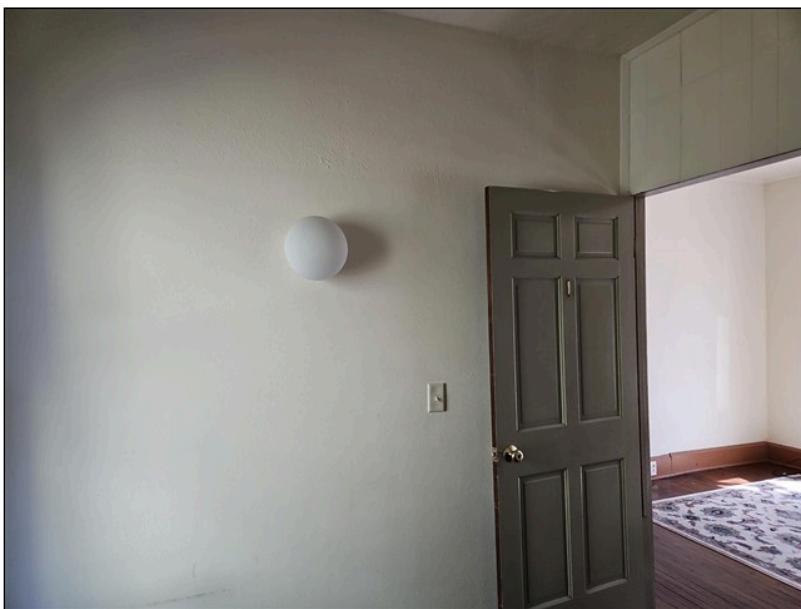
(5) **Further Evaluation:** Light fixture(s) did not respond to the switch. The bulb may need to be replaced or there may be a problem with the switch, fixture or wiring. If after the light bulb is replaced, the fixture does not respond to the switch, recommend further evaluation and repair as necessary by licensed electrician.

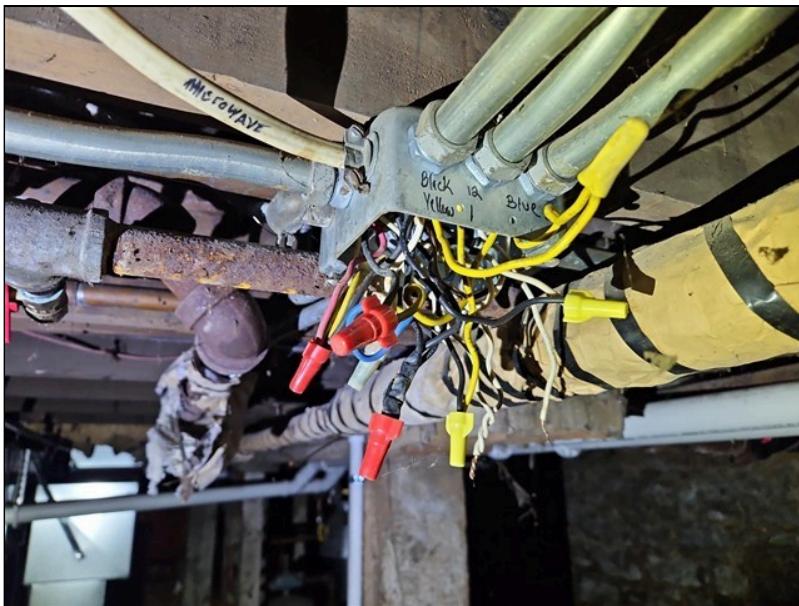
(6) **Further Evaluation:** There is a limit to the number of wires that can be in a junction box. An excessive number may cause overheating and can be a fire hazard.

Recommend further evaluation of all junction boxes by licensed electrician.

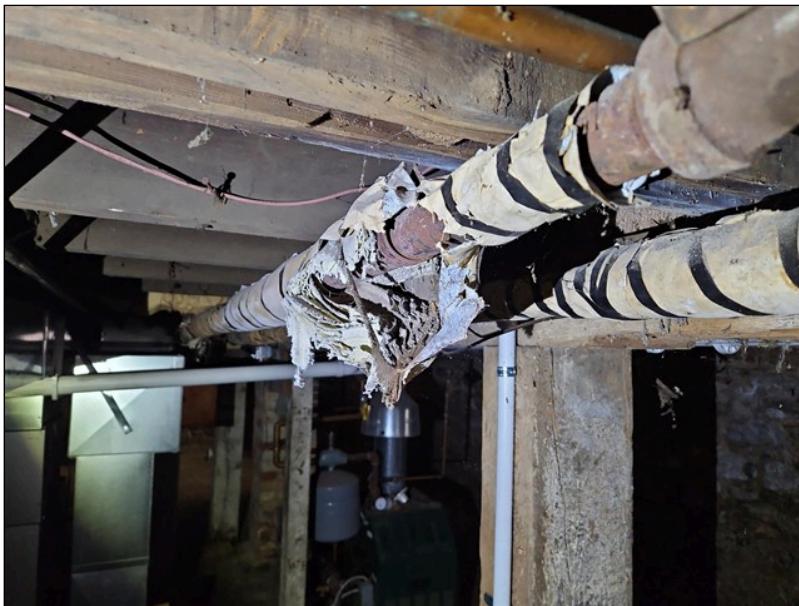
Further Evaluation: A material that has the appearance of asbestos was present on the legacy water pipes for the radiators. Asbestos is linked to health concerns. Recommend further evaluation and addressing as necessary by a qualified professional.

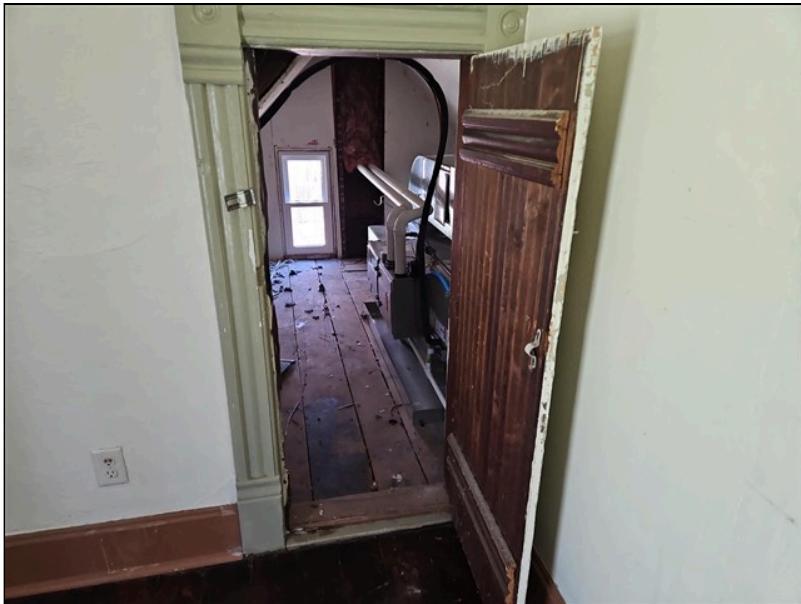
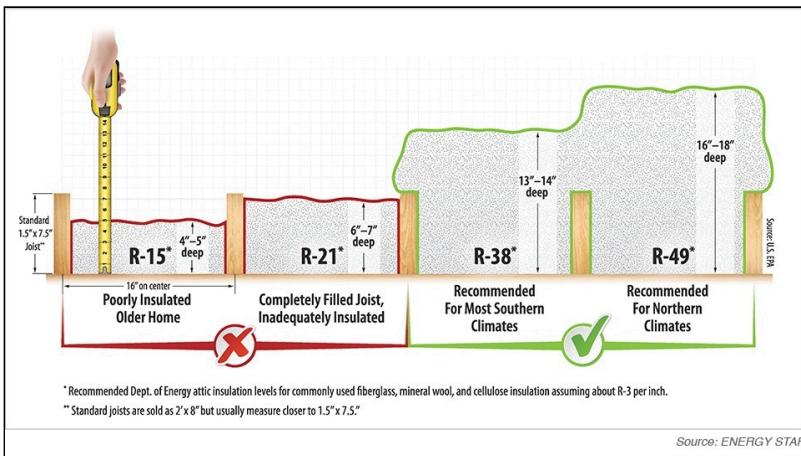
(1) **Repair:** An insufficient amount of insulation was installed in this attic per today's standards. Recommend a qualified insulation specialist provide further evaluation and add insulation as necessary. Please note that adding insulation may require more ventilation and/or air sealing. All three should be evaluated together.

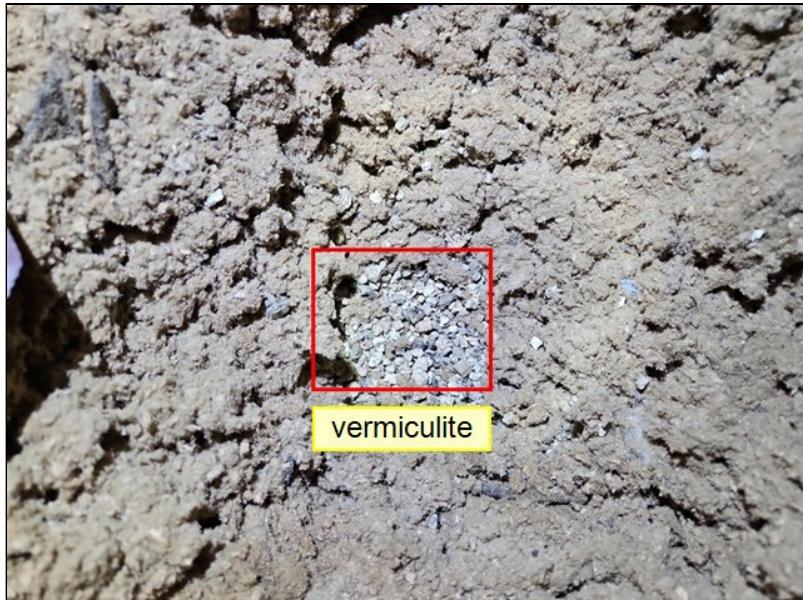
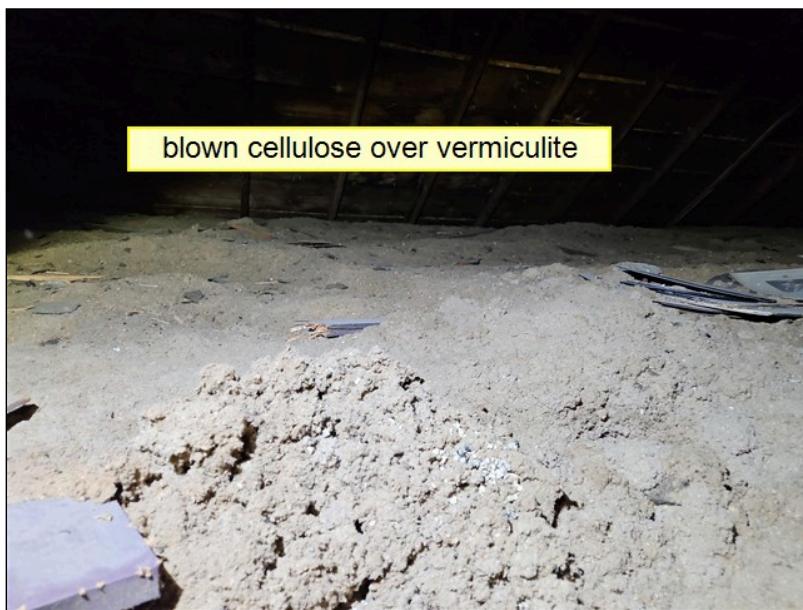
(2) Further Evaluation: Vermiculite insulation was present in the attic. Vermiculite insulation is known to contain asbestos. Testing by a qualified asbestos abatement specialist would need to be conducted to confirm the presence of asbestos with certainty.

Recommend further evaluation of the attic in these photos and the attic space with the planking on the floor and addressing as necessary by qualified asbestos abatement specialist.

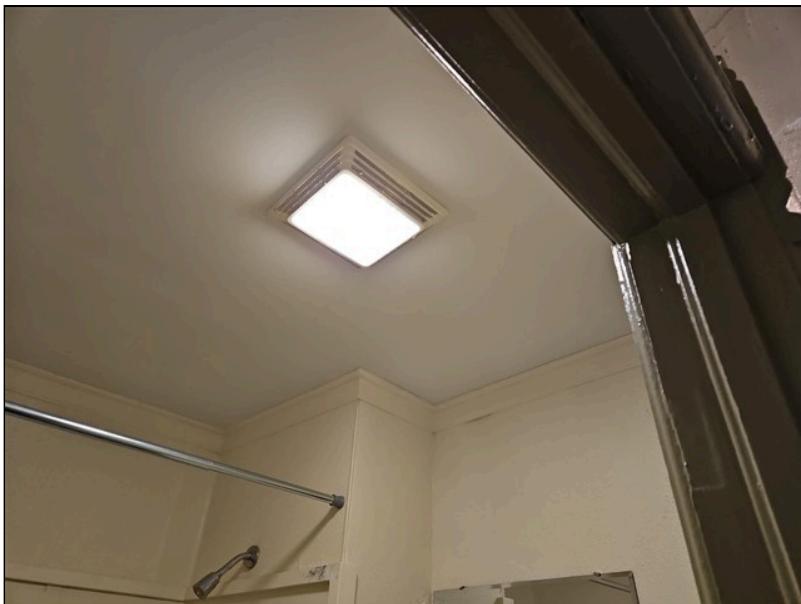
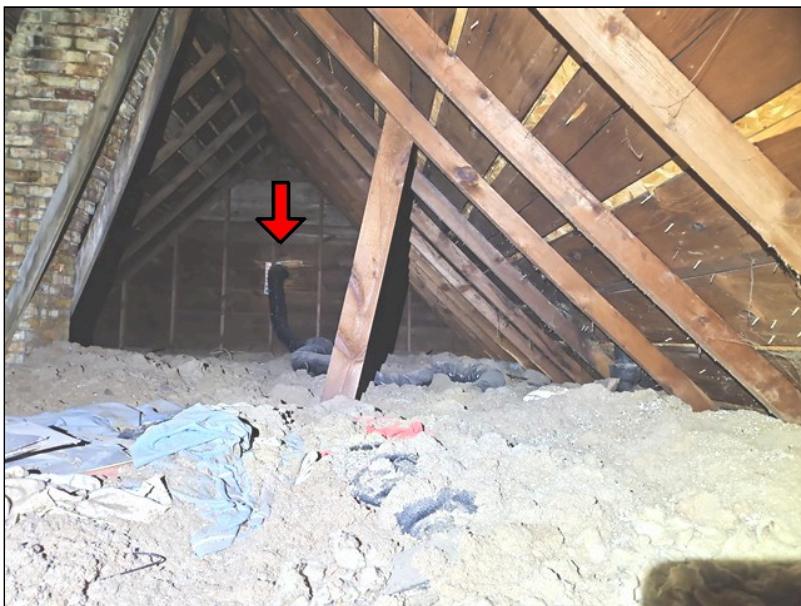
(1) **Repair:** A gable vent that would be used to vent the attic space was in use for the bathroom fan.

Recommend further evaluation and repair as necessary by a qualified contractor.

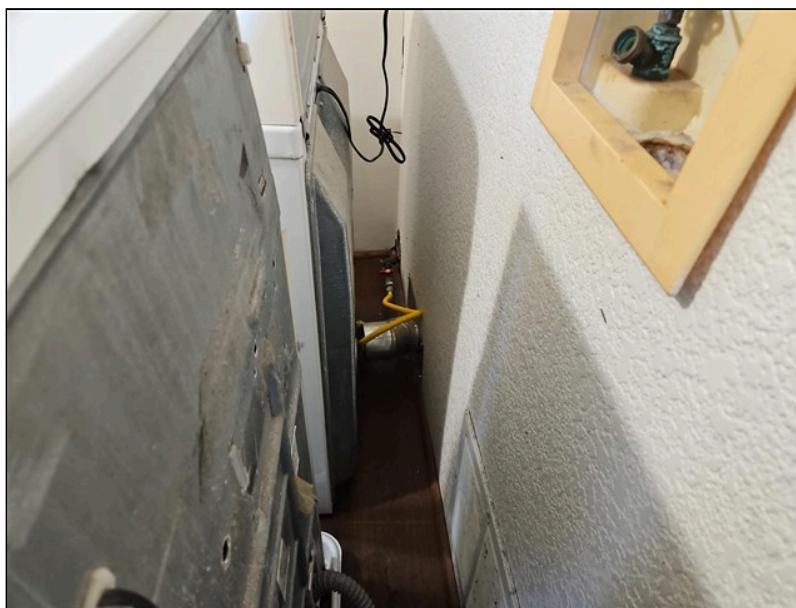
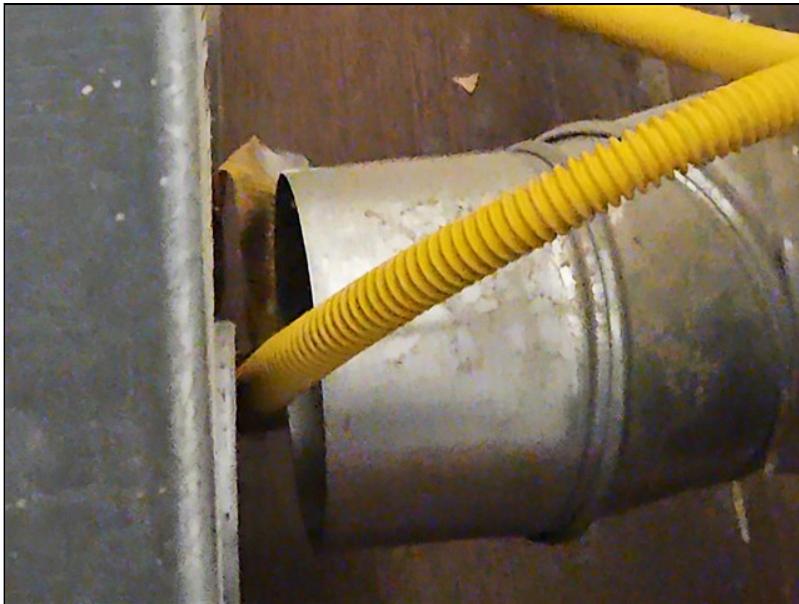
(2) **Repair:** The dryer vent was disengaged and not venting to the outside. This can create high levels of humidity in the home and introduce lint into the air.

Recommend further evaluation and repair as necessary by a qualified individual.
