Charles J. Quagliana, AIA
Preservation Architect
5641 Willoughby Road
Mazomanie, WI 53560

May 31st, 2019

Re: Essen Haus Property
506/508, 510, 514/516 & 518 East Wilson Street

The following is my report on the properties at 506/508, 510, 514/516 & 518 East Wilson Street, Madison, Wisconsin.

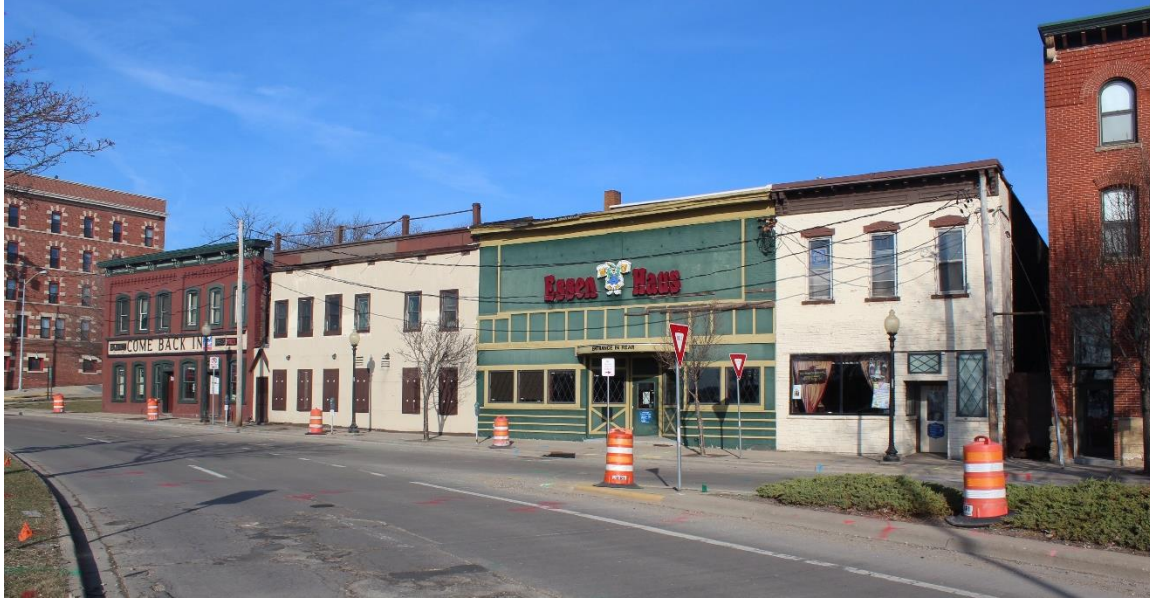
View of 506/608, 520, 524/526 and 518 East Wilson Street March 29, 2019.

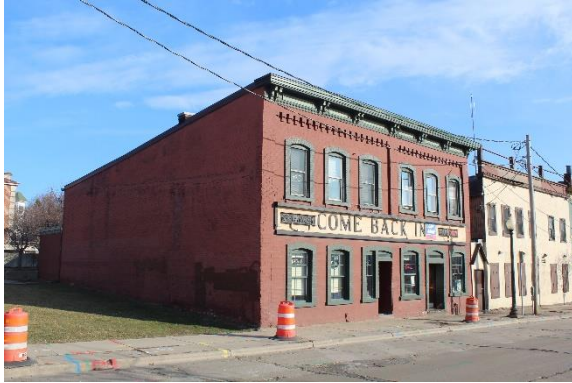
View of the street façade of 506/508 East Wilson Street

The second floor front façade is relatively intact from original conditions, although the masonry has been painted and replacement non-sympathetic windows installed. The first floor original commercial façade with its large open display windows, recessed double doors and transoms has been infilled to replicate the façade above.

The west masonry wall originally functioned as a party wall for a now lost adjacent building. This exterior of this wall has the ghost of the roof line of the former neighboring building imprinted upon it. This wall is deteriorating along the ground plane as water infiltrates the porous brick masonry.

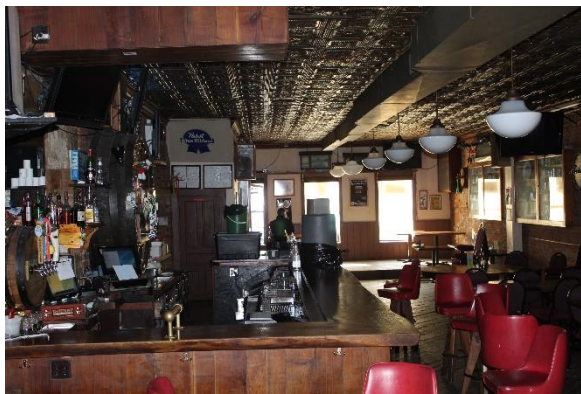
View of bar area of 506.

The first floor interior has been modified over time by multiple remodeling projects. The “volumes” of the original primary historic commercial space(s) of the first floor are recognizable but the wall and ceiling finishes and mechanical systems are contemporary. The diagonal 5” wide oak wood floor does remain.

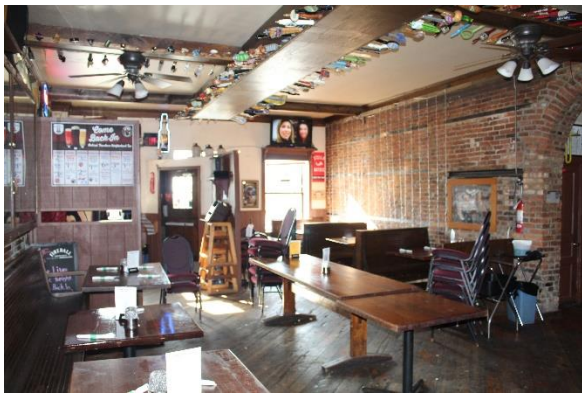
The existing second floor rooms are worn, outdated and deteriorated. They are very substandard in terms of condition. The state of condition does warrant a very significant extent of repair and rehabilitation to bring these spaces into contemporary standards.

Interior view of 508

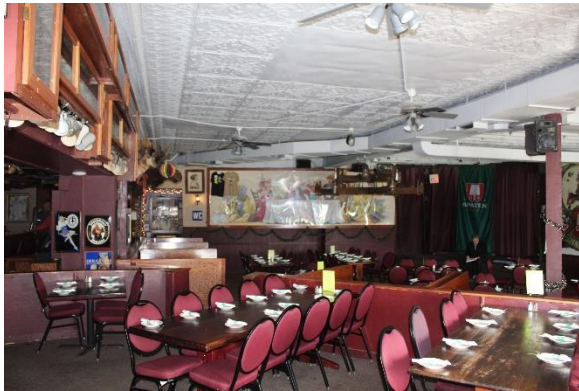
This building has originally housed restaurants, men's clothing store and a shoe store. The first floor interior has been significantly modified by multiple "subtractive" remodeling projects. The primary historic commercial space(s) of the first floor is unrecognizable. The original finishes, floors, walls, ceilings and components (doors/windows) are all lost.

View of portion of dining room in the Essen Haus.

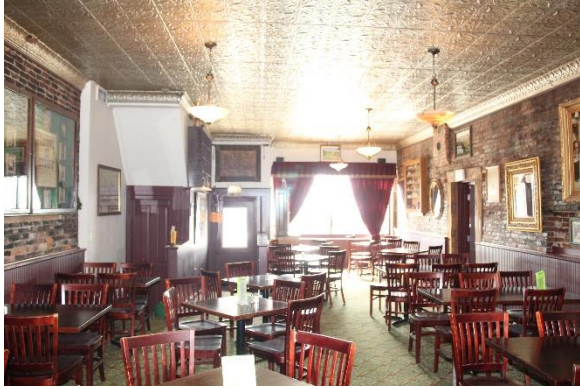
First floor of 518

The first-floor framing at the back half of the building has collapsed into the basement. The progression of the floor collapse has damaged the brick masonry rear wall of the building. In addition, without the attachment to a first floor, the exterior masonry walls of the back of the building are now much taller and slender, taken with the damage, portions may be unstable. The front portion of the building's first floor are showing similar signs of deterioration.

The first floor interior has been modified by multiple “subtractive” remodeling projects. The primary historic commercial space of the first floor is unrecognizable. The original finishes, floors, walls, ceilings and components (doors/windows) for first are lost. The rear section of the interior is a ruin, as the first floor has collapsed into the basement.

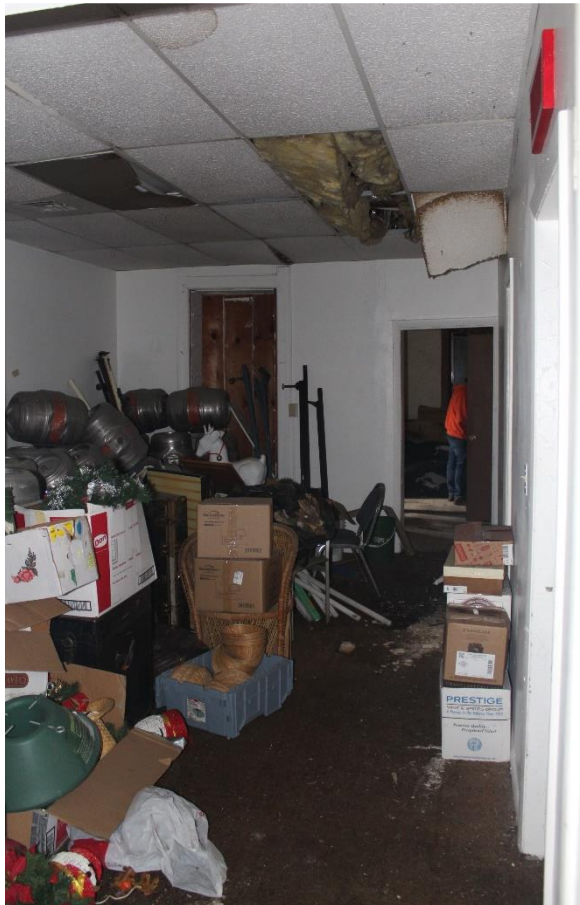
Second floor 518

The second floor interior remains an apartment, but this has been modernized several times and only fragments of original fabric remain in one bedroom. Access is from an interior stair on the right side of the building.
