EXISTING BUILDING REVIEW

125 State Street

Name: Madison Fire Engine House No. 2/ Castle & Doyle Building

125 State Street – Architectural Review

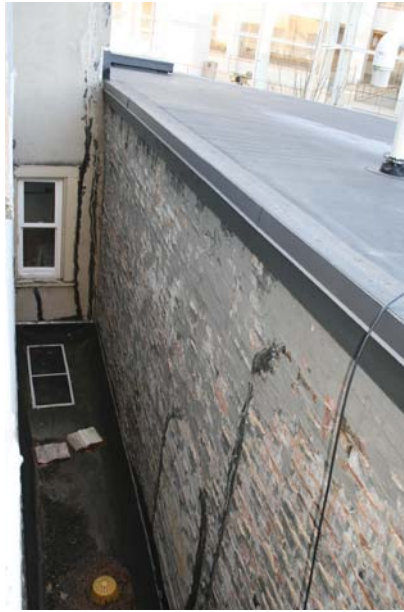
Exterior: View of side wall (party wall) between 125 state street and 121-123 State Street

The east and west walls of the building are common brick party walls. A small portion of the party wall is exposed at the light well of the adjacent building at 121–123 State Street. Where observed, the masonry appeared to be in fair condition, with some erosion of brick units and extensive mortar parging on the surface (Figure 14).

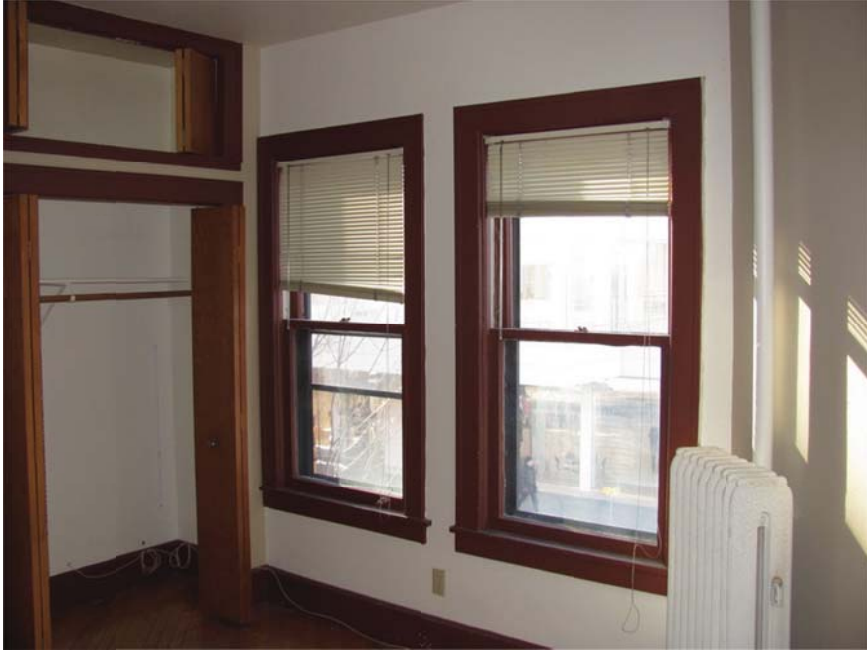
The second floor interior has been adapted as a two-bedroom apartment. The kitchen and bathroom are several decades old. The two bedrooms and main living room have painted wood baseboard and window and door trim, hardwood floors, painted plaster walls, and several historic wall sconce light fixtures (Figure 17 and Figure 18). These finishes apparently date to the 1921 renovation of the building. Throughout the second floor, the plaster ceiling has been covered with rigid insulation and painted gypsum board. Second floor interior doors are newer flat panel wood veneer doors.

Figure 17. The second floor interior.

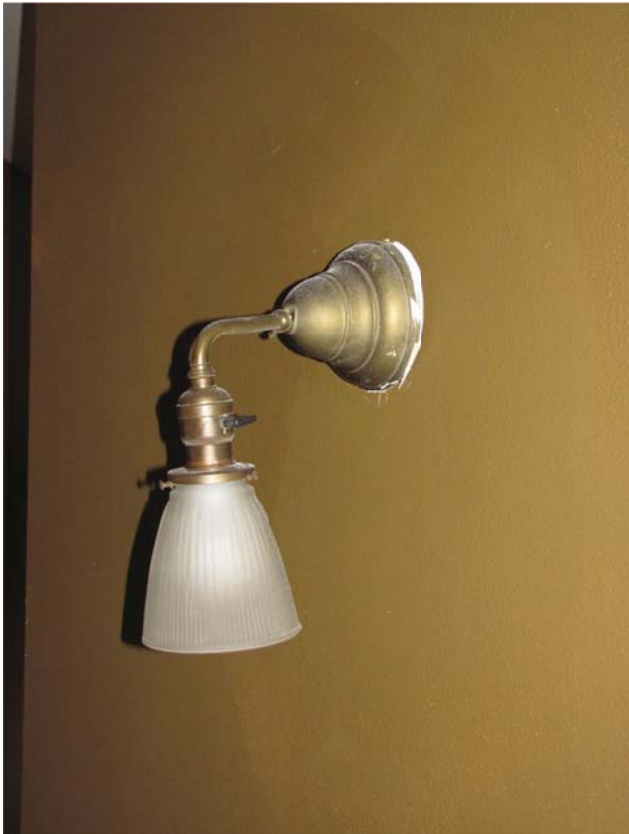
Figure 18. Circa 1921-era wall sconce light fixture at the second floor.

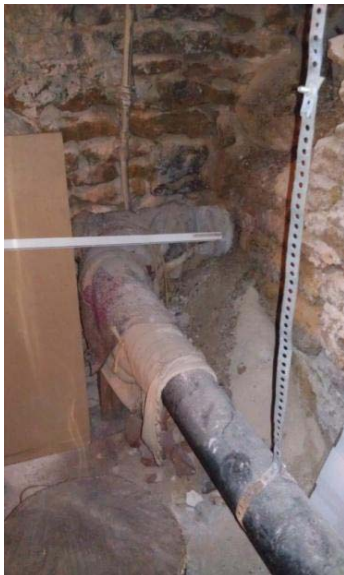
Sanitary sewer

The heating system consists of a gas-fired atmospheric hot water boiler located in the basement. A gas-fired domestic water heater is next to the boiler. The retail space has an air conditioning unit but the apartments not air conditioned. There is a single gas meter and single water meter for this building, which serves only this building. The roof drains into a gutter along N. Fairchild St. and into an exterior downspout .

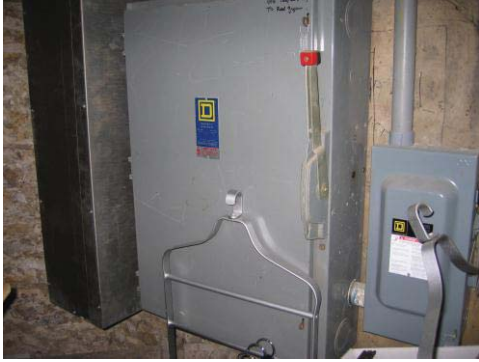
Building main disconnect.

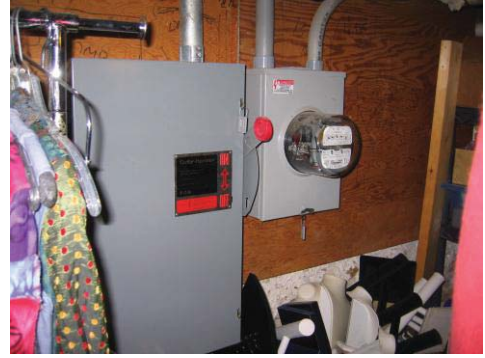
Basement electrical meter and disconnect.

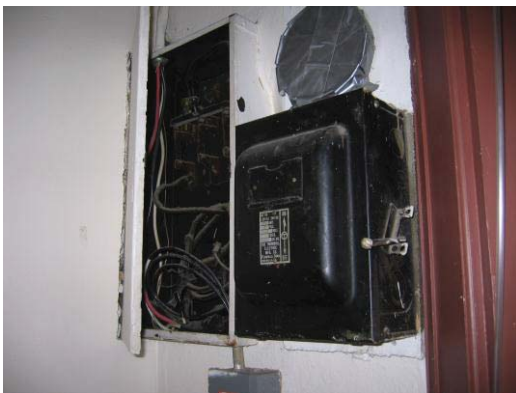
The current wiring device locations in the apartment do not comply with accessibility requirements. Receptacle quantity and locations in the apartment do not comply with current NEC requirements. The knife switch disconnect does not comply with current NEC requirements. Compliance with current codes for these items would require branch circuit and receptacle replacement.

Knife switch and disconnect in 125 1/2 State Street (2nd floor apartment).
