2015 East Washington TID 36 Expansion Blight Study

Madison, WI

Prepared by MSA Professional Services, Inc.

January 11, 2016

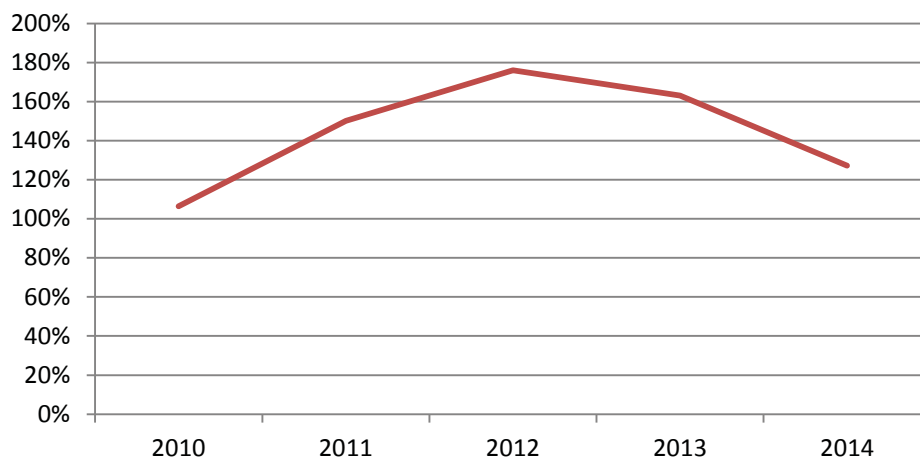
Figure 4.1- Police Calls per Acre, East Washington TID 36 Expansion area Versus the City of Madison

Figure 4.1 shows “police calls per acre” in the East Washington TID 36 Expansion study area as a percentage of the same number city-wide, and it reveals that police calls in the East Washington TID 36 Expansion study area are slightly higher than that of the city as a whole.
