**FREIBURGER CONSTRUCTION CONSULTING, Inc.**  
**5438 County Highway M**  
**Fitchburg, WI 53575**  
**(608) 835-0001**

Woodland Montessori School  
1124 Colby St.  
Madison, WI 53715

The following report is based upon observations made at the two school buildings March 21, 2016. The object of the report is to outline the current condition of then two buildings. The final section of the report will list deferred and future maintenance with the object of allowing forward planning for the maintenance of the buildings, modification of the buildings or replacement of the former residential building.

**Photo Log: 114 Van Deusen Street**

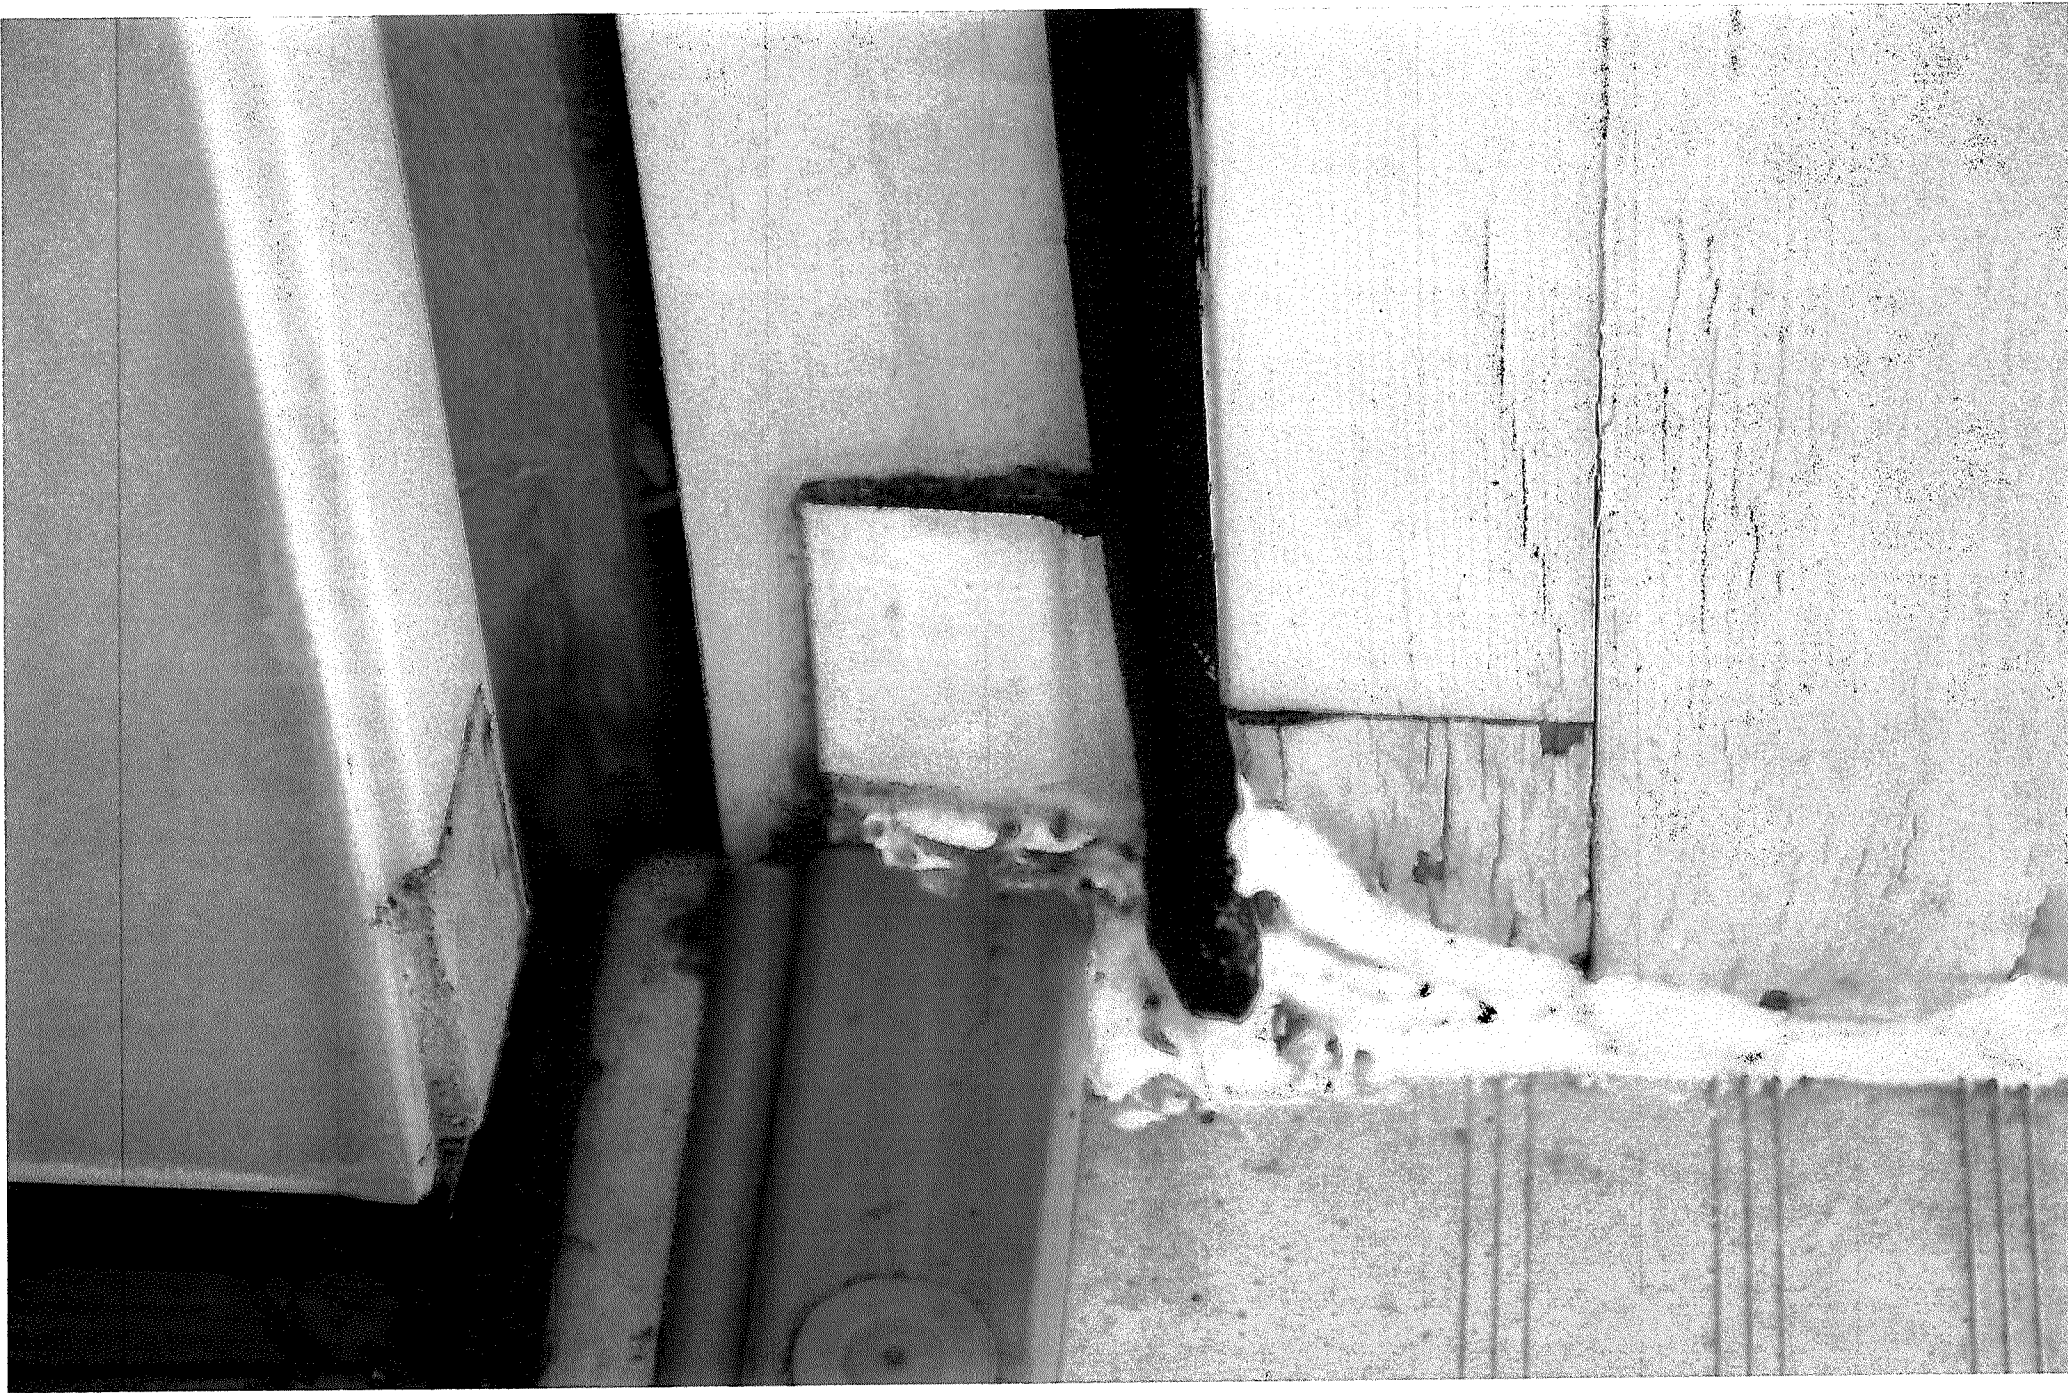
(40)

There is also a rescue platform bolted to the house on the second floor west elevation. The metal is rusted and needs to be painted. We could not study the attachments, but there is no evidence of current movement.

- Photo 39:** West side of Toddler House. Note rescue platform.
- Photo 40:** Closer look at rusty platform and paint peeling from siding that may contain lead.

put in new good door

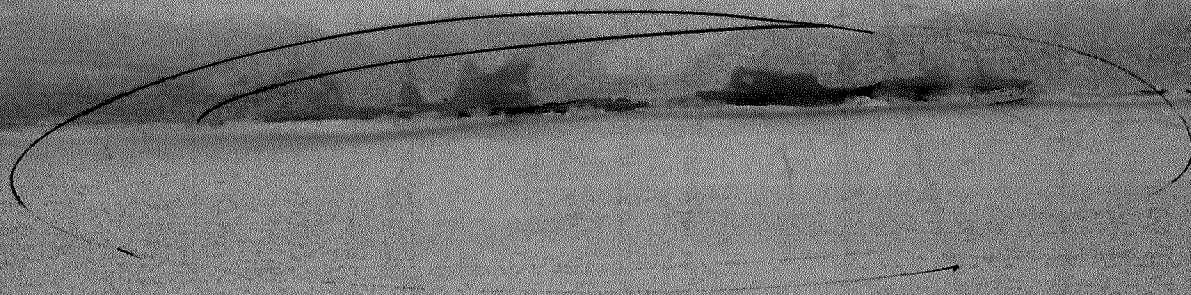
★ (42)

- Photo 41:** Threshold of platform access door where leak exists. Note that jamb is deteriorated.
- Photo 42:** Stain on wall to ceiling interface below platform door leak.

possible mold
