# Park Drake Blight Study - Proposed Redevelopment District

February 14, 2013

City of Madison,  
Wisconsin

PREPARED BY MSA PROFESSIONAL SERVICES, INC.

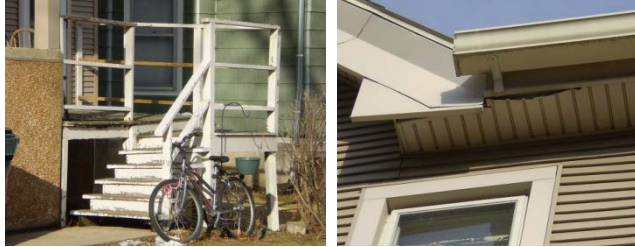
**Score: 57.4**

Soffits separated in places, vinyl fascia is ripped exposing wood; front overhang poorly installed; back porch sagging and leaning with chipping paint and unfinished wood; garage roof damaged and moldy and missing doors; driveway is uneven and asphalt is faded; rusting mailboxes; debris scattered around garage

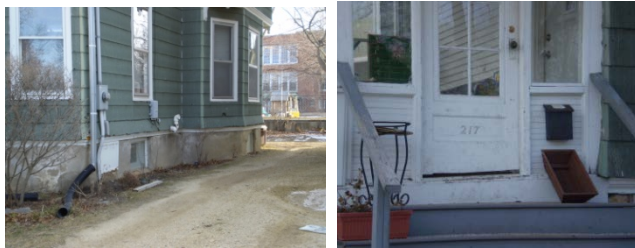
**Parcel 115**

**Score: 46.7**

Foundation resurfaced with poor patch work; chunks missing from siding; floor sloping in sun porch; gutters separating from fascia; wood stairs worn and dirty; concrete stairs missing pieces; driveway has large ruts and potholes; debris scattered around house

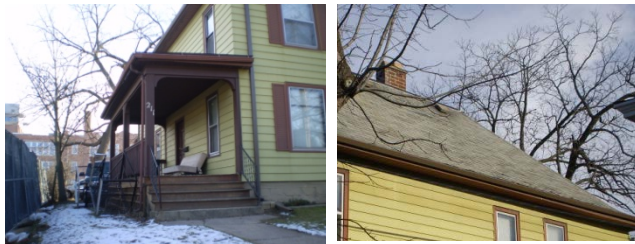
**Parcel 221**

**Score: 49.4**

Shingles faded and damaged; soffit discolored; window screens out of place; front porch has worn floor boards; concrete stairs uneven, cracked and exposed aggregate; no cover on light fixture; driveway has missing pieces; indoor furniture on porch

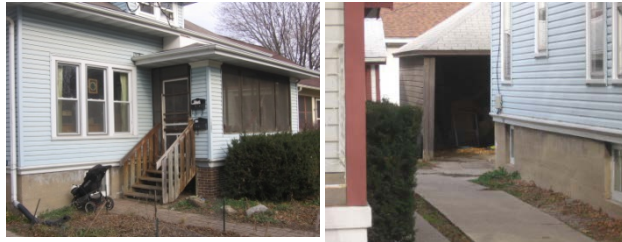
**Score: 57.5**

Foundation dirty; siding dirty; shingles damaged near gable and are peeling up; screens on porch have holes and rips; chipped paint on trim; side porch has unfinished railing on stairs; poorly patched chimney; garage roof worn, fading paint, missing garage door; shared driveway uneven with cracks and heaving.

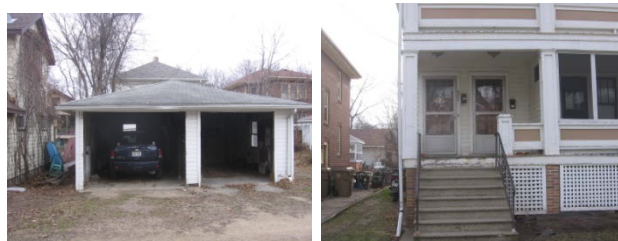
**Parcel 308**

**Score: 56.7**

Foundation exterior insulation panels are flaking; poor siding patchwork; window trim chipping paint; front porch floor boards worn, no paint, header joist significant chipping paint with signs of rot; garage roof is faded, missing siding, dented gutters, and no garage doors.

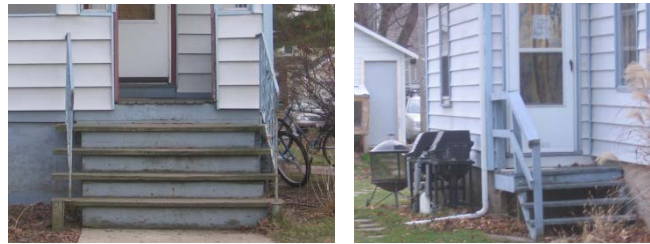
**Score: 51.4**

Poor patchwork on the foundation, places still flaking and cracked; dirty siding; window trims faded and chipped paint; overhang and porch sagging and sloping, worn floor boards, chipping paint, mold on sideskirts; Brick on chimney broken; front stairs stained, chipped paint; side stairs leaning; all doors have fading trim and front porch is missing door; garage is leaning and has chipped paint.

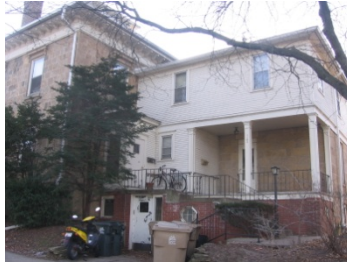
**Score: 58.4**

Brick separating, efflorescence, and poor mortar patchwork; soffits have chipped paint and separating wood panels; chipping paint on window trim; front porch wood worn, and paint chipping; broken pailings on porch skirt; left porch sagging; gutters sagging and dented; side concrete steps aggregate exposed; side door rusting; cracked retaining wall; indoor furniture on porch

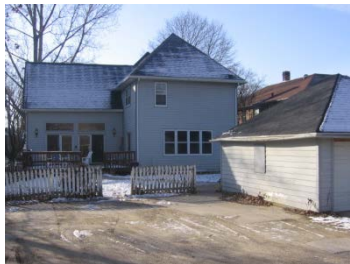
#### ***Parcel 170***

**Score: 59.9**

Left side foundation cracked and flaking; window frames chipped paint; stain on porch is wearing off; gutters stained, twisted and dented; chimney brick is separating and missing mortar; vent damaged; wood stairs sagging; garage sagging roof, chipping paint, gutters falling off; ruts in gravel driveway; debris

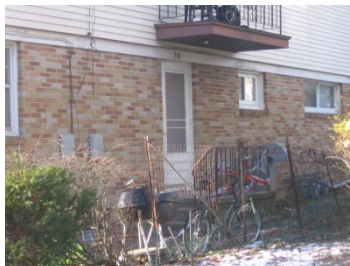
#### ***Parcel 250***

**Score: 58.3**

Siding discolored and chipping paint in places; roof is faded; mismatched window trim color; balcony discolored; gutters sagging, missing downspouts and gutter segments; chimney flashing poorly patched; concrete stairs discolored; brick stoop loose and not level; fence rusting and leaning; brick walk uneven

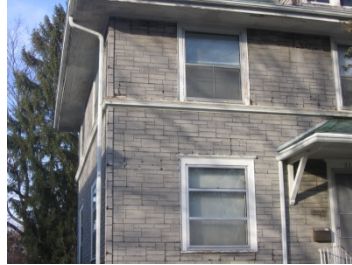
**Parcel 259**

**Score: 45.7**

Foundation has significant patching; siding is discolored with pieces broken off; chipping wood on trim; cornice and soffit have rotting wood; window trim has chipping paint; gutters discolored; concrete stairs are flaking; cracked; exposed aggregate; stoop is leaning; garage is leaning and roof is sagging; driveway not level; concrete at garage heaving, cracked with chunks missing

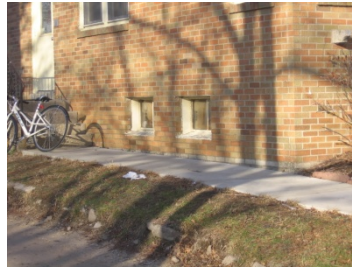
**Parcel 274**

**Score: 42.2**

Brick is stained near chimney; roof is discolored; windows chipped paint and paint on glass; basement windows have rust stains and sills have chipping paint; front overhang discolored; side balcony floor flashing peeling up; concrete stairs have chunks missing and exposed aggregate; garbage cans in front yard; garage roof damaged and heavy patchwork; gravel ruts forming; duct taped "For Rent" sign

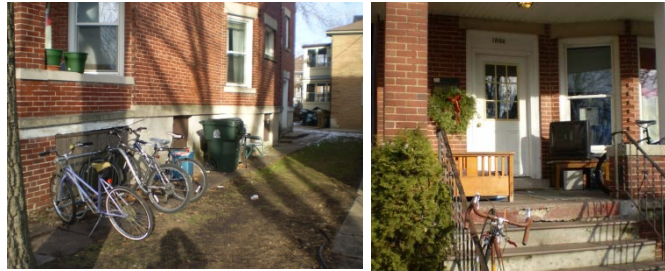
**Score: 56.2**

Foundation has significant patching; siding discolored with pieces broken off; chipping wood on trim; cornice and soffit have rotting wood; window trim has chipping paint; gutters discolored; concrete stairs are flaking, cracked, exposed aggregate; stoop is leaning; garage is leaning and roof is sagging; concrete at garage heaving, cracked with chunks missing

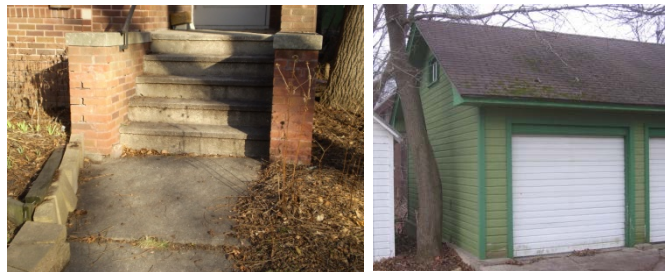
#### ***Parcel 94***

**Score: 53.8**

Brick walls dirty with some efflorescence; damage over 2<sup>nd</sup> floor roof; signs of wear on roof, some shingles peeling up; window frames chipping paint; different paint colors; front concrete stairs dirty/stained; cheek wall separating brick, missing mortar; rust on chimney cap; garage poorly painted, chipping paint; fence on right side broken; concrete pad at garage dirty, severe cracks and heaving

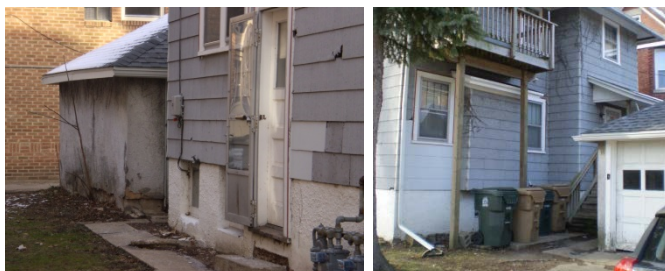
#### ***Parcel 125***

**Score: 42.7**

Foundation is dirty, cracked on right side; siding is dirty, has mismatch patchwork, siding has missing chunks; shingles appear damaged; unfinished wood on all porches; flashing on chimney piece meal; doors dirty, threshold worn; garage has large chunks of missing stucco; garage door bowing out; chipping paint; heaving and cracked walks and drives

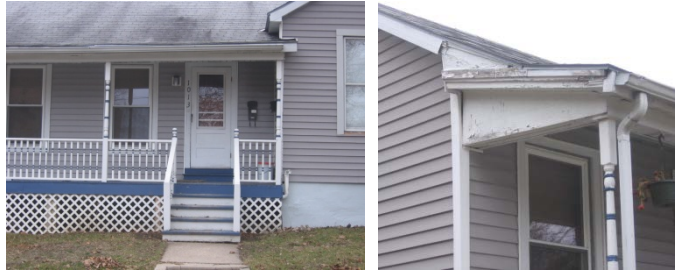
**Parcel 138**

**Score: 57.2**

Siding dirty and stained, odd patchwork under window on left side; roof is sagging in front; worn and faded shingles, damaged shingles around chimney; chipping paint on window trim; windows missing sill trim; porch has chipping paint, poor connection of roof joist to house; fence unfinished, moldy; bare spots and weeds in lawn, retaining wall in rear not back filled

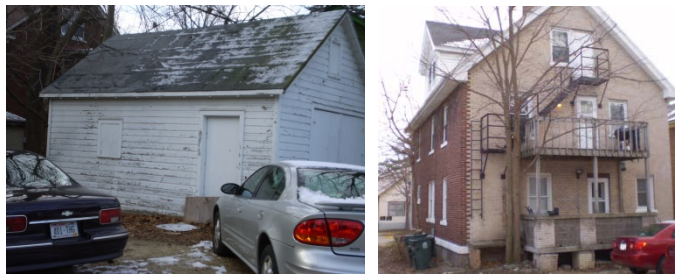
**Parcel 176**

**Score: 42.9**

Foundation is dirty and has minor cracking; brick siding has some mismatched colors, efflorescence, mortar patchwork; roof shingles faded, flashing paint chipped; porches have chipping paint; back porch columns have loose/broken bricks, leaning, balcony has unfinished wood; concrete steps have cracks; cheek walls have separating brick; garage has chipping paint, roof damaged, mold

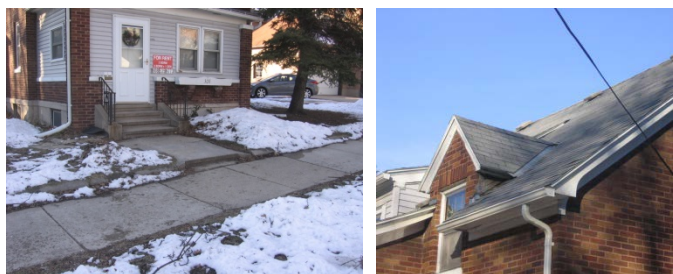
**Score: 51.4**

Foundation has some abrasions; brick is dirty, some mortar patchwork; siding is dirty; roof is faded, some peeling shingles in back; flashing has chipping paint; windows dirty, have chipping paint on trim; rusted emergency balcony; garage dirty; concrete drive cracked, missing chunks; scattered debris

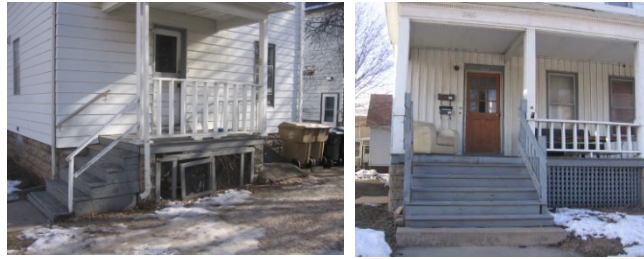
**Score: 58.9**

Foundation is discolored with aggregate showing; siding has areas that are quite dirty; roof eave fascia is missing on side; eave soffit panels are dirty and some loose; paint worn on windows trim and frames; sections of screening missing; floor boards worn, chipping paint; chipping paint on stairs and railings; dirt lawn areas, shrub stumps along foundation; indoor furniture on porch

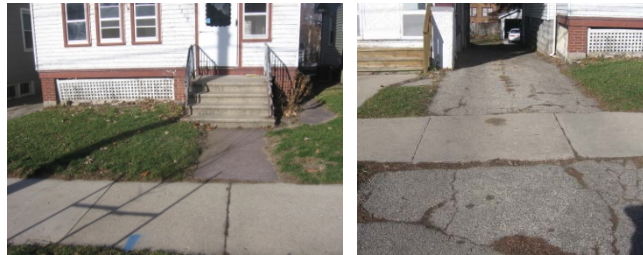
**Score: 56.7**

Foundation is dirty and moldy, siding is dirty; lower roof is sagging, faded with a few peeling shingles; window trim is faded; basement windows dirty; porch lattice skirt is broken, chipping paint; chimney is dirty with some mortar patchwork and dented flashing; concrete stairs dirty with rust stains; asphalt drive cracked, exposed aggregate; remnant vines on house

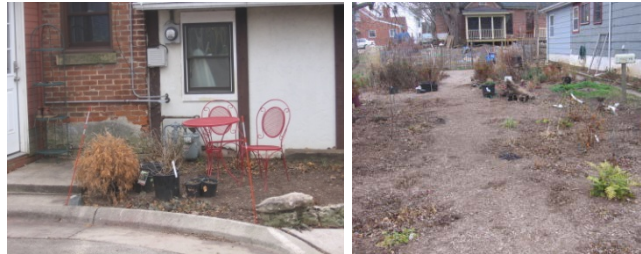
**Score: 59.2**

Brick is dirty and stained with mortar patchwork, siding is chipping paint; roof shingles mismatched; chimney is molding and stained; fence on side is leaning and unfinished wood; garbage cans in front yard, bare dirt, weeds in planting beds, piles of materials and outside storage

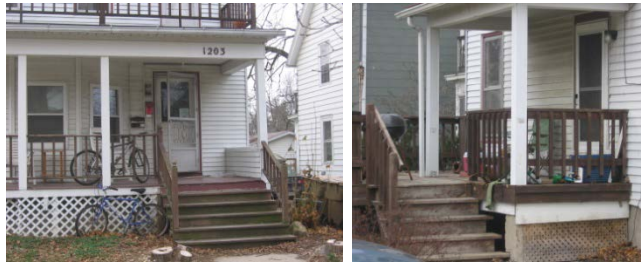
#### ***Parcel 265***

**Score: 57.3**

Foundation is dirty and uneven; cladding very dirty; windows dirty with chipping paint on frames; porch and balcony sagging, chipping paint, moldy; gutters sagging in places and dirty; chimney missing chunks; front storm door is missing closer; mismatch mailboxes, debris on roof, weeds and bare spots, remnant tree trunks

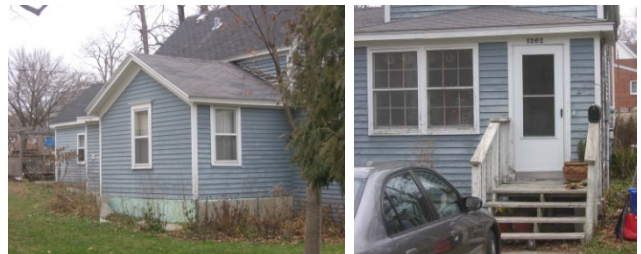
#### ***Parcel 282***

**Score: 54.2**

Foundation poorly resurfaced, insulation visible; significant discoloration and chipping paint on siding, signs of rot along roof line; mismatched patchwork on roof; chipping paint on most window trim; stairs have chipping paint; significant cracks in concrete drive; bare spots and weeds in lawn

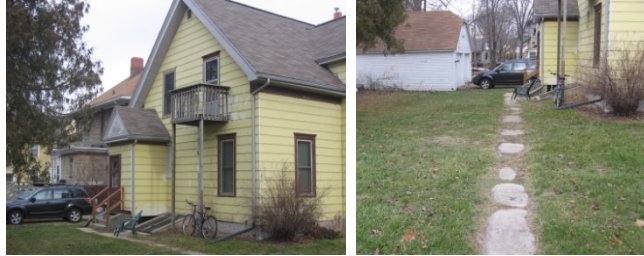
**Score: 59.8**

Foundation has mismatched color and texture; areas of siding have missing paint, missing pieces of siding; paint is worn on window frames; missing skirts on porch; dented downspouts; spalling concrete stairs in front; sidewalk to rear door in poor condition; weathered driveway; junk in back parking area

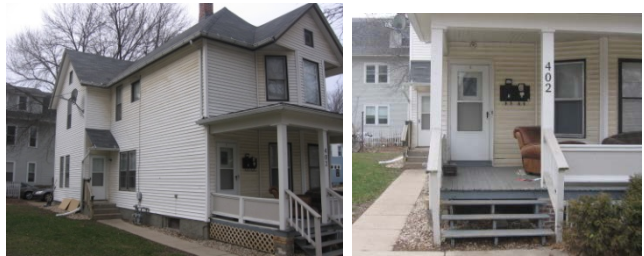
#### ***Parcel 257***

**Score: 59.6**

Foundation spalling; areas where walls are discolored; soffit panels, fascia, window frames and sills have worn paint; worn floor boards on porch, patchwork on foundational corners; minor rust on gutters; worn, leaning railing; litter, boards leaning against house; indoor furniture on porch

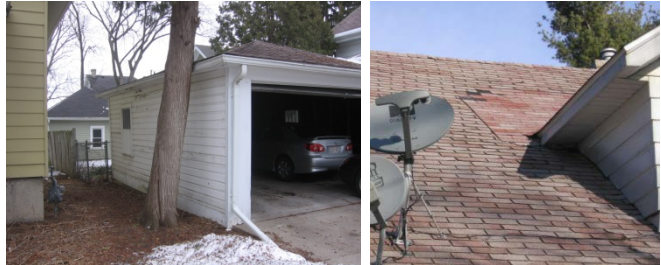
**Score: 53.4**

Foundation is dirty and discolored; siding is dirty, has paint wearing off, loose corner pieces, patched holes; shingles are worn, peeling up in places and replacement near dormer not doesn't match rest of roof: dormer windows boarded; chimney missing mortar, discolored; front steps have minor spalling and rust; garage paint is wearing off

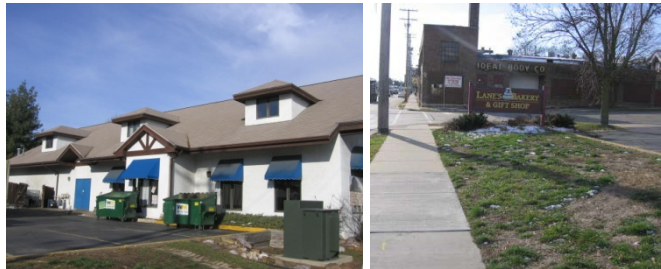
#### ***Parcel 141***

**Score: 58.0**

Parcel is vacant; some discoloration around vent on roof; awnings are quite dirty; front balcony stained on wood; vents rusting; stairs have minor discoloration and rust staining; lights are dirty; parking lot has cracks, potholes; rusted guard rail along alley; some areas of dead grass, dumpsters in parking lot unscreened

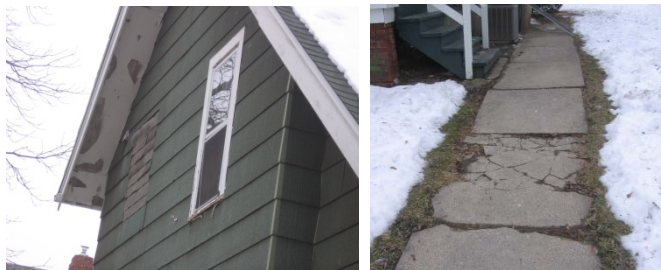
#### ***Parcel 177***

**Score: 58.0**

Siding is worn, discolored, many sections have pieces breaking off; missing flashing on dormer; shingles worn; eaves cracking, rotted, paint chipping; soffit chipping paint; side window filled in with mismatch material and color; chimney brick eroding in areas; shed chipping paint, door degrading at corner; concrete walk cracked and heaving

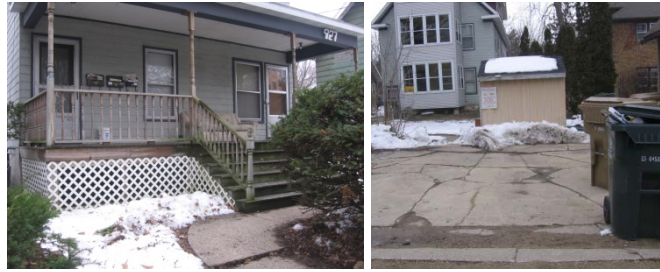
**Parcel 201**

**Score: 55**

Siding dirty with paint wearing; porch columns and railing unfinished wood, flooring discolored, lattice paint wearing thin; front wood stair and railing significantly discolored, two different door styles; shed is worn; front light is missing cover; concrete parking has several cracks, missing paved section; walk uneven with exposed aggregate; over grown shrubs, leaf debris; retaining wall cracked, leaning

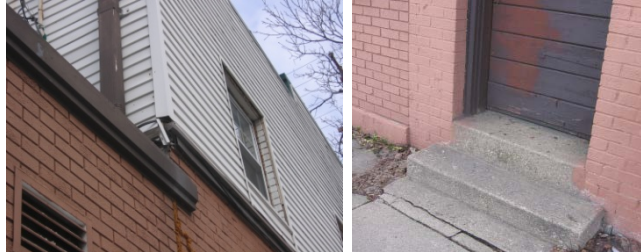
**Score: 57.8**

Siding has mismatched paint and tar residue, brick has splotches at base and water damage at corner; trim is chipping paint; upper window wood frame is discolored; stoops discolored with paint splotches, ramp is cracked; sign light is dirty; parking lot has cracks and a section crumbling and missing asphalt; weeds

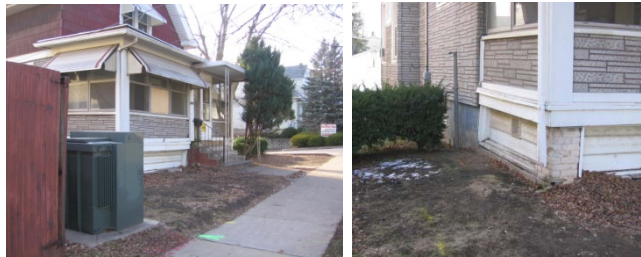
#### **Parcel 157**

**Score: 45.3**

Less intensive use than preferred in plan; paint is wearing off foundation; siding very worn and discolored, missing edges and excess paint from window trim; shingles worn and peeling up; paint wearing on window frames awnings worn and dirty; porch is unfinished, siding deteriorating, stairs discolored; garage paint is wearing; dirt areas within lawn and sidewalk terraces

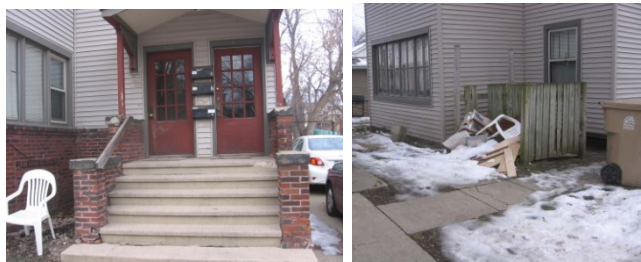
#### **Parcel 169**

**Score: 57.1**

Foundation discolored; metal sheathing dented on eaves; boarded up basement windows, wearing paint on frames; stairs and brick cheek wall mortar and bricks missing, patchy concrete cap, minor discoloration and spalling; fence unfinished, discolored and missing boards; front drive has uneven settling and is cracked, spalling sections on side driveway; walk is discolored

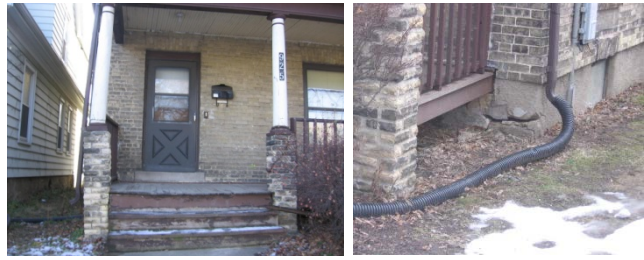
**Parcel 171**

**Score: 58.4**

Foundation has missing mortar in front corner; siding paint is wearing off; brick has significant discoloration; roof eaves have chipping paint; boarded basement window; left porch column bowing out; porch ceiling wood separating and dirty, floor boards separating; chimney discolored, missing brick; step paint mostly worn off; screen door is damaged

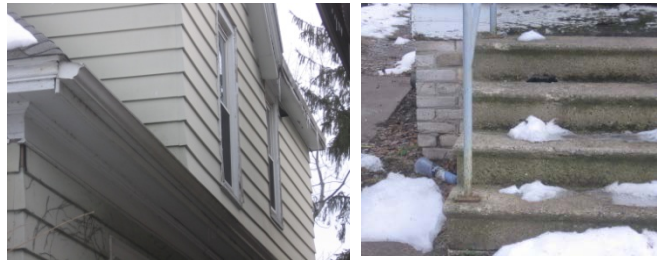
**Parcel 174**

**Score: 55.7**

Foundation discolored, patchy and spalling; siding missing sections on side façade; shingles worn, stained, chipping paint on eaves; enclosed porch has peeling paint from base trim; brick columns missing and spalling bricks; no skirting; stairs discolored, spalling, aggregate showing, missing concrete section; garage paint wearing thin, rust stains from nails

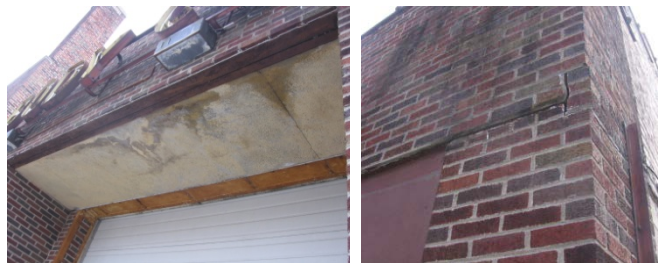
**Parcel 240**

**Score: 30.1**

Brick has cracks through brick and mortar and separation at NW corner, back brick rust stained, discolored; boarded up windows, chimney missing mortar in joints; garage door entry discolored, rusted safety bollards; signs of graffiti on metal fence divider; back metal fence discolored; worn signs, rusted and discolored

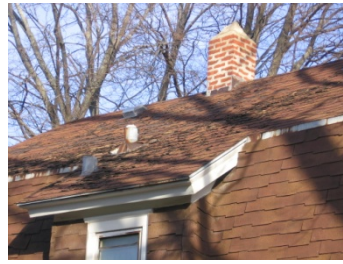
**Parcel 245**

**Score: 56**

Parcel has less intensive use than preferred in plan; foundation is discolored, spalling and bowed in along side; 2<sup>nd</sup> story siding quite worn, foam insulation oozing out of siding on porch; shingles severely degraded; rusted metal window frames; covered porch, shingles worn and peeling up; missing gutters; dirty/weeds growing over driveway pavers
