City of Madison

**Madison Municipal
Building
Conceptual
Schematic
Design Study**

November 2013

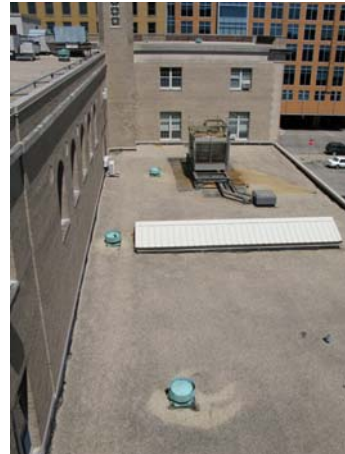
Built similarly but with considerably lower and fewer slopes is the roof within the “U” shape. This structure essentially slopes in one direction with slight depressions at the two drain locations. The north edge of this roof is covered with aluminum cap flashing with counter-flashing continuing on each wall.

Figure 12 – The “U” Shaped Roof Area Slopes in One Direction

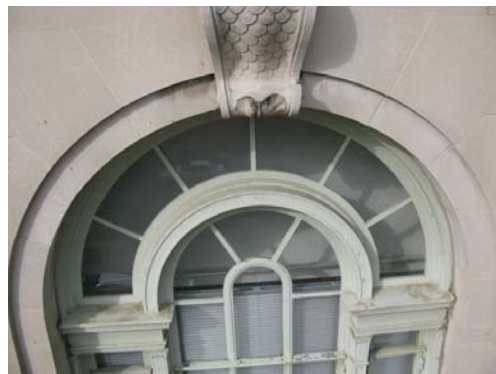
Figure 13 – Windows are Framed with Decorative Cast Iron, Sashes are Steel.

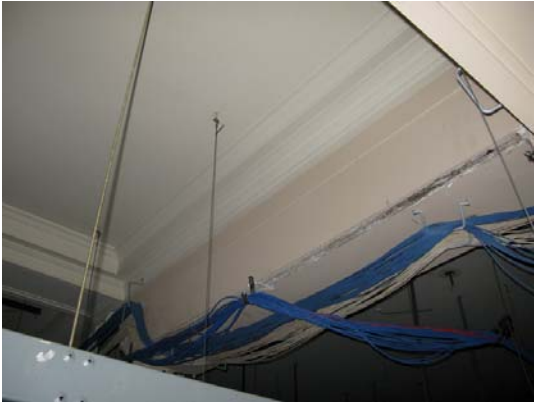
Figure 25 – Original Plaster Ceilings and Decorative Crown Moldings remain above the Suspended Ceilings on the First Floor

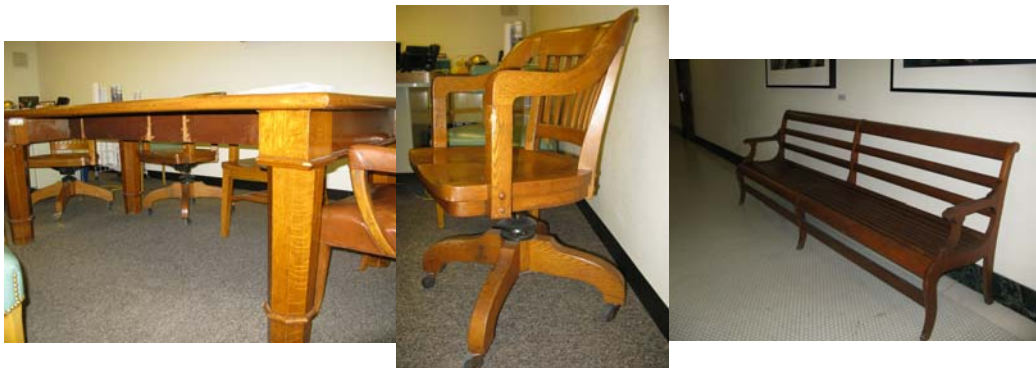
MMB is largely furnished with a variety of free standing and systems office furniture of differing age, finish and condition. The building does retain a certain amount of furniture pieces original to its use as a U.S. Courthouse. These furniture pieces are constructed of wood, predominantly light oak and finished with a clear sealer. Early photographs confirm that these pieces were original to the building's second floor courtroom. Today, most of the pieces can be found in Room 260, the large second floor meeting room, formerly the courtroom. Several pieces from the courtroom can be found in private offices and corridors. This sturdy furniture is in good condition, consisting of three basic types: hearing room tables, hearing room chairs and gallery benches.

Figure 26 – Original Furniture

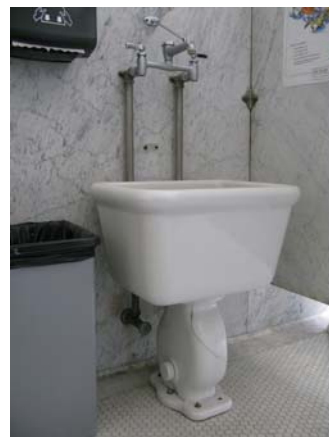
Figure 27 – Slop Sink in Women's Restroom

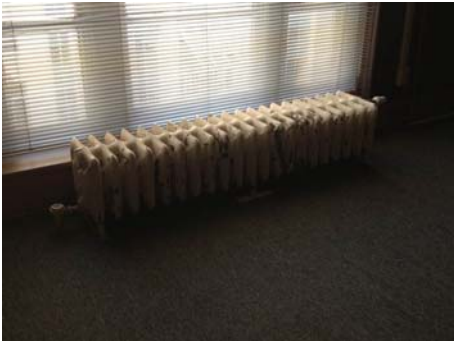
Figure 35 – Steam Radiator

The only temperature controls on second and third floor during heating season is through manually opening or closing the control valve located at each radiator. These radiators and associated steam and condensate piping are approximately eighty-seven years old and are at the end of their expected life. Moisture damage was noted in multiple locations due to radiator leaks, and the radiators have been painted multiple times with paint peeling on all radiators.

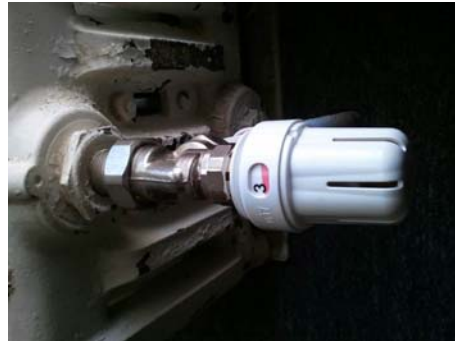
Figure 36 – Steam Radiator Control Valve

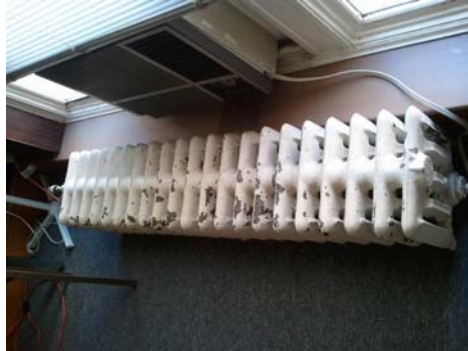
The zone level cooling system is split into two separate systems similar to the heating system. The lower level and first floor are cooled by overhead recirculating fan coil units with chilled water cooling coils. The fan coil units were installed during the 1979 renovation, and are nearing the end of their expected life. The facilities staff noted maintenance issues such as fan replacement and leaking valves for the overhead fan coil units, which reflects expected maintenance for units thirty-four years old. The second and third floor is cooled using electric window air conditioning units.

Figure 37 – Electric Window Air Conditioning Unit Installed

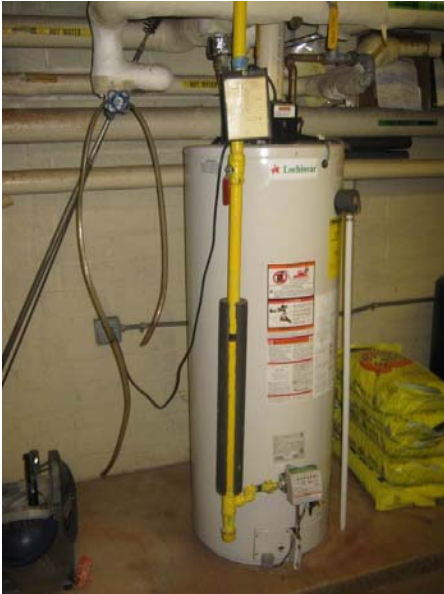
One gas fired water heater, located in the lower level mechanical room, provides hot water to the building. All hot water is softened by a water softener located in the same mechanical room. The domestic hot water system is currently stored and circulated at approximately 115°F. Both the water heater and softener appear to be a newer vintage and are said to be in good working condition.

Figure 40 – Water Heater

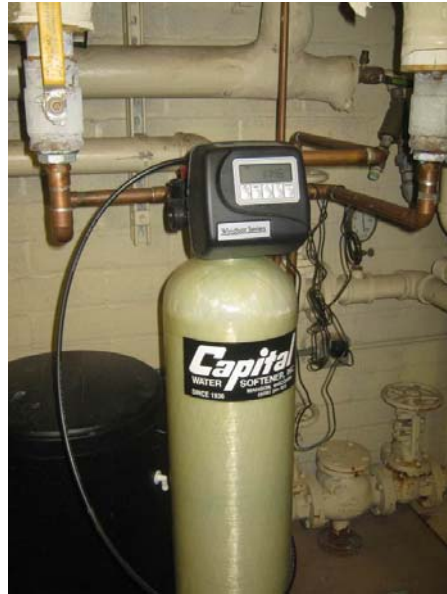
Figure 41 – Water Softener

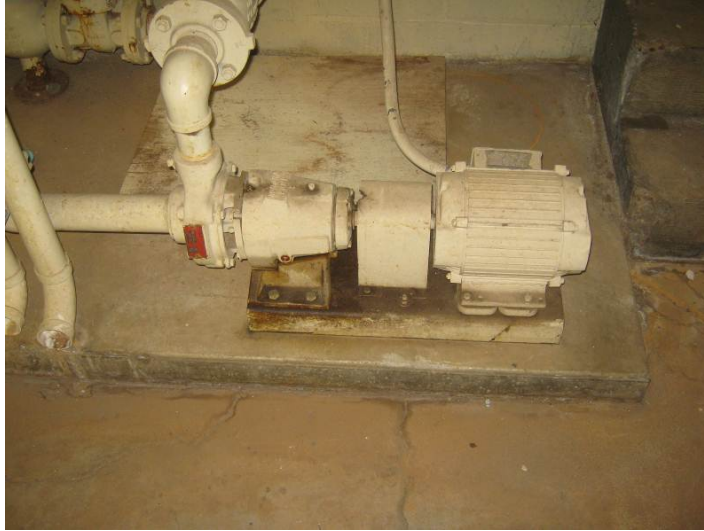
The existing fire protection system is served by a 3" water main located in the basement. This water main serves as a combination domestic water and fire protection service. The fire service is routed through a reduced pressure backflow preventer located in the lower level mechanical room. The fire service is then boosted by an existing fire pump installed during the 1979 renovation of basement and first floor.

Figure 43 – Fire Pump

The building is currently not sprinkled and the only means for fire protection are 1-1/2" hose valves located in multiple locations on each floor. The existing system is not currently monitored by the fire alarm system, and does not provide monitoring of water flow to indicate an alarm condition. The current fire protection system does not meet the minimum code requirements for a building of this type. Current code would require the building to be fully sprinkled per NFPA 13 and Class III standpipes in stairwells per NFPA 14. The existing incoming water service will likely be undersized for the code required fire protection system.

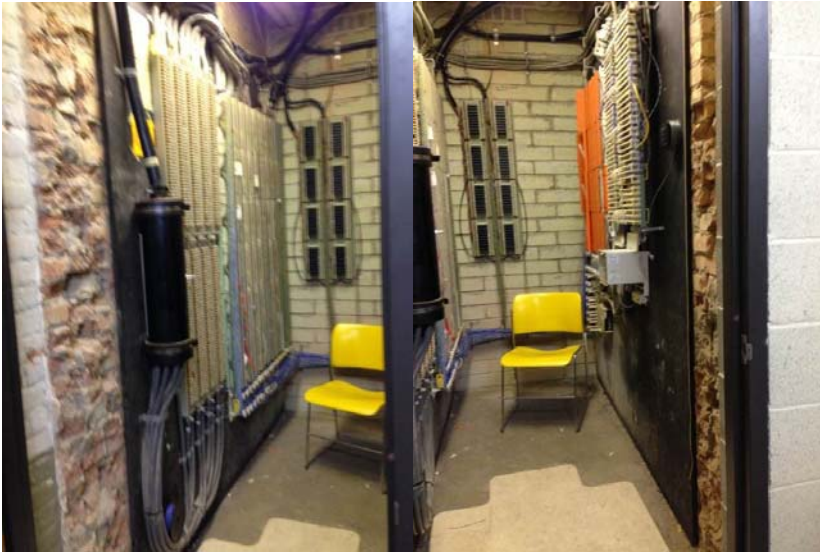
Telecommunications service for the building consists of copper and optical fiber cabling. Incoming telecommunications copper cabling from the service provider enters the building at the west end of the Lower Level Mechanical Room and routes to the Lower Level Telephone Equipment room. Copper backbone cabling to serve Madison Municipal Building spaces is then routed to telecommunications rooms on the first and third floors. Existing service entrance copper cabling is in good condition. However, the telecommunications room used for service entrance is at maximum capacity, and is undersized in comparison to what is required by ANSI/TIA/EIA-569 Standards.

Figure 44 – Telecommunications Service Entrance Room

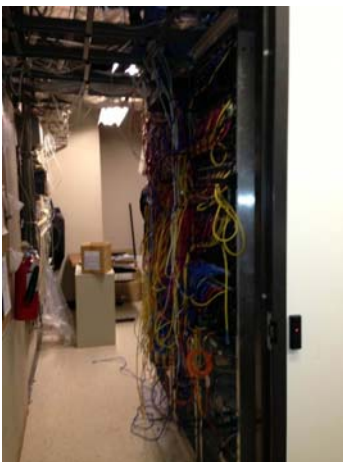
Figure 45 – First Floor Telecommunications Room

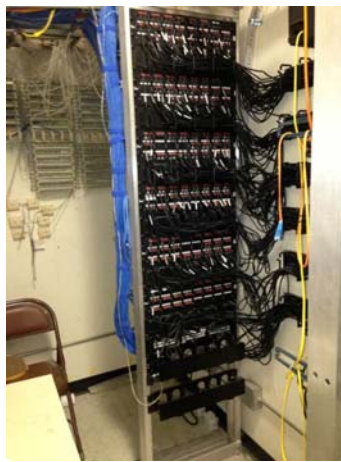
Figure 46 -- Third Floor Telecommunications

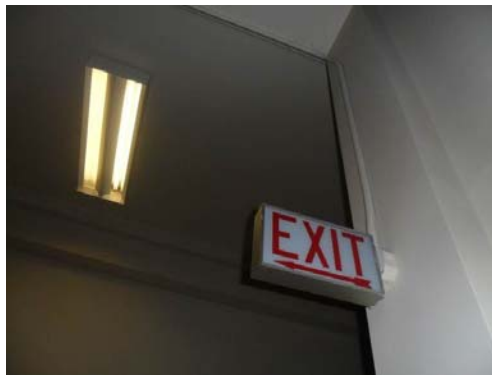
The existing electrical system is a 4000 Amp, 120/208V 3-phase, 4-wire service, which is adequate for the facilities current functions and use. This electrical system is most likely more than capable of handling modifications and minor expansions to the existing building, as the majority of new systems are very efficient compared to what is currently installed. The existing lighting is largely outdated, and very inefficient to modern fluorescent and LED fixtures. Fire alarm is dated and may require updates in the near future. All three electrical systems have a fair amount of exposed conduit and junction boxes, especially on second and third floor due to the original block walls and additional system items being added over the years.

Figure 47 – Exit Sign

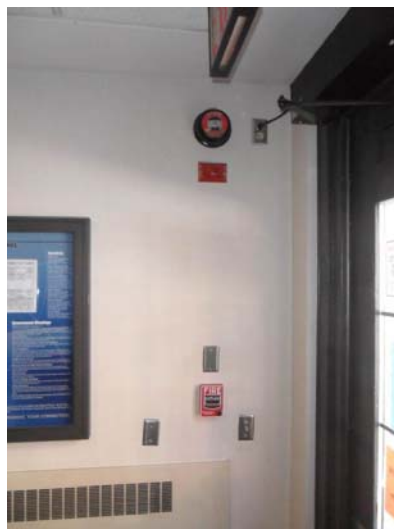
Figure 51 – Fire Alarm

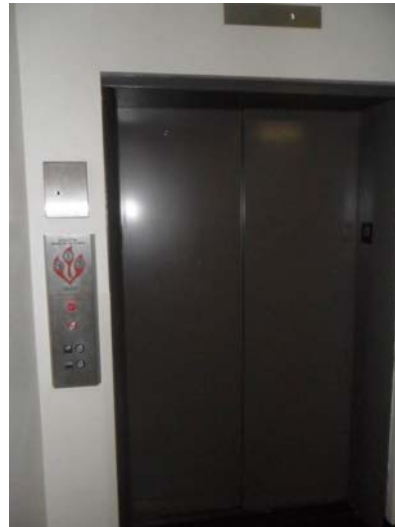
The building also has an elevator, which has undergone some changes since the original building. It appears to still be served from the original exposed motor located in the penthouse equipment room. The inspection dates looked current and the elevator appears to be in good working condition. The elevator cab itself has had at least one recent upgrade, and so have the button interfaces on each floor.

Figure 53 – Elevator Button Interfaces

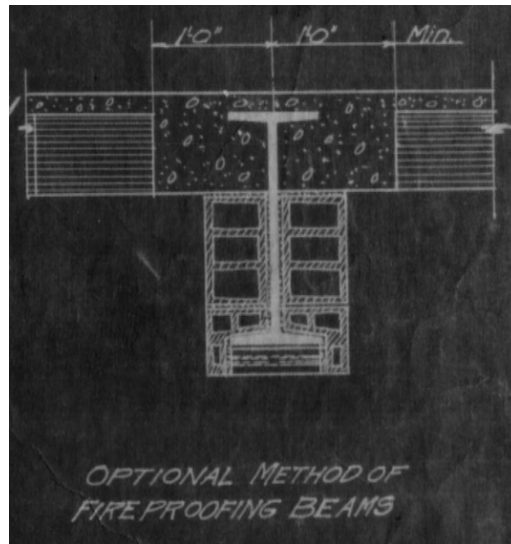
The existing drawings note that the concrete around the steel framing is for fireproofing. An alternate fireproofing detail is shown, using clay tile block, which indicates the steel and concrete were likely not designed to work together as a composite section.

Figure 54 – Alternate Fire Proofing Detail from Existing Drawings

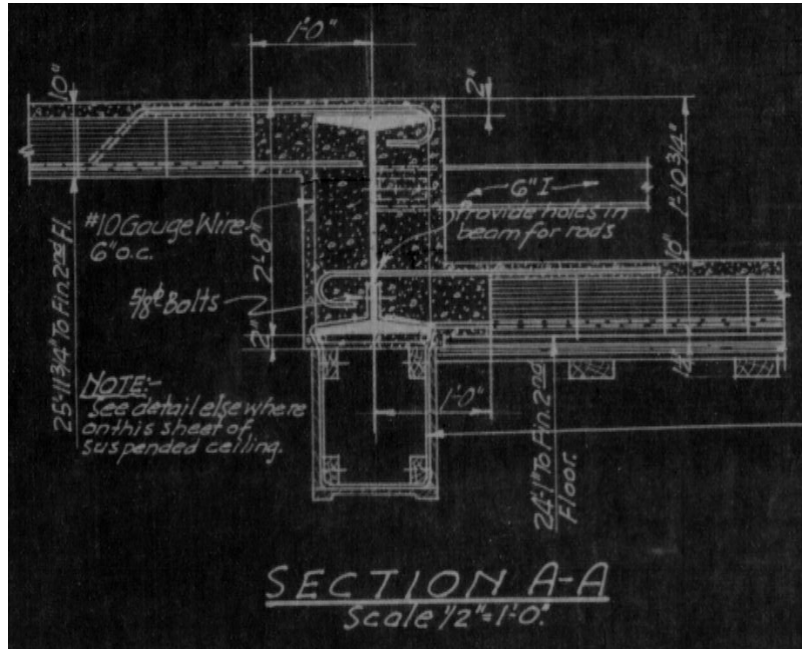
The old court room on second floor is a two story space. There is an opening in the third floor slab for this space and the existing drawings indicate the roof slab is recessed 1'-10 3/4".

Figure 56 – Recessed Roof Slab at Court Room from Existing Drawings

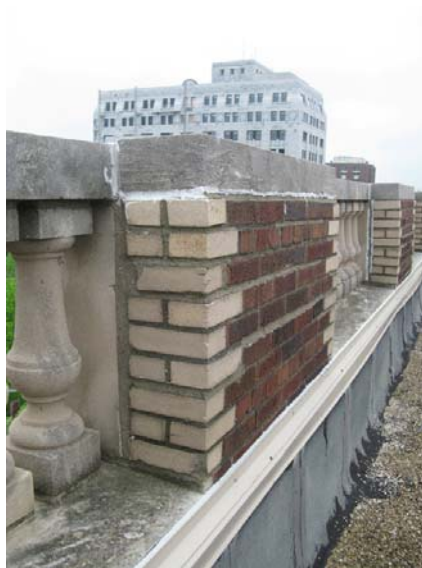
Figure 62 – Brick and Stone Parapet

The brick and stone parapet sits on top of the massive, through-wall stone cornice.

Drawings have not been found to determine how these elements are connected together but standard practice at the time of construction does suggest that some sort of mechanical means was used. It is also not known whether steel anchors were used to tie the stone to the brick inside the parapet. The amount of movement seen in the parapet increases the possibility that rust jacking of steel is occurring; that freeze/thaw of the brick and mortar are not enough to warrant this movement. We recommend a portion of a parapet wall be deconstructed down to the top of a cornice block in order to study and fully understand the dynamics occurring in the wall. From this evaluation we will be able to determine the cause of the movement and what the best methods are to resolve the issues. Adjustment to the shifted portions of the stone cornice is not required since it is very slight and further movement can be arrested. At this time, we do not suggest installing metal on top of the stone coping or cornice as long as the joints are maintained on a regular basis.

Replacement mortar for both re-building and/or re-pointing shall be based on test results taken from mortar samples within the wall. Achieving the correct ratio between sand, lime, Portland cement and water is crucial to getting the correct color and absorptive qualities that will be compatible with the stone. Replacement stone shall also be as close a match to the original as possible so the restored wall works as one unit.

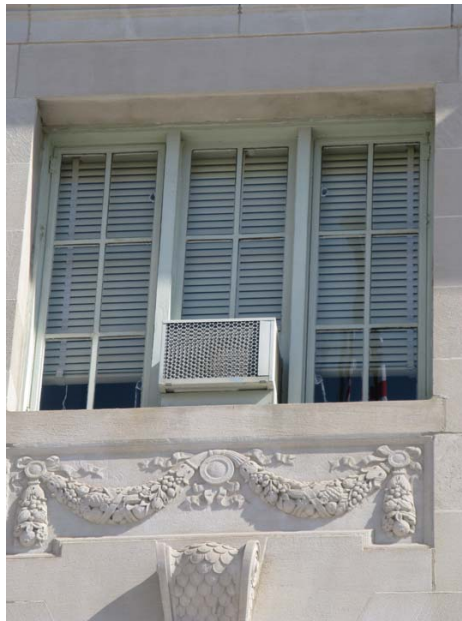
Figure 63 – Steel Window with Stone Carving Decorations

There are no products available today that can replicate the intricacies of these steel windows. Their design and contribution to the overall aesthetics and historic nature of the building is the same as the two-story stone columns on the front elevation. Removal of them would irrevocably harm the character of the building.

A thorough condition survey should be conducted at the Design Development stage to create a comprehensive scope of work for each window. Removal for any reason, including refurbishment, of the cast iron framing members is not recommended as they are imbedded in the stone rough opening and their removal could result in undue damage to the opening. The cast iron should be stripped in place of any existing coatings and re-coated with high quality advance engineered coating products. The steel sashes should be removed, tagged with their individual window opening number and restored off site. All of the hardware should be removed and completely reconditioned including the removal of all paint. The sliding tube hold-opens will properly function after a rigorous clean-up and re-lubing.
