# City of Madison Landmarks Commission

Project Title / Description: Demolition, fill-in, and replacement with green space

At your request we have inspected the residential building located at 929 Williamson St. Madison, Wisconsin, and have compiled the following report. This report is for your information and is not to be construed as a warrantee of any mechanical system, nor does it guarantee any portion of the building against subsequent failure.

# 929 Williamson St Freiburger Consulting Review

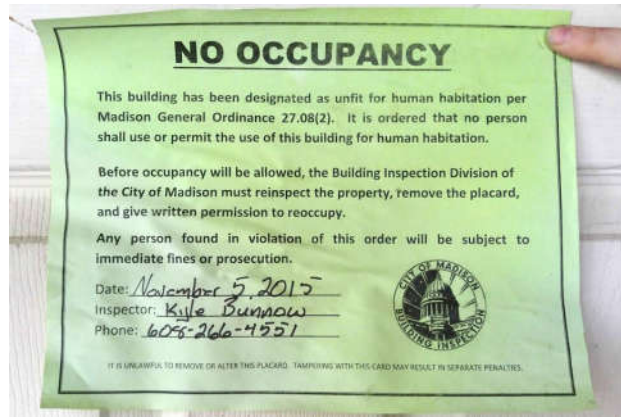
The No Occupancy Posting on 929 Jenifer St

floor, toilet not operating correctly, damaged flooring, general disrepair and deterioration."
November 5, 2015	City of Madison posts "No Occupancy" on 929 Williamson St.
October 26, 2016	House purchased from Ray A. Peterson by Caden Howell
