Re: 104 East Gilman

Front Entrance Replacement Plan

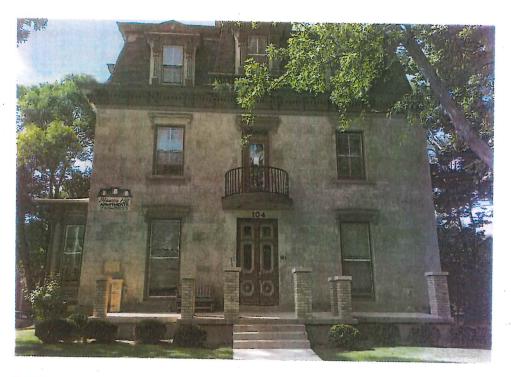
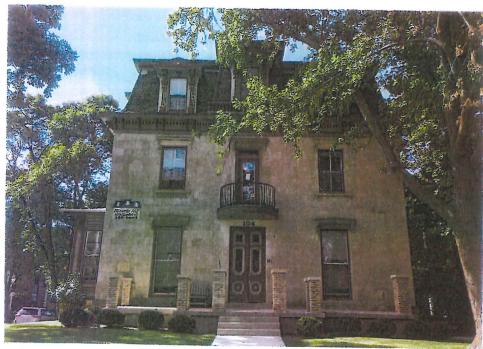
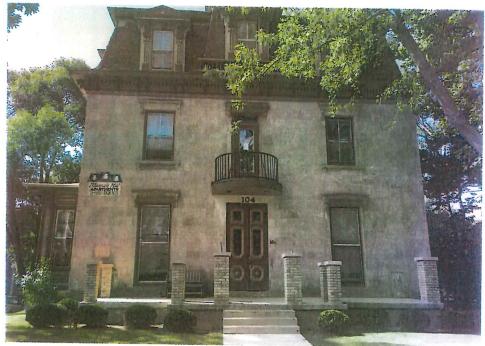
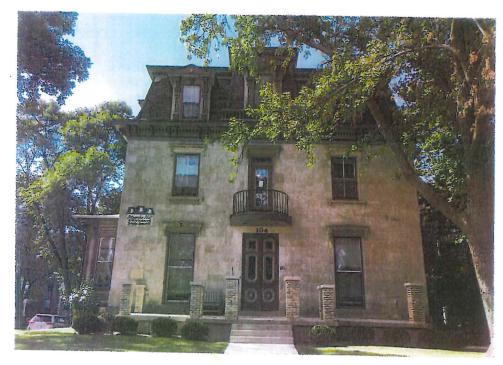
Lastly, in the process of restoration it has come to our notice that a spindled railing on 3rd floor mansard is in disrepair and has plant life growing around it. We wish to remove and rebuild this feature reusing parts such as spindles, or as closely matching as possible. We would look to rebuild using cedar or similar rot resistant wood, and paint to match existing rail.

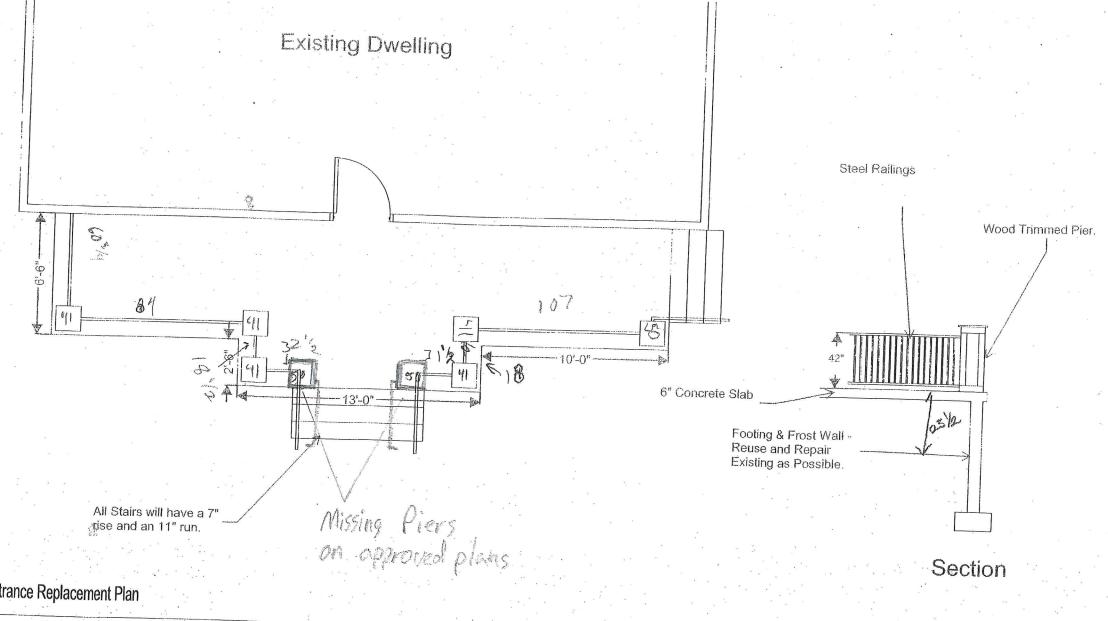
Railing Detail Center detail salvaged from original railings

We are submitting plans for a new wrought iron railing. The original railings were in poor condition, but the artistic panel can be salvaged and incorporated into the new design (see drawing). Though the porch height is currently over 24 inches we propose to alter the landscaping to allow for the use of more historically appropriate 36 inch railing height.
