Certificate of Appropriateness Review for 1450 Monroe St.

April 8, 2019

UW-MADISON FIELD HOUSE HISTORIC STRUCTURE REPORT

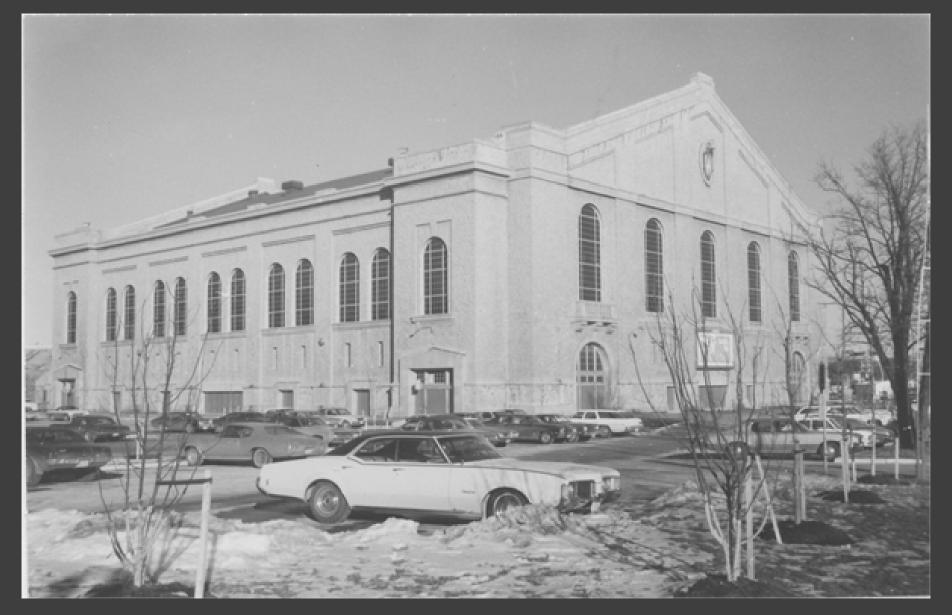
CONDITION ASSESSMENT SUMMARY - SOUTH ELEVATION - BAY S2

- AD1 NON-ORIGINAL HOLLOW-METAL DOORS ARE IN GOOD CONDITION
- ADS SEALANT AT DOOR PERIMETER IN POOR CONDITION
- AD4 NON-ORIGINAL PLASTER DOOR SURROUND IN FAIR CONDITION

AE2 LIGHT FIXTURE MISSING - ORIGINAL FIXTURE MOUNTING HARDWARE REMAINS

- MASONRY
- AM1 EVIDENCE OF PREVIOUS TUCKPOINTING EFFORT WITH NON-MATCHING MORTAR
- AMS EVIDENCE OF TERRA COTTA SPALLING
- AM4 FRACTURED TERRA COTTA UNIT(S) AM5 DIAGONAL STEP CRACKING PRESENT
- AMB BRICK AT THE PERIMETER OF THE WINDOW APPEARS TO BE IN GOOD CONDITION
- AM7 MASONRY STAINING PRESENT AM10 FLASHING AND SEALANT IN POOR CONDITION
- AM11 CRACK OBSERVED IN "W" CARTOUCHE

- AWI DETERIORATED FINISH AT METAL WINDOW
- AWZ GLAZING UNITS HAVE BEEN PAINTED ON THE INTERIOR FACE
- AW3 SEALANT AT WINDOW PERIMETER IN POOR CONDITION
