## 5. EXISTING CONDITIONS

## CURRENT USE ANALYSIS

The current use analysis provides an overview of the current conditions of facilities at Vilas Park. These uses are examined in these sub-section; Structures, Playgrounds and Other Activities, Drinking Fountains, Historic Stonework, Annie Stewart Fountain, Roads and Parking, Bridges, Paths, Signs and Wayfinding, Edible Landscape, and Children’s Memorial Benches. Some of these facilities are at the end of their expected life and should be considered for repair or replacement and others are in good condition and may last for some time. This analysis is based on visual inspection coupled with background information provided by the City.

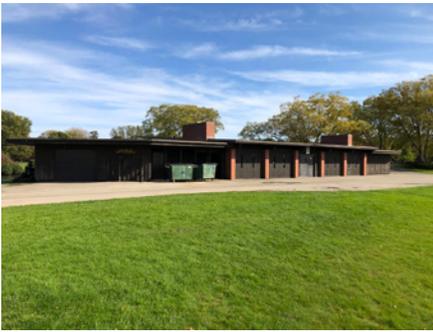
Figure 5.1. Main Shelter

The main shelter building was constructed in 1951 and has been repaired through the years to address varying levels of structural issues. The building is constructed of brick and wood on a concrete slab (Figure 5.1). The brick work has been tuckpointed including several large cracks (Figure 5.2). The foundation slab extends past the exterior columns on the lagoon side and consist of concrete steps which have several large cracks (Figure 5.3).

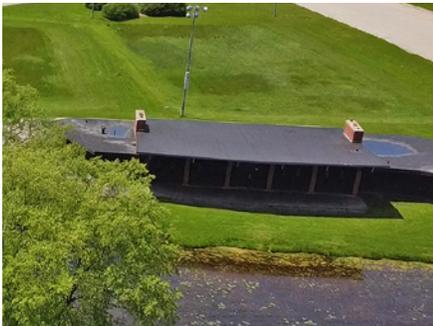
Figure 5.4. Water Ponding on Roof

Ponding of rainwater is evident from aerial views of the building (Figure 5.4). The roof will need replacement in 3 to 5 years. The building provides a covered open-air picnic and gathering space in the warm months and a warming house in winter for ice-skating on the neighboring lagoon (Figure 5.5). Temporary wood doors are placed between columns in the winter to create an enclosed space. The doors need replacement. There is a concession stand within the building that is only open in the winter (Figure 5.6). There are old restroom facilities and two unused fireplaces in the building. The shelter has electrical, water and wastewater services as well as access to propane from an adjacent tank. The electrical system could be updated to be more efficient. There have been requests for improved lighting in the building. The plumbing fixtures and pipes are well past useful life but functioning. Fixtures are not water saving models. The building has HVAC which needs frequent repair and will need full replacement soon. The surrounding pavement connects to paths and the parking lot. The asphalt has been patched and is cracked, a PASER of 6.

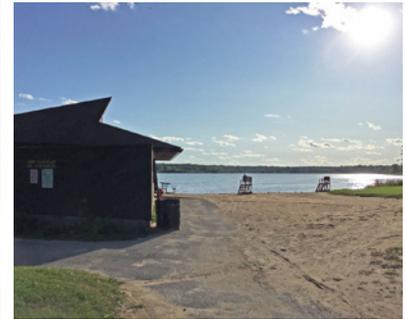
Figure 5.10. Access to Beach

wood and is in relatively good shape structurally, however functionally the facility does not meet the needs of the current beach operations. Overall, the roof, doors, electrical and plumbing are in good condition. The bathhouse is connected to Vilas Park Drive and to parking with an asphalt path (Figure 5.10). There are potential accessibility concerns. The remainder of the site has bike parking racks on a concrete pad on the north side of the building and beach access on the Lake Wingra side.

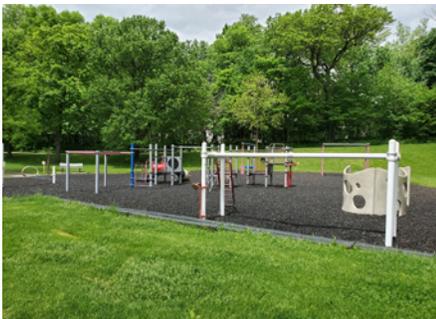
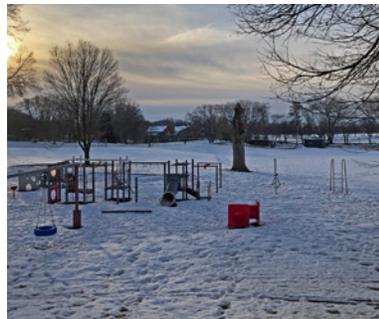
There are three playgrounds in Vilas Park. The west playground is near the multi-use trail and is connected to it by an asphalt path (Figures 5.13 and 5.14). The surface material is rubber mulch over a gravel base. This playground was manufactured by Miracle<sup>60</sup> and placed in 1994.

In accordance with City of Madison Parks typical maintenance practices, replacement of equipment generally occurs between 20 and 25 years after installation. This replacement schedule is in part to difficulty in obtaining replacement parts and general wear and tear. All of the Vilas Park playground equipment is past due (26 years old) but is scheduled to be replaced as early as 2021/2022.<sup>63</sup> At 26 years old the equipment is past the end of its serviceable life.

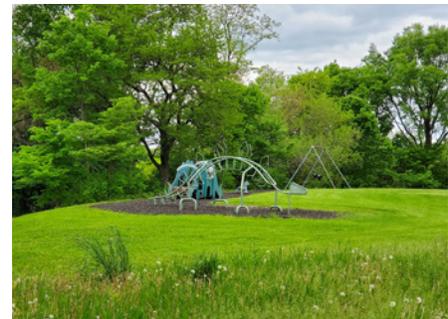
Figure 5.15. Dinosaur Playground

A small playground is located near the mounds in the upper park along Erin Street. This playground is known as the "Dinosaur Playground" due to the dinosaur-themed equipment (Figure 5.15). The equipment is Landscape Structures<sup>61</sup> and was also installed in 1994. The surface is rubber mulch over gravel with no connection to the surrounding walkways. The equipment is not compliant with current ADA guidelines.

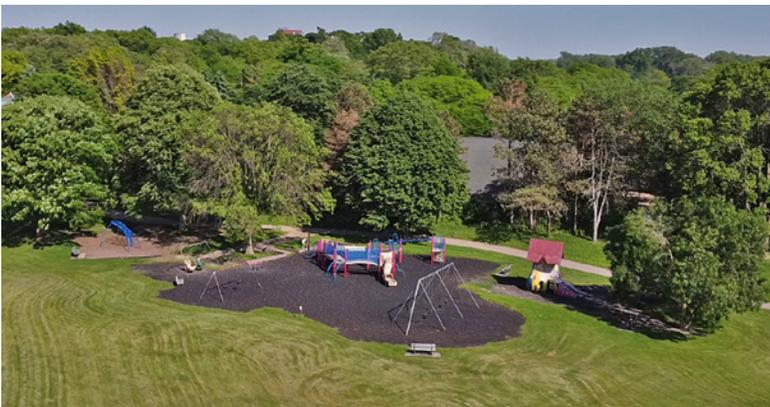
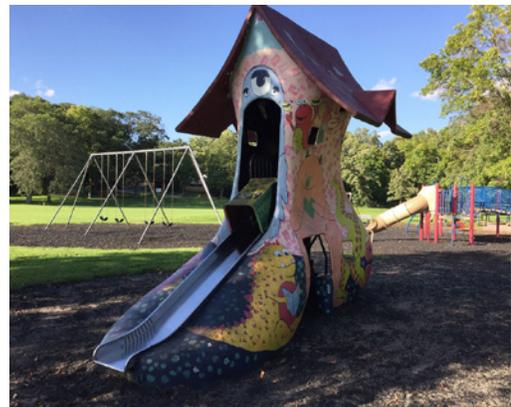
A large playground is across the meadow from the west playground and is the location of the “Old Woman in the Shoe” (Figures 5.16 and 5.17). The shoe is on a concrete slab and in good condition. As with the other playgrounds, this equipment was installed in 1994 and was manufactured by Game Time.<sup>62</sup> The surface is rubber mulch over gravel as well with access to the path from the north parking lot. The surface is also rubber mulch over gravel with access to a path from the north parking lot.

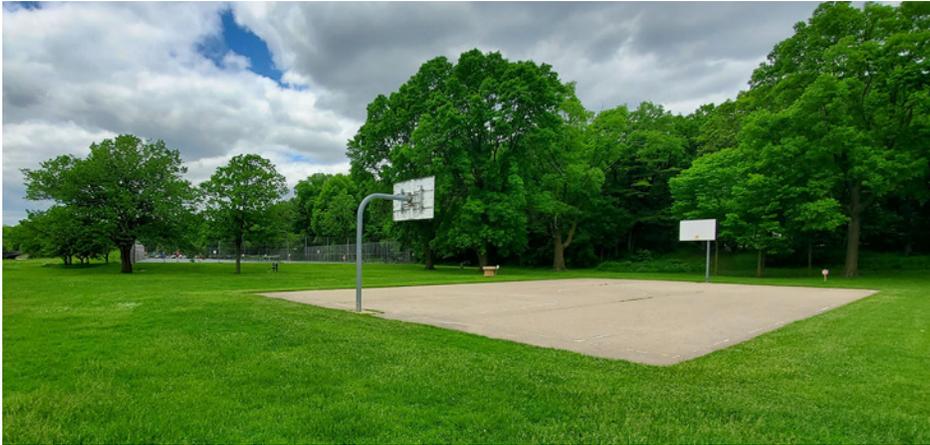
Figure 5.20. Basketball Court

The basketball court was added to the park sometime in the 1980's. The court is also in the meadow and has no connection to any accessible route or trail system (Figure 5.20). The basketball court is asphalt with some minor cracking and the paint markings are heavily faded, but it has a PASER of 8. The backboards are metal and are attached to metal posts which are in fairly good shape with some minor rusting and peeling paint (Figure 5.21).

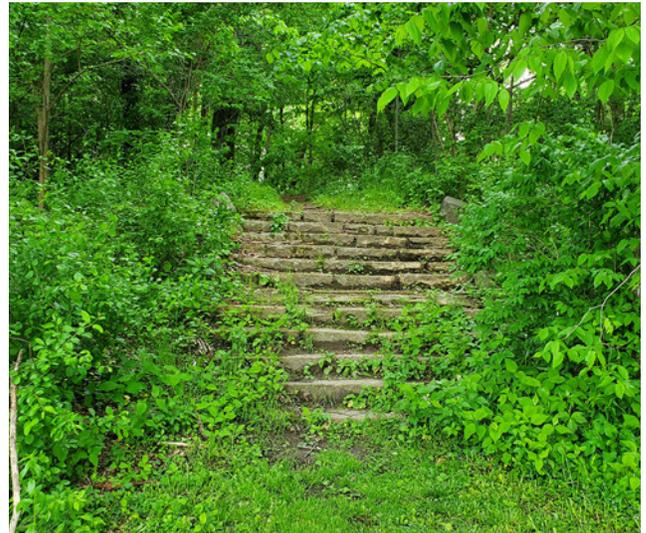
Figure 5.28. Stone Seat Wall/Steps

There are a few remnant stonework elements from the initial construction of Vilas Park. The John L. Burke drinking fountain is a limestone fountain that was constructed in 1931 (Figure 5.27). It is located near the basketball court and is not operational, but the stone is in good condition. Near the Burke fountain is a stone step system (Figure 5.28). These located west of the tennis courts along the woodland edge near the multi-use trail. The stone is in good condition, but the steps have shifted and become uneven. Vegetation is also overgrowing the steps which creates unsafe conditions.

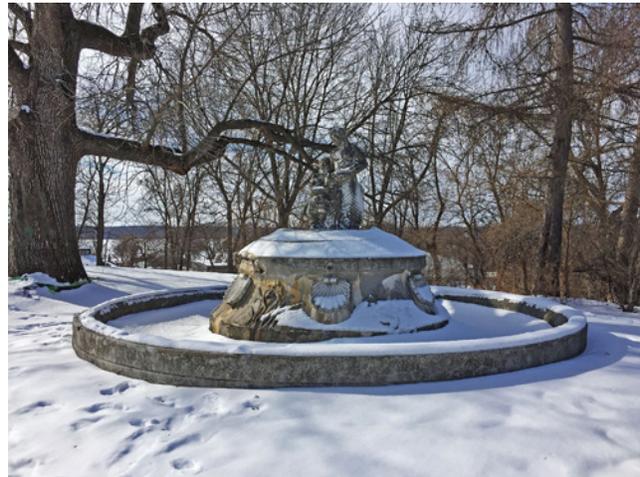
Figure 5.30. Anne Stewart Fountain in Winter

The Annie Stewart Fountain was completed in 1925 for the pedestrian entrance to the park addition at Erin Street. The fountain was heavily vandalized in 1931. The fountain is constructed of marble and concrete and has significantly deteriorated (Figure 5.29 and 5.30). The fountain has not had flowing water for most of its existence. The fountain is connected to the park and city walk system in the Greenbush Neighborhood. A preservation report was completed in 2017<sup>67</sup> that outlines the steps needed to preserve the fountain. The report noted much of the fountain needs to be replaced and it is unexpected that it will ever function as a fountain again. The City has started a separate planning effort to determine the future of the fountain.

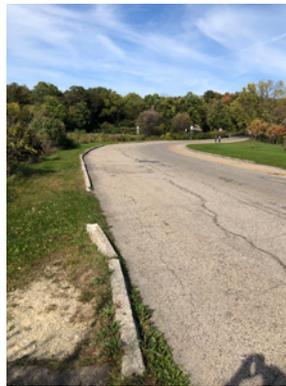
Figure 5.35. VPD Curb

Vilas Park Drive extends most of the length of the park along Lake Wingra. There is a short segment of Edgewood Drive that enters the park and intersects with Vilas Park Drive. The pavement of Edgewood Drive is in fair condition and the City does not have a PASER for that road segment. The Vilas Park Drive asphalt is cracked and patched (Figure 5.31). The entire length of Vilas Park Drive received a 2 to 4 PASER in 2018, meaning potential reconstruction. The asphalt surface drains to lawn areas, asphalt trenches leading to Lake Wingra and some storm sewer pipes (Figures 5.32, 5.33, and 5.34). The edge of the road has a segmented concrete curb that has shifted in places or has been removed altogether (Figure 5.35). Overall, the curb is in poor condition (Figure 5.36).

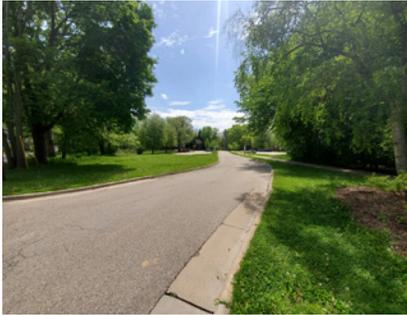
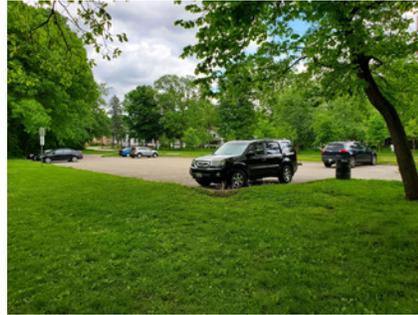
The analysis of parking lots begins on the north end of the park going counterclockwise around the site. The north parking lot and the north parking entry drive, mainly utilized by zoo visitors, is in fair condition with cracks and patches (Figures 5.40 and 5.41). The lot has a PASER of 6. The exit road returning to Drake Street has alligator cracks (Figure 5.42). Like Vilas Park Drive, the curb has segments that are cracked and separated.

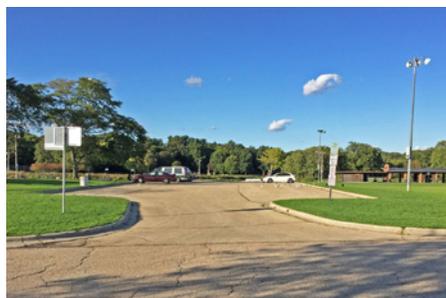
Figure 5.44. Main Shelter Parking Lot

The main shelter parking lot is in fair condition with a PASER of 5.5 to 6 (Figure 5.44). There are longitudinal and transverse cracks. The lot has curbing around all sides except for the north end where there is paved access to the lagoons for the weed cutter and ice grooming equipment.

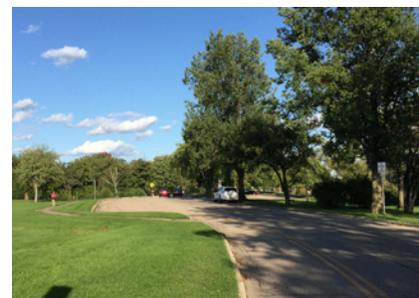
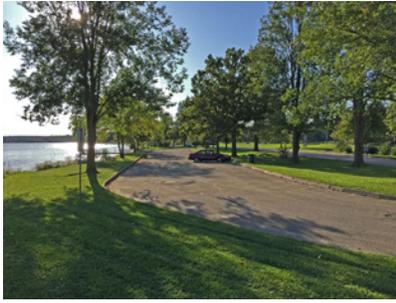
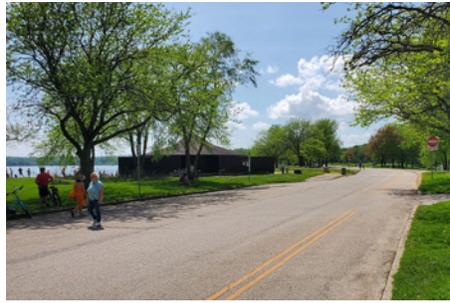
There are three linear parking lots on Vilas Park Drive. A lot on the north side of Vilas Park Drive has angled stalls accessed directly from the road (Figure 5.45). Another linear lot is along the Lake Wingra shoreline with connections to the accessible pier. This lot is separated by a landscape island from Vilas Park Drive (Figure 5.46). The third lot serves the beach bathhouse and has direct access to Vilas Park Drive (Figure 5.47). All 3 lots have cracks and poor curbing. The lots have a PASER of 3 and need replacement.

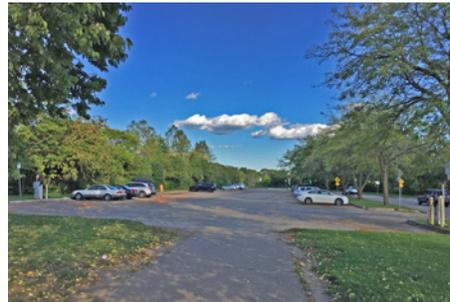
Figure 5.50. South Parking Lot

The parking lot near the south entrance to the zoo is in poor condition (Figure 5.48 & 5.49). The pavement has many patches and is oversized for a typical parking lot design (Figure 5.50). The parking lot received a very low PASER of 2. The lot near Orchard Street is also in poor condition with cracking and has a PASER of 4 (Figure 5.51). Both parking lots have failing curbing along most edges. Both lots also have connections to walks.

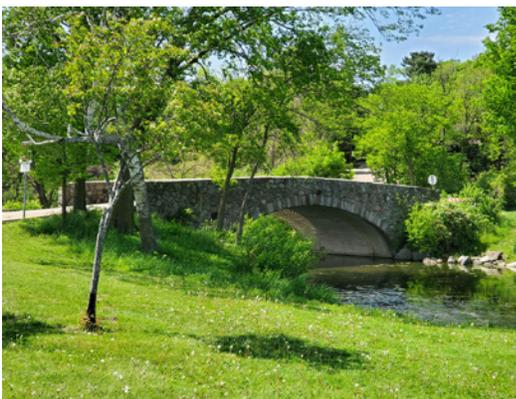
Figure 5.52. Historic Bridge

A structural load rating analysis for the historic bridge at the west end of Vilas Park Drive was performed by Strand Associates in 2012. The bridge was constructed in 1915 and has a wood pile foundation (Figure 5.52). The Strand analysis estimated a load capacity of approximately 11.1 tons (capable of safely supporting a bus) for the bridge. The stone façade of the bridge is in good condition, but the masonry joints need tuck pointing (Figure 5.53). The concrete arch support has several cracks and gaps also in need of masonry work (Figure 5.54).

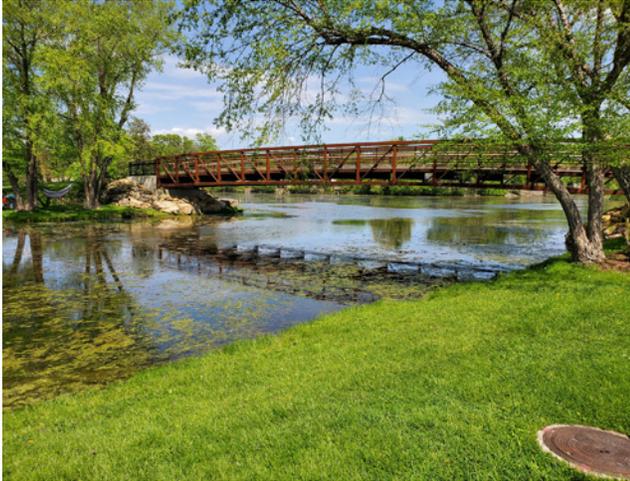
Figure 5.55. Pedestrian Bridge

The City of Madison recently replaced the two pedestrian bridges that cross to the island located in the lagoon (Figures 5.55 and 5.56). The bridges are prefabricated steel structures with a concrete walking surface. The abutments are large glacier stones and riprap. The paths leading up to the bridges were repaved in asphalt and are in good condition. The slope of the paths to the bridges meet current ADA accessibility guidelines.

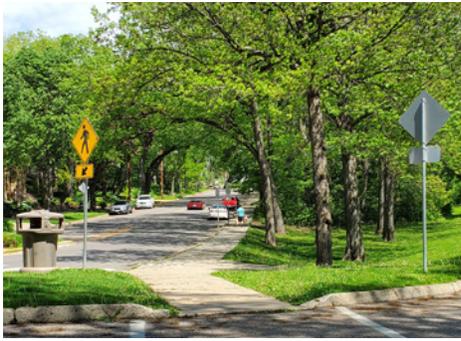
Figure 5.57. Drake Street Walk

The sidewalk in the Drake Street right-of-way was recently added (Figure 5.57). From the Drake Street sidewalk, there is a connection to a walk that extends along the entry road to the north parking lot (Figures 5.58 and 5.59). All the concrete is in good condition and maintained in the winter. The asphalt path that is parallel to the exit road from the north parking lot to the intersection of Grant and Drake Streets is also in good condition with a PASER of 8 (Figure 5.60).

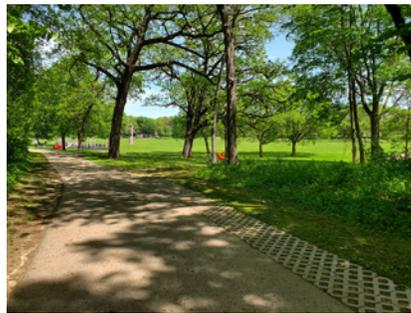
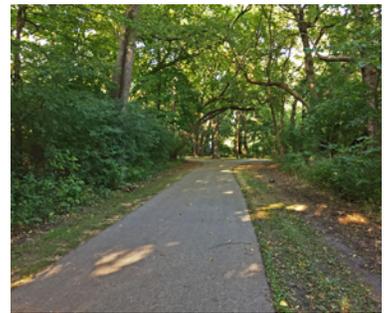
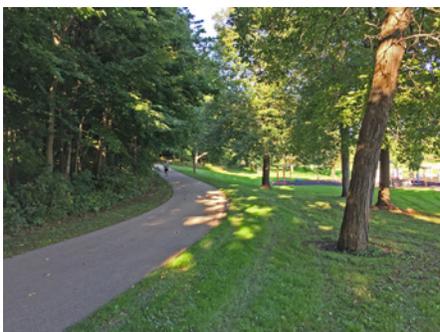
The multi-use trail extends from the Grant and Drake Street intersection along the west boundary of the park to Edgewood Drive (Figures 5.61, 5.62 and 5.63). The asphalt pavement has a PASER of 8 and is in good condition. The trail is the widest paved pedestrian path in the park at 10 feet. The multi-use path is plowed regularly during the winter as a heavily used commuter route (Figure 5.64). There are connections to Vilas

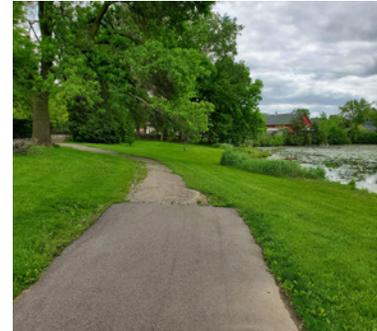
Figure 5.68. Path to Closed Zoo Gate

short connection to the former west entrance to the zoo which is poor condition and is no longer used (Figure 5.68). The path on the island extending to Vilas Park Drive also serves as an access for park maintenance (Figures 5.69 and 5.70). The entire length of the path is cleared of snow in the winter.

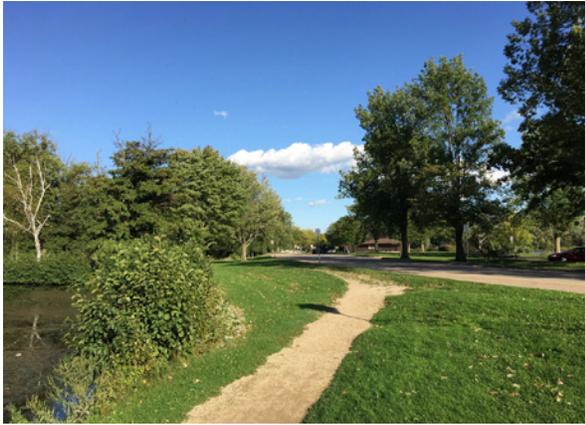
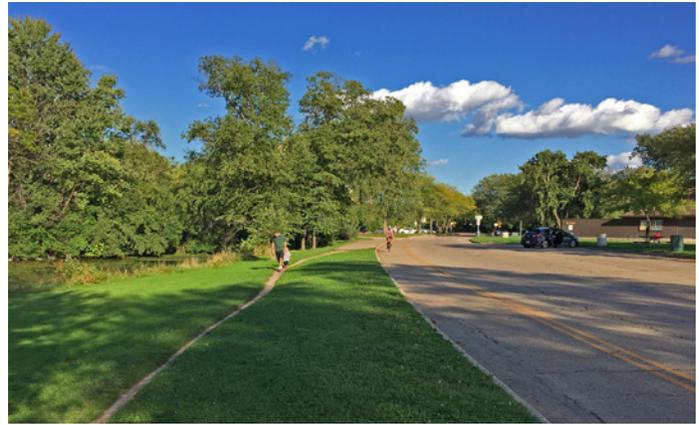
Once the central path terminates at Vilas Park Drive there are no paved connections east or west other than the road. There is a worn dirt foot path along the lagoon shoreline to the south entrance of the zoo (Figures 5.71 and 5.72).

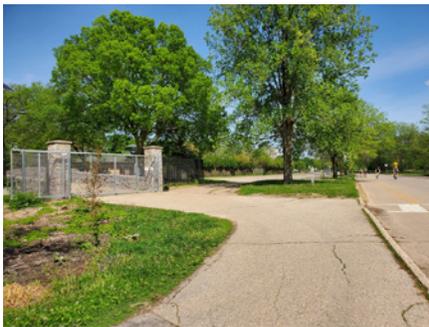
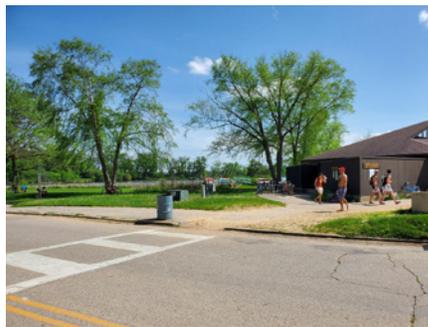
There are three short asphalt paths connecting the south zoo entrance, the beach and the kayak launch to Vilas Park Drive (Figures 5.73 to 5.75). These paths provide accessible connections to use areas but are in poor condition. There has not been a formal assessment of these paths. The south zoo connection is the only link maintained in the winter.

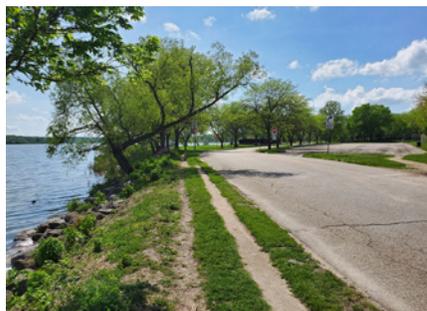
Figure 5.77. Dirt Path at Lake Wingra

There are no pedestrian walkways along a narrow corridor of Vilas Park Drive where the south zoo fence is near the Lake Wingra shoreline (there is only 44.5 feet from the fence to the top of the shoreline slope). There are worn footpaths on both sides of Vilas Park Drive here. The north side dirt path is adjacent to the zoo fence (Figure 5.76). On the south side, there are two worn paths between the curb and rip-rap shoreline (Figure 5.77). The corridor is used by people on foot during the winter and is hazardous (Figure 5.78).

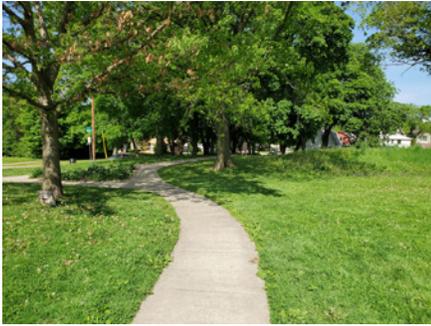
Figure 5.79. Walks at Mounds

At the upper park along Erin Street there are concrete walks connecting to the City walk system and down to the lower park (Figure 5.79). The concrete is in good condition, but the walks exceed an 8% slope in several locations, especially from the top of the hill down to Randall Avenue (Figure 5.80). This condition is not compliant with ADA guidelines. Handrails and landings every 30-feet would need to be added to meet minimum compliance. The walks are cleared in the winter (Figure 5.81). Due to the sensitivity of the mounds, any improvements to the walks are subject to review by the State Archaeologist.

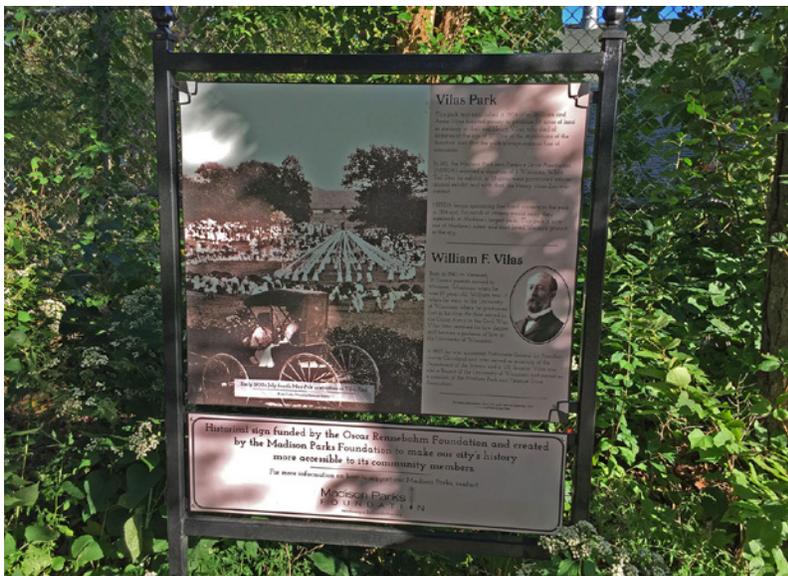
Figure 5.85. Vilas Park History Sign

There is a sign with photographs and information about the history of Vilas Park near the shoe playground along the zoo west fence (Figure 5.85). The sign is in good condition and has information that users may find interesting. There is also a plaque about William Vilas and his role in creating the park on a stone near the main shelter (Figure 5.86).

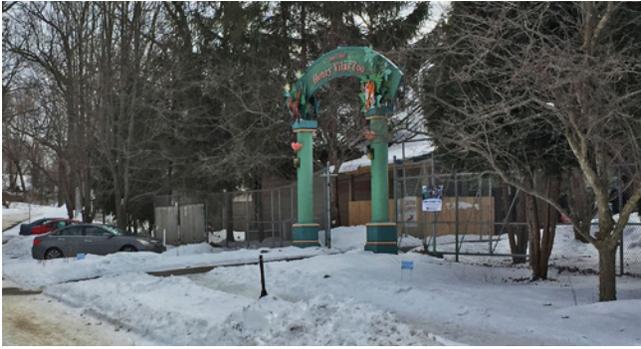
Figure 5.93. North Zoo Gateway

The north sign is a gateway structure which will be replaced and relocated to align with the entry road from the Drake Street and Randall Avenue intersection (Figure 5.93). The south zoo entrance is the former east historic bridge which was built in 1915 as a companion to the park bridge on Vilas Park Drive (Figure 5.94). The bridge walls were extended, and columns were added many years ago to create a gateway into the zoo. There is a small remnant of the lagoon system that provides a pool of water for a garden at that entrance. The bridge and garden are maintained by the zoo.
