RE: Garver Arts Incubator
 Submission to City of Madison Landmarks Commission

The Garver Arts Incubator is a transformational economic and community development project that will create badly needed jobs and renovate a vacant historic landmark into a LEED certified public arts incubator facility that will benefit all Madison residents. The Garver Arts Incubator will preserve the industrial character of the building and bring new life to a site with a rich history as the United States Sugar Beet Company from 1907-1926 and later as the Garver Feed Mill and Supply Company from 1929-1997. Commonwealth Wealth Development, Inc. is requesting a Certificate of Appropriateness from the City of Madison Landmarks Commission for the redevelopment of the Garver Feed Mill building into the Garver Arts Incubator.

GARVER ARTS INCUBATOR
COMMON WEALTH DEVELOPMENT, INC.
HPZS - ARCHITECTS / ENGINEERS
06/01/10
SHEET 2

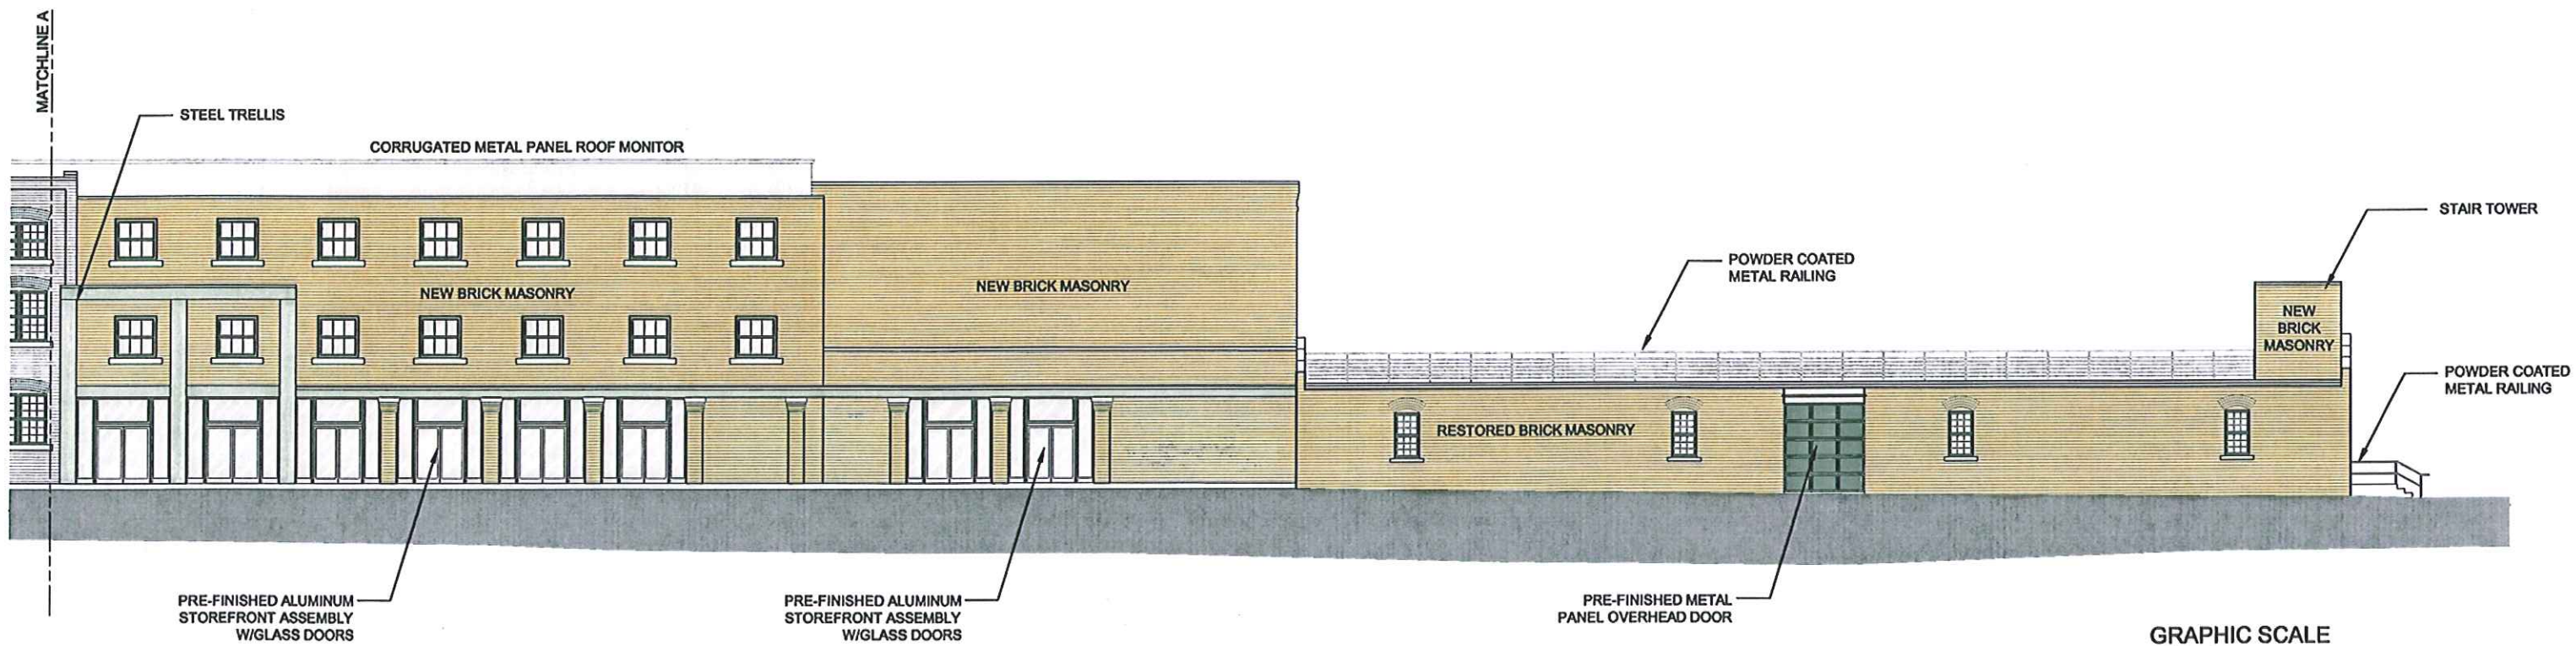
NORTH ELEVATION

- TYPICAL WINDOW:**
- PRE-FINISHED ALUMINUM, DARK GREEN OR DARK BROWN COLOR
 - THERMALLY BROKEN SASH AND FRAME ASSEMBLY
 - INSULATED GLAZING
 - DIVIDED LITES REPLICATING ORIGINAL MUNTIN PATTERN AS CLOSELY AS POSSIBLE BASED ON HISTORIC PHOTOS
 - MUNTIN AND BRICK MOLDING PROFILES TO BE HISTORICALLY CONSISTENT WITH PUTTIED GLAZING BEAD AND WITH INDUSTRIAL CHARACTERISTICS OF BUILDING'S ORIGINAL USE (SEE ATTACHED EXAMPLES FOR GENERAL REPRESENTATION)
- TYPICAL MASONRY RESTORATION:**
- TUCKPOINT 100%
 - DISMANTLE AND REBUILD DETERIORATED PARAPETS TO EXTANT ORIGINAL CONFIGURATION AND PROFILE
 - REMOVE NON-HISTORIC INFILL MATERIALS TO RESTORE ORIGINAL WINDOW MASONRY OPENINGS
 - REPAIR AREAS OF DETERIORATED BRICK MASONRY WITH SALVAGED AND/OR MATCHING BRICK MASONRY

1. Remove all non-historic window infill and restore the original window masonry openings.
2. Eliminate selected non-original door openings.
3. Repoint 100% of the exterior mortar joints.
4. Repair / replace selected and limited areas of deteriorated masonry.
5. Dismantle and reconstruct 100% of the masonry parapet, reusing the existing bricks, and replicating their current configuration and profile.
6. Route and seal all cracks in the concrete string course below the second floor windows, and coat with a protective breathable masonry coating.

A portion of the building on the north side was damaged by fire in May of 2001. This section was subsequently razed, leaving a significant void in the original building facade. In the proposed plan this area is utilized as the location of the new north entry, and will be reconfigured with new door and window openings and a steel trellis canopy. Brick masonry salvaged from this area will provide a matching brick that will be used to patch damaged portions of the restored facade, and to construct a new stair tower projection that will provide egress from the roof garden on the west side.
