LETTER OF INTENT

127-129 State Street (Francis Vallender Building 1867)5

125 State Street (Fire Engine House No. 2/Castle & Doyle Building 1856/1921-22).....6

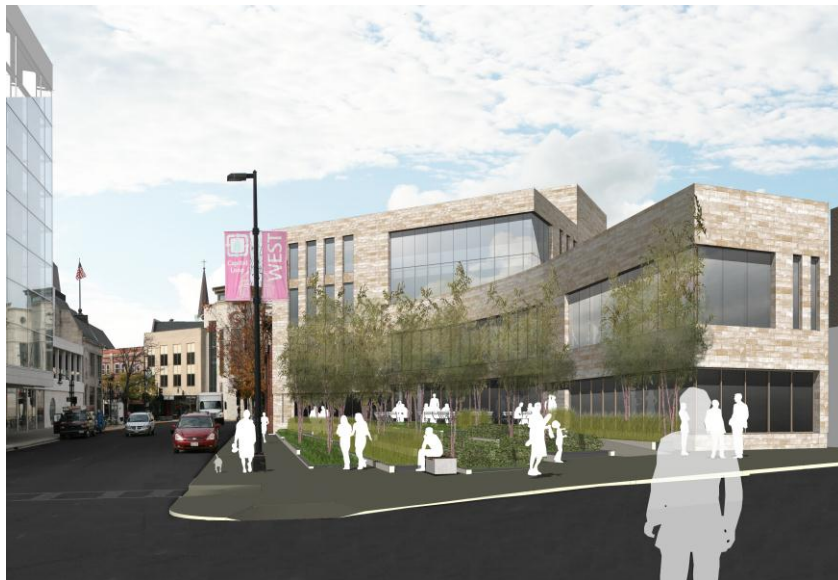
Light defines space. For open spaces it creates a transition between environments instead of separation. A suspended catenary lighting system is proposed in the garden that allows light to be focused in areas, leaving other places in darkness. This system allows light to be pinpointed where desired, with light spill reduced to minimize light pollution and energy consumption. Catenary lighting is based on “less is more” and the system allows light fixtures without the intrusive support structures of light poles and bollards. What is proposed would be unique in downtown Madison and it would create a unique ambience and environment for the civic node at night.
