Re: oLiv Sound Isolation Study Phase 2 (Revision)  
Madison, WI  
KN° 3243

## PROJECT UNDERSTANDING

Kirkegaard was engaged by Antunovich Associates to provide an acoustic study of the predicted sound isolation at a ten-story student housing project in Madison. Our study will focus on airborne sound isolation between bars on the first floor occupying a 15,000 sf space and residential units directly above on the second floor. We understand that Core Spaces is working on the lease and work letter and wants to understand the isolation with the current design and what details would be required for greater isolation. The potential Tenant's schematic design shows four different bar types, and each may involve different expected noise levels; the "Roxxy 2" bar has a stage and dance floor and is connected to the "Roxxy 1" bar, "Double Tap" is more arcade oriented, and the other bar is "Olive".

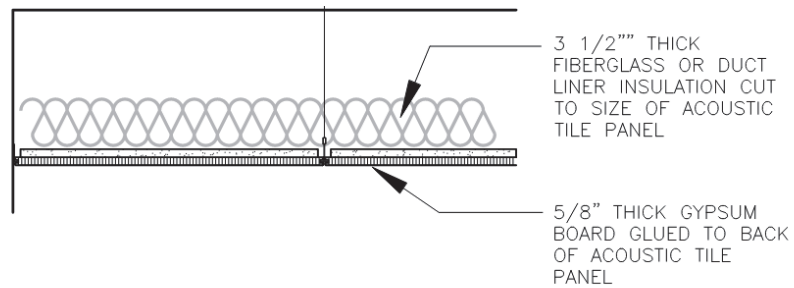
- High Isolation Acoustic Ceiling Tile

### “Good” Recommended Ceiling

- High Isolation Acoustic Ceiling Tile
- Acoustic ceiling tiles with gypsum board backer for isolation. Tiles to be CAC 40+, NRC 0.80+.
- 3” thick batt insulation resting above tiles.
- Minimum 14” airspace between ACT and bottom of structure. MEP may route above ACT.
- Note: Our recommendations assume continuous ACT ceiling and gypsum backer. If speakers are flush mounted in the ACT grid, the slab will be exposed to back-radiated noise and acoustic isolation performance may be closer to that of “Current” floor-ceiling assembly.

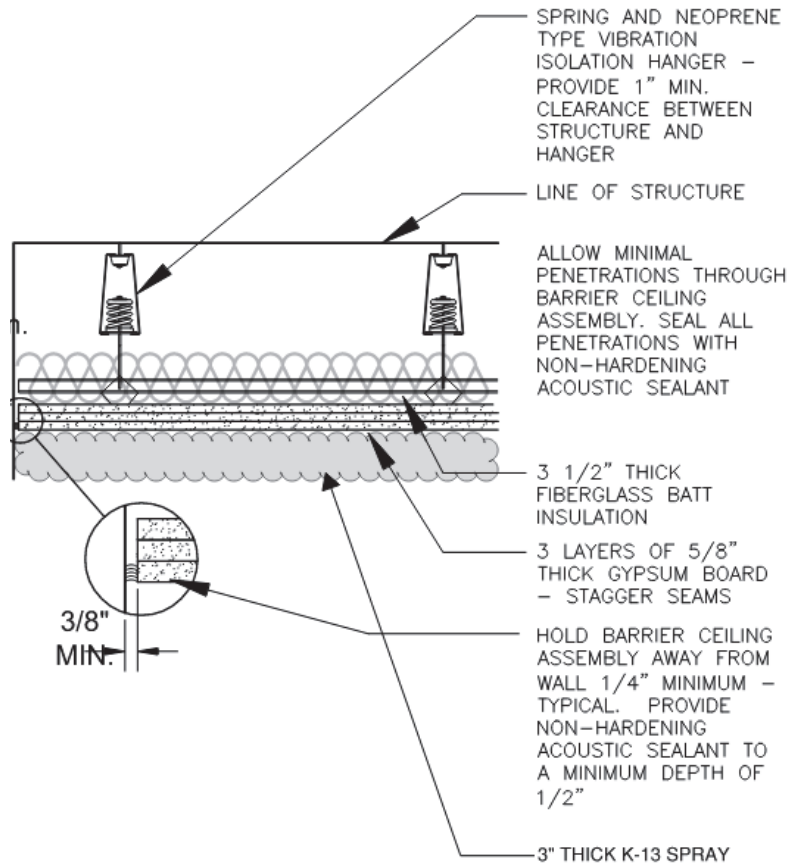
### “Better” Recommended Ceiling

- Gypsum Board Barrier Ceiling

## “Better” Recommended Ceiling

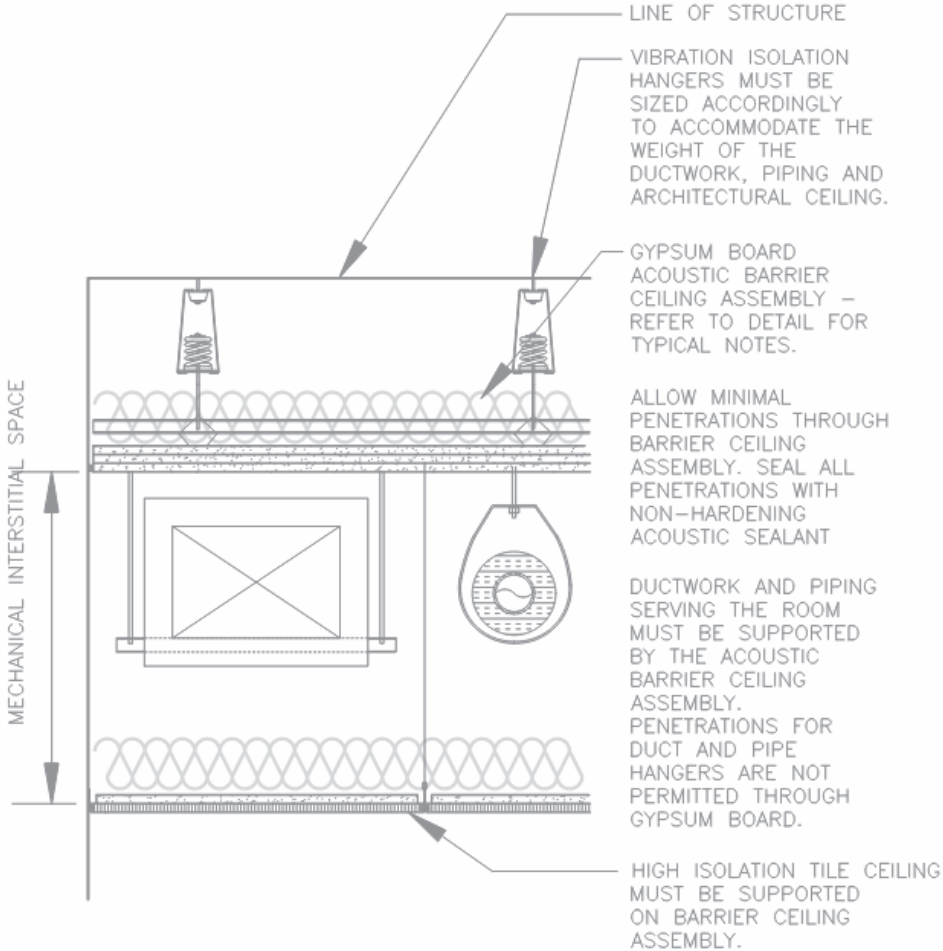
**“Best” Recommended Ceiling**

- ~~High Isolation Acoustic Ceiling Tile + Gypsum Board Barrier Ceiling~~

## “Best” Recommended Ceiling

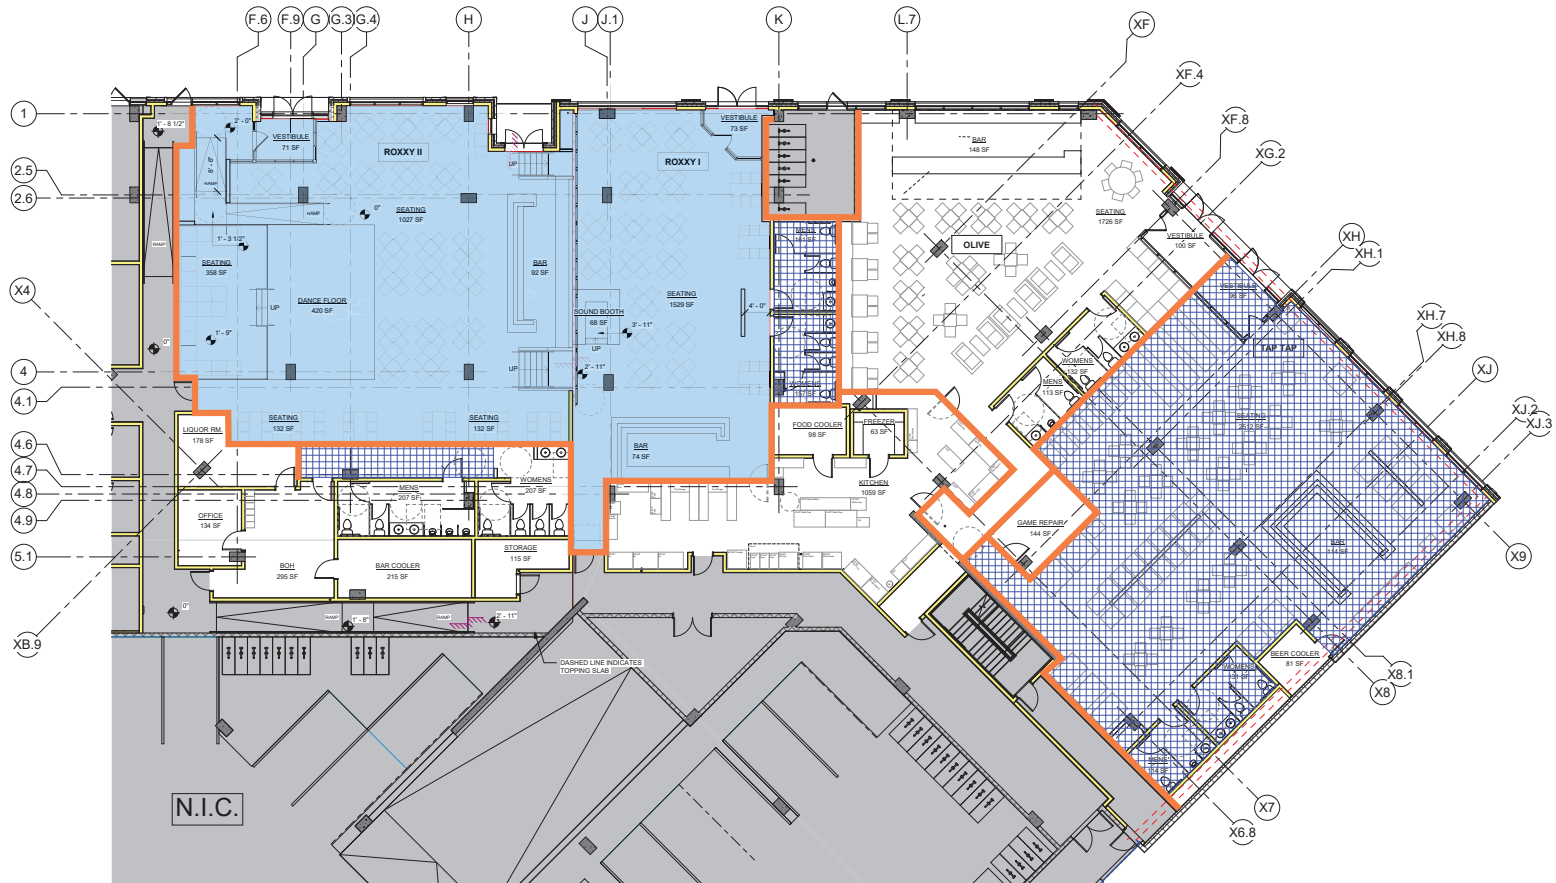
KIRKEGAARD RECOMMENDED CEILING TREATMENT EXTENTS

- "BETTER" GYP BD BARRIER CEILING
- "GOOD" HIGH ISOLATION ACT CEILING
- FULL-HEIGHT, INSULATED PARTITIONS CONTINUOUSLY SEALED TO STRUCTURE. DOORS REQUIRE FULL-PERIMETER GASKETING.

1 LEVEL 01 FURNITURE PLAN  
1/8" = 1'-0"

The attached markup of isolation treatment extents includes our minimum recommendation for full-height partitions (insulated, continuously sealed to structure with full perimeter gaskets on doors). Within these isolation partitions, the extent of the “Good” and “Better” ceiling recommendations are as follows.

We recommend the “Better” treatment should cover the entire ceiling above both Roxxy spaces. After further review from our previous discussions, there is greater overlap above than originally thought (see attached markup). The reason for including the barrier ceiling below the green roof is that it is difficult to predict how sound energy might energize the concrete slab and travel horizontally into 2<sup>nd</sup> floor units (bypassing the barrier ceiling).

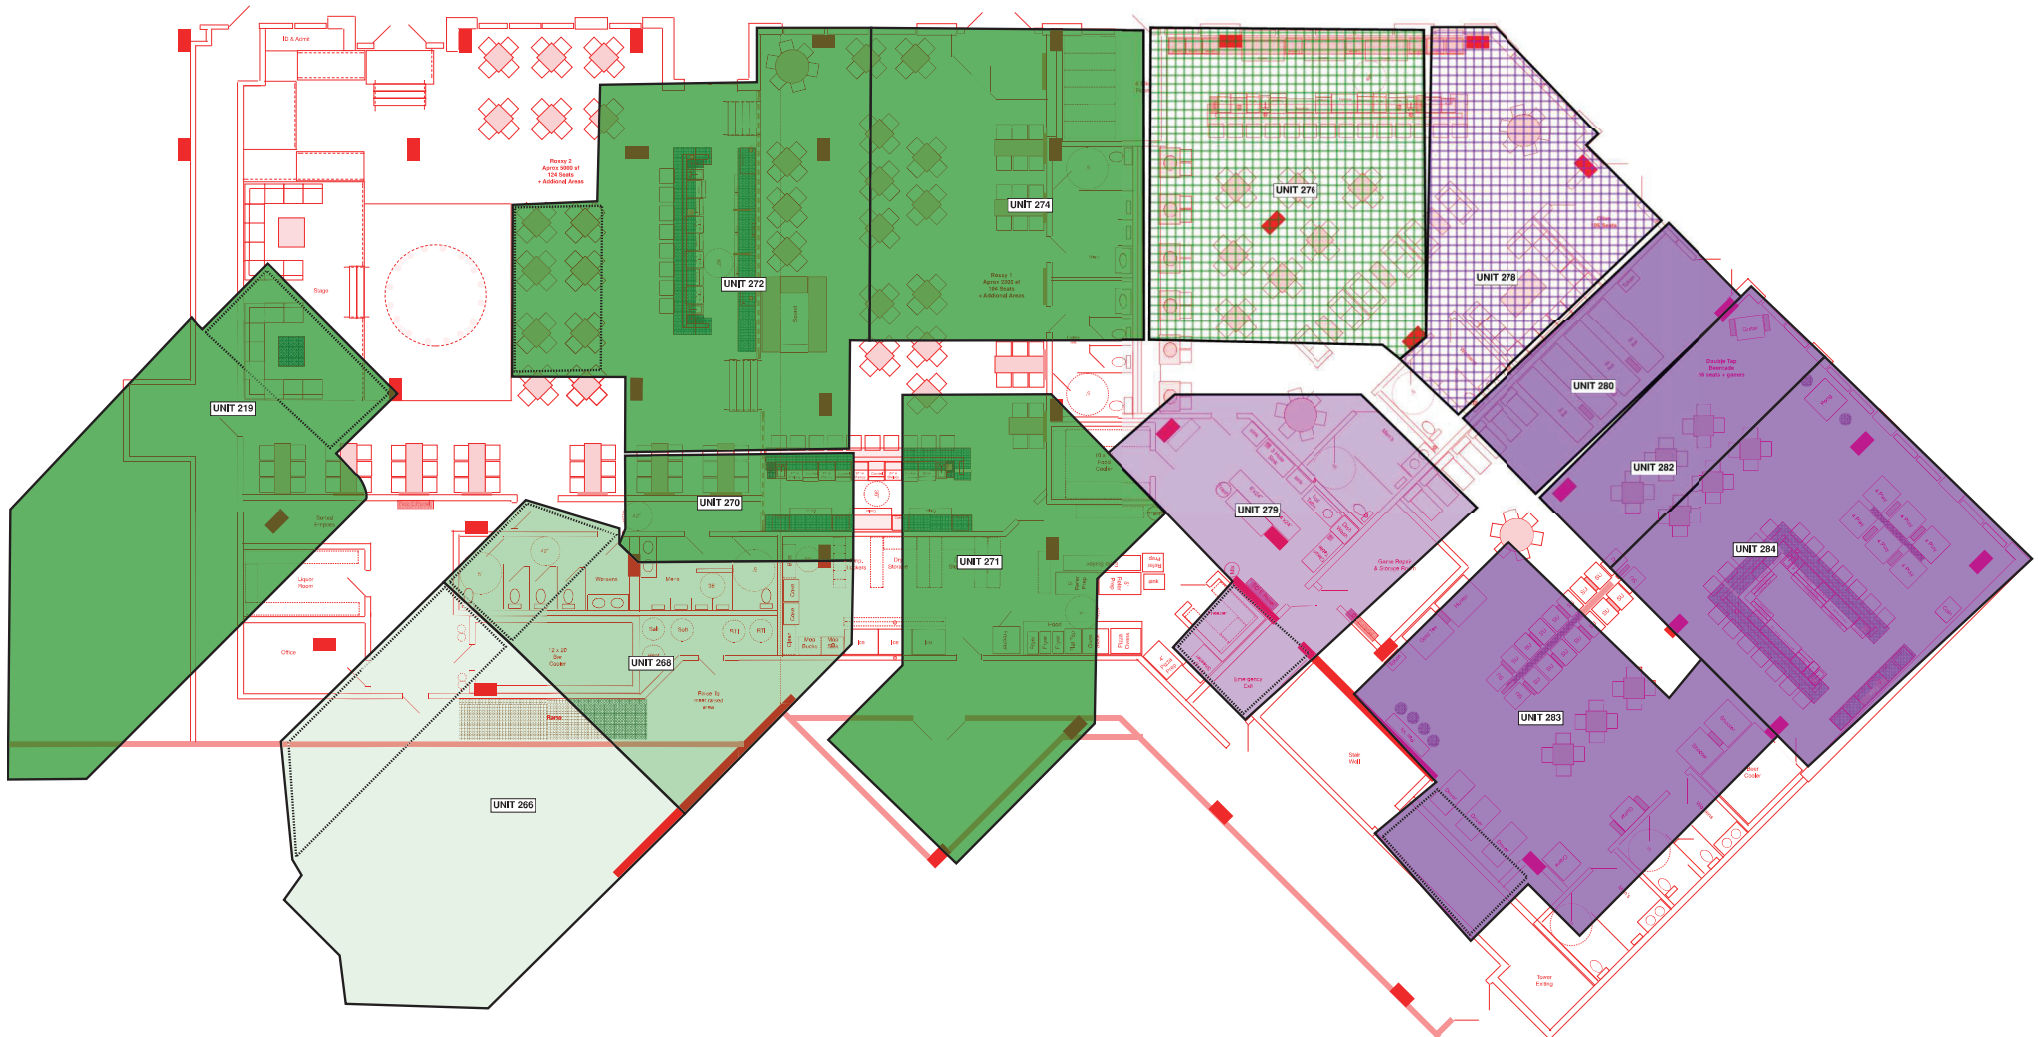
# KIRKEGAARD - BAR NOISE AFFECTED 2ND FLOOR RESIDENTIAL UNITS

HIGH LIKELIHOOD THAT UNIT IS DISTURBED DUE TO ROXXY NOISE IF ACOUSTICAL RECOMMENDATIONS ARE NOT FOLLOWED
-

MEDIUM LIKELIHOOD THAT UNIT IS DISTURBED DUE TO ROXXY NOISE IF ACOUSTICAL RECOMMENDATIONS ARE NOT FOLLOWED
-

LOW LIKELIHOOD THAT UNIT IS DISTURBED DUE TO ROXXY NOISE IF ACOUSTICAL RECOMMENDATIONS ARE NOT FOLLOWED
-

HIGH LIKELIHOOD THAT UNIT IS DISTURBED DUE TO DOUBLE TAP NOISE IF ACOUSTICAL RECOMMENDATIONS ARE NOT FOLLOWED
-

MEDIUM LIKELIHOOD THAT UNIT IS DISTURBED DUE TO DOUBLE TAP NOISE IF ACOUSTICAL RECOMMENDATIONS ARE NOT FOLLOWED
-

HIGH LIKELIHOOD THAT UNIT IS DISTURBED DUE TO DOUBLE TAP NOISE WITHOUT UPGRADED BAR WINDOW
