# LANDMARKS COMMISSION APPLICATION

Project Address: 2129 Kendall Ave Aldermanic District: 5

Project Title/Description: Rehabilitation of Exterior Windows, Siding and Roofing

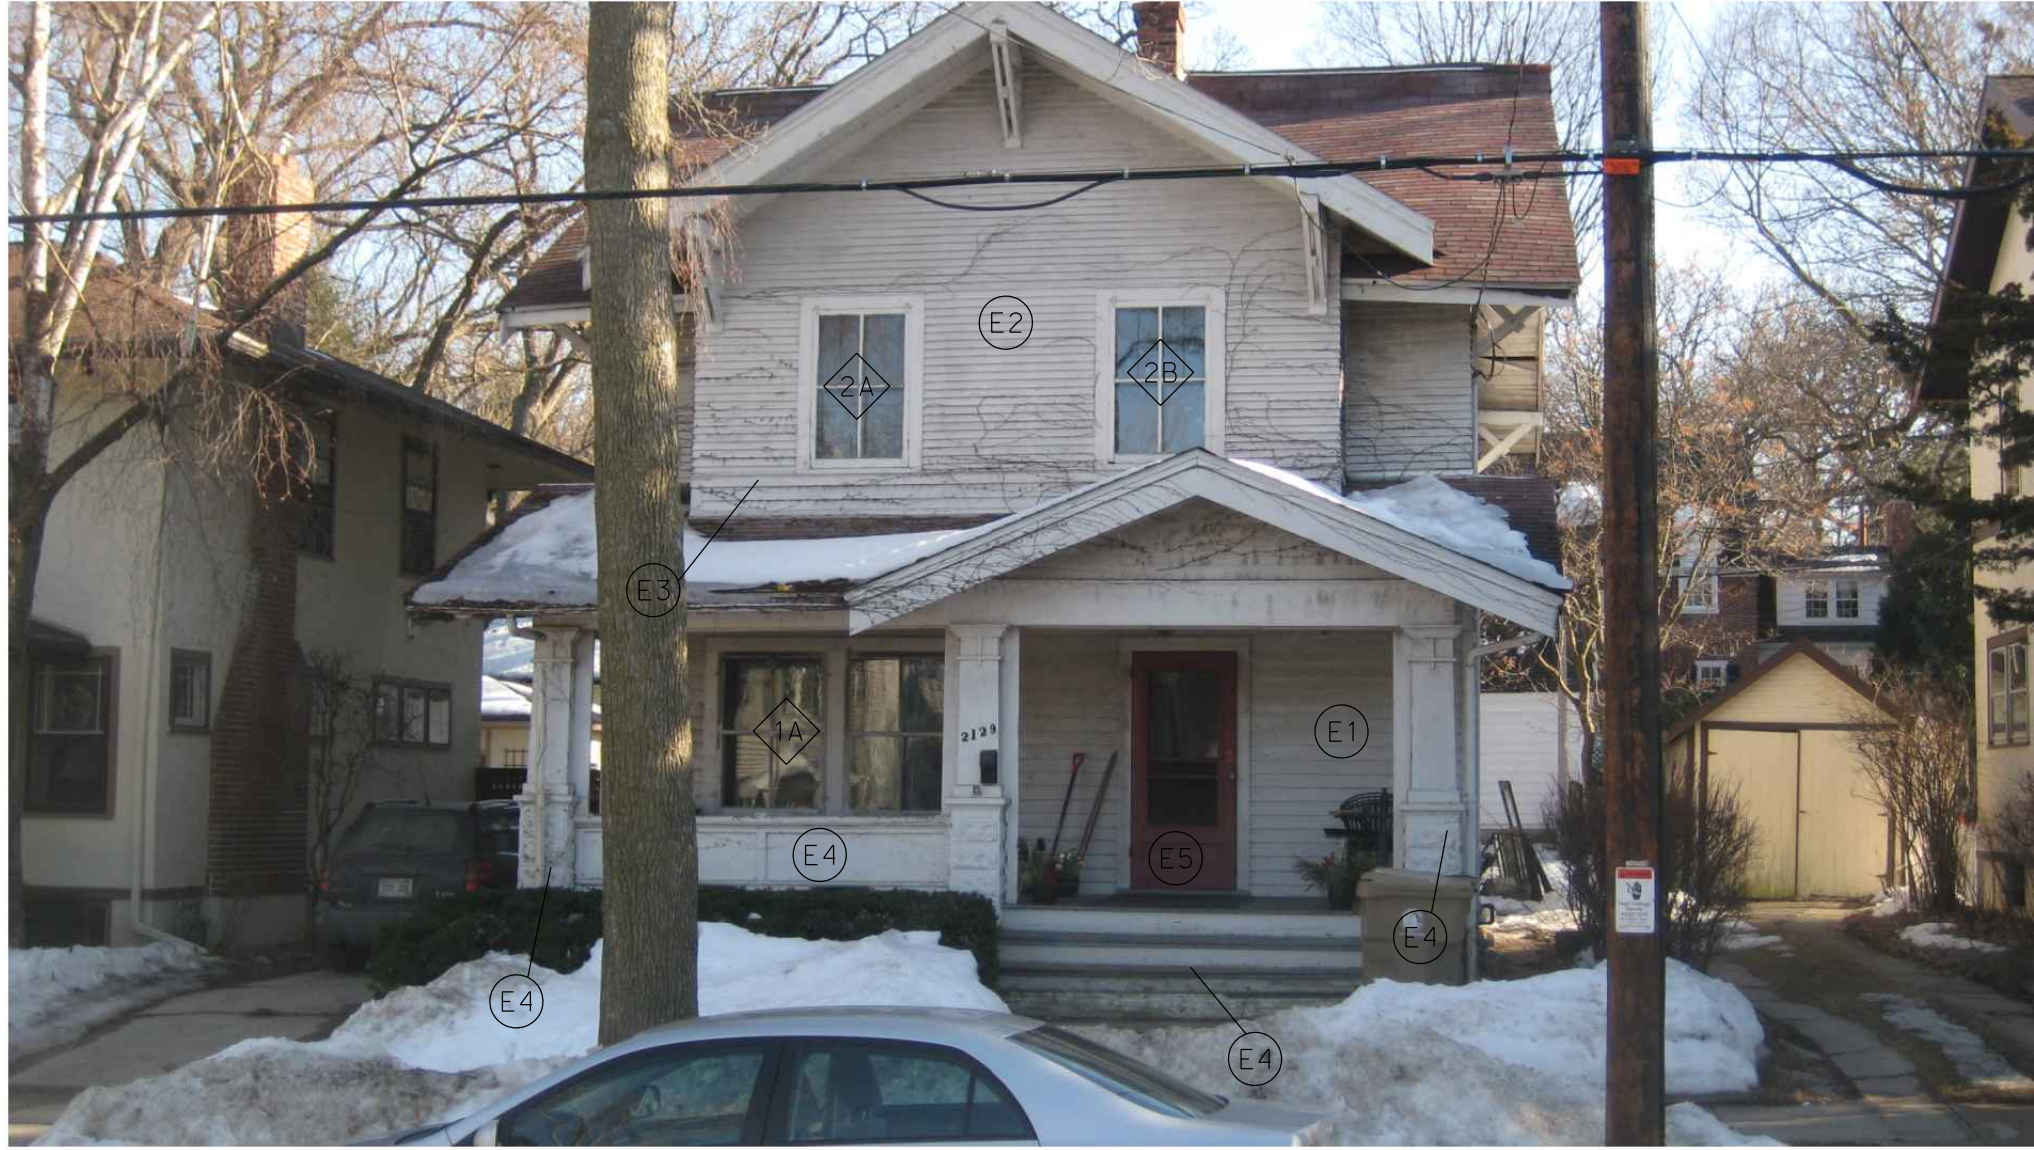
**1** FRONT ELEVATION - PROPOSED SCOPE OF WORK  
N.T.S

- (E1) REMOVE EXISTING WOOD LAP SIDING AND REPLACE WITH 6" LP SMART SIDING.
- (E2) REMOVE EXISTING WOOD LAP SIDING AND REPLACE WITH 4" LP SMART SIDING.
- (E3) REMOVE AND REPLACE EXISTING TRIM BAND. REPLACEMENT TO MATCH EXISTING.
- (E4) REHAB EXISTING PORCH ENCLOSURE, FLOORING, WOOD PILARS, CONCRETE SUPPORTS, STEPS, AND RAILING.
- (E5) REMOVE AND REPLACE EXISTING DOOR.

WINDOW SCHEDULE <span style="border: 1px solid black; padding: 0 2px;">1A</span>					
ID	WINDOW			ASSEMBLY	NOTES
	W	H	TYPE		
1A	32"	X 60"	DOUBLE HUNG	DOUBLE	
2A	38"	X 57"	DOUBLE HUNG	SINGLE	3:1 TDL
2B	38"	X 57"	DOUBLE HUNG	SINGLE	3:1 TDL

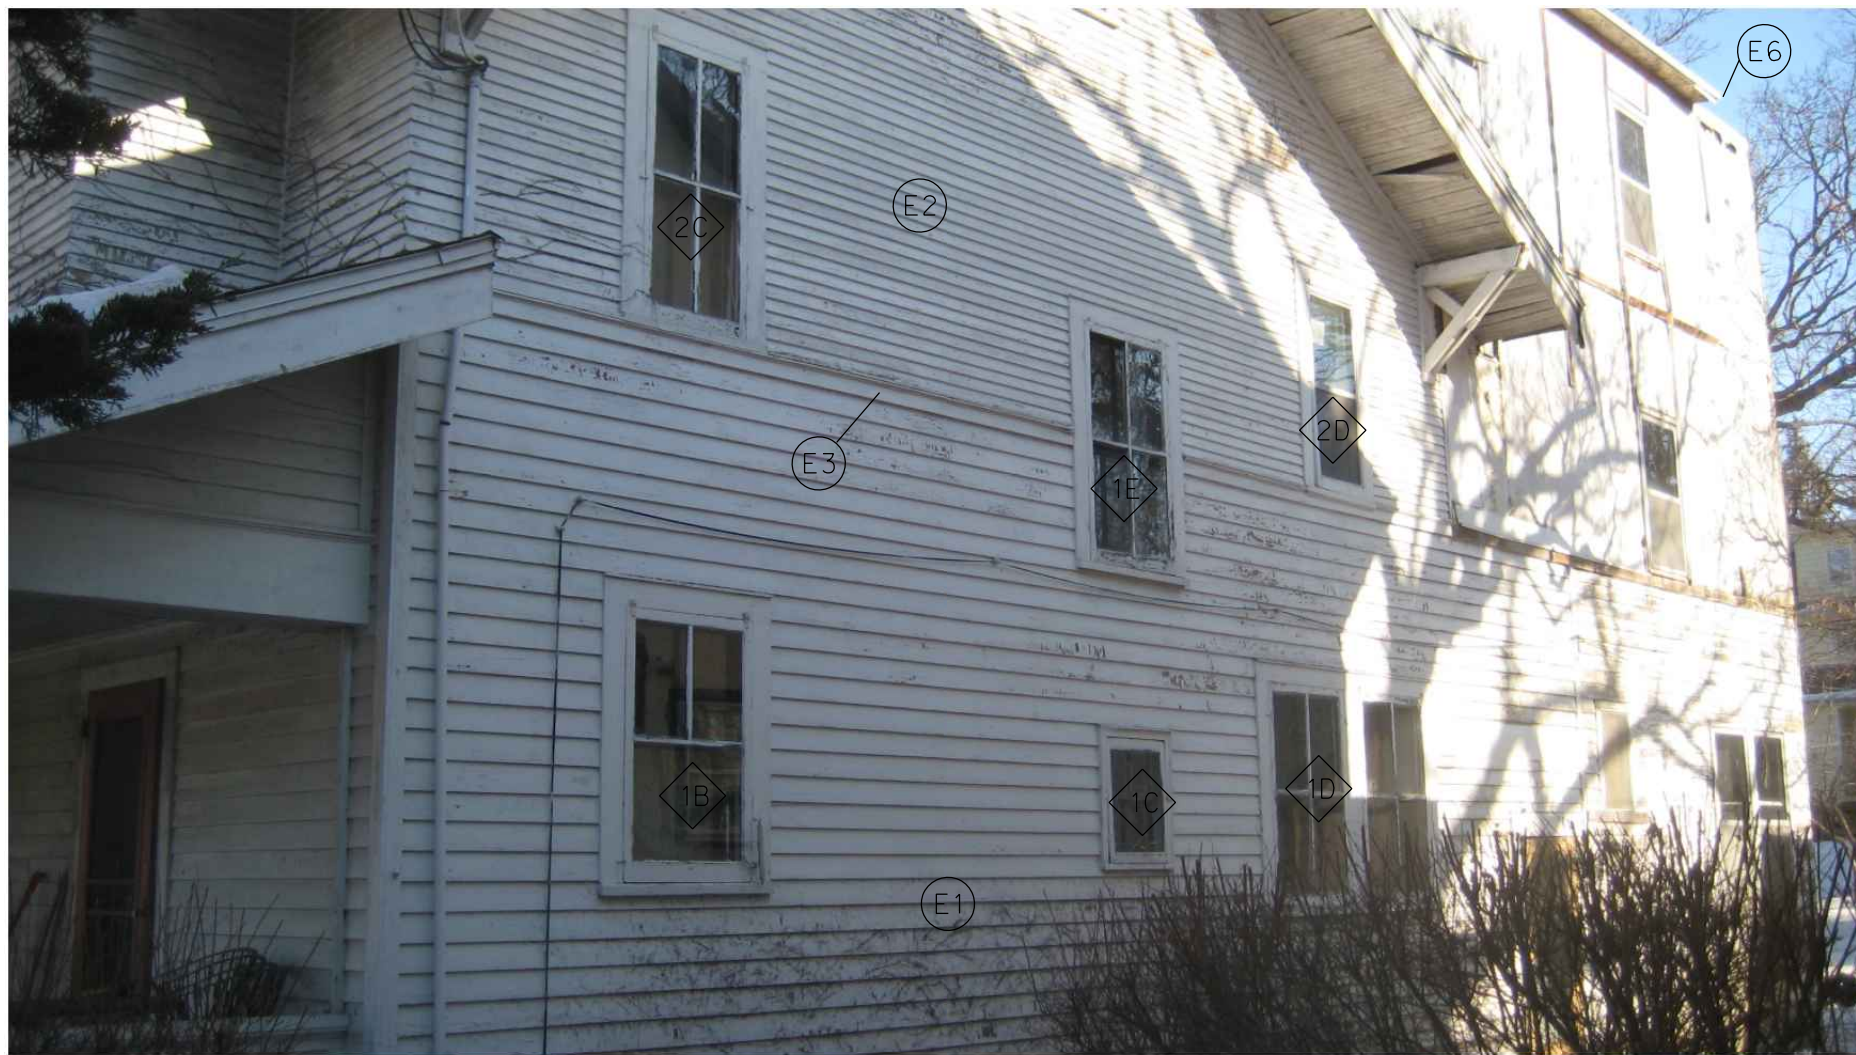
**2 WEST ELEVATION - PROPOSED SCOPE OF WORK**  
N.T.S.

- (E1) REMOVE EXISTING WOOD LAP SIDING AND REPLACE WITH 6" LP SMART SIDING.
- (E2) REMOVE EXISTING WOOD LAP SIDING AND REPLACE WITH 4" LP SMART SIDING.
- (E3) REMOVE AND REPLACE EXISTING TRIM BAND. REPLACEMENT TO MATCH EXISTING.
- (E4) REHAB EXISTING PORCH ENCLOSURE, FLOORING, WOOD PILARS, CONCRETE SUPPORTS, STEPS, AND RAILING.
- (E5) REMOVE AND REPLACE EXISTING ROTTING PANEL BOARD AND REPLACE WITH 4" LP SMART SIDING.
- (E6) REMOVE EXISTING FLAT ROOF AND WATER DAMAGED THIRD FLOOR. REPLACE WITH TRADITIONAL GABLE ROOF MATCHING EXISTING HOUSE CHARACTERISTICS.
- (E7) REMOVE AND REPLACE EXISTING DOOR.

WINDOW SCHEDULE <sup>1A</sup>					
ID	WINDOW			ASSEMBLY	NOTES
	W	H	TYPE		
1B	32"	X	60"	DOUBLE HUNG	SINGLE
1C					REMOVE
1D	38"	X	60"	DOUBLE HUNG	DOUBLE
1E	32"	X	48"	DOUBLE HUNG	SINGLE
2C	38"	X	57"	DOUBLE HUNG	SINGLE
2D	30"	X	57"	DOUBLE HUNG	SINGLE
2E	24"	X	24"	PICTURE	SINGLE

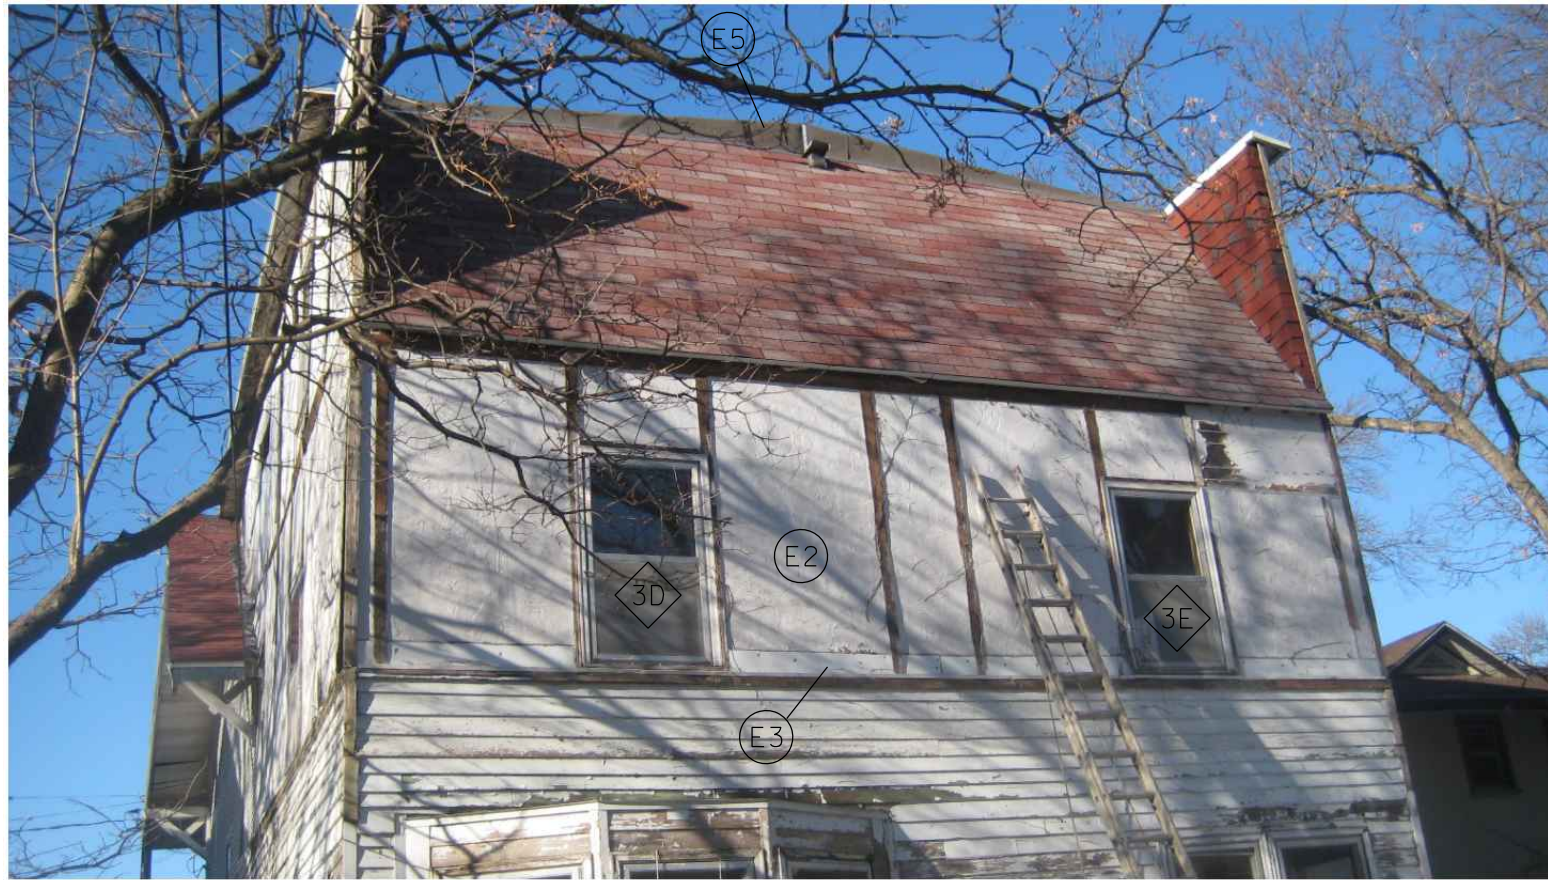
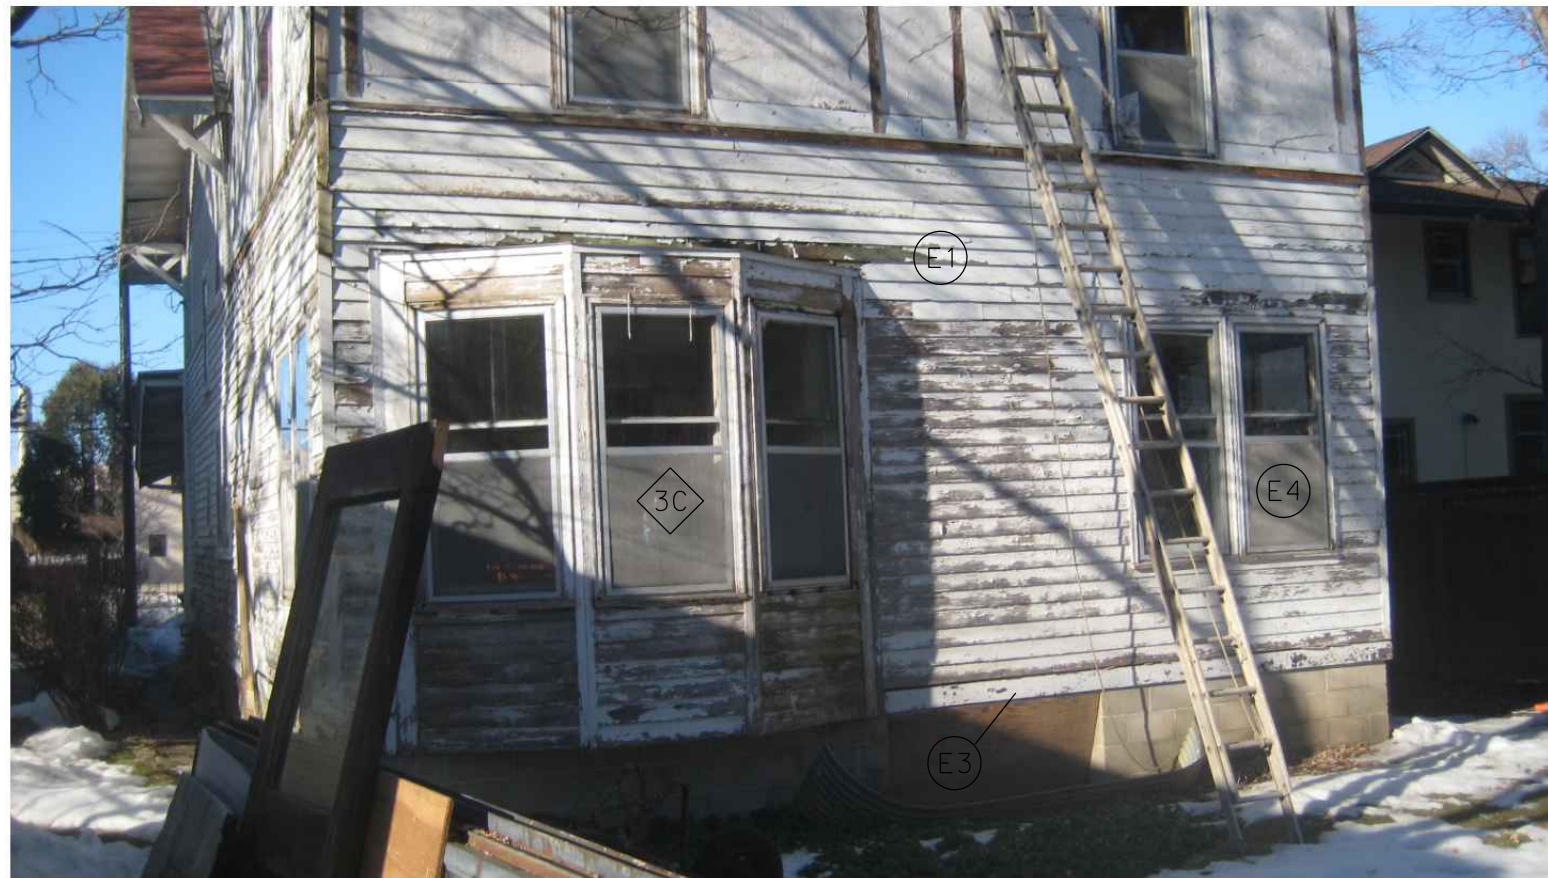
**1** BACK ELEVATION - PROPOSED SCOPE OF WORK  
N.T.S.

- (E1) REMOVE EXISTING WOOD LAP SIDING AND REPLACE WITH 6" LP SMART SIDING.
- (E2) REMOVE EXISTING PANEL BOARDS AND REPLACE WITH 4" LP SMART SIDING.
- (E3) INSTALL NEW TRIM BAND TO MATCH EXISTING TRIM BAND.
- (E4) REMOVE EXSITING WINDOWS AND INSTALL NEW EXTERIOR DOOR WITH STEPS.
- (E5) REMOVE EXISTING FLAT ROOF AND WATER DAMAGED THIRD FLOOR. REPLACE WITH TRADITIONAL GABLE ROOF MATCHING EXISTING HOUSE CHARACTERISTICS.

WINDOW SCHEDULE <span style="border: 1px solid black; padding: 0 2px;">1A</span>					
ID	WINDOW			ASSEMBLY	NOTES
	W	H	TYPE		
3C	44" & 40"	60"	DOUBLE HUNG & PICTURE	TRIPLE	CENTER w/ FLANKERS CENTER w/ UPPER HORIZ. TDL
3D	38"	57"	DOUBLE HUNG	SINGLE	
3E	38"	57"	DOUBLE HUNG	DOUBLE

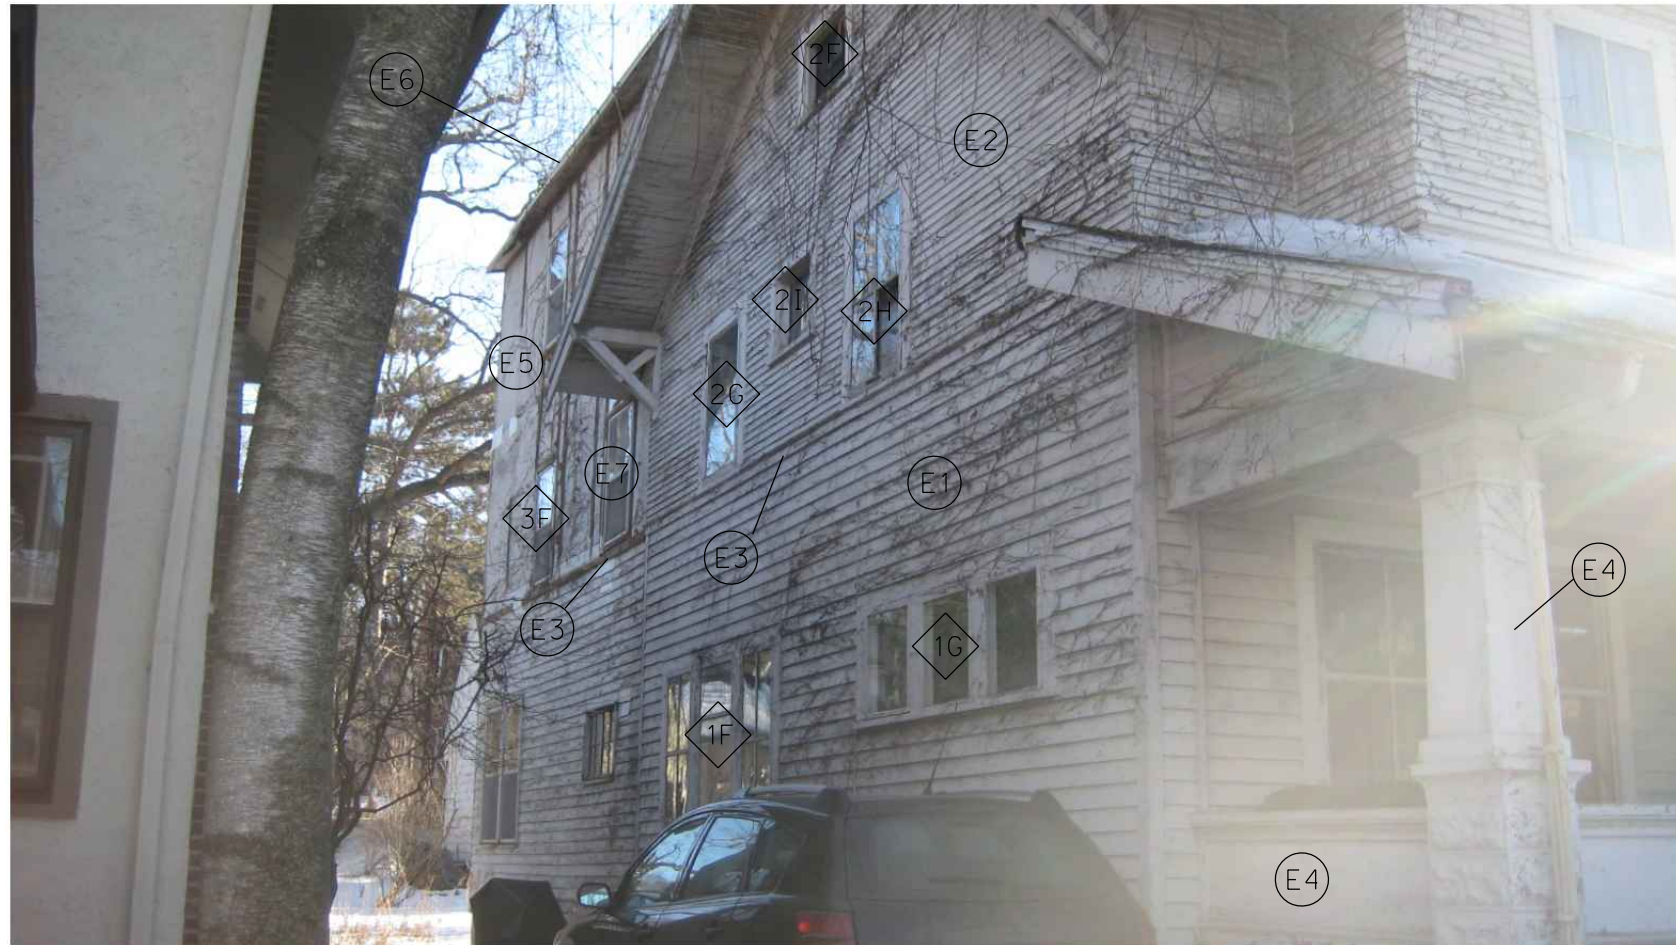
**1** EAST ELEVATION - PROPOSED SCOPE OF WORK  
N.T.S.

WINDOW SCHEDULE <sup>1A</sup>					
ID	WINDOW			ASSEMBLY	NOTES
	W	H	TYPE		
1F	44" & 40" X	60"	DOUBLE HUNG & PICTURE	TRIPLE	CENTER w/ FLANKERS CENTER w/ UPPER HORIZ. TDL
1G	32" X	32"	PICTURE	TRIPLE	
2F	24" X	24"	PICTURE	SINGLE	
2G	38" X	57"	DOUBLE HUNG	SINGLE	
2I					REMOVE
2H	38" X	57"	DOUBLE HUNG	SINGLE	
3F	38" X	57"	DOUBLE HUNG	SINGLE

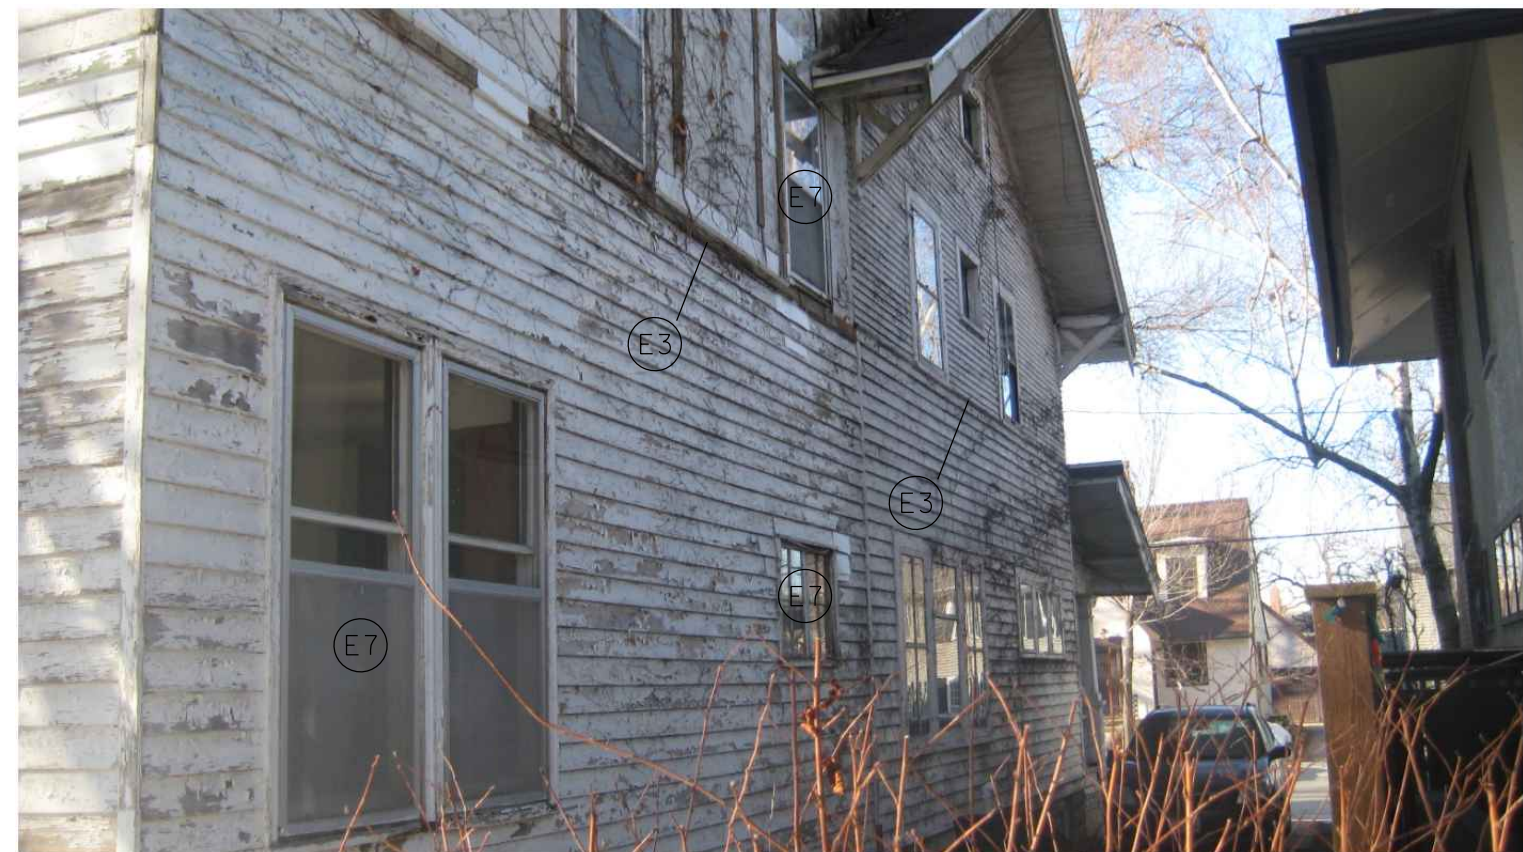
**2** EAST ELEVATION - PROPOSED SCOPE OF WORK  
N.T.S.

- (E1) REMOVE EXISTING WOOD LAP SIDING AND REPLACE WITH 6" LP SMART SIDING.
- (E2) REMOVE EXISTING WOOD LAP SIDING AND REPLACE WITH 4" LP SMART SIDING.
- (E3) REMOVE AND REPLACE EXISTING TRIM BAND. REPLACEMENT TO MATCH EXISTING.
- (E4) REHAB EXISTING PORCH ENCLOSURE, FLOORING, WOOD PILARS, CONCRETE SUPPORTS, STEPS, AND RAILING.
- (E5) REMOVE AND REPLACE EXISTING ROTTING PANEL BOARD AND REPLACE WITH 4" LP SMART SIDING.
- (E6) REMOVE EXISTING FLAT ROOF AND WATER DAMAGED THIRD FLOOR. REPLACE WITH TRADITIONAL GABLE ROOF MATCHING EXISTING HOUSE CHARACTERISTICS.
- (E7) REMOVE AND BOARD UP EXISTING WINDOW.

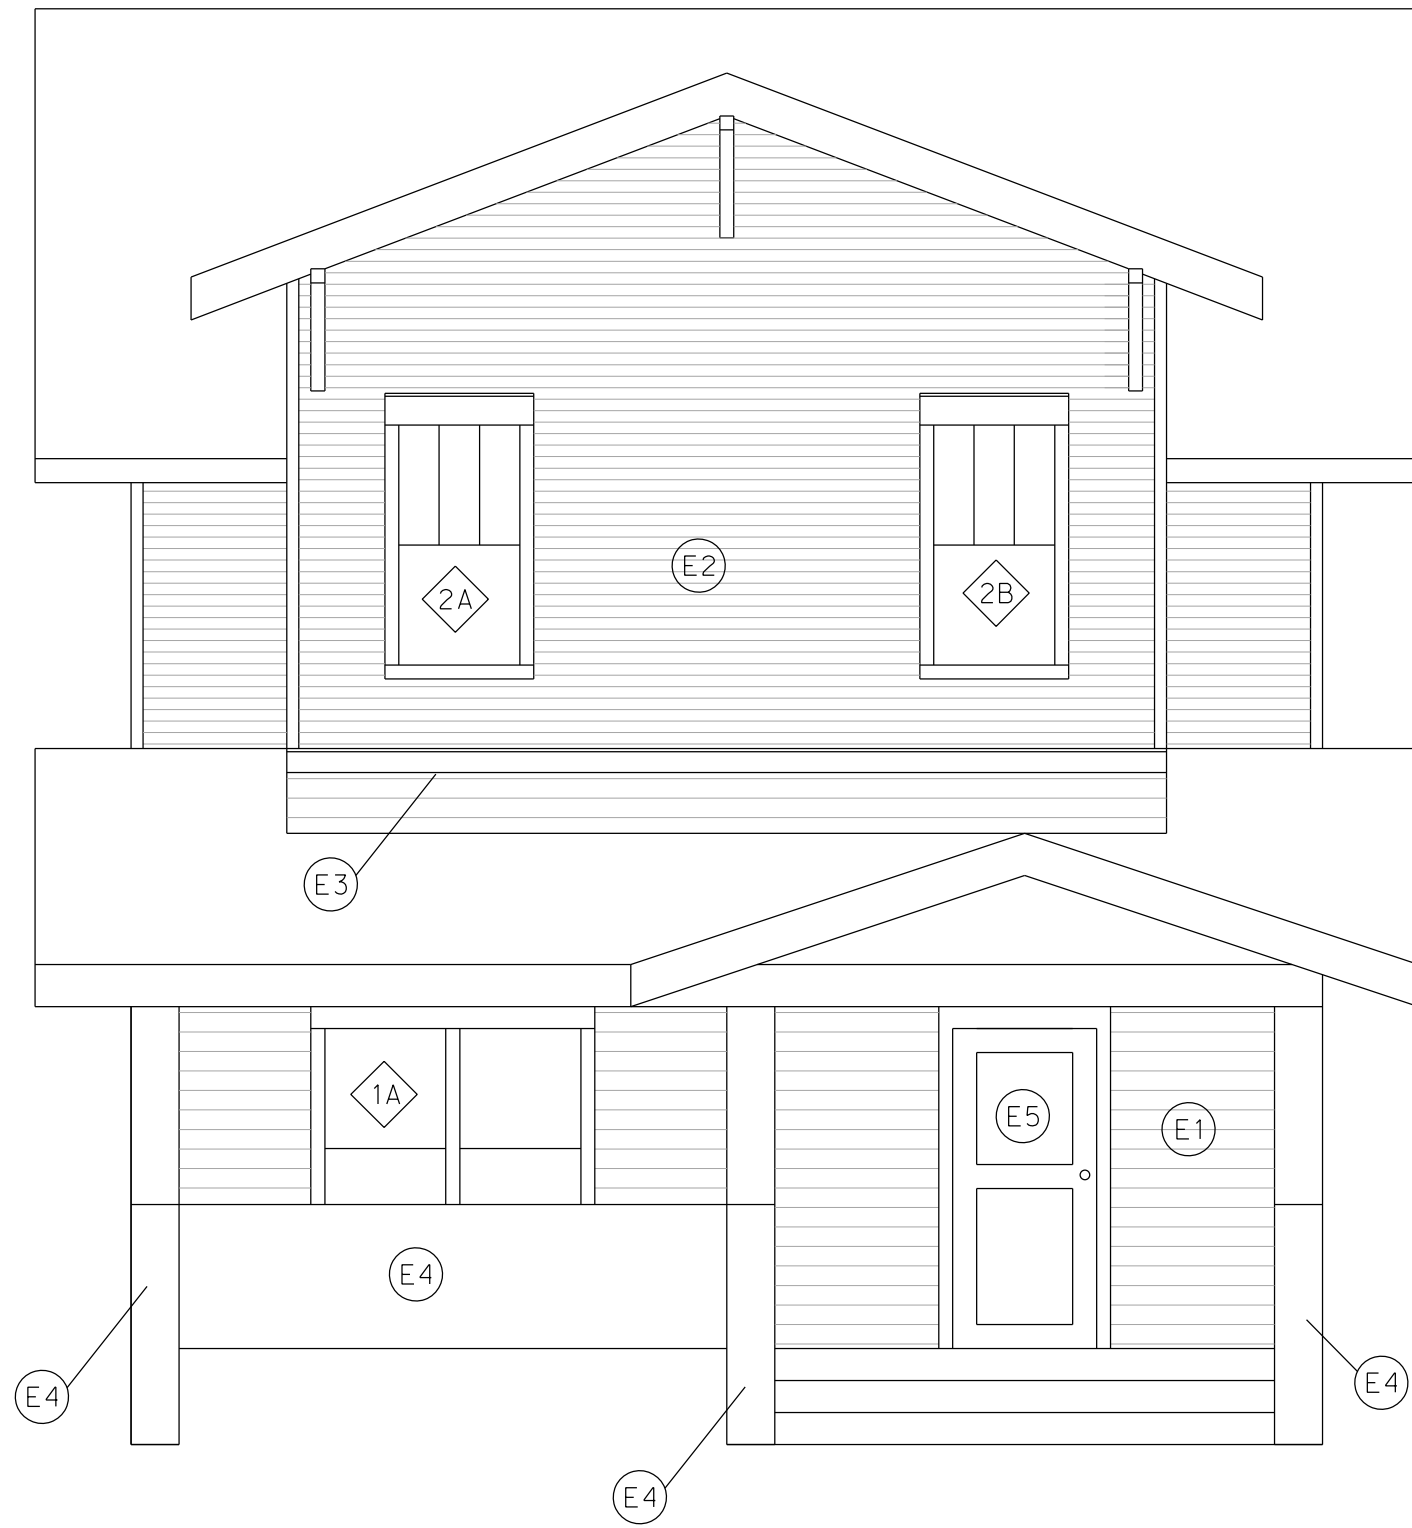
**1** FRONT ELEVATION - PROPOSED  
1/4" = 1'-0"

- (E1) REMOVE EXISTING WOOD LAP SIDING AND REPLACE WITH 6" LP SMART SIDING.
- (E2) REMOVE EXISTING WOOD LAP SIDING AND REPLACE WITH 4" LP SMART SIDING.
- (E3) REMOVE AND REPLACE EXISTING TRIM BAND. REPLACEMENT TO MATCH EXISTING.
- (E4) REHAB EXISTING PORCH ENCLOSURE, FLOORING, WOOD PILARS, CONCRETE SUPPORTS, STEPS, AND RAILING.
- (E5) REMOVE AND REPLACE EXISTING DOOR.

WINDOW SCHEDULE					
ID	WINDOW			ASSEMBLY	NOTES
	W	H	TYPE		
1A	32"	X 60"	DOUBLE HUNG	DOUBLE	
2A	38"	X 57"	DOUBLE HUNG	SINGLE	3:1 TDL
2B	38"	X 57"	DOUBLE HUNG	SINGLE	3:1 TDL

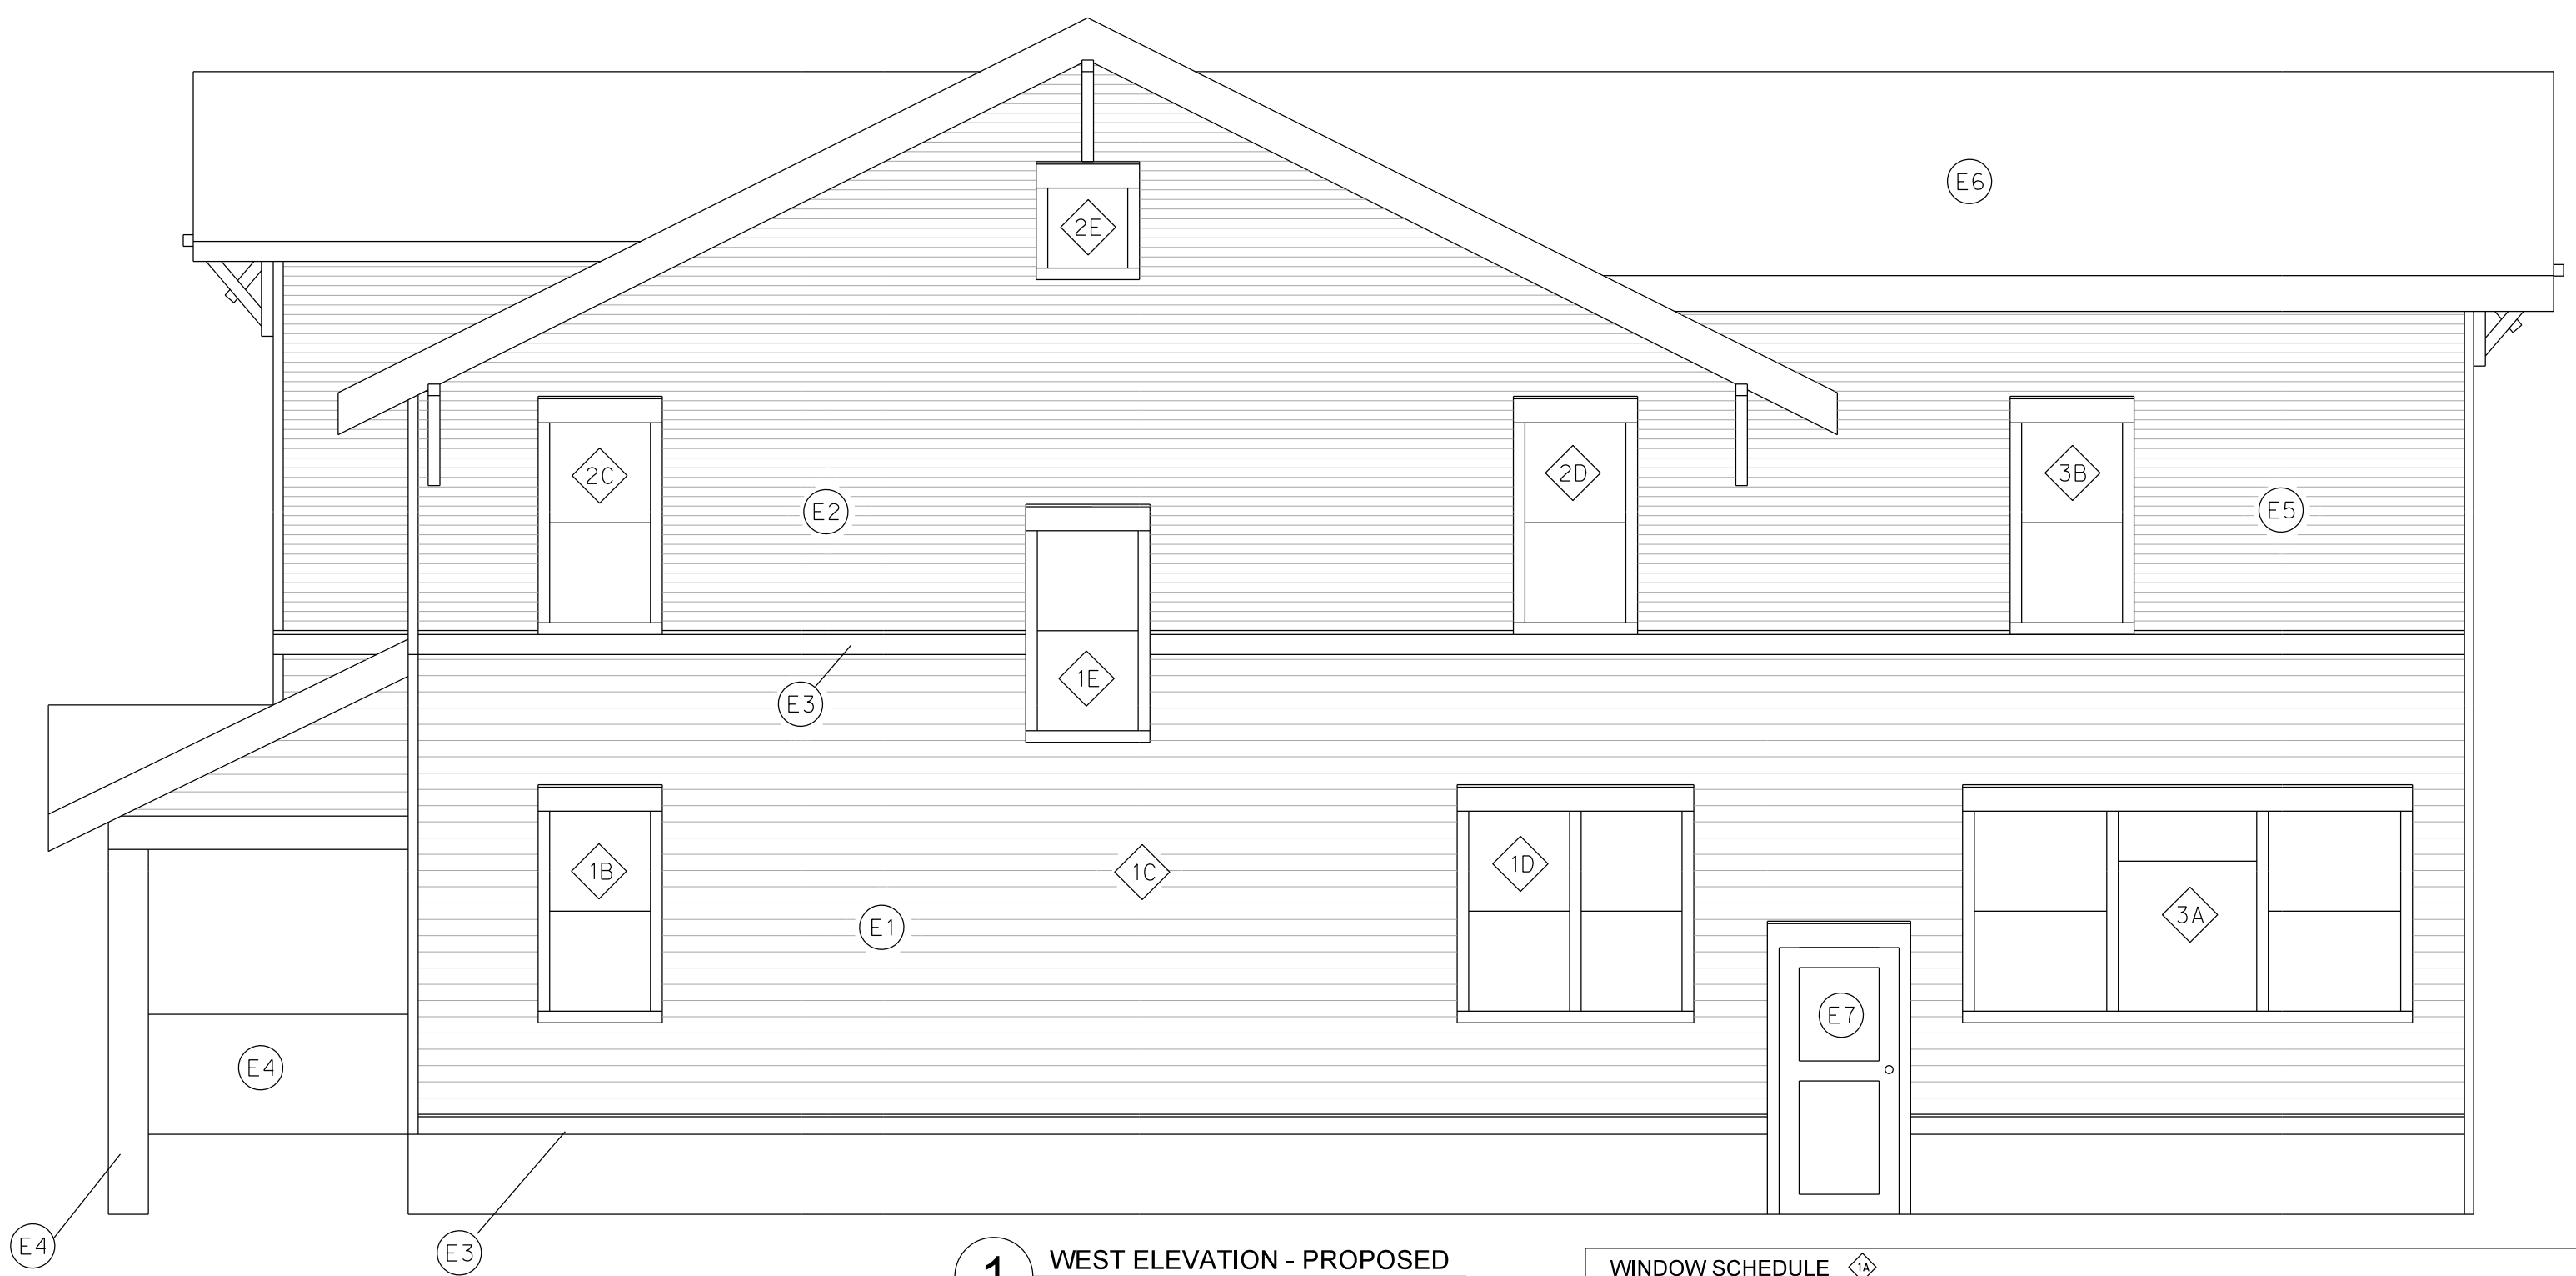
**1** WEST ELEVATION - PROPOSED  
1/4" = 1'-0"

- (E1) REMOVE EXISTING WOOD LAP SIDING AND REPLACE WITH 6" LP SMART SIDING.
- (E2) REMOVE EXISTING WOOD LAP SIDING AND REPLACE WITH 4" LP SMART SIDING.
- (E3) REMOVE AND REPLACE EXISTING TRIM BAND. REPLACEMENT TO MATCH EXISTING.
- (E4) REHAB EXISTING PORCH ENCLOSURE, FLOORING, WOOD PILARS, CONCRETE SUPPORTS, STEPS, AND RAILING.
- (E5) REMOVE AND REPLACE EXISTING ROTTING PANEL BOARD AND REPLACE WITH 4" LP SMART SIDING.
- (E6) REMOVE EXISTING FLAT ROOF AND WATER DAMAGED THIRD FLOOR. REPLACE WITH TRADITIONAL GABLE ROOF MATCHING EXISTING HOUSE CHARACTERISTICS.
- (E7) REMOVE AND REPLACE EXISTING DOOR.

WINDOW SCHEDULE <span style="border: 1px solid black; padding: 0 2px;">1A</span>					
ID	WINDOW			ASSEMBLY	NOTES
	W	H	TYPE		
1B	32"	X 60"	DOUBLE HUNG	SINGLE	
1C					REMOVE
1D	38"	X 60"	DOUBLE HUNG	DOUBLE	
1E	32"	X 48"	DOUBLE HUNG	SINGLE	
2C	38"	X 57"	DOUBLE HUNG	SINGLE	
2D	30"	X 57"	DOUBLE HUNG	SINGLE	
2E	24"	X 24"	PICTURE	SINGLE	
3A	44" & 40"	X 60"	DOUBLE HUNG & PICTURE	TRIPLE	CENTER w/ FLANKERS CENTER w/ UPPER HORIZ. TDL
3B	38"	X 57"	DOUBLE HUNG	SINGLE

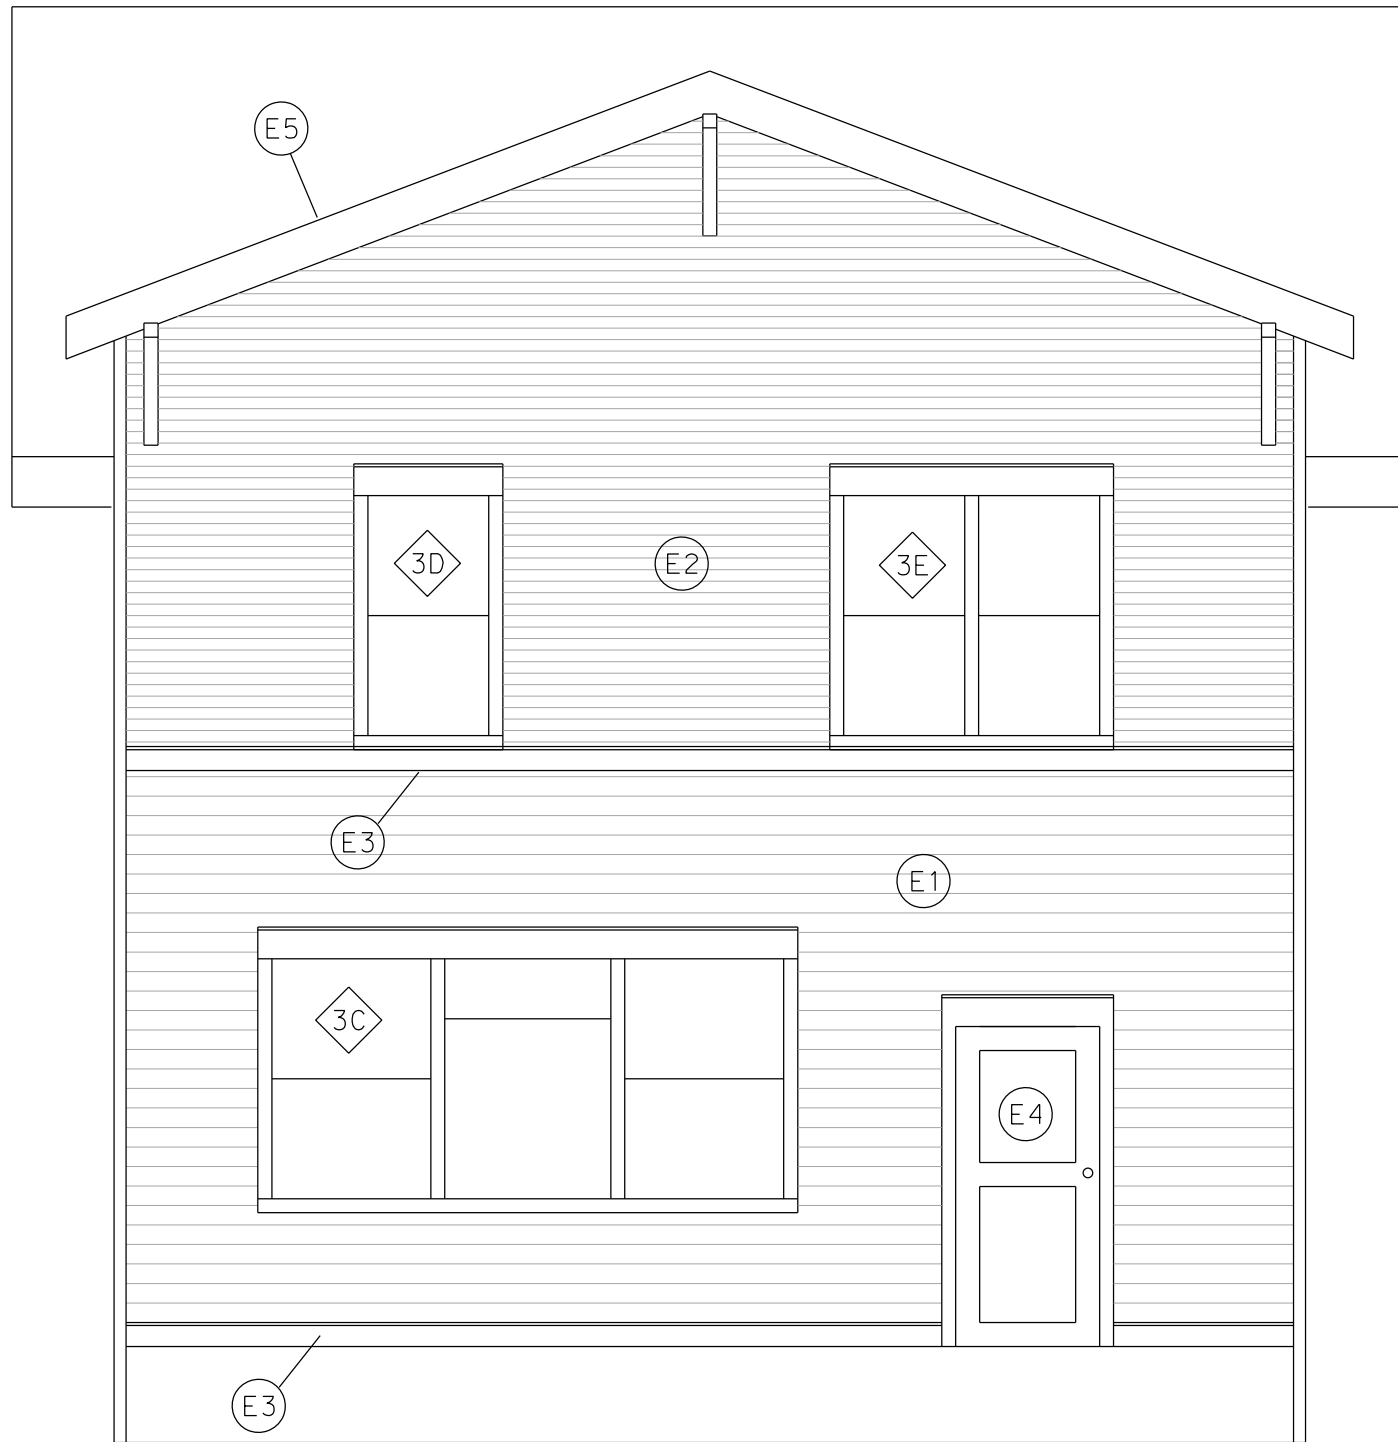
**1** BACK ELEVATION - PROPOSED  
1/4" = 1'-0"

- (E1) REMOVE EXISTING WOOD LAP SIDING AND REPLACE WITH 6" LP SMART SIDING.
- (E2) REMOVE EXISTING WOOD LAP SIDING AND REPLACE WITH 4" LP SMART SIDING.
- (E3) REMOVE AND REPLACE EXISTING TRIM BAND. REPLACEMENT TO MATCH EXISTING.
- (E4) REMOVE EXSITING WINDOWS AND INSTALL NEW EXTERIOR DOOR WITH STEPS.
- (E5) REMOVE EXISTING FLAT ROOF AND WATER DAMAGED THIRD FLOOR. REPLACE WITH TRADITIONAL GABLE ROOF MATCHING EXISTING HOUSE CHARACTERISTICS.

WINDOW SCHEDULE <span style="border: 1px solid black; padding: 0 2px;">1A</span>					
ID	WINDOW			ASSEMBLY	NOTES
	W	H	TYPE		
3C	44" & 40"	60"	DOUBLE HUNG & PICTURE	TRIPLE	CENTER w/ FLANKERS CENTER w/ UPPER HORIZ. TDL
3D	38"	57"	DOUBLE HUNG	SINGLE	
3E	38"	57"	DOUBLE HUNG	DOUBLE

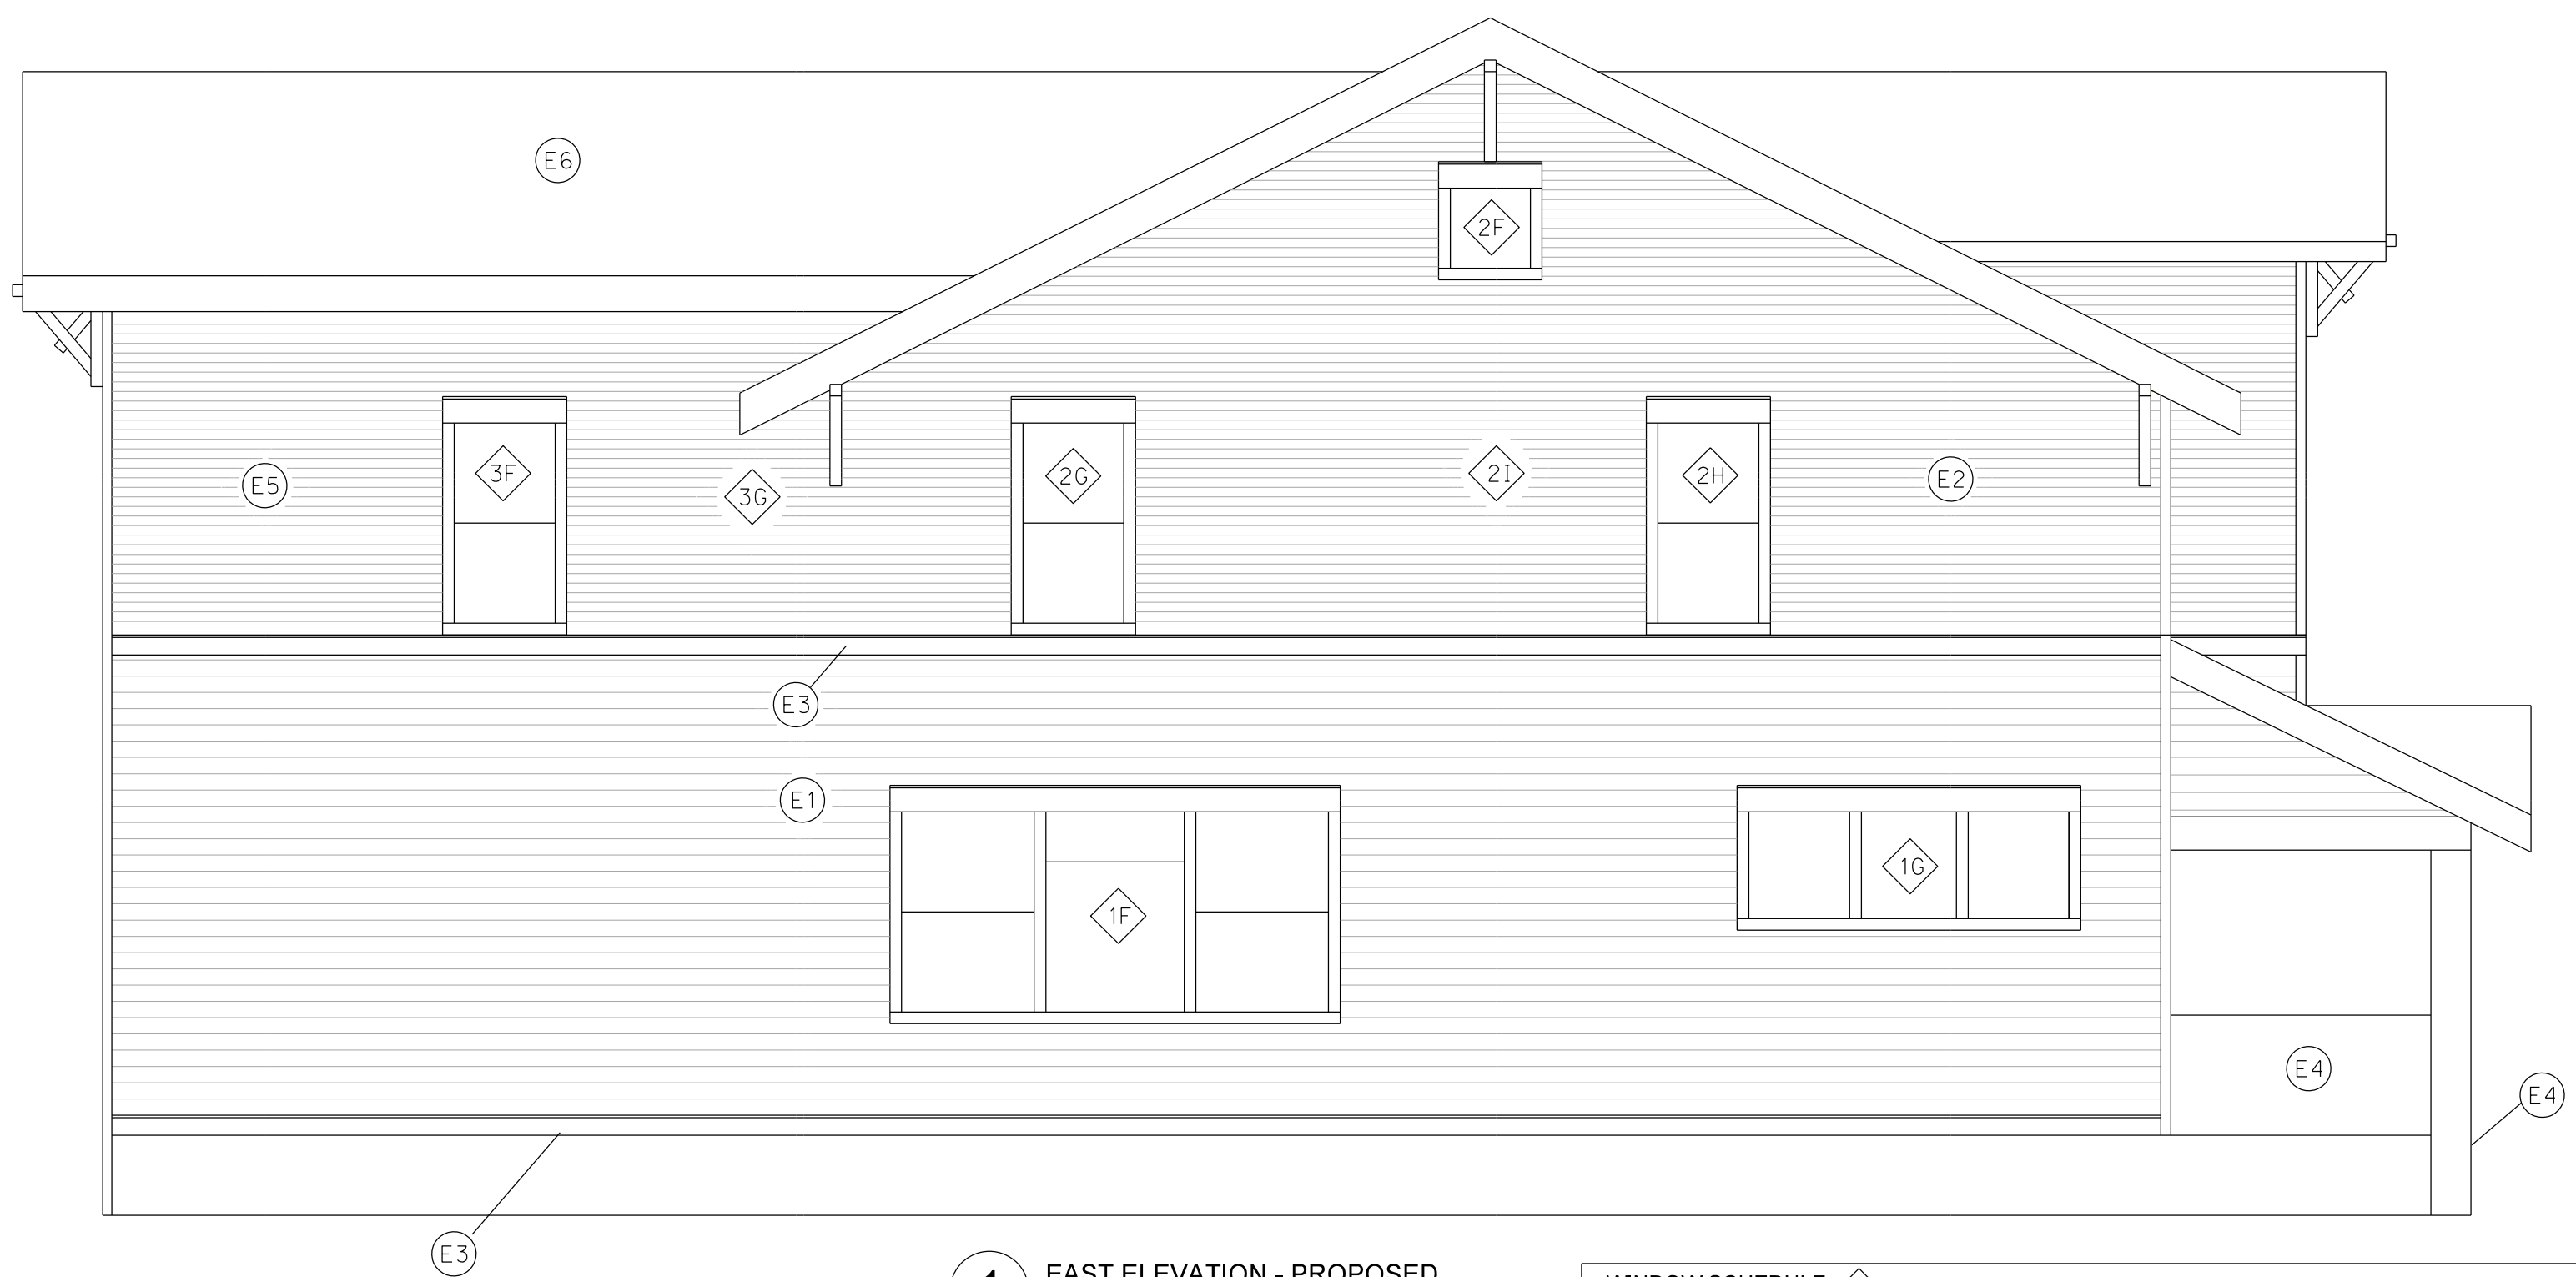
**1** EAST ELEVATION - PROPOSED  
1/4" = 1'-0"

- REMOVE EXISTING WOOD LAP SIDING AND REPLACE WITH 6" LP SMART SIDING.
- REMOVE EXISTING WOOD LAP SIDING AND REPLACE WITH 4" LP SMART SIDING.
- REMOVE AND REPLACE EXISTING TRIM BAND. REPLACEMENT TO MATCH EXISTING.
- REHAB EXISTING PORCH ENCLOSURE, FLOORING, WOOD PILARS, CONCRETE SUPPORTS, STEPS, AND RAILING.
- REMOVE AND REPLACE EXISTING ROTTING PANEL BOARD AND REPLACE WITH 4" LP SMART SIDING.
- REMOVE EXISTING FLAT ROOF AND WATER DAMAGED THIRD FLOOR. REPLACE WITH TRADITIONAL GABLE ROOF MATCHING EXISTING HOUSE CHARACTERISTICS.
