# LANDMARKS COMMISSION APPLICATION

Project Address: 2129 Kendall Ave Aldermanic District: 5

Project Title/Description: Rehabilitation of Exterior Windows, Siding and Roofing

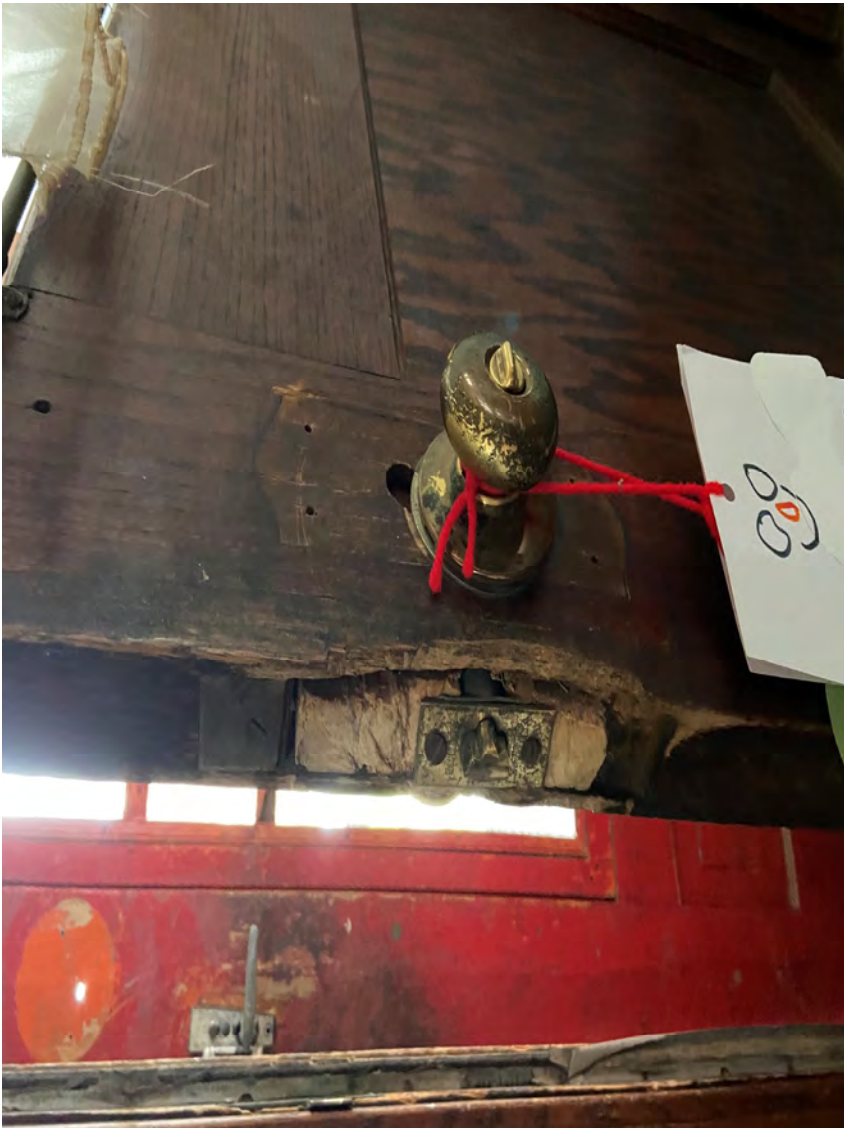
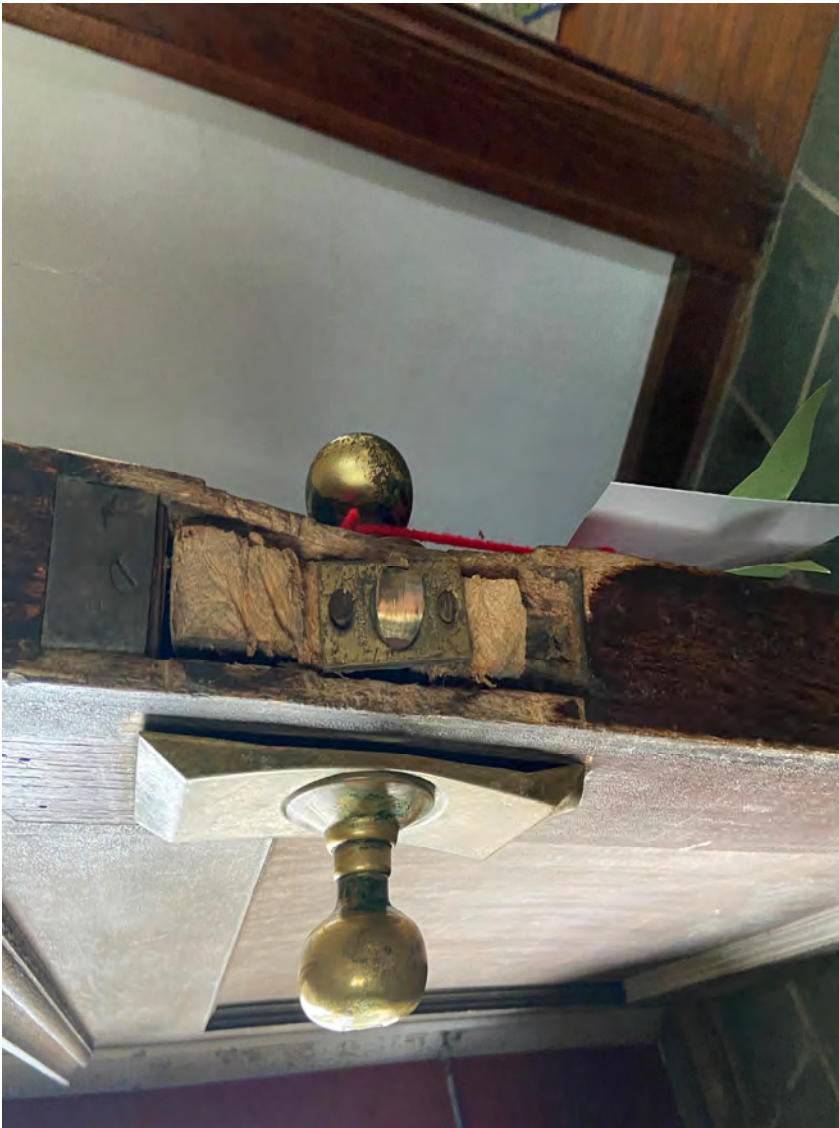
Heather - I already explored this possibility myself. I attempted to have the door weather stripped to prevent cold air from entering the house this winter and I can personally say it failed. The door is extremely warped at the upper closing corner which prevents it from securing a seal. Also, the locking/door latch has been significantly damaged from poor replacements under prior ownership. Honestly, the door latches less than 25% of the time and is a significant security risk to my family and me. Attached are some photo's of the damaged latch. There does not appear to be any economical way to rehabilitate the existing front door.

I would also encourage rehabilitating the existing front door. It looks like it is likely original to the house and the proposed replacements do not replicate its appearance.

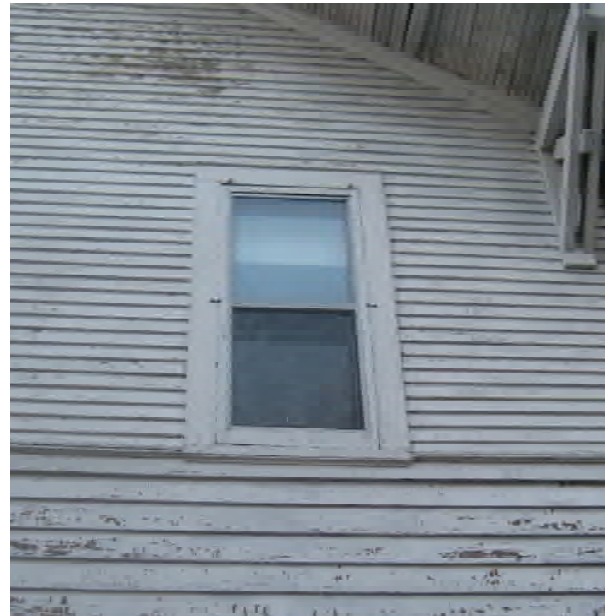
# Window 2D

- Interior

- Exterior

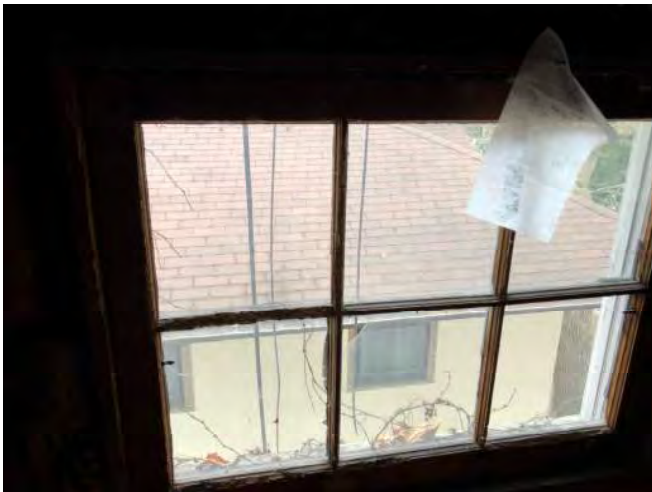
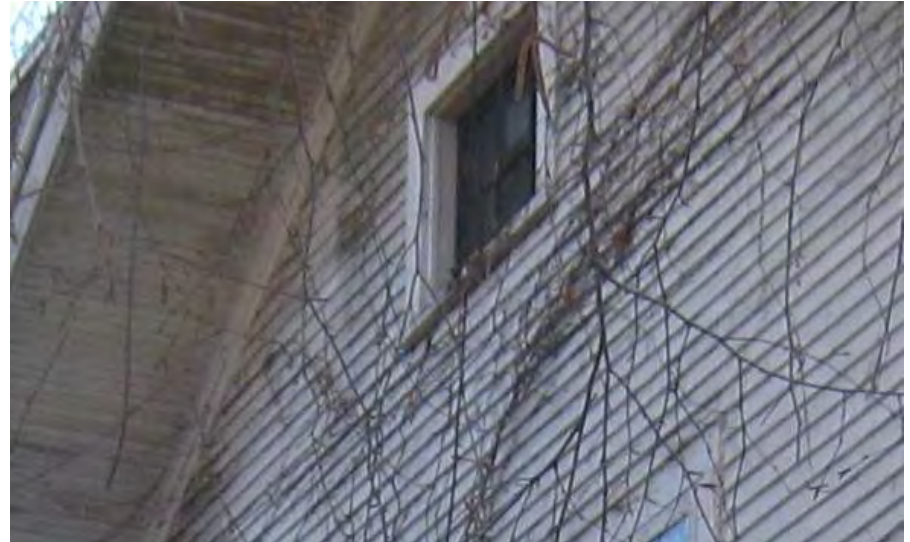
# Window 2E

- Interior

- Exterior

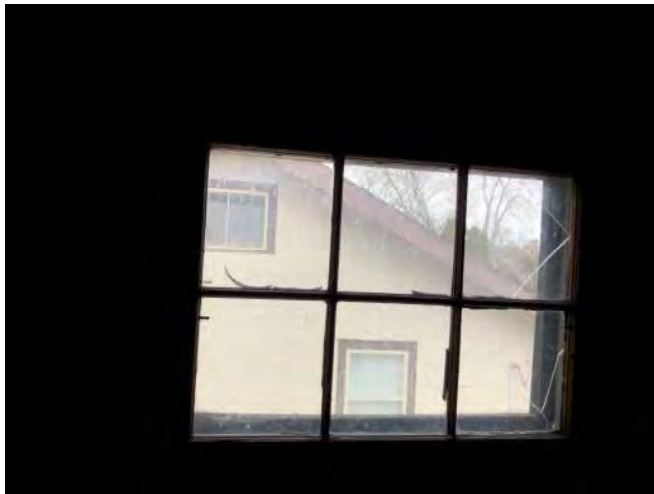
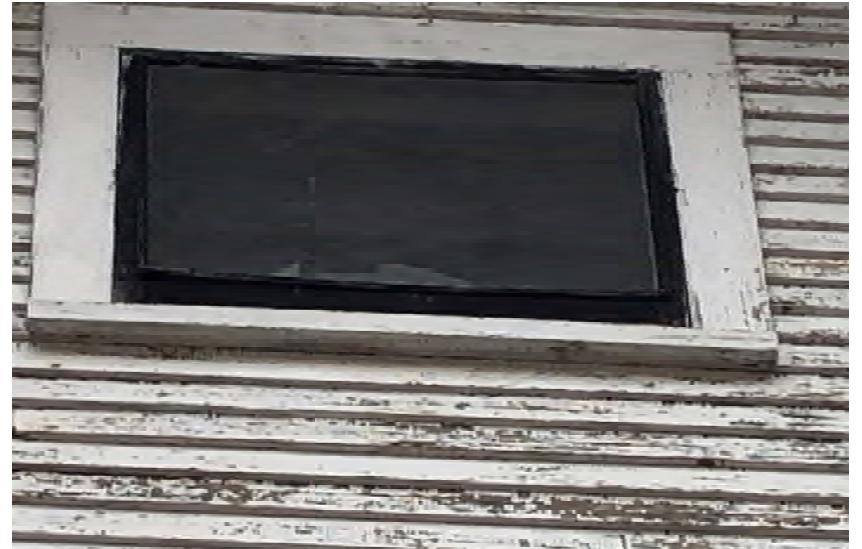
# Window 2F

- Interior

- Exterior

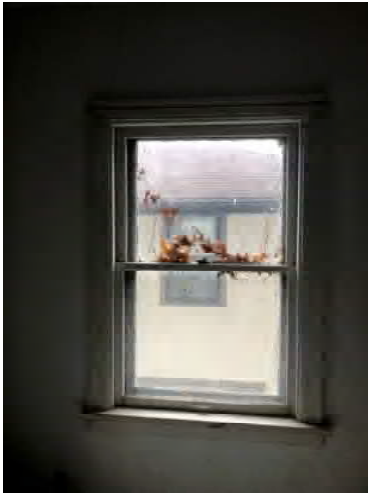
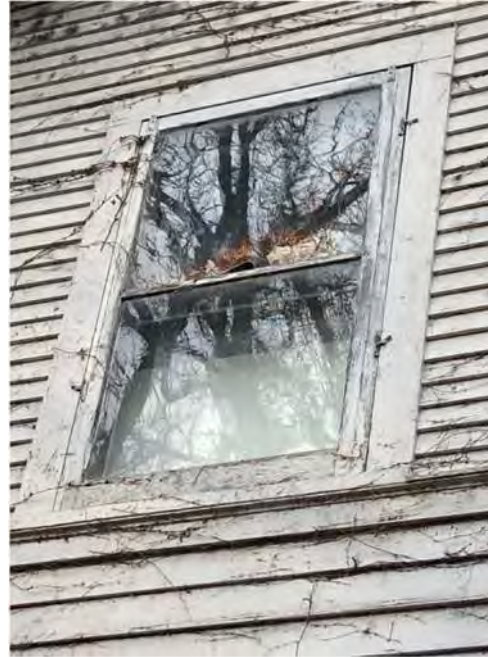
# Window 2G

- Interior

- Exterior

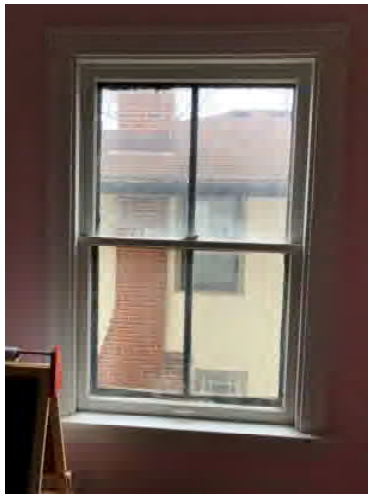
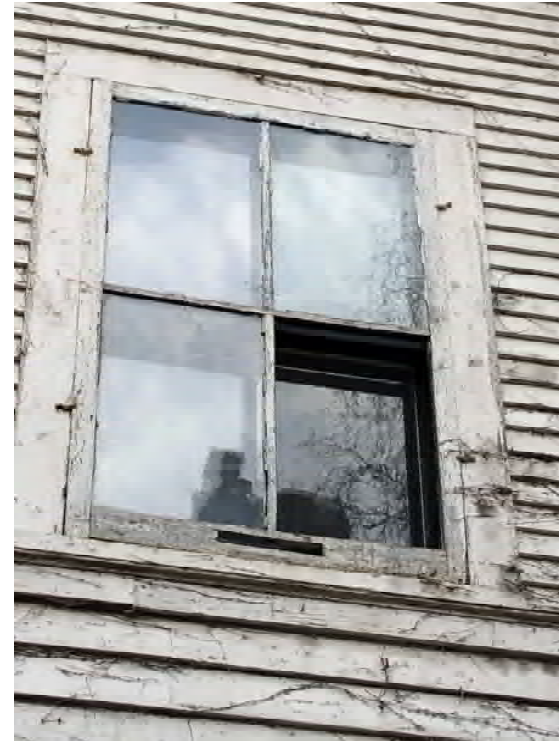
# Window 2H

- Interior

- Exterior

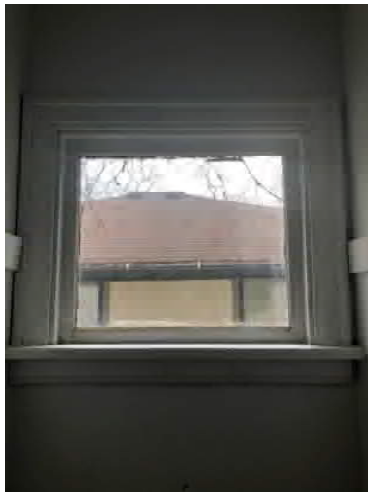
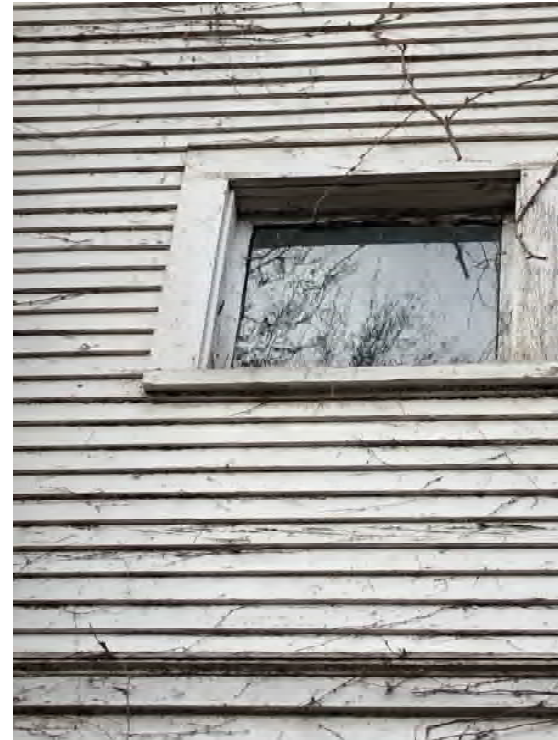
# Window 2I

- Interior

- Exterior
