LETTER OF INTENT

120 West Mifflin Street (Andrew Schubert Building 1908); Local Historic Landmark since 2008

122-124 West Mifflin Street (Fairchild Building Corporation Building 1925/1969)

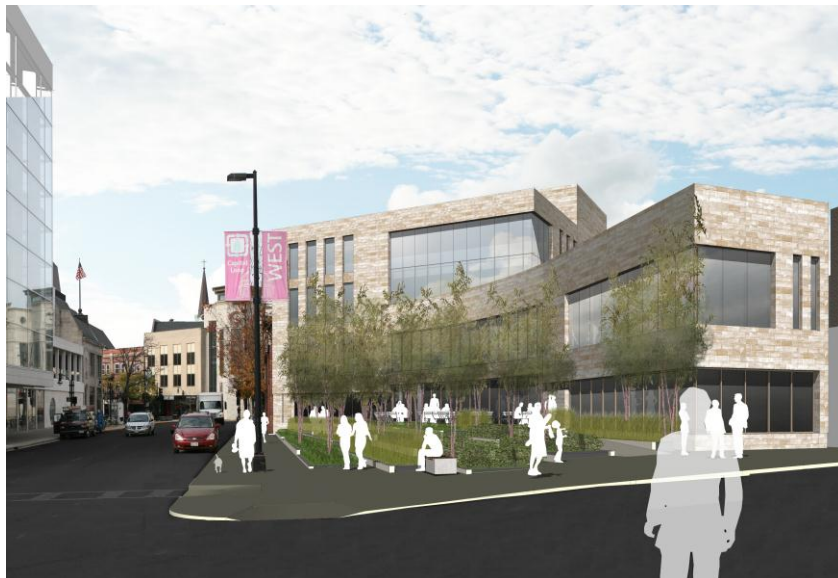
The new restaurant facing the garden will provide increased activity and energy for the W. Mifflin Street and N. Fairchild Street intersection. A significant portion of the first floor (restaurant) level façade is glazed to provide an opportunity for the restaurant patrons to enjoy the garden and an opportunity for the restaurant to open up and provide an exciting new front on N. Fairchild Street. A portion of the glass wall separating the restaurant from the garden will be a NanaWall system. This type of wall allows a large area to be opened up to the outside without the intrusion of columns or posts separating the inside space from the outside space. This wall system is proposed as the separator between the indoor dining area and the outdoor seating area within the garden. Dining patrons will have the opportunity to dine outside, but enjoy the atmosphere and environment of the interior dining, so that there is an unobstructed continuation of dining space between the inside restaurant and the garden.

Light defines space. For open spaces it creates a transition between environments instead of separation. A suspended catenary lighting system is proposed in the garden that allows light to be focused in areas, leaving other places in darkness. This system allows light to be pinpointed where desired, with light spill reduced to minimize light pollution and energy consumption. Catenary lighting is based on “less is more” and the system allows light fixtures without the intrusive support structures of light poles and bollards. What is proposed would be unique in downtown Madison and it would create a unique ambience and environment for the civic node at night.
