An Architectural and Historical Study of Seven properties along the 400 Block of East Washington Avenue, Madison, Wisconsin

Rowan Davidson, Associate AIA &
Jennifer L. Lehrke, AIA, NCARB, LEED AP
Legacy Architecture, Inc.
605 Erie Avenue, Suite 101
Sheboygan, Wisconsin 53081

February-March 2020

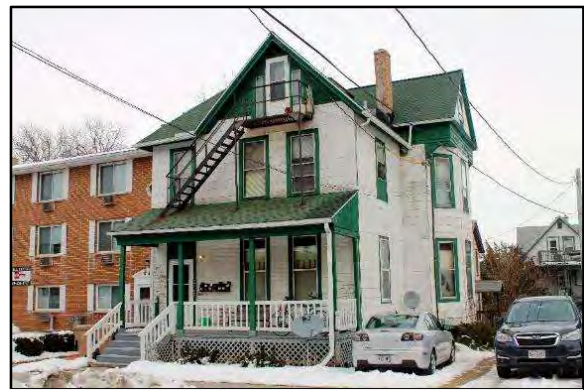
The Queen Anne style house at 9 North Hancock Street was constructed in 1892 by Ida Scheibel and Herman Pfund. Ida Scheibel was the widow of Frederick Scheibel, and the couple owned the neighboring house at 402-408 East Washington Avenue. When Frederick died, Ida sold the house and constructed a new one on the adjacent property that the family owned, previously occupied by a large greenhouse. Herman Pfund, an attorney, was Ida's son in law. Ida Scheibel died in 1899. The Pfund family lived in the house for the following decade. Morris and Nora Tierney, both teachers, bought the house in 1909.

The building at 9 North Hancock Street is a two and one-half story Queen Anne style house. It has a stone foundation, wood frame structure, and wood and asbestos siding. The painted wood siding, trim, and scalloped details on the exterior only exist in certain locations and not consistently on the exterior. Most of the original wood windows still exist, and the doors have been replaced. The roof is asphalt shingles. There is a small brick chimney and an added fire escape on the main facade. The front porch has been replaced while the back porch remains. Some of the original spaces on the interior remain, especially at the first floor, with the main staircase and balustrade in place and the front parlor, dining room, and kitchen in place. However, the interior walls have been added, especially on the second floor and attic, to create additional rooms. The floors are often covered with carpeting, tiles, and linoleum, especially on the upper floors. The walls are a mix of painted plaster and drywall, and the ceilings are plaster throughout. There are seven rental units in the 2,900 square foot building. Notable alterations to the building include the exterior siding and the reorganization of interior spaces.⁸

The house lacks architectural integrity due to its replacement siding and interior layout. The siding is in poor condition, there are extensive cracks and warping in the plaster walls, and the foundation requires repairs. Some elements, especially the historic window sashes and radiators, could be salvaged and repurposed.

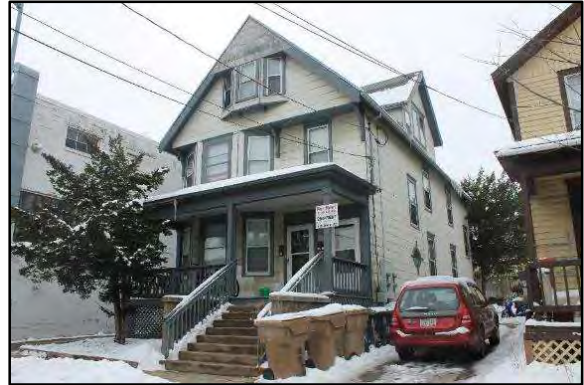
The vernacular front-gabled style house at 8-10 North Franklin Street was constructed 1901 as a two-flat duplex with two family residences, one on the first floor and the other on the second with separate entries. The first owners were the families of W. C. Bonow and T. L. Tuttle, both salesmen. By 1915, the building was divided into three apartments and rented. The Salvation Army had one of its regional headquarters in the building from 1929 to the late 1930s, by which time it was a rental property again, which it has remained, divided into three units, to the present. A non-extant garage was constructed in the 1930s and has since been demolished.²

The building at 8-10 North Street is a two and one-half story Front Gabled style house built as a duplex. It has a stone foundation, wood frame structure, and asbestos siding. The painted wood brackets, trim, and board details on the exterior appear to be original. Most of the original wood windows still exist, and the doors have been replaced. The roof is non-historic asphalt shingles. The front porch is wood frame with concrete stairs and appears to be historic. Back stairs have been replaced with wood porches and a covered basement entrance. Some of the original spaces on the interior remain, especially on the first and second floors, which have matching floor plans in line with the historic use of the building as a two-flat. The floors are often covered with carpeting, tiles, and linoleum, throughout. The walls are a mix of painted plaster and some have been covered with wood paneling. The ceilings are historic plaster in some locations, but there are also dropped acoustic tile ceilings in other places. There are three rental units in the 3,083 square foot building. Notable alterations to the building include the exterior siding and interior finishes.⁹

The house lacks architectural integrity due to its replacement siding and interior layout. The siding is in poor condition. Few if any of the architectural elements could be salvaged and repurposed.

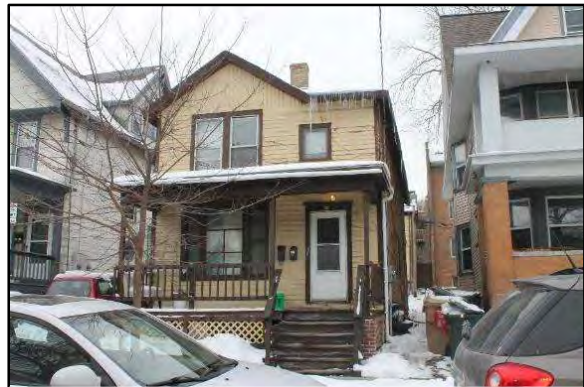
The vernacular house at 12 North Franklin Street was constructed in 1879. It is unknown at this time who built the small house. By 1914, the house was occupied by Carl and Katherine Koehn. Carl was a printer at the Madison *Capital Times* newspaper. The Koehn family remained at the house until 1946, when the building was sold and converted into two rental apartments, which it has remained to the present. A large non-extant carriage house was constructed in the late nineteenth century at the rear of the property, but it was replaced by a non-extant garage in the 1920s, which has since been demolished.³

The building at 12 North Franklin Street is a two-story vernacular style house. It has a stone foundation, wood frame structure, and vinyl and asphalt siding. There is vinyl siding on the main façade and asphalt faux-brick siding elsewhere. There is a non-historic enclosed wood stair on the rear of the building. Some of the original wood windows and doors still exist. The roof is asphalt shingles, and there is a small brick chimney. The front porch has been replaced. Some of the original spaces on the interior remain, especially at the entryway and main stair, but elsewhere it is difficult to assess what the original floor plan may have been historically, and interior walls have been added to create additional rooms. The floor is either vinyl or carpeted throughout. The walls are a mix of painted plaster and drywall, and the ceilings are plaster throughout. There are two rental units in the 1,580 square foot building. Notable alterations to the building include the exterior siding, rear stair addition, replacement finishes, and the reorganization of interior spaces. Very little of the historic building remains besides its basic form and foundation.¹⁰

The house lacks architectural integrity due to its replacement siding and interior modifications. The siding is in poor condition everywhere, and the foundation requires repairs. Few if any of the architectural elements could be salvaged and repurposed.

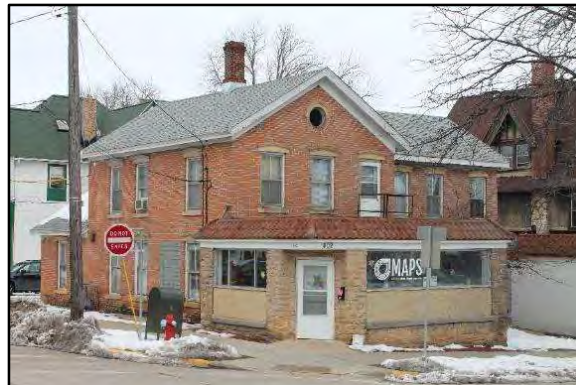
402-408 East Washington Avenue

The Greek Revival style house at 402-408 East Washington Avenue, and its numerous additions, was constructed in 1866 by Frederick and William Scheibel and their families. German immigrants, Fred Scheibel was a miller and William Scheibel, his brother, was a tailor. In 1875, only Frederick and his wife Ida lived at the house, and they began a florist business. A large non-extant greenhouse was constructed at the rear of the property, and Scheibel Florist became one of the most popular in the City of Madison. A small brick rear addition was also constructed around this time. The florist shop operated until

The building at 402, 404, 406, and 408 East Washington Avenue is a two-story Greek Revival style house. It has a stone foundation, wood frame structure and red brick exterior with sandstone lintels and sills at the openings. Most of the original wood windows and doors still exist. The roof is asphalt shingles, and there is a small brick chimney. The building has four significant additions, a wood frame one and a painted brick one in the rear and two commercial storefront additions on the front main façade facing East Washington Avenue. The commercial addition at the southwest corner of the lot has a stone veneer with aluminum windows, pebbledash panels, and a clay tile edge to an otherwise flat roof. The other commercial storefront has a concrete block exterior with aluminum windows and a plastic panel veneer along with a similar clay tile edge to an otherwise flat roof. Some of the original spaces on the interior remain, especially at the first floor, with the main staircase and damaged balustrade in place. Otherwise, much of the interior spaces have been rearranged into apartments with new walls and enclosures. Many of the interior walls are drywall with some plaster exceptions. The original wood floors remain in some locations, though they are often covered with carpeting, tiles, and linoleum. The walls are a mix of painted plaster and drywall, and the ceilings are plaster throughout and are cracking and warping in locations. There are four rental units and two small commercial spaces in the 5,031 square foot building. Notable alterations to the building include

The house lacks architectural integrity due to its additions, damaged exterior, and interior layout. The brick and stone exterior is in poor condition due to past painting and sandblasting. There are extensive cracks and warping in the plaster walls and ceilings, and water damage in ceiling locations. There is also evidence of termite damage on wood structural members in the basement, and there is mold in nearly every damp interior space such as bathrooms and kitchens. Some elements, especially the historic windows, doors, glass block, and radiators, could be salvaged and repurposed. The brick and sandstone on the exterior are likely too damaged from sandblasting and cleaning to reuse.

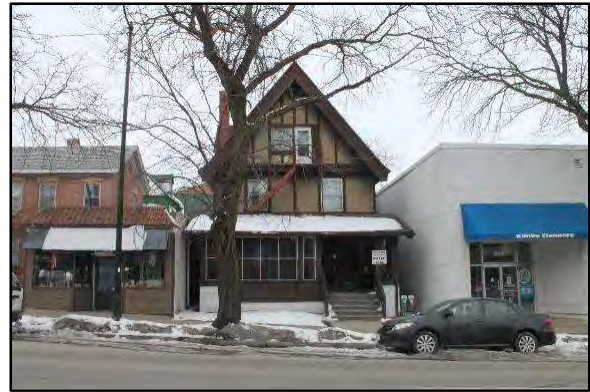
The Craftsman front-gabled style house at 410 East Washington Avenue was constructed in 1907 by Emil J. and Ida Frautschi. The house replaced an older non-extant wood frame building, and an additional small existing house was moved to the rear of the property at the same time. Emil Frautschi had purchased the property in 1901, and the family lived in the non-extant house until it was demolished to make way for the existing building. Emil Frautschi, born in 1871, was the son of Christian Frautschi, an Italian immigrant, who established the Frautschi and Sons Funeral Directors business and began a prominent Madison family business that has remained influential to the present day. Emil, who had a stake in the funeral and furniture business, was also the manager and treasurer of the Madison Fuel Company and the Wisconsin Brick Company by the 1910s. He was active in the Madison Chamber of Commerce, the Rotary Club, the YMCA, and the YWCA. The Frautschi family moved in 1924 to the Nakoma neighborhood on the west side of Madison. However, it appears that they still owned the house and rented it. Emil Frautschi died in 1959. The house has since been subdivided into seven apartments. The front porch was reconstructed within the last decade.⁵

The building at 410 East Washington Avenue is a two and one-half story Craftsman style house. It has a concrete foundation, wood frame structure and half-timber and stucco exterior. The historic stucco, timber, and wood trim exterior is largely intact, though it is damaged in locations. Most of the original wood windows and doors still exist. The roof is non-historic asphalt shingles. There is a prominent brick chimney and an added fire escape on both the main and rear facades. The front porch appears historic, though it has been rebuilt within the last decade to match the original. Some of the original spaces on the interior remain with the main staircase and balustrade in place and the second-floor hallway and stairwell intact. The original wood floors remain in some common locations, though they are often covered with carpeting and linoleum in the units themselves. The rear unit on the first floor has the greatest degree of integrity with dark wood trim, board and batten wainscoting, wood floors, built-in benches and bookcases, and plaster walls. The rest of the building has a mix of painted plaster and drywall, and the ceilings are plaster in some locations and a replacement dropped acoustical tile in others. There are seven rental units in the 3,108 square foot building. Notable alterations to the building include a fire escape, a series of interior remodels with different finishes and the replaced front porch.¹²

The house lacks architectural integrity due to its interior layout. The exterior stucco is poor condition with mold and occasional damage, and there is mold in many of the damp spaces of the building including the basement. Some elements, especially the historic windows doors, wood trim, and built-ins could be salvaged and repurposed.

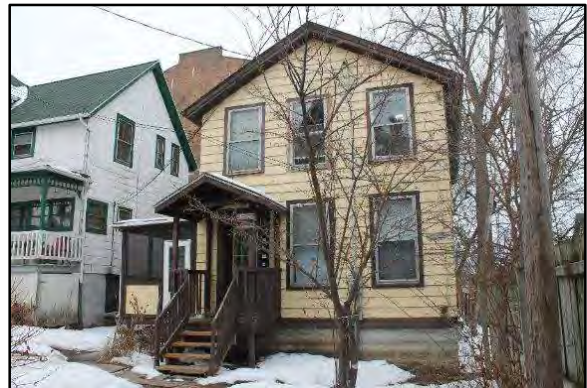
The vernacular front-gabled house at 410 1/2 East Washington Avenue was moved to its present site behind 410 East Washington Avenue in 1907 by Emil and Ida Frautschi. It is unknown at this time where the house came from and who built it; however, it appears that it is small vernacular balloon-frame structure from the second half of the nineteenth century and was likely located elsewhere in the city. It was not the older home of the Frautschi family. It does not match the older wood house that was demolished at the 410 East Washington Avenue address in its scale or proportions. The house was originally used as a rental property when it was moved to the site. A large porch was added as a wing in the 1910s. Jonathan and Ida Makuson, a concrete mixer and contractor, rented the house until 1924, while it was owned by the Frautschi family. It has since been divided into two units and remains apartments.⁶

The building at 410 1/2 East Washington Avenue is a two-story vernacular style house. It has a cast concrete foundation, wood frame structure, and painted wood siding and trim. The painted wood siding and trim appear to be historic. Most of the original wood windows still exist, and the doors have been replaced. The roof is non-historic asphalt shingles. Both the front entry

The house lacks architectural integrity due to its interior layout and the foundation requires repairs. Few if any of the architectural elements could be salvaged and repurposed.

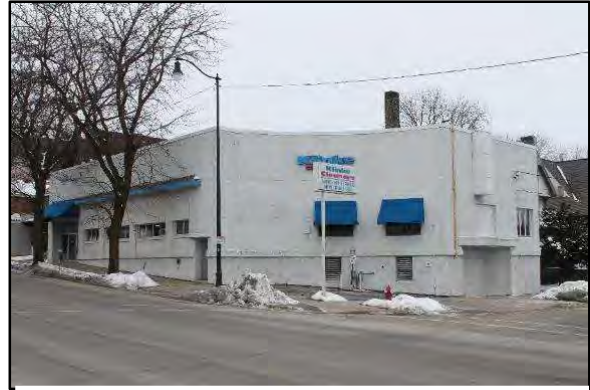
The industrial warehouse at 412-414 was constructed in 1924 as the Gillespie Motor Sales Company showroom and garage. Previously, the site was occupied by two non-extant wood frame houses. Gillespie Motor Sales specialized in Packard, Paige, and Jewett brand automobiles and transitioned into the Damsin Auto Service Company and the Christiansen Motor Company in the late 1930s. In 1942, the building was purchased by the Manchester Inc. Service Co., a dry-cleaning business, and the building was extensively renovated in 1948. Much of the property was used as a clothing warehouse at that time. The building briefly served as a Social Security Administration office and garage from 1954 to the 1958, when it was purchased by the Madison Steam Dye Works. The Madison Steam Dye Works was an established Madison dry-cleaner and went out of business in 1986. The building was then purchased by the Klinke Cleaners chain, which has operated at the 412-414 East Washington Avenue to the present. Actual dry-cleaning processes and storage have not been located on the property for the last two decades.⁷

The building at 412 and 414 East Washington Avenue is a two-story utilitarian industrial warehouse. It has a concrete foundation, reinforced concrete and steel truss structure, and an EIFS stucco exterior finish except in the rear of the building, where the exterior is a mix of concrete block. The EIFS exterior was likely added to an otherwise concrete block building in 1986 or 1987, when ownership of the building changed. The roof is flat with a short parapet wall. The windows are non-historic fixed aluminum windows, also likely from the late 1980s, and there are additional and enlarged openings on all the building's facades. Many of the original spaces on the interior remain, including the back-of-house warehouse and processing floor on both first floor and lower level. However, the public spaces at the front of the building have finishes that date to the 1980s. The floors are typically concrete, or tile where it has been added. Walls are likewise also concrete, or drywall in the front public spaces. The ceilings have exposed structural members or a hollow clay fire-block system, unless it is the front public spaces where they are dropped acoustic panels in a grid. The 5,366 square foot building has historically served as a garage, dry-cleaning plant, warehouse, and commercial storefront. Notable alterations to the building include the exterior finishes and window and door replacements.¹⁴

The building lacks architectural integrity due to its exterior remodeling. It is likely, due to the nature of the structure and its use and various owners that this building has been altered several times throughout its history as various exterior concrete patching is evident. The interior has a series of different structural grid patterns as well. There is water damage at both the ceilings and floors of the main warehouse space on the interior. It is unlikely that any elements could be salvaged and repurposed.

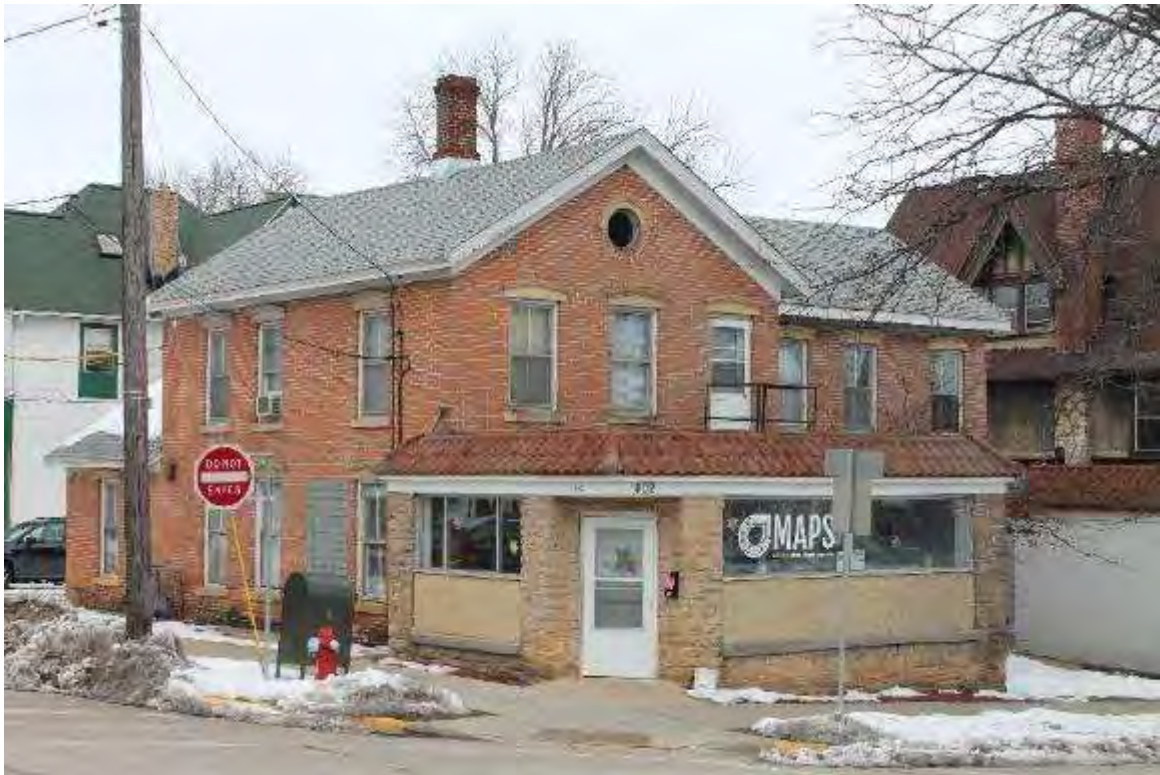
Photo 131: 402-408 East Washington Avenue, Exterior, facing northwest

402, 404, 406, and 408 East Washington Avenue
(see photos 131 through 225)

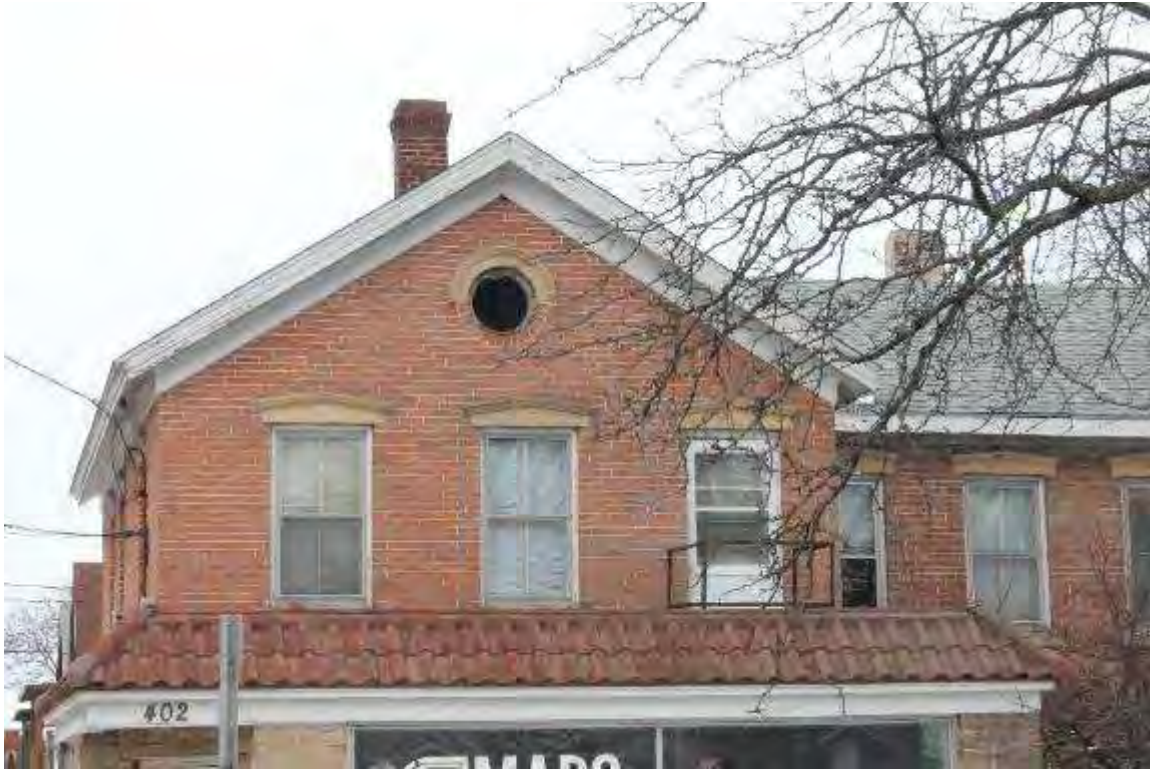
Photo 132: 402-408 East Washington Avenue, Exterior, facing north

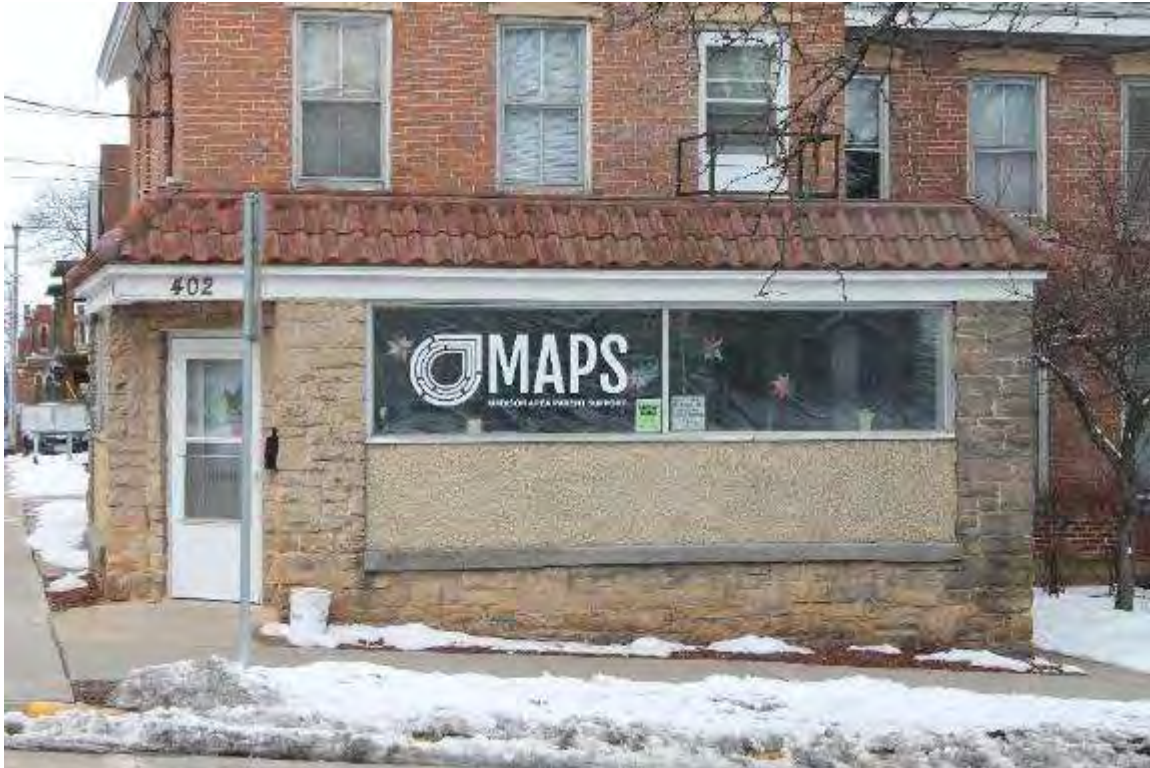
Photo 133: 402-408 East Washington Avenue, Exterior, facing northwest

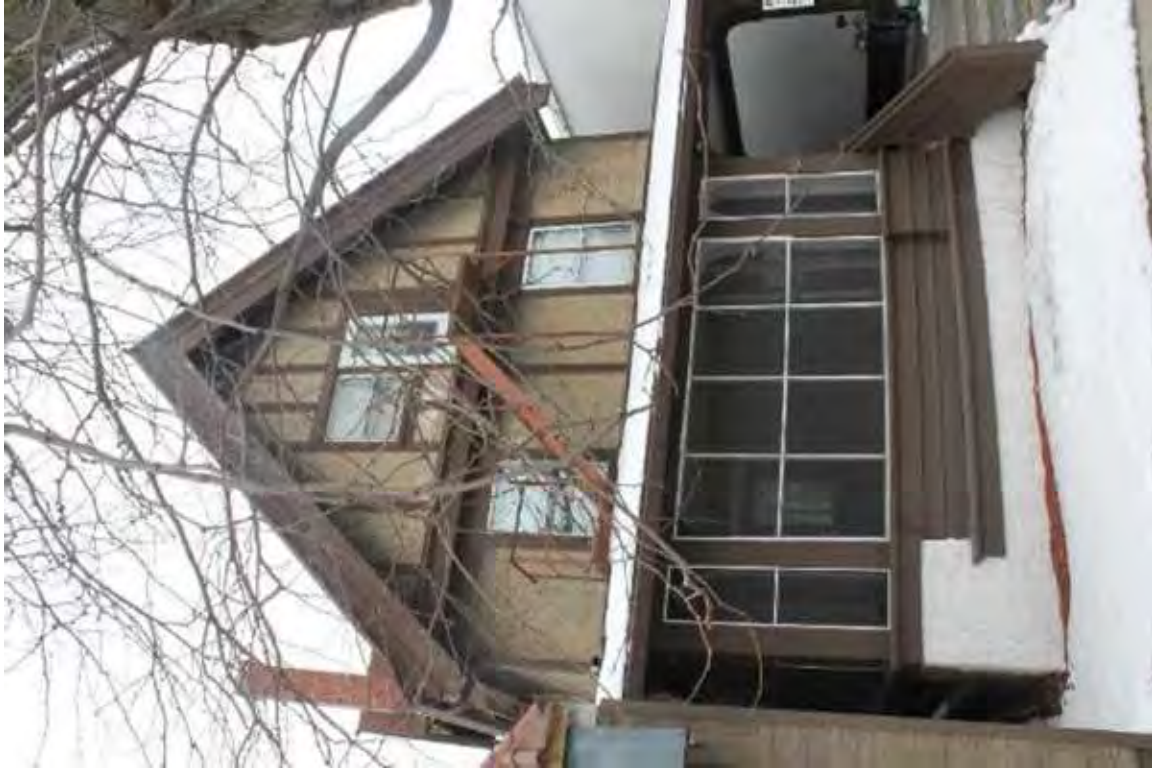
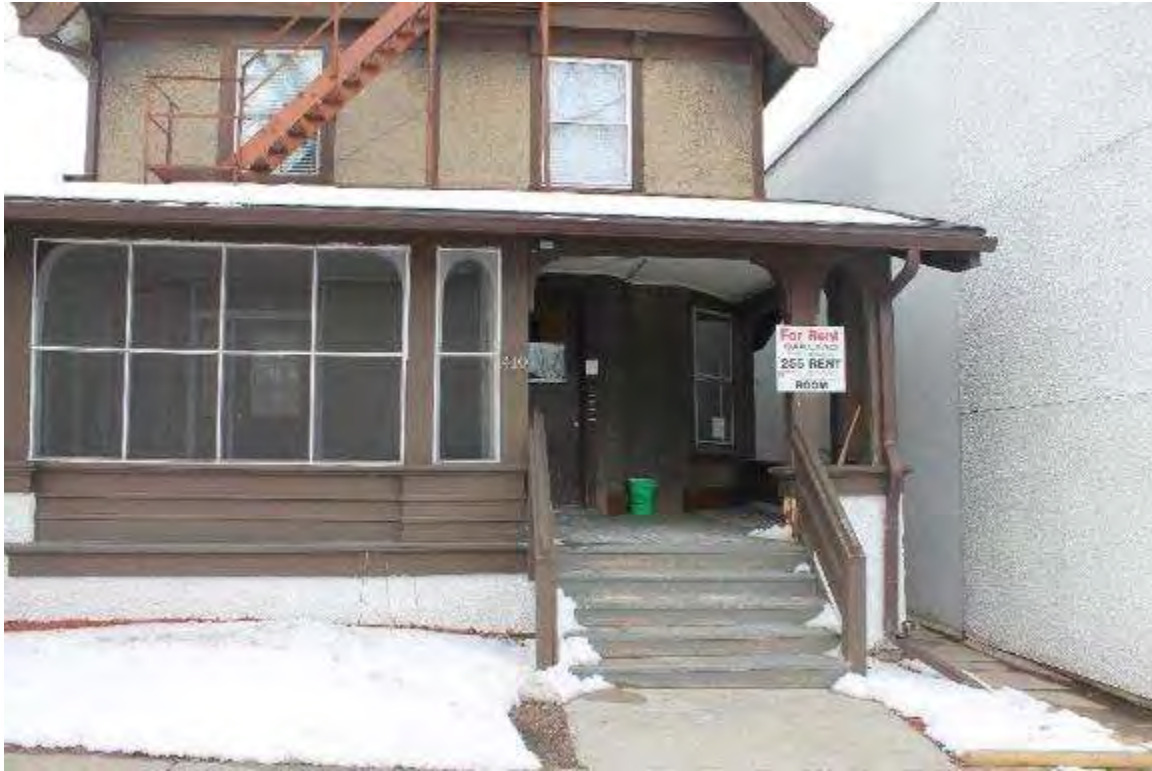
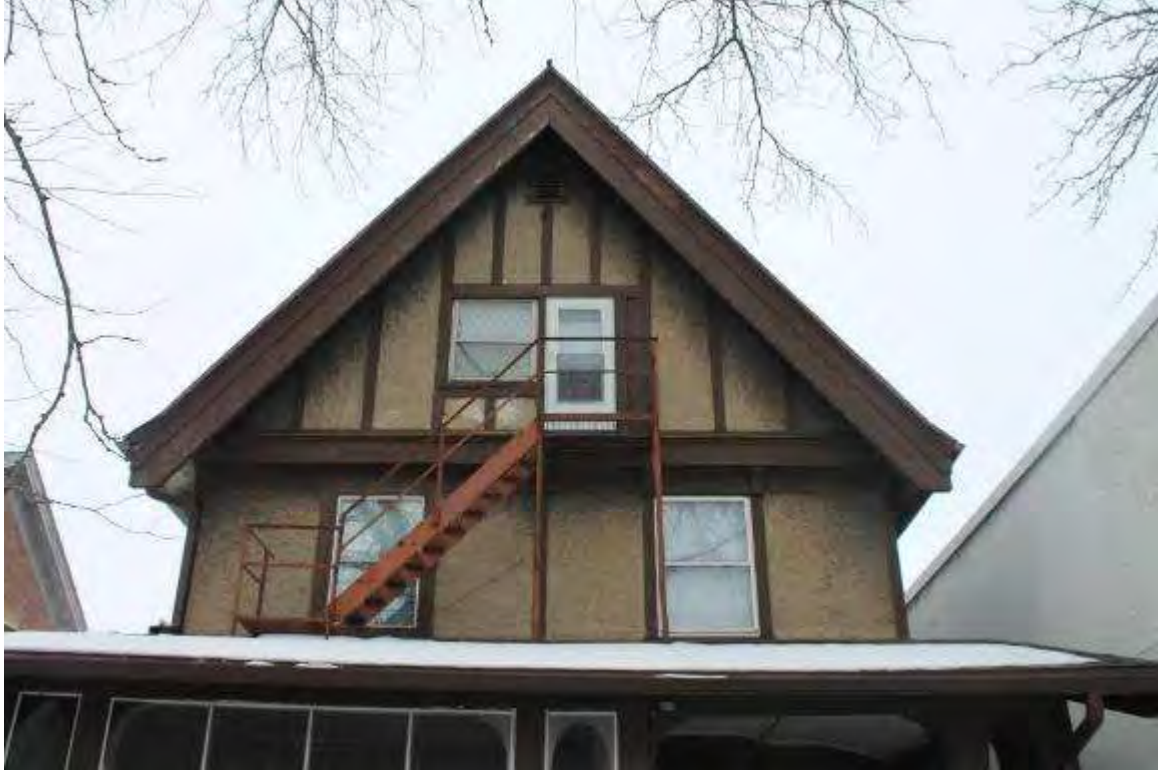
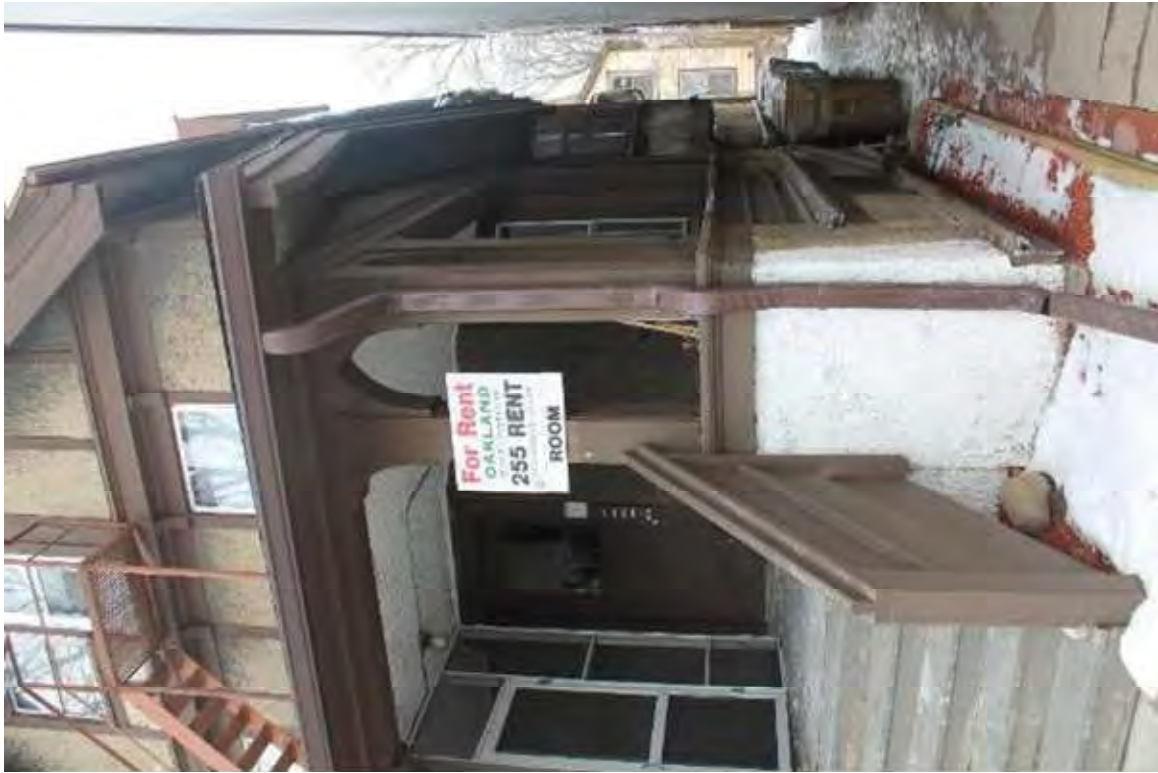
Photo 226: 410 East Washington Avenue, Exterior, facing northwest

Photo 227: 410 East Washington Avenue, Exterior, facing north

Photo 228: 410 East Washington Avenue, Exterior, facing northwest

Photo 229: 410 East Washington Avenue, Exterior, facing northwest

410 East Washington Avenue
(see photos 226 through 295)

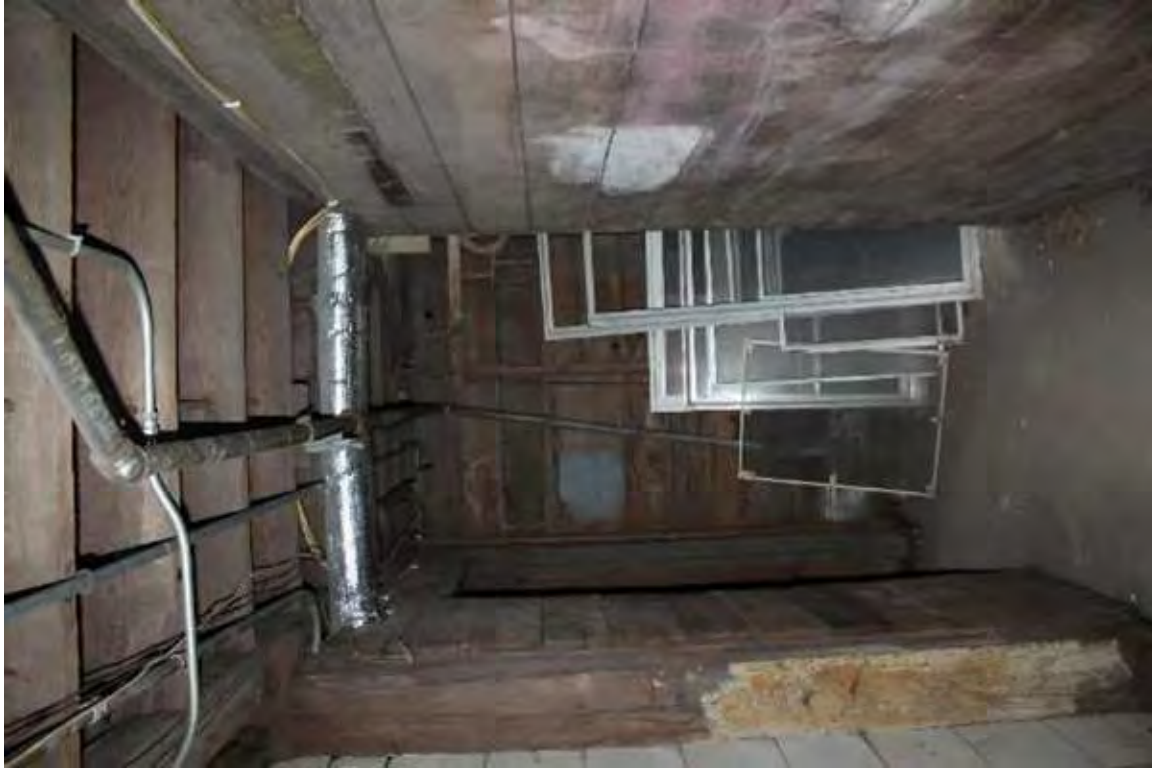
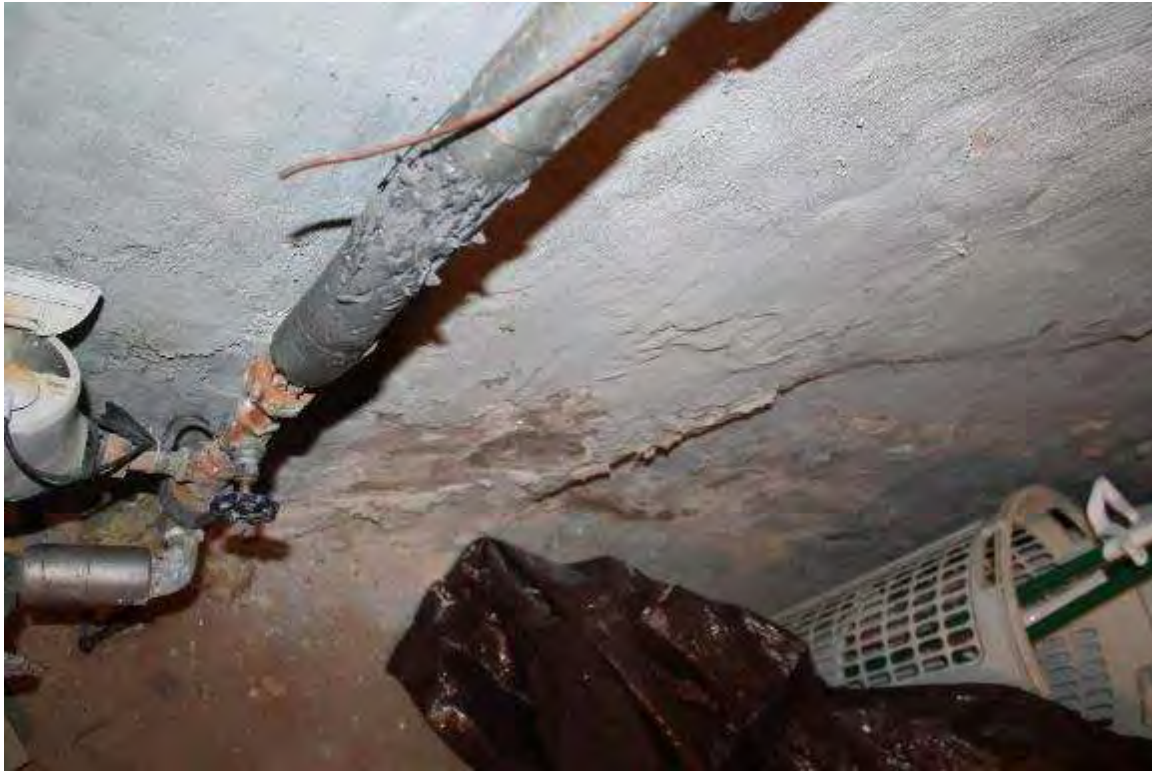
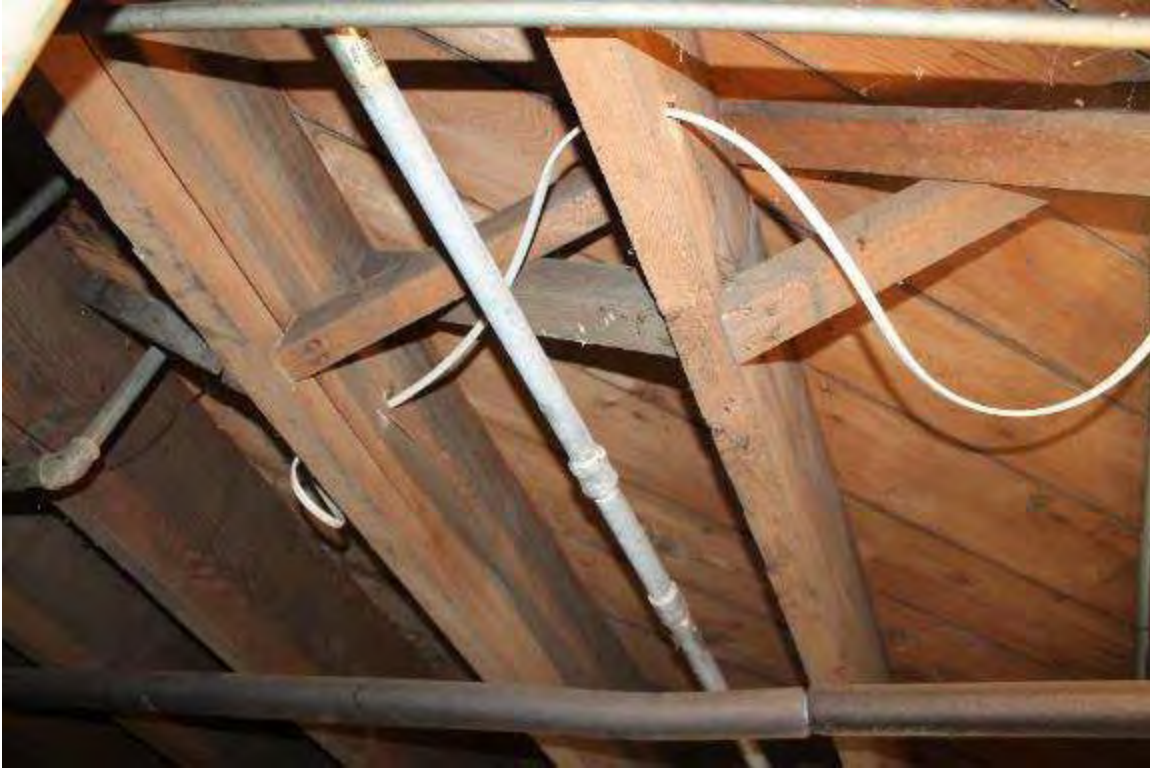
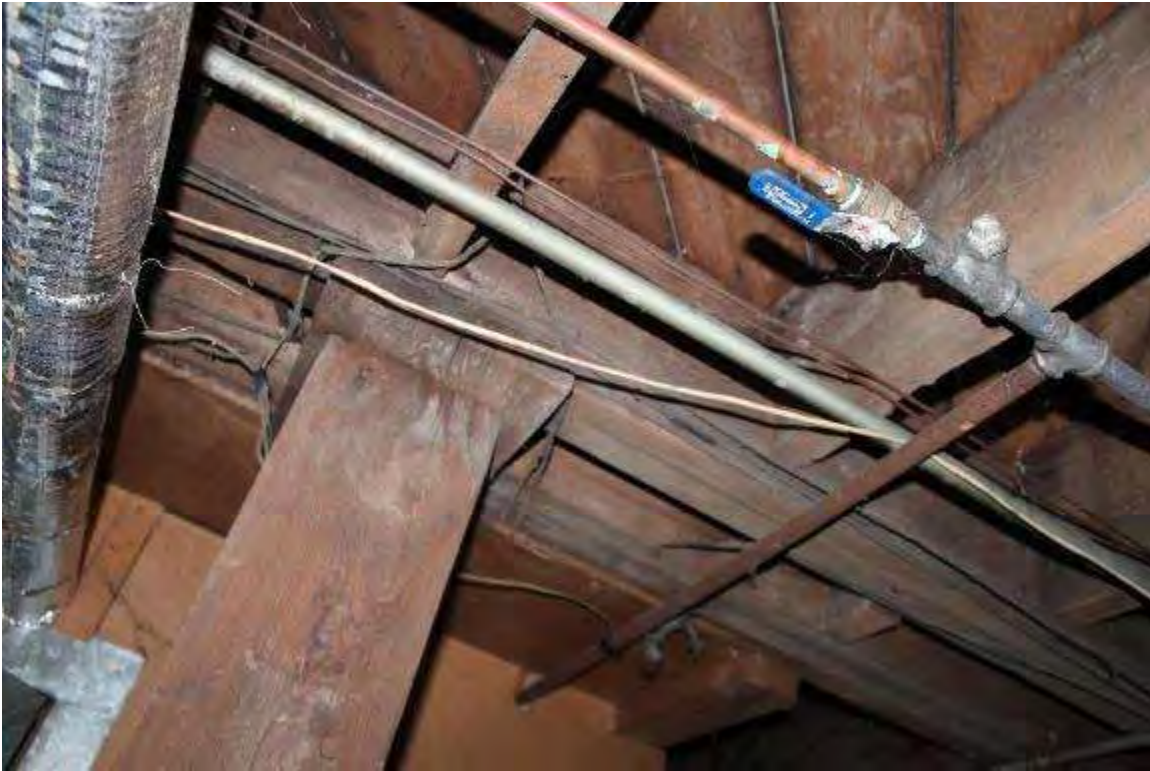
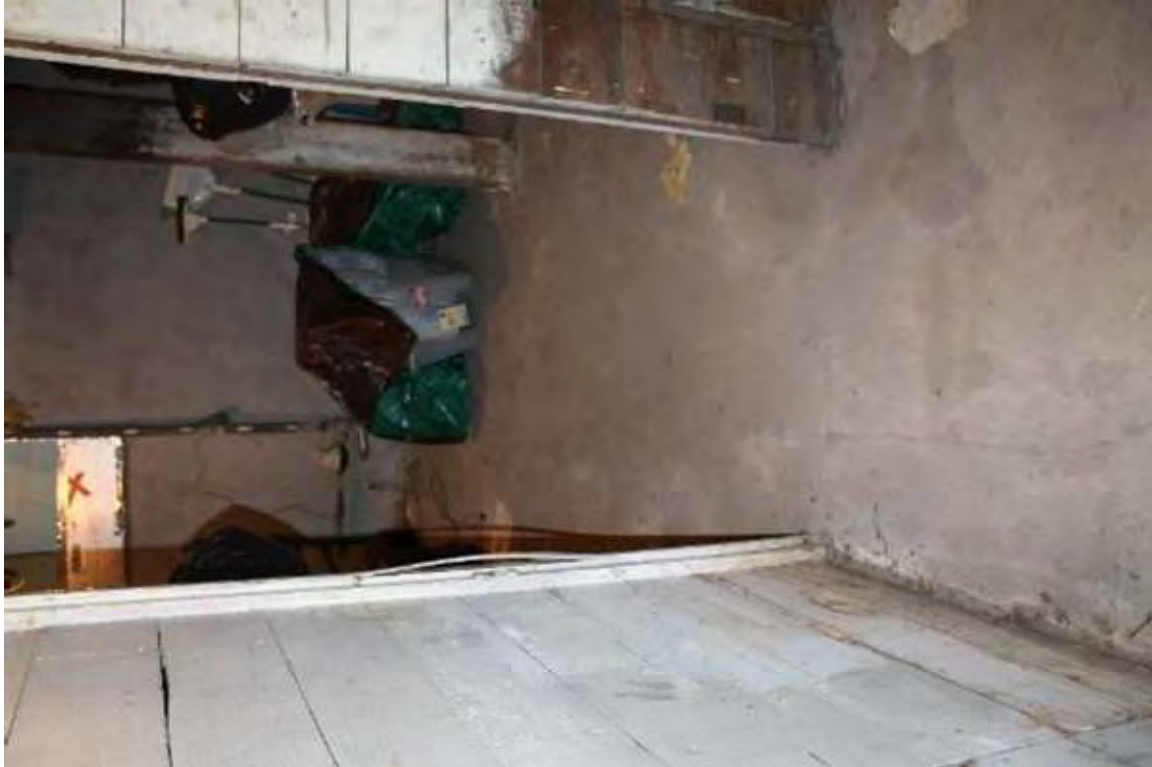
Photo 290: 410 East Washington Avenue, Interior, basement

Photo 291: 410 East Washington Avenue, Interior, basement

Photo 292: 410 East Washington Avenue, Interior, basement

Photo 293: 410 East Washington Avenue, Interior, basement

Photo 294: 410 East Washington Avenue, Interior, basement

Photo 295: 410 East Washington Avenue, Interior, basement
