An Architectural and Historical Study of Seven properties along the 400 Block of East Washington Avenue, Madison, Wisconsin

Rowan Davidson, Associate AIA &
Jennifer L. Lehrke, AIA, NCARB, LEED AP
Legacy Architecture, Inc.
605 Erie Avenue, Suite 101
Sheboygan, Wisconsin 53081

February-March 2020

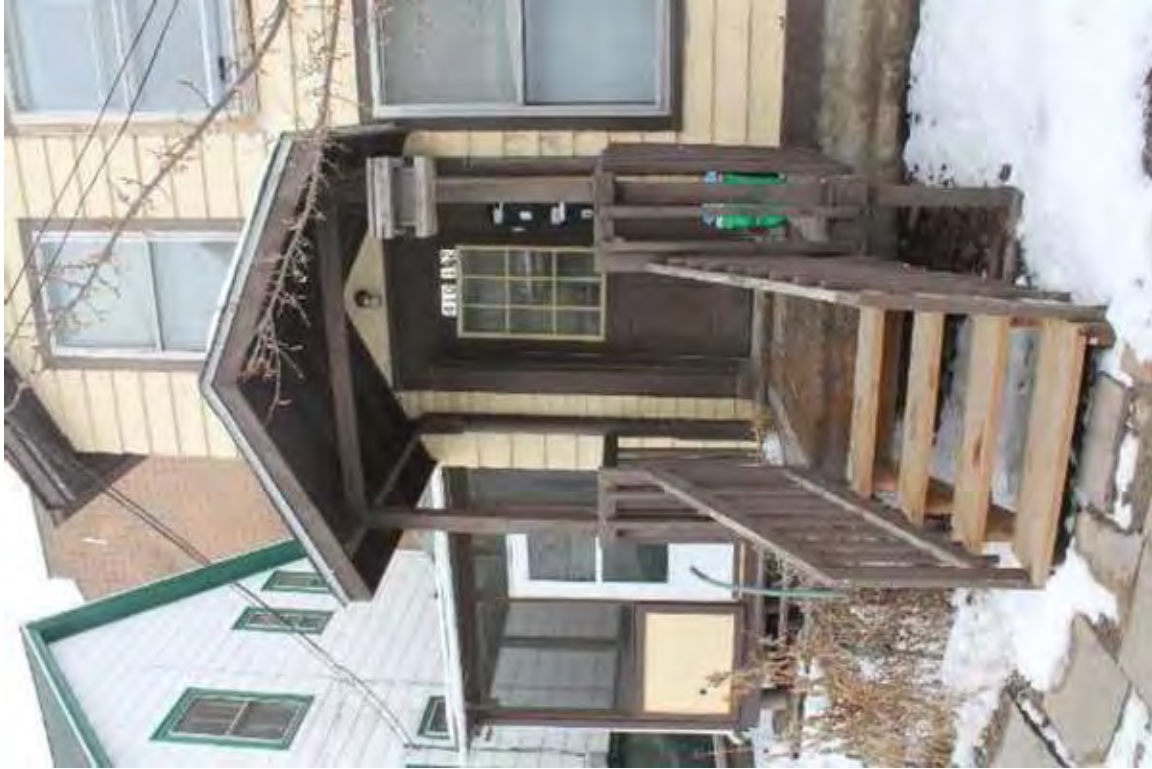
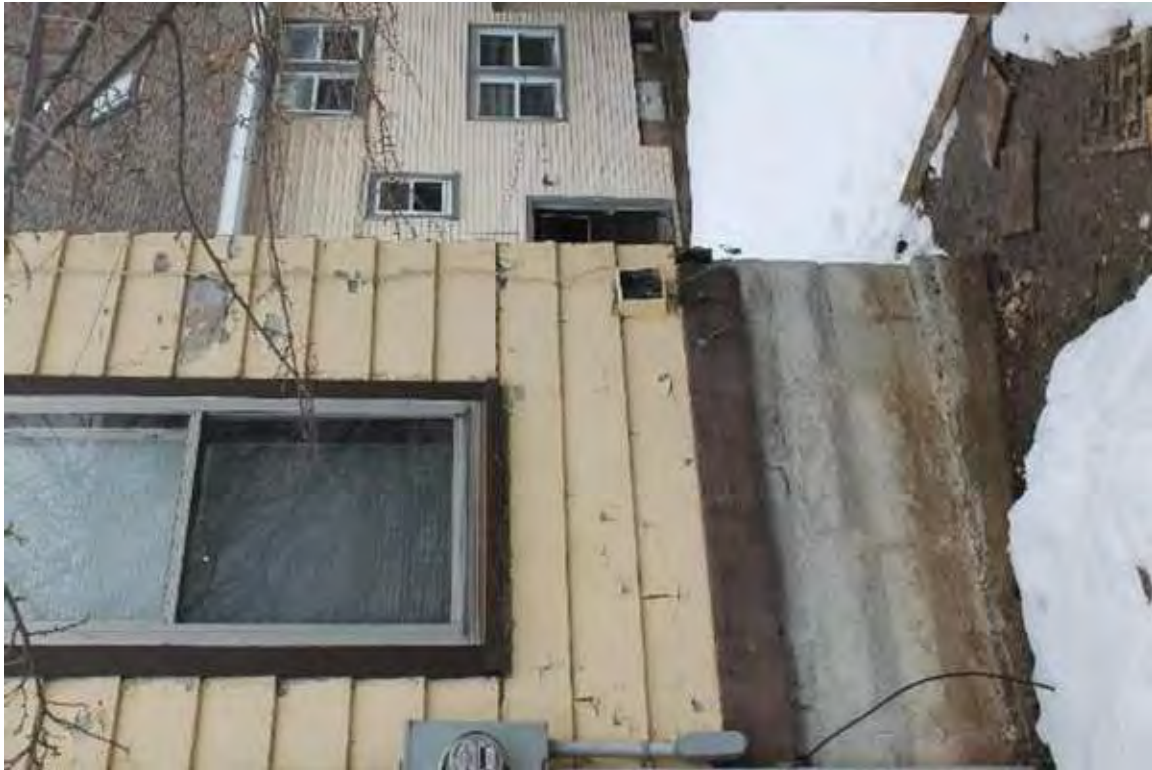
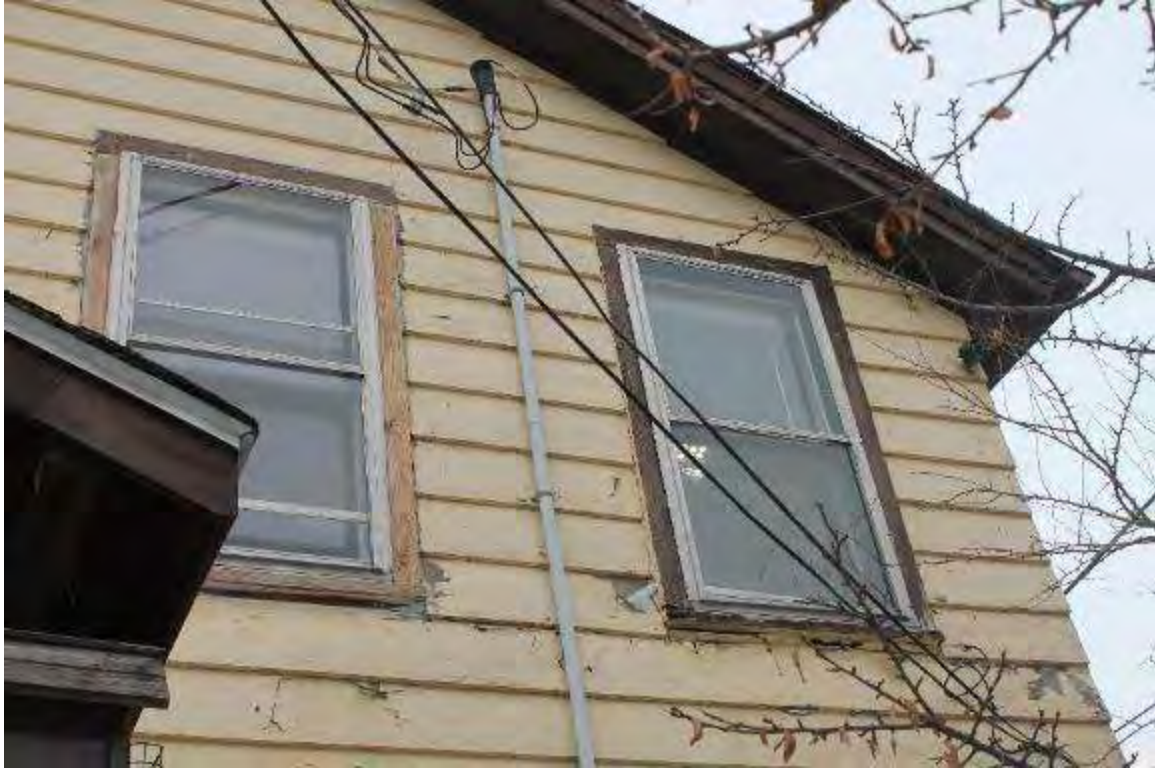
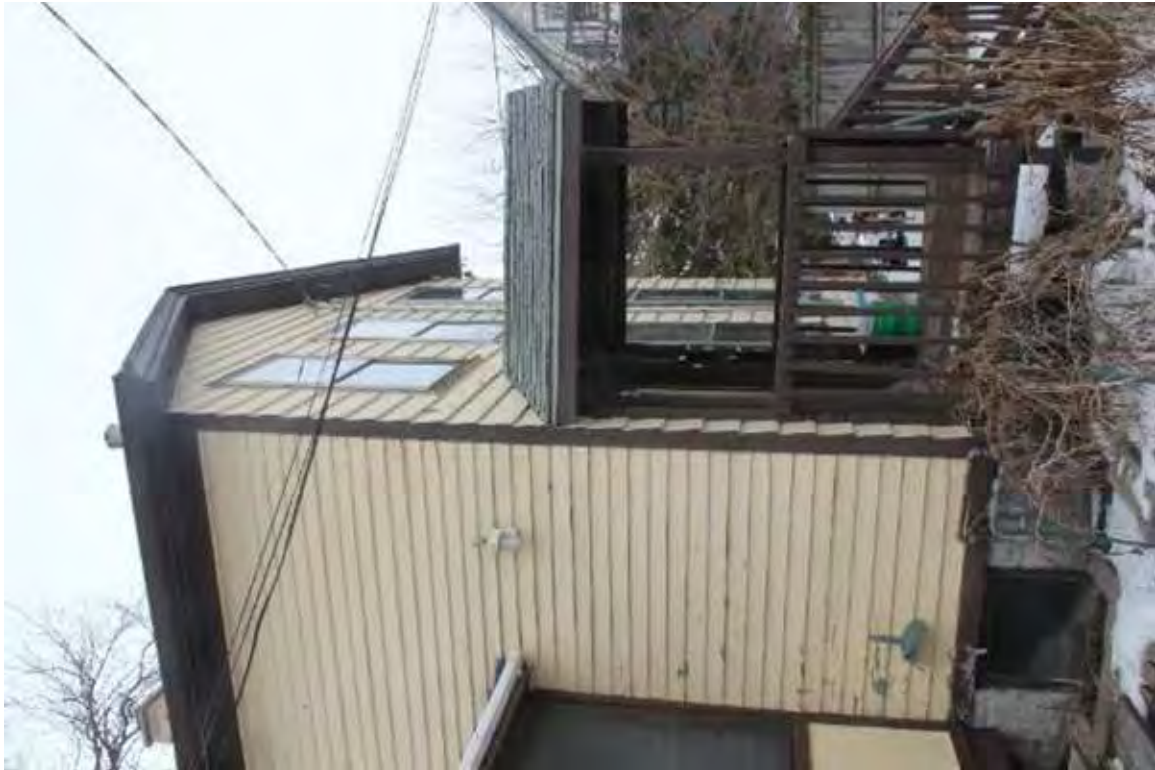
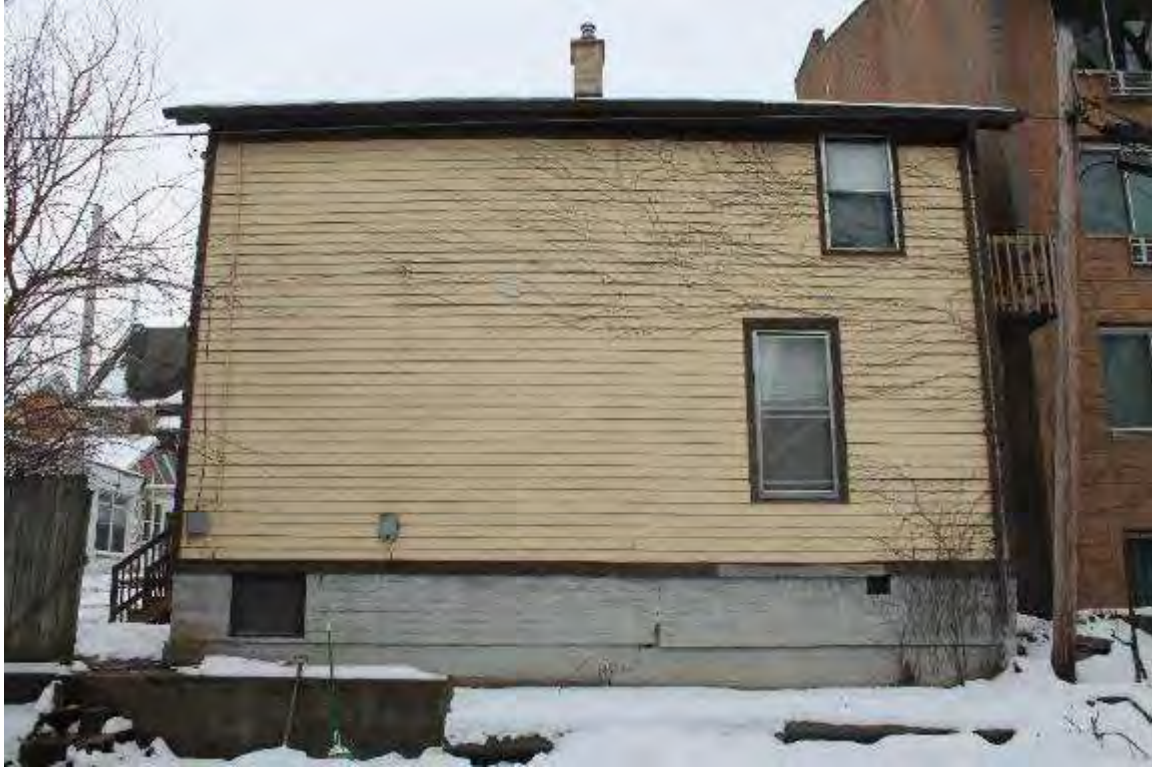
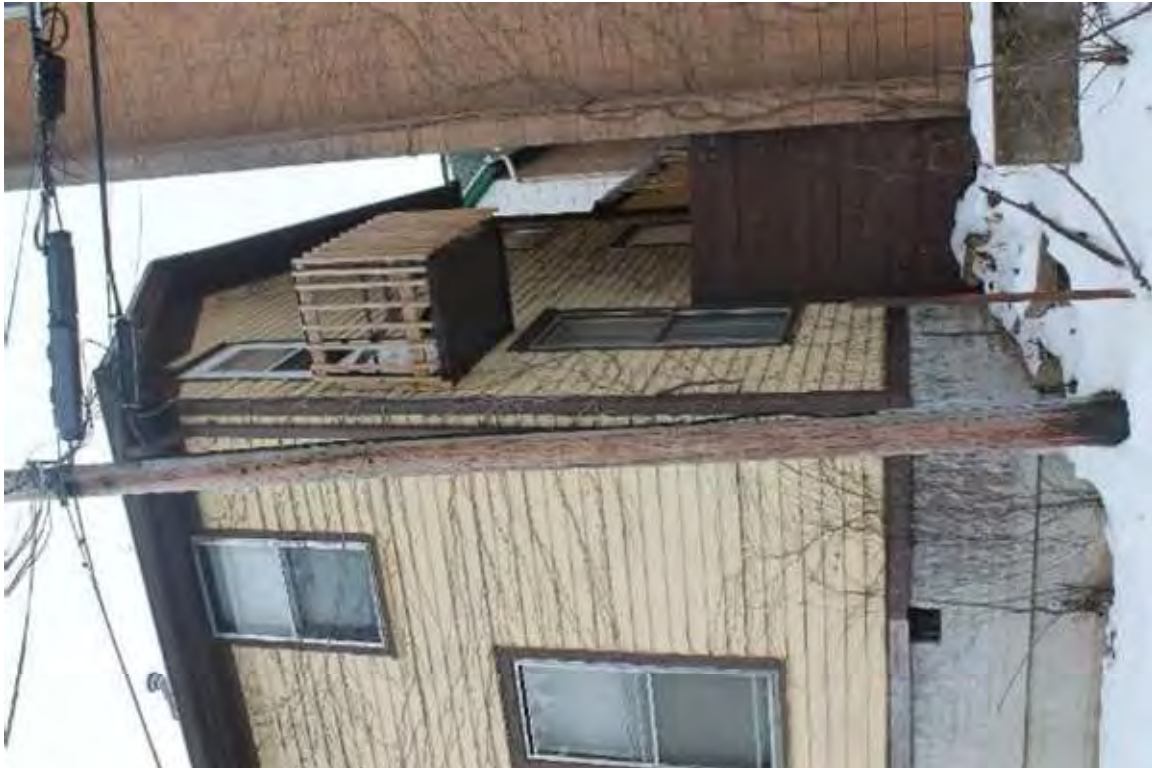
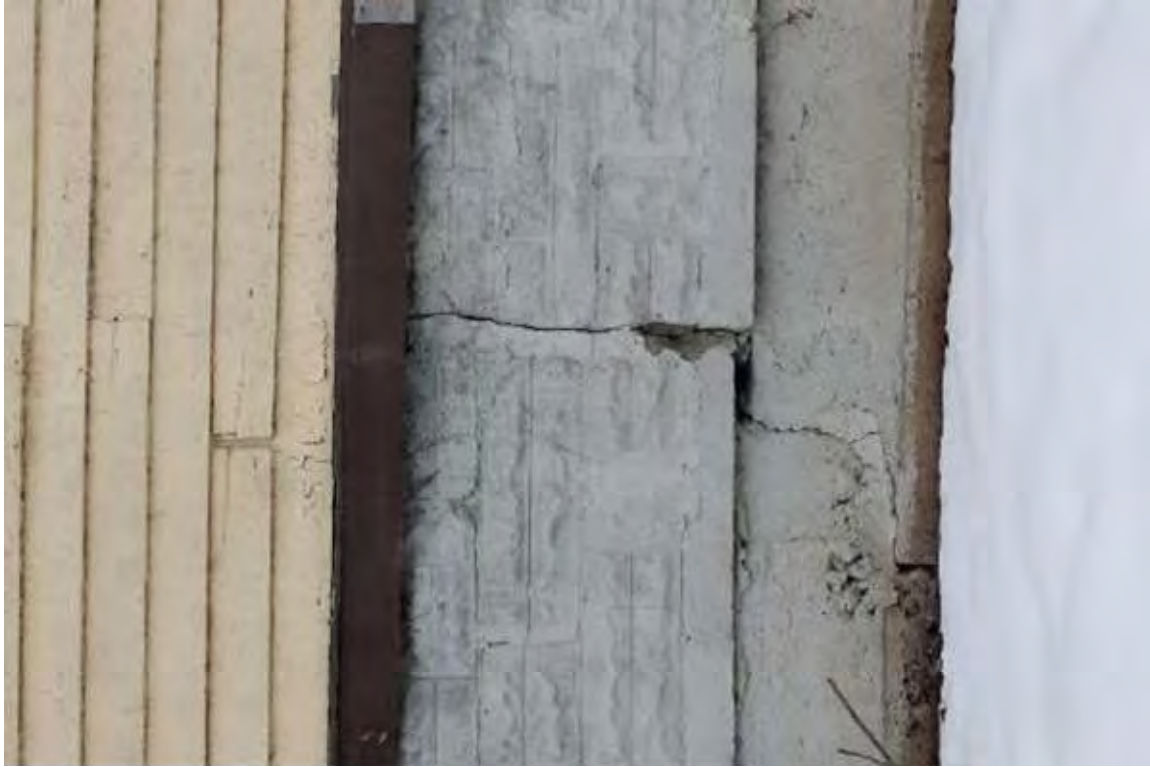
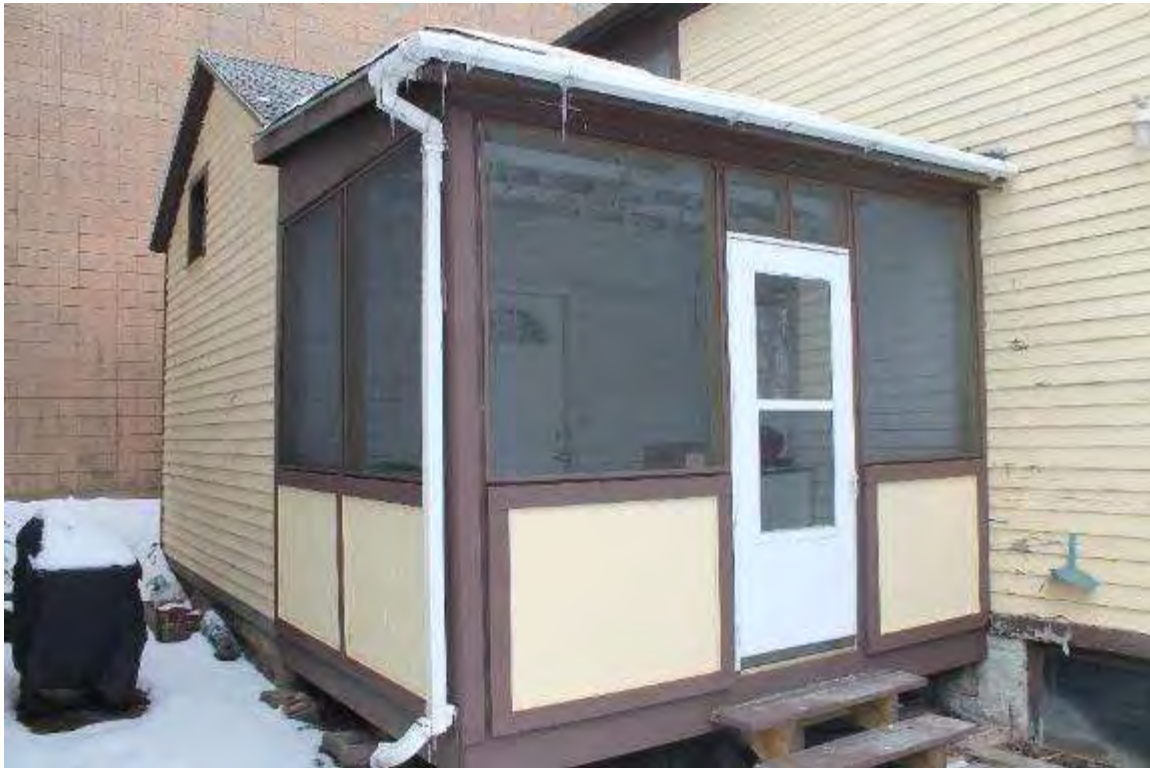
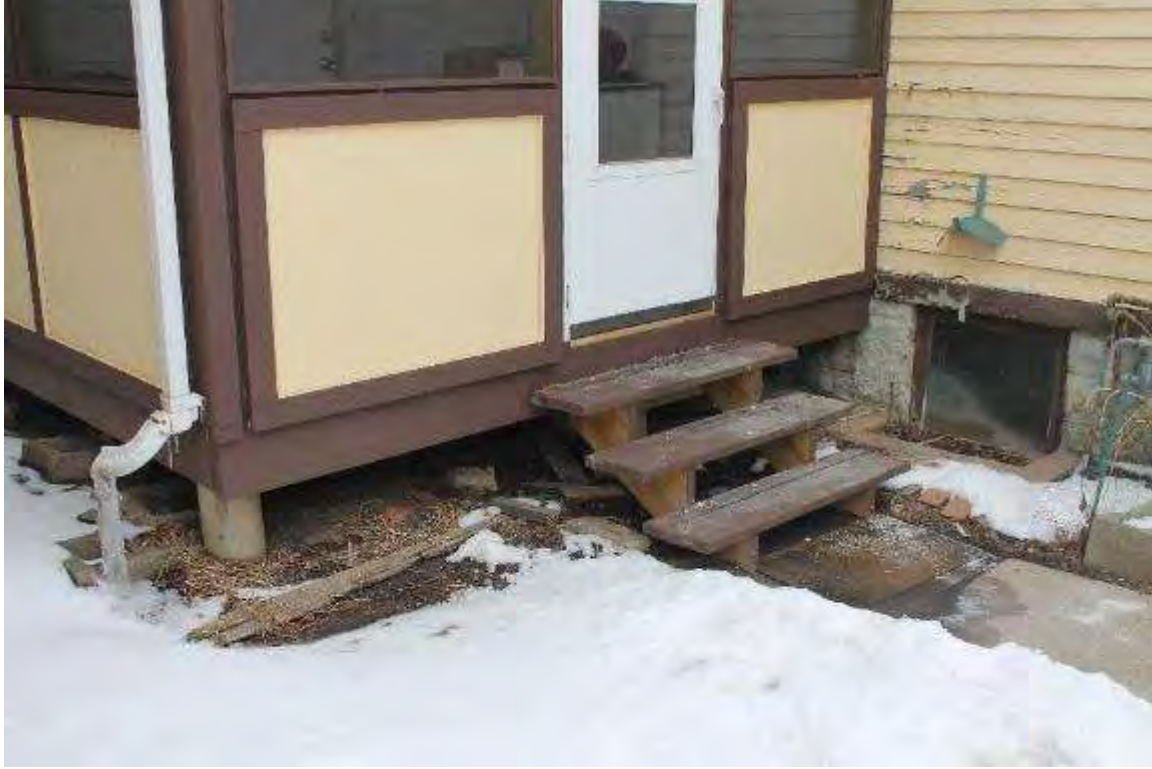
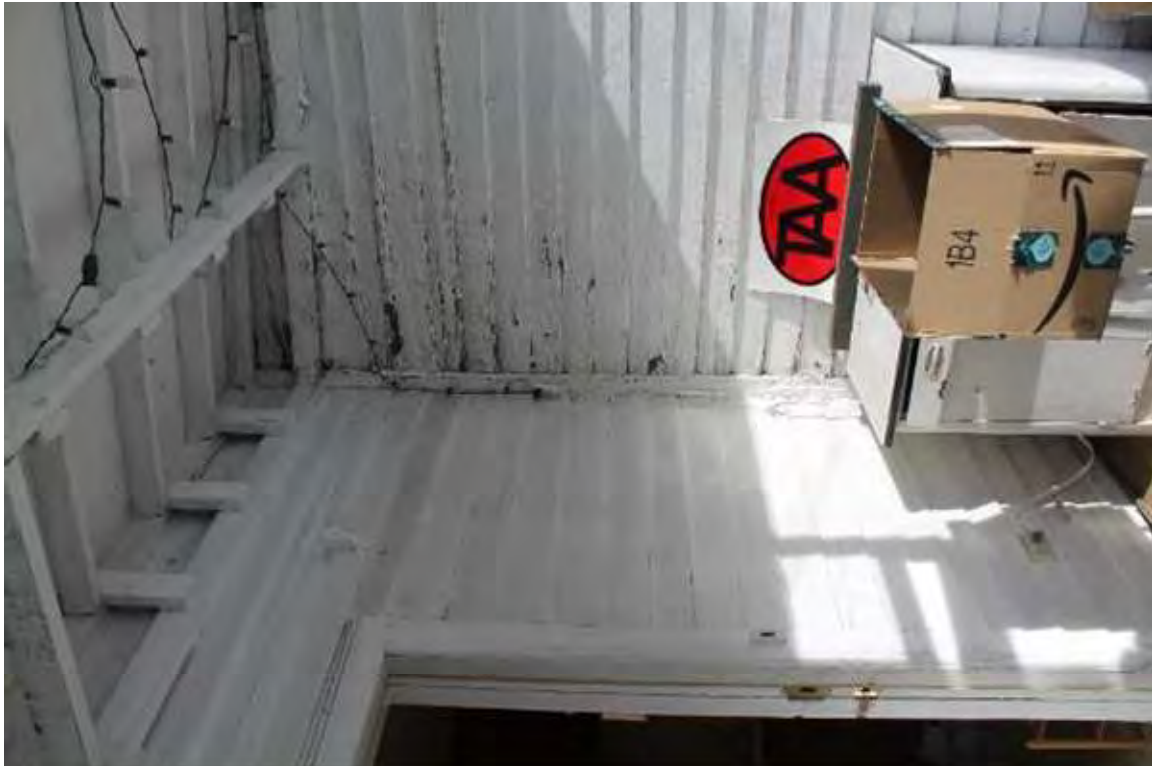
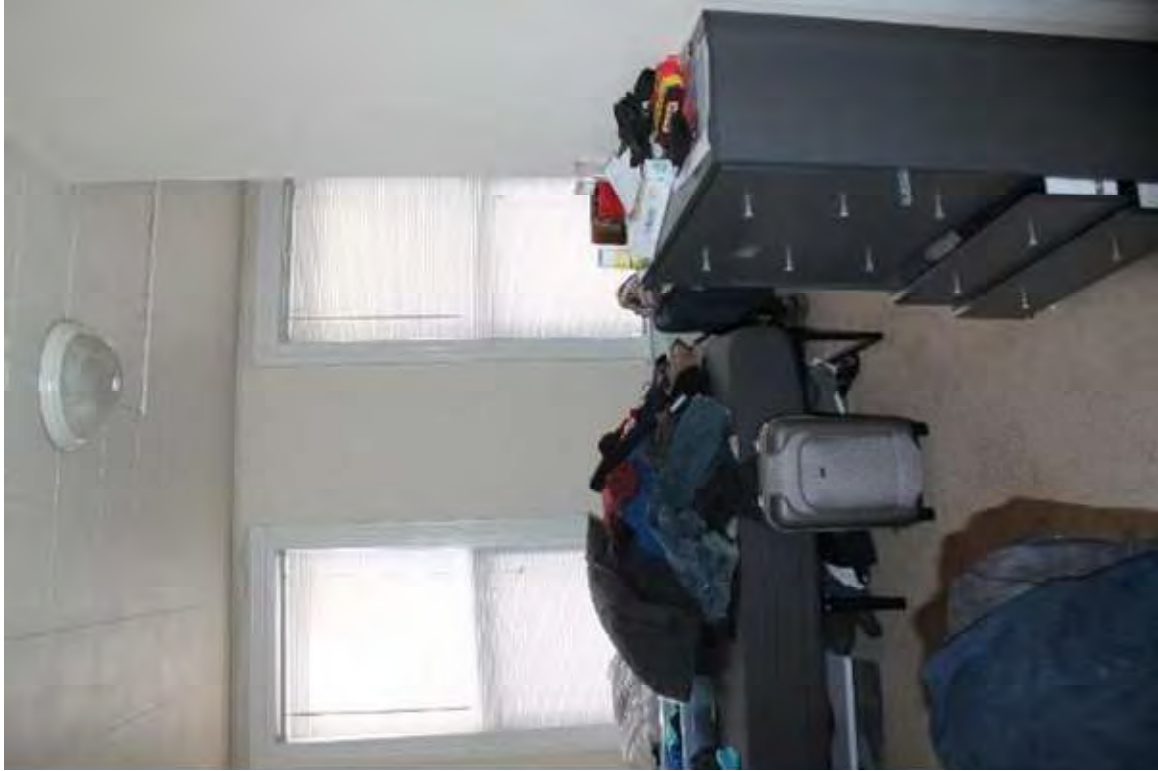
Photo 296: 410 1/2 East Washington Avenue, Exterior, facing northwest

Photo 297: 410 1/2 East Washington Avenue, Exterior, facing northwest

Photo 298: 410 1/2 East Washington Avenue, Exterior, facing north

Photo 299: 410 1/2 East Washington Avenue, Exterior, facing northwest

Photo 300: 410 1/2 East Washington Avenue, Exterior, facing northeast

Photo 301: 410 1/2 East Washington Avenue, Exterior, facing southwest

Photo 302: 410 1/2 East Washington Avenue, Exterior, facing southwest

Photo 303: 410 1/2 East Washington Avenue, Exterior, facing southwest

Photo 304: 410 1/2 East Washington Avenue, Exterior, facing north

Photo 305: 410 1/2 East Washington Avenue, Exterior, facing north

Photo 306: 410 1/2 East Washington Avenue, Exterior, facing northeast

410 1/2 East Washington Avenue
(see photos 296 through 325)

The building at 410 1/2 East Washington Avenue is a two-story vernacular style house. It has a cast concrete foundation, wood frame structure, and painted wood siding and trim. The painted wood siding and trim appear to be historic. Most of the original wood windows still exist, and the doors have been replaced. The roof is non-historic asphalt shingles. Both the front entry

porch and the side porch are wood and have been added and repaired. The interior spaces have been reorganized and little of the original historic finishes remain. The floors are carpeted or are linoleum. The walls are painted drywall on the interior, though the exterior walls have plaster in some locations. The ceilings are drywall as well. There is a full basement underneath the front portion of the building, while the back half of the house only has a crawlspace. The house was moved from another location to this one and set on the new foundation in 1907. There are two rental units in the 1,209 square foot building. Notable alterations to the building include the exterior porches, interior finishes, and the reorganization of interior spaces.¹³

The house lacks architectural integrity due to its interior layout and the foundation requires repairs. Few if any of the architectural elements could be salvaged and repurposed.
