# Stormwater Issues on Monona Golf Course –Related to E. Dean Ave., Reconstruction 2021

**by City of Madison Engineering Division**

**2-10-2021**

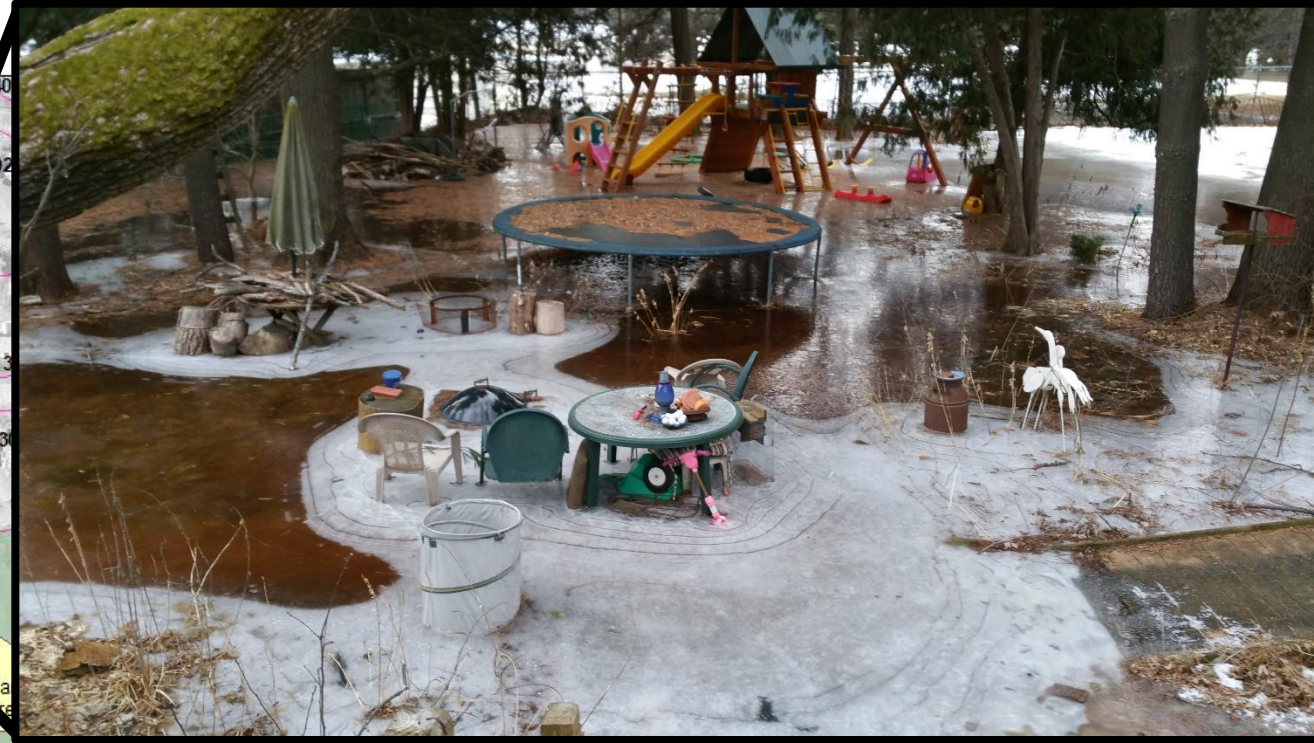
# Monona Golf Course - Part of Stormwater System

- ..... Intended flowpath, but does not drain well
- Overland flow of stormwater
- Stormwater Pipes
- Water ponds in spring or high runoff event
- Fairway can be wet
- Ownership Parcels
- Monona Golf Course
- Monona Park

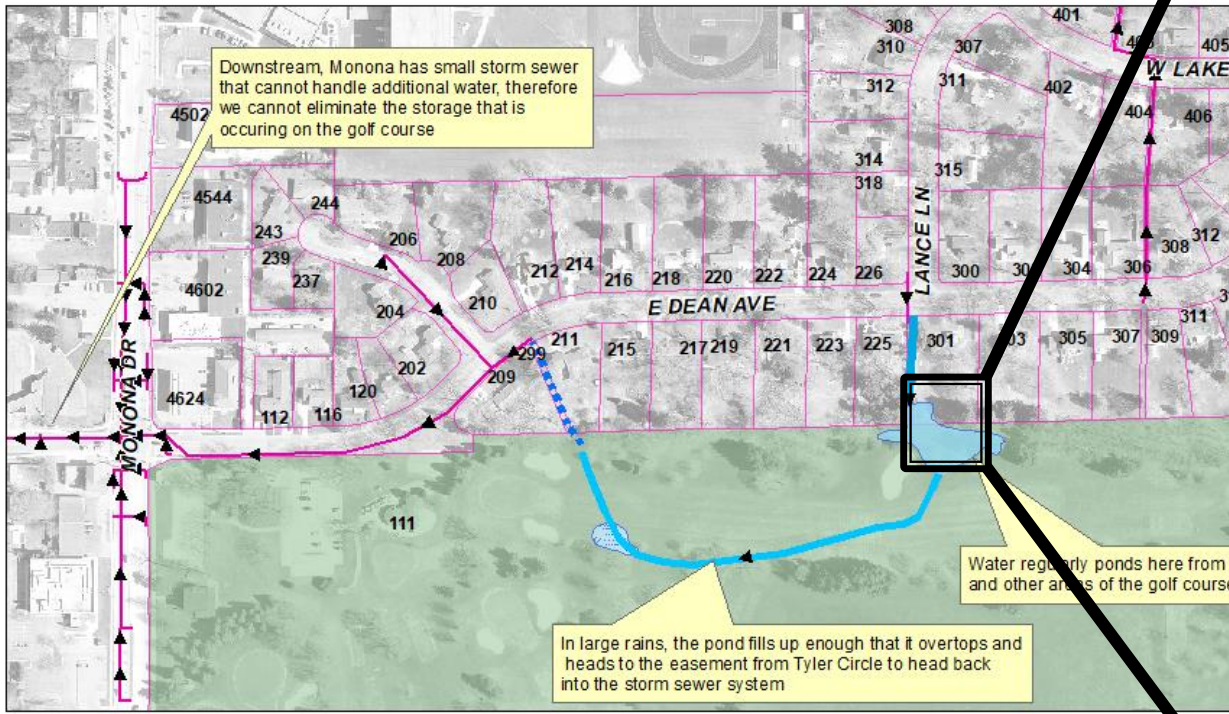
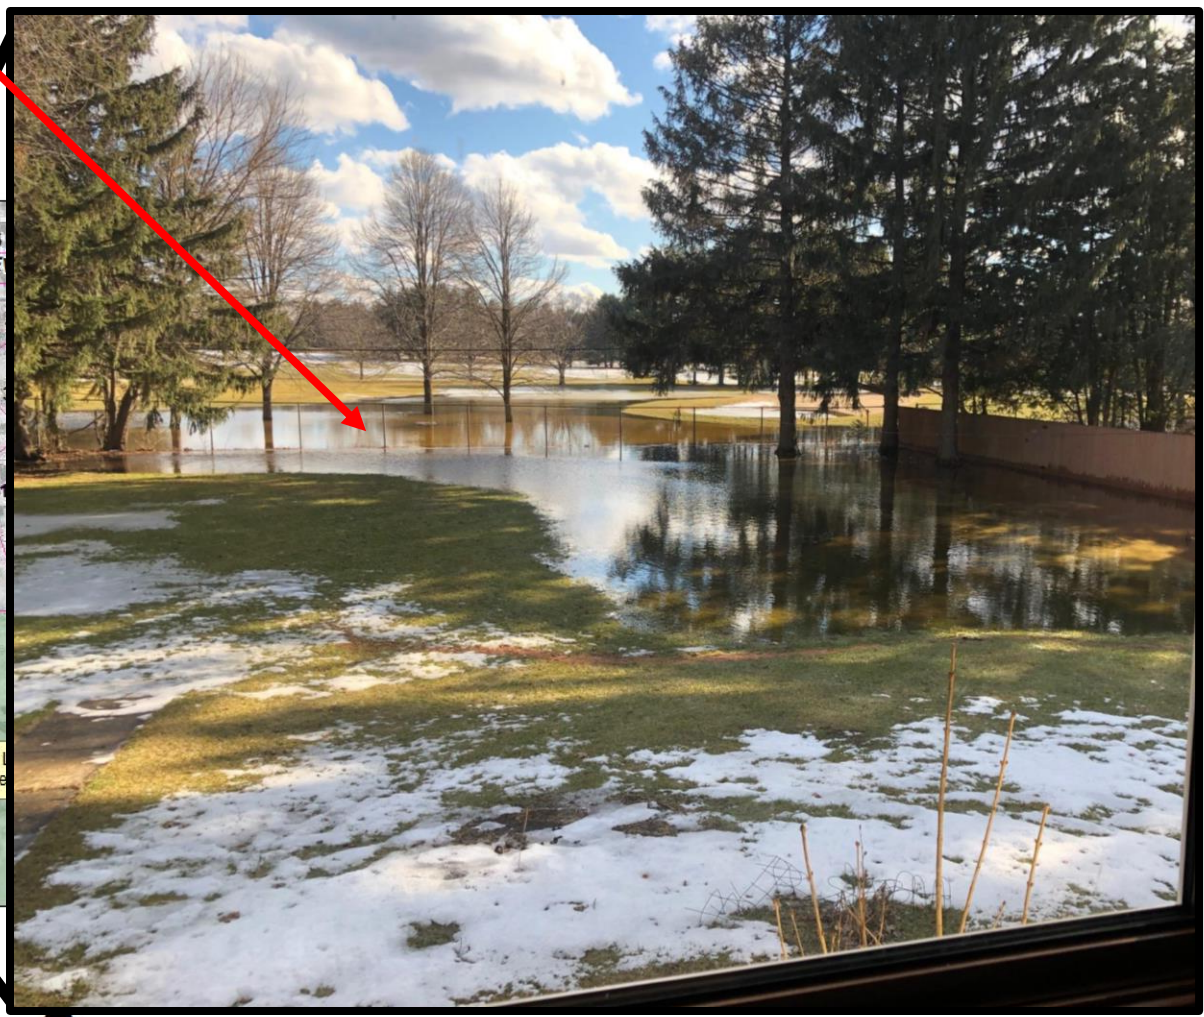
# Monona Golf Course - Part of Stormwater System

- Intended flow path, but does not drain well
- ▶▶▶▶▶ Overland flow of stormwater
- ▶▶▶▶▶ Stormwater Pipes
- Water ponds in spring or high runoff event
- Fairway can be wet
- Ownership Parcels
- Monona Golf Course
- Monona Park

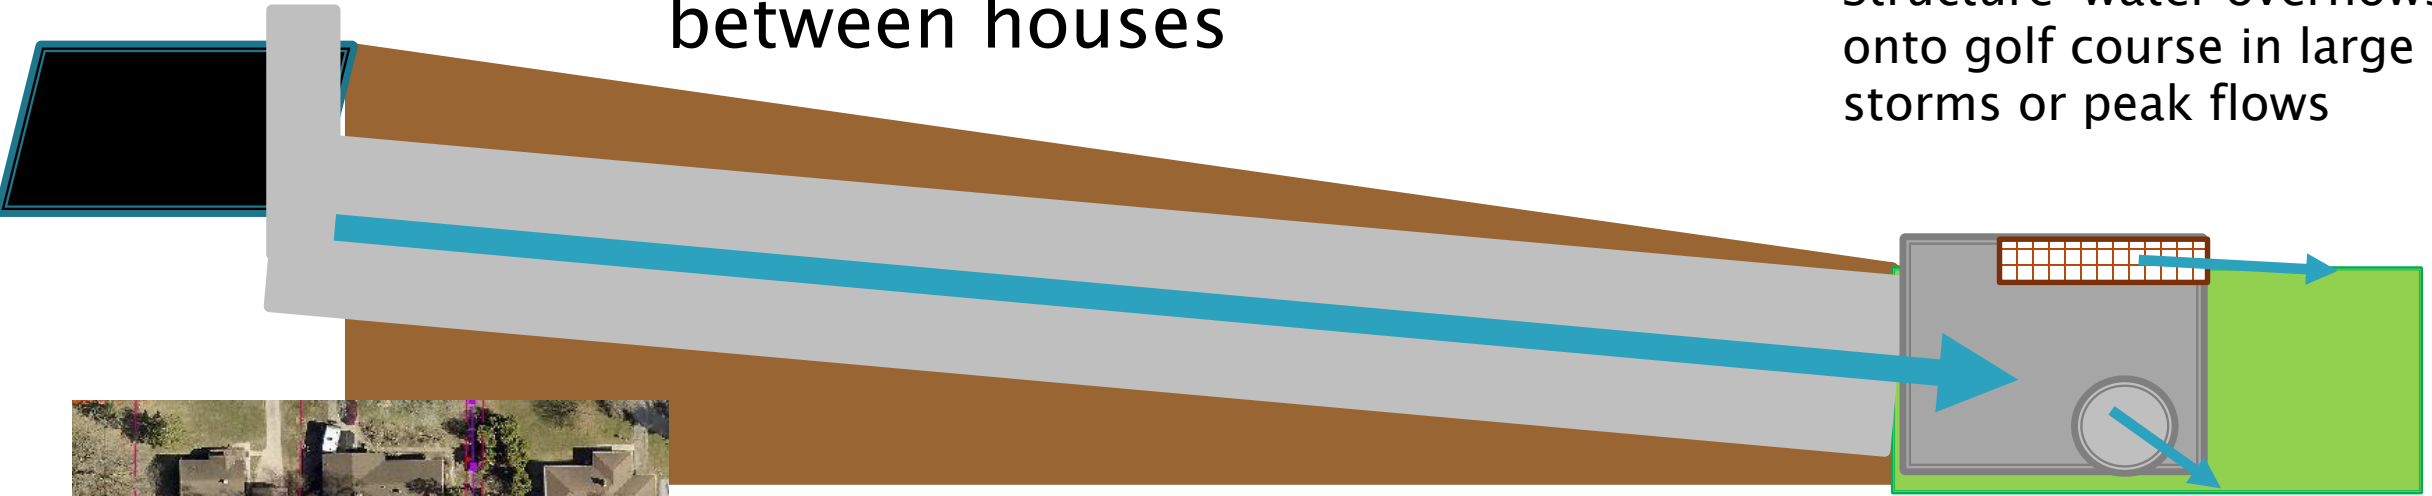
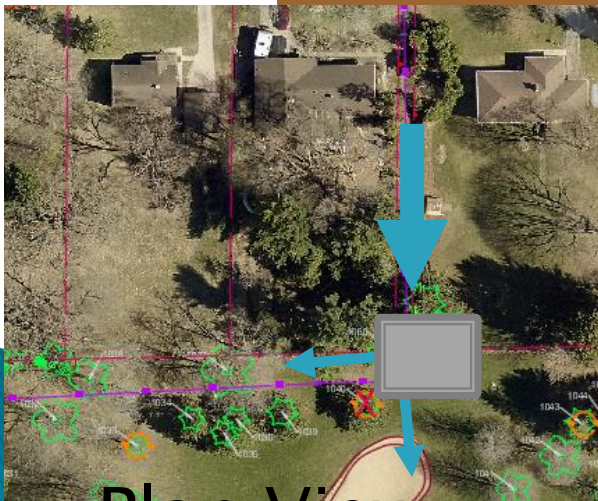
# Pond Alternative

Structure—water overflows onto golf course in large storms or peak flows

Small pipe carries water thru hill due west towards Dean Ave. Allows for drawdown that isn't thru golf course

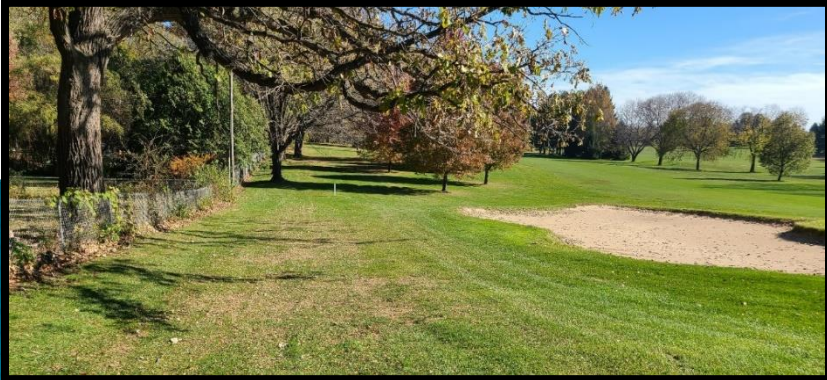
# Impact on Trees on Private Property

*Impact on private property trees to be assessed*

Designing around mature oak on private property.  
~1/3 of canopy is over park property

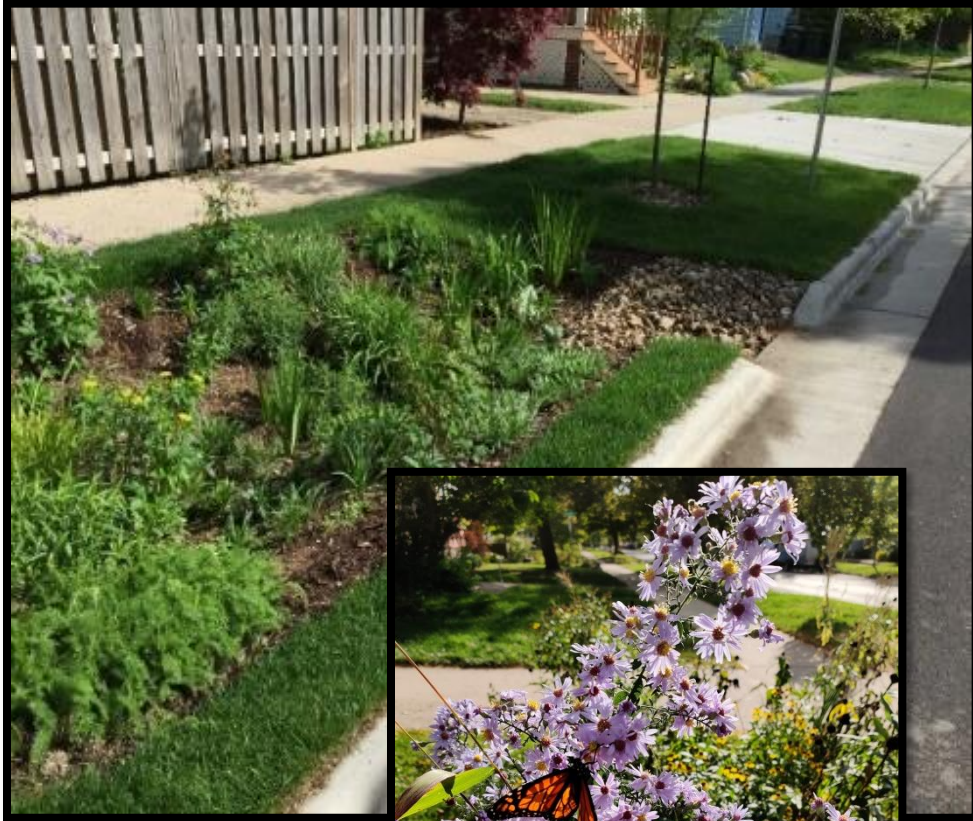
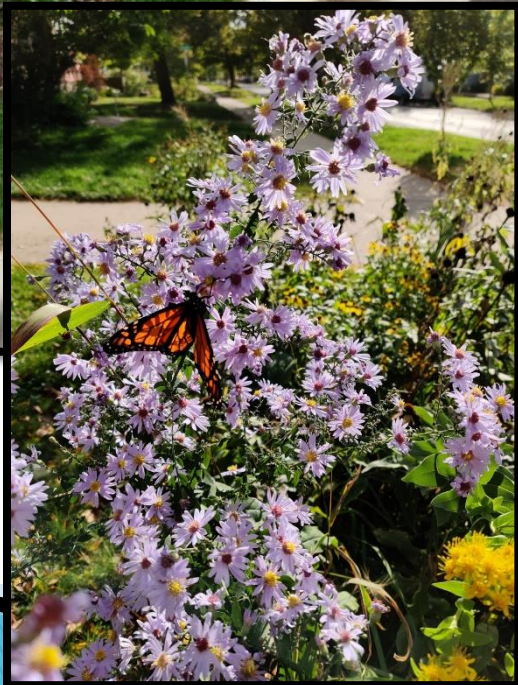
# Terrace Rain Garden

- ▶ So far, 6 homes upstream of golf course have opted into the terrace rain garden program
- ▶ These rain gardens are not included in the model, but would further reduce golf course flooding in small events (50% chance, 25% chance)
  - Will have no impact on large events
- ▶ City offered reduced price, \$100, per BPC suggestion
