1322 Chandler St Demolition and Rebuild Project

Assessment and Condition Study for the Existing Residence at 1322 Chandler Street Madison, WI

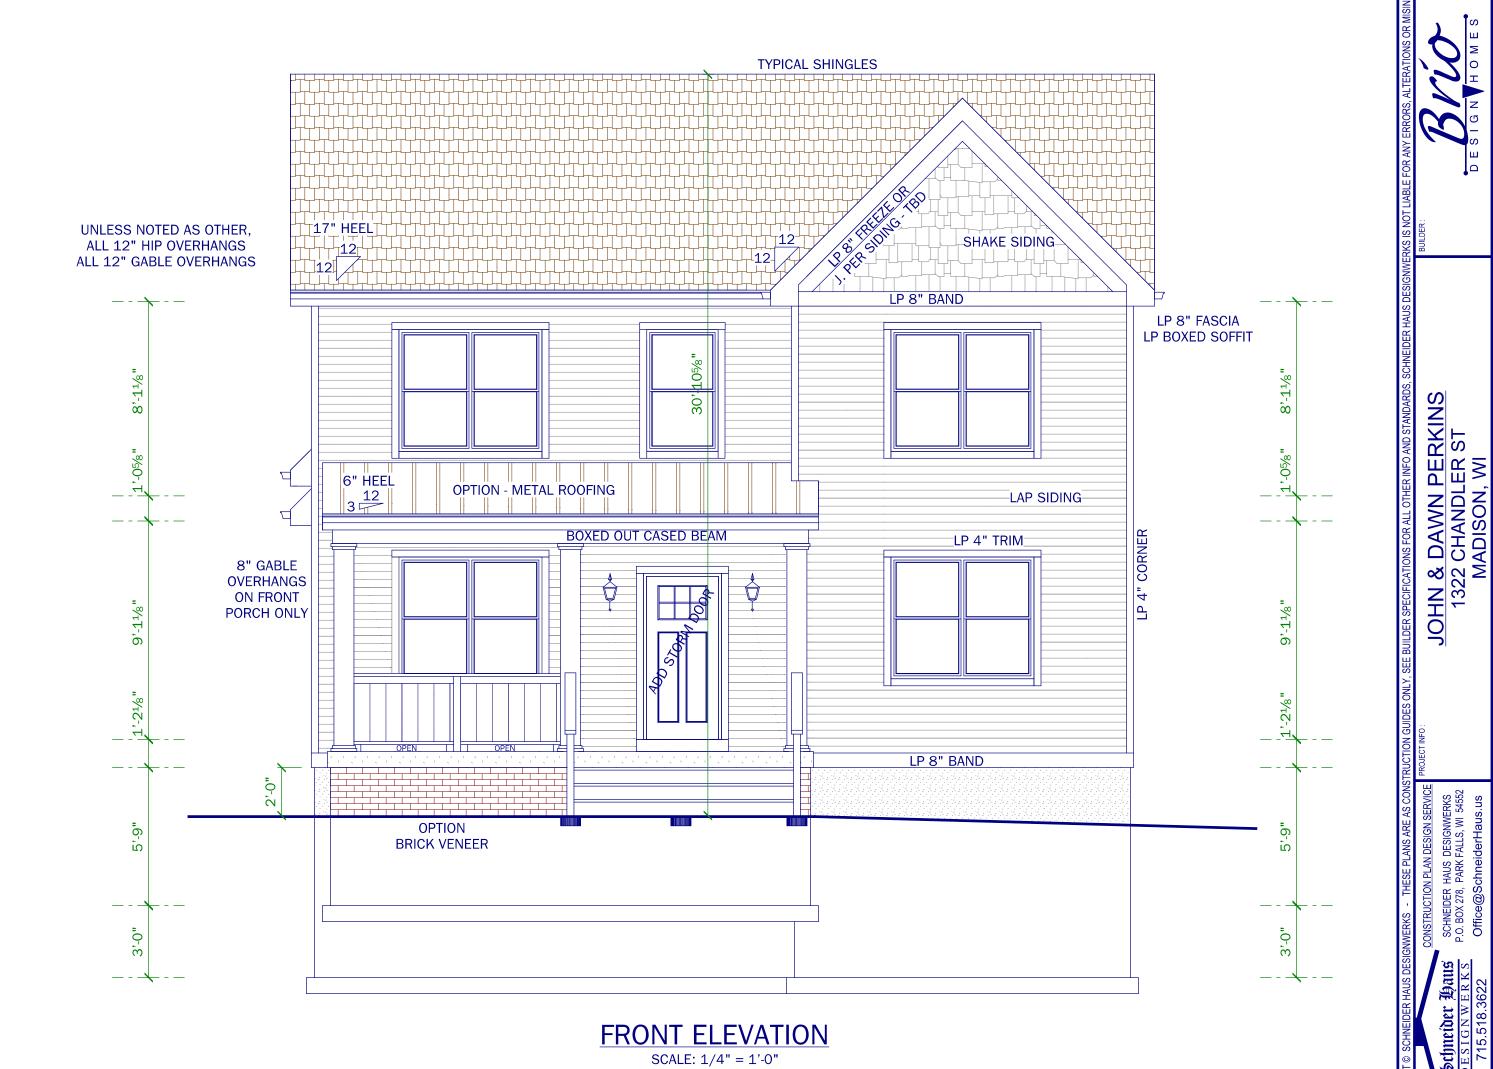
FRONT PORCH RAILING SECTION

TOP OF PORCH

FLOOR

- 2x4 CAP RAIL - 1x4 RAIL BAND

- 1x VERTICAL BOARDS

2x4 BOTTOM RAIL
