# McKenna Blvd./Park Edge-Park Ridge Flood Mitigation

MARCH 13, 2019

# Proposed Public Works Project Design

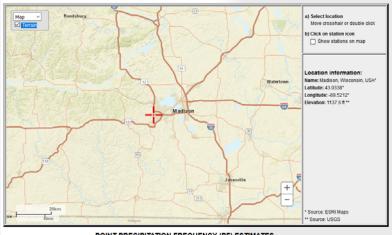
# Most recent (Atlas 14) rainfalls from NOAA

POINT PRECIPITATION FREQUENCY (PF) ESTIMATES
WITH 90% CONFIDENCE INTERVALS AND SUPPLEMENTARY INFORMATION
NOAA Atlast 14, Volume 8, Version 2

In August some areas in Madison and the surrounding areas received 12-15 inches in approximately 8 hours. This is literally off the chart.

- Historic rain .... (what do I mean if I say 100-year event)
  - The term "100-year storm" is used to define a rainfall event that statistically has a 1% chance of occurring in any given year. Just because it rained 10 inches in one day last year doesn't mean it can't rain 10 inches in one day again this year.
- ► To define an event you must know its INTENSITY and DURATION.
  - ▶ There are multiple combinations that result in "100 year" events. In our area for example:
    - ▶ 1 hour 3.09″
    - ▶ 2 hours 3.87"
    - ▶ 12 hours 5.96"
    - ▶ 24 hours 6.76"

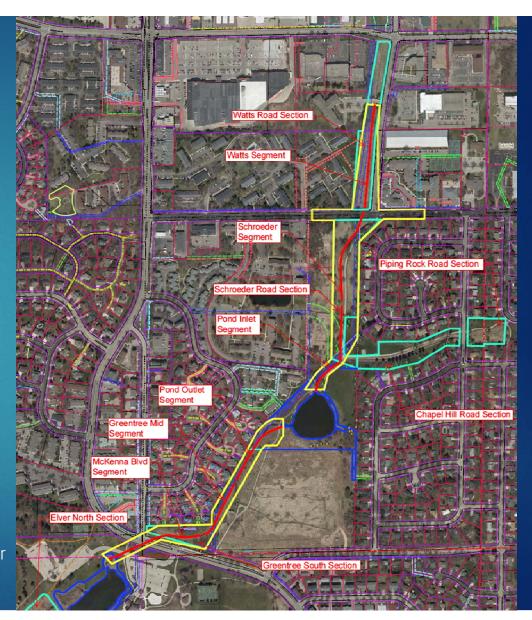
### Project Features

- Large box culverts (2-5'x12' & 2-5'x10') at McKenna Blvd. to carry flood flows
- Replace concrete channel lining
  - Re-align and lower cunette
  - Retaining wall with protective railing
- Remove and replace culverts at Greentree Pond
  - ▶ Lower pipe invert elevations by 1.5′
  - Modify bike path in Greentree Landfill
- Lower channel upstream of Greentree Pond
  - Extend greenway modification upstream past Schroeder Road
  - Proposed grading match into existing ground
  - ▶ Remove and replace culverts under Schroeder

- Specific modeling/design challenges in the watershed
  - Grate clogging/greenway maintenance
  - Culverts under McKenna are undersized
  - Cunette is very shallowly sloped (0.1%)
  - Greentree Landfill limits expansion of channel to the east
  - Older construction means older design standards for stormwater control and development
  - Redevelopment is more difficult to retrofit
  - Emergency access on McKenna Blvd
- Aug 20, 2018 forced City Engineering to step back and review design standards
- ▶ BUDGET! We had sufficient funds for a much smaller project in 2017, but requested additional funding Nov 2018 for a more comprehensive design.
