Facility Name	Unit Well 11	Facility Description
Well ID	BF511	Drilled in 1956, Unit Well 11 has a pumping capacity of 2,300 gallons per minute. It operates year-round and serves Madison’s East side including the Emerson East, Eken Park, Marquette, Schenk-Atwood, Hawthorne, and Worthington Park neighborhoods as well as homes in Burke Heights, Hiestand, Rolling Meadows, and Eastmorland. In 2017, the well pumped 625 million gallons of water compared to its 5-year average of 526 million gallons annually.
Service Zone	6E	
Capacity	2.88 MGD	
Reservoir Capacity	0.150 MG	
Number of Assets	31	
Current Replacement Cost	\$3.2M

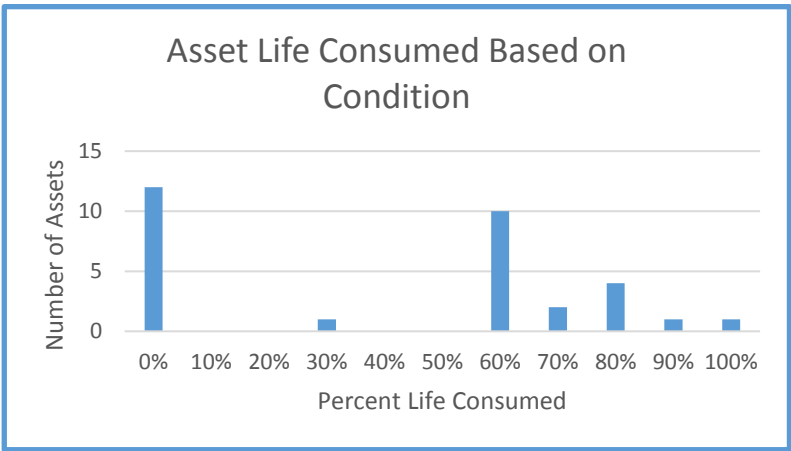
Figure 1. Life Consumed

Overall Condition Assessment: The assets at Unit Well 11 are in good to excellent condition with over 90% scoring 3 or better.

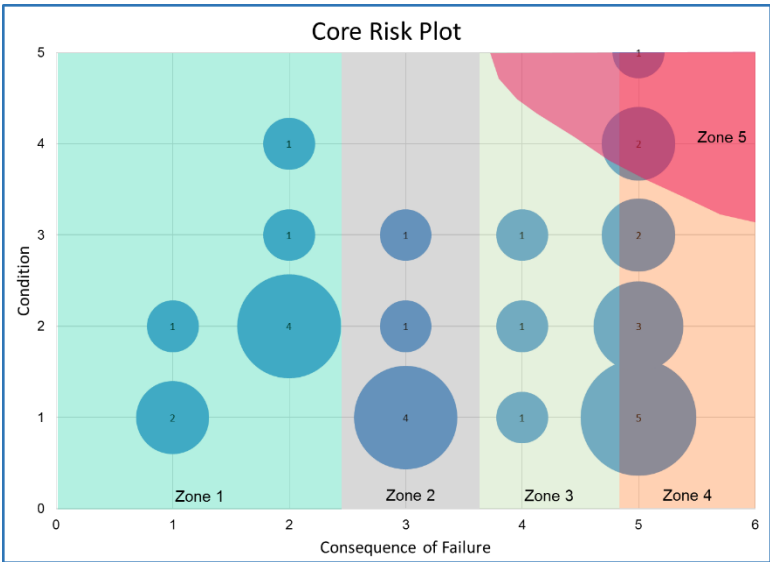
Figure 3. Risk Zone Plot

Based on the analysis, there are 3 assets falling in zone 5 (significant risk zone) that require immediate attention, Including: Chlorine System, Fluoride System, and PUMP-71 Starter. The MCC and Level/Pressure Instruments fall just outside zone 5 and should also be addressed in the short term.

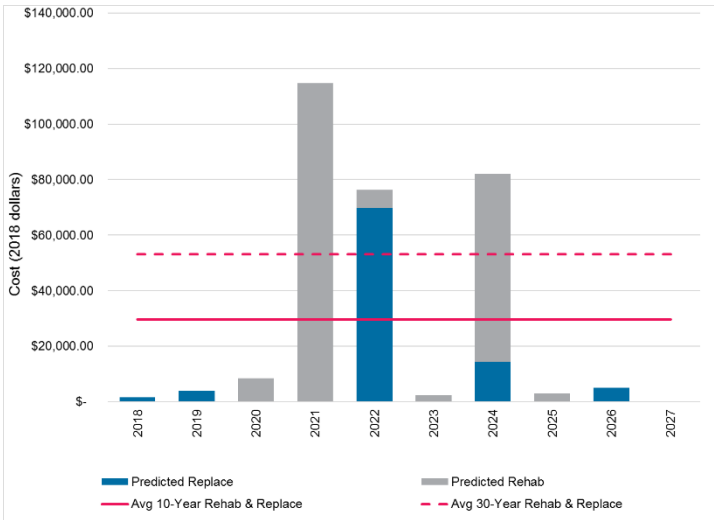
Figure 4. Base Scenario 10-Year Investment Requirements

The Base Scenario runs all assets to failure (condition 5) regardless of risk management zone. This scenario results in a baseline, lowest possible investment requirements, without regard to risk. The Base Scenario 10-year investment requirement for Unit Well 11 is shown in Figure 4. Although the investment requirement is relatively low with this scenario, it results in a much higher level of residual risk.

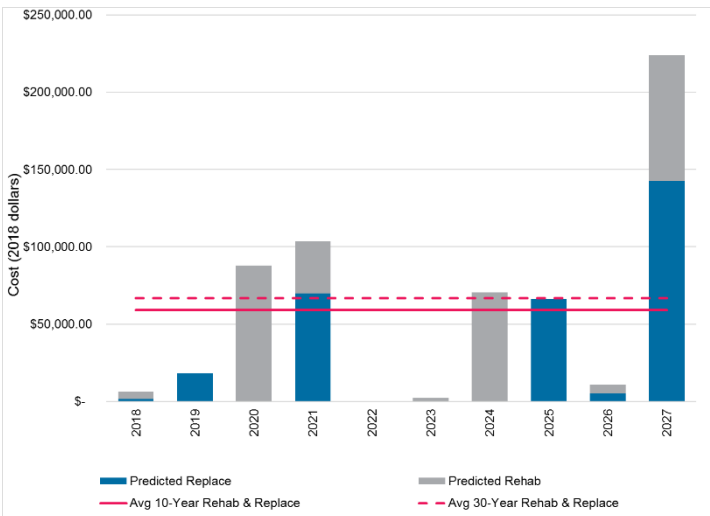
Figure 5. Significant Risk Scenario 10-Year Investment Requirements

The Significant Risk Scenario establishes a trigger for asset replacement or rehabilitation for assets that reach the tolerable core risk limit of 16. In this scenario, intervention occurs for assets in risk management zones 3 and 4 before they reach the significant risk zone. Action is taken to move assets that are already in zone 5. Assets in zones 2 and 3 are run to failure (condition 5). The Significant Risk Scenario 10-year investment requirement for Unit Well 11 is shown in Figure 5.
