Certificate of Appropriateness 115 N Spooner St

March 1, 2021

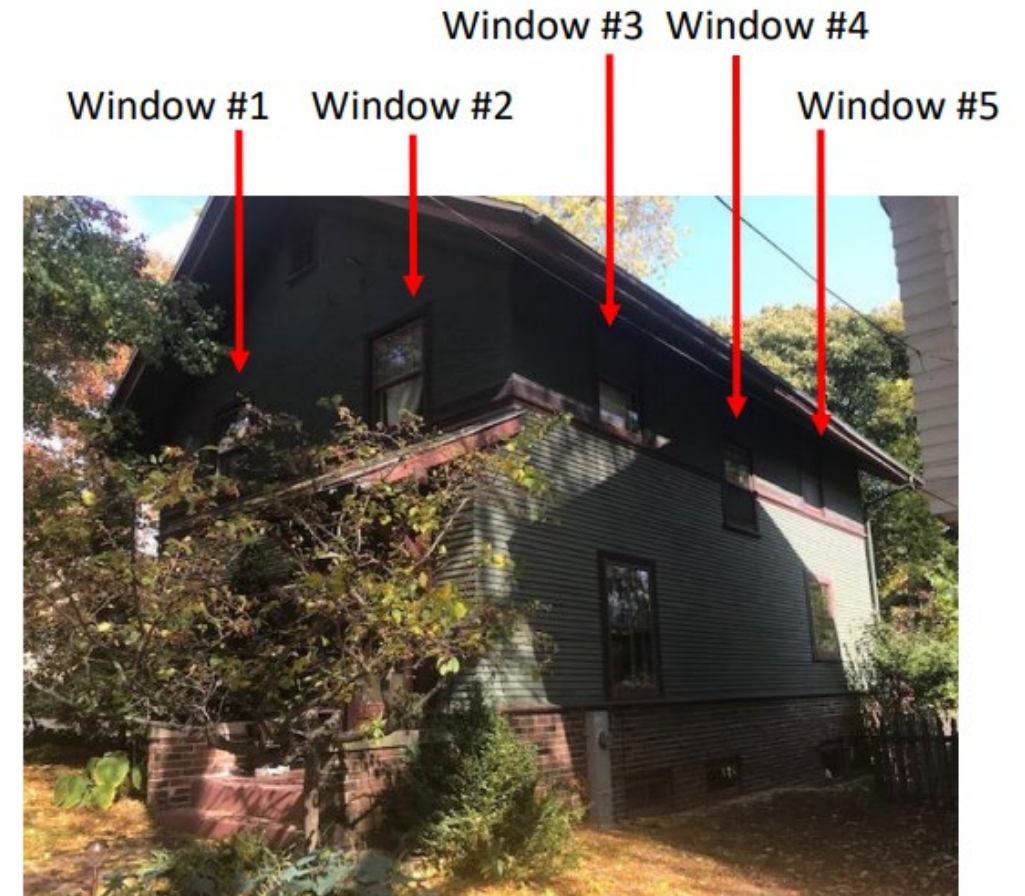
(West side and South side)

- Replace 7 windows on second story
- Replace 1 window in stair landing with safety glass
