Why salt spray is wrong for bike-pedestrian paths

> February, 2016 Southwest Path Alliance Madison, WI

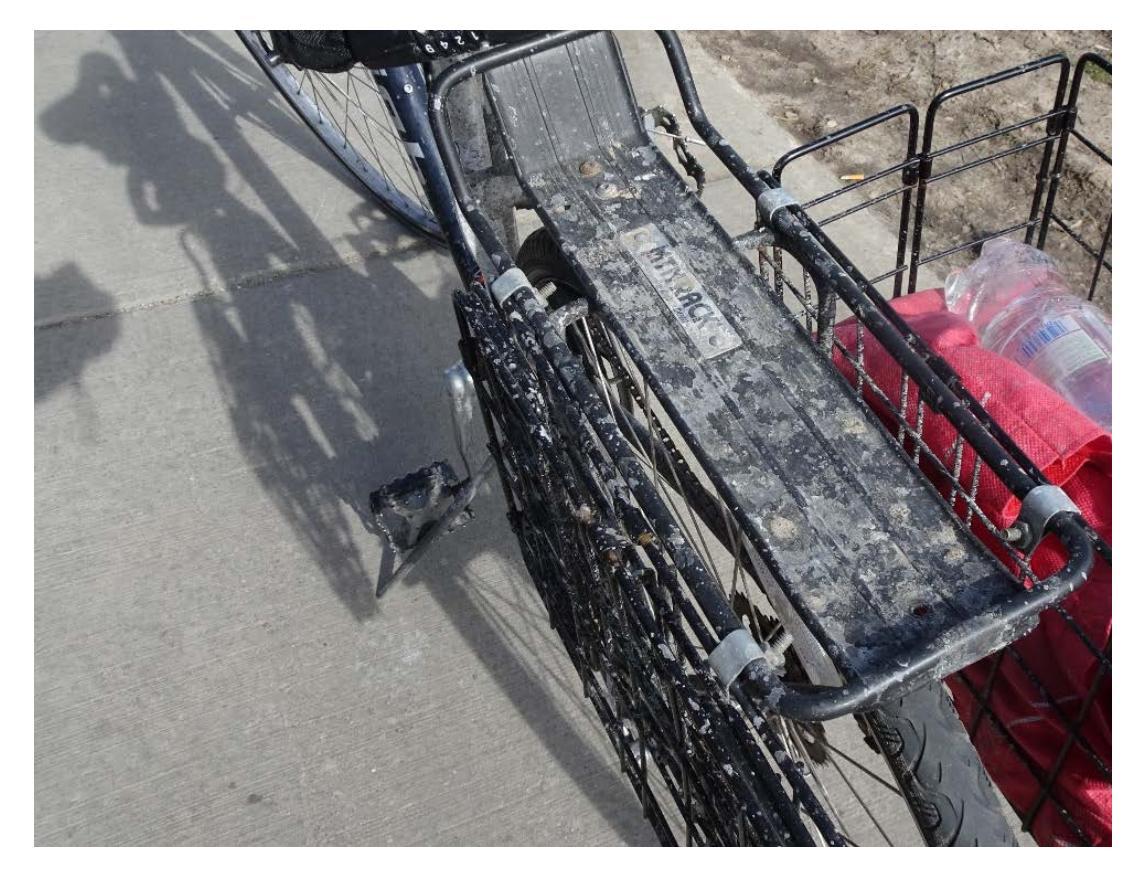
Salt coating from brine slush on SW Path during 2015-16 "pilot program"

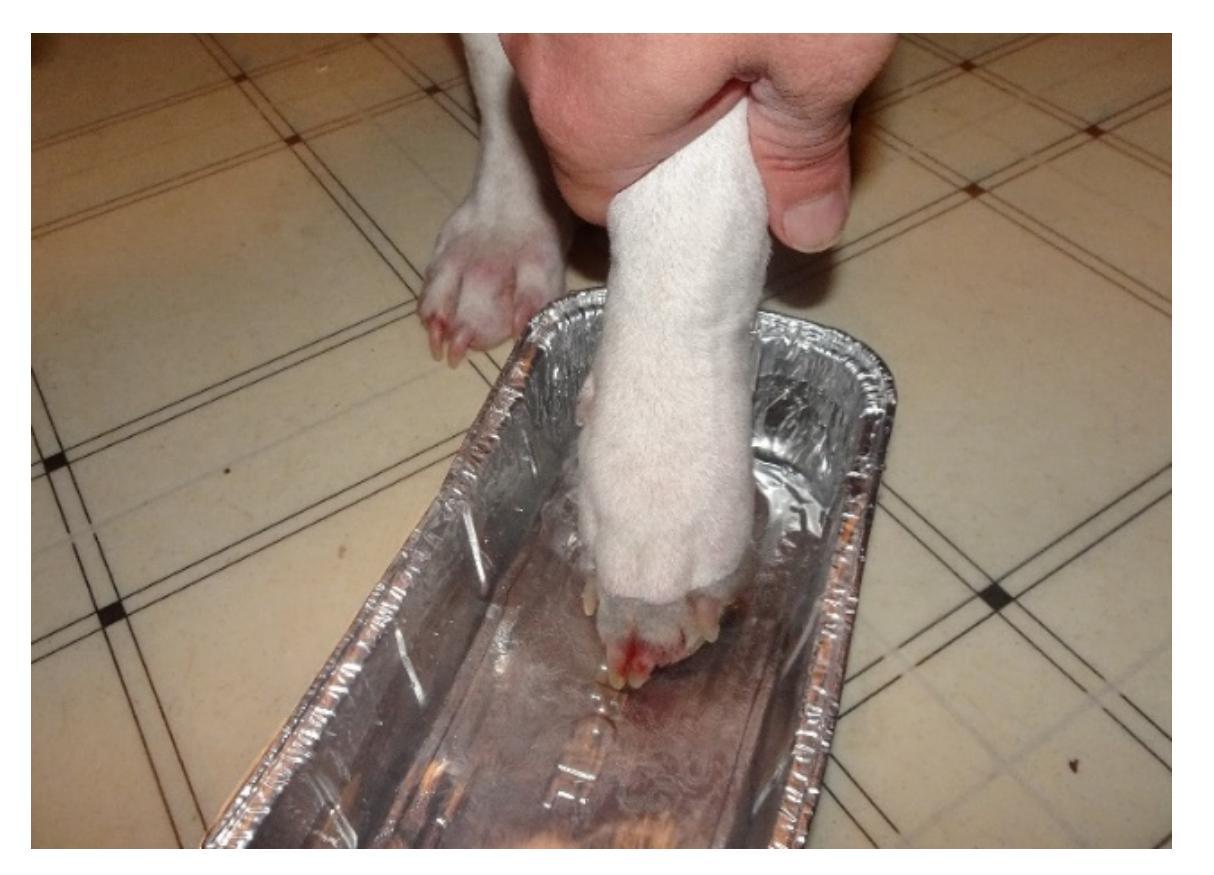
Decontamination is required after dogs are walked on brine-treated path

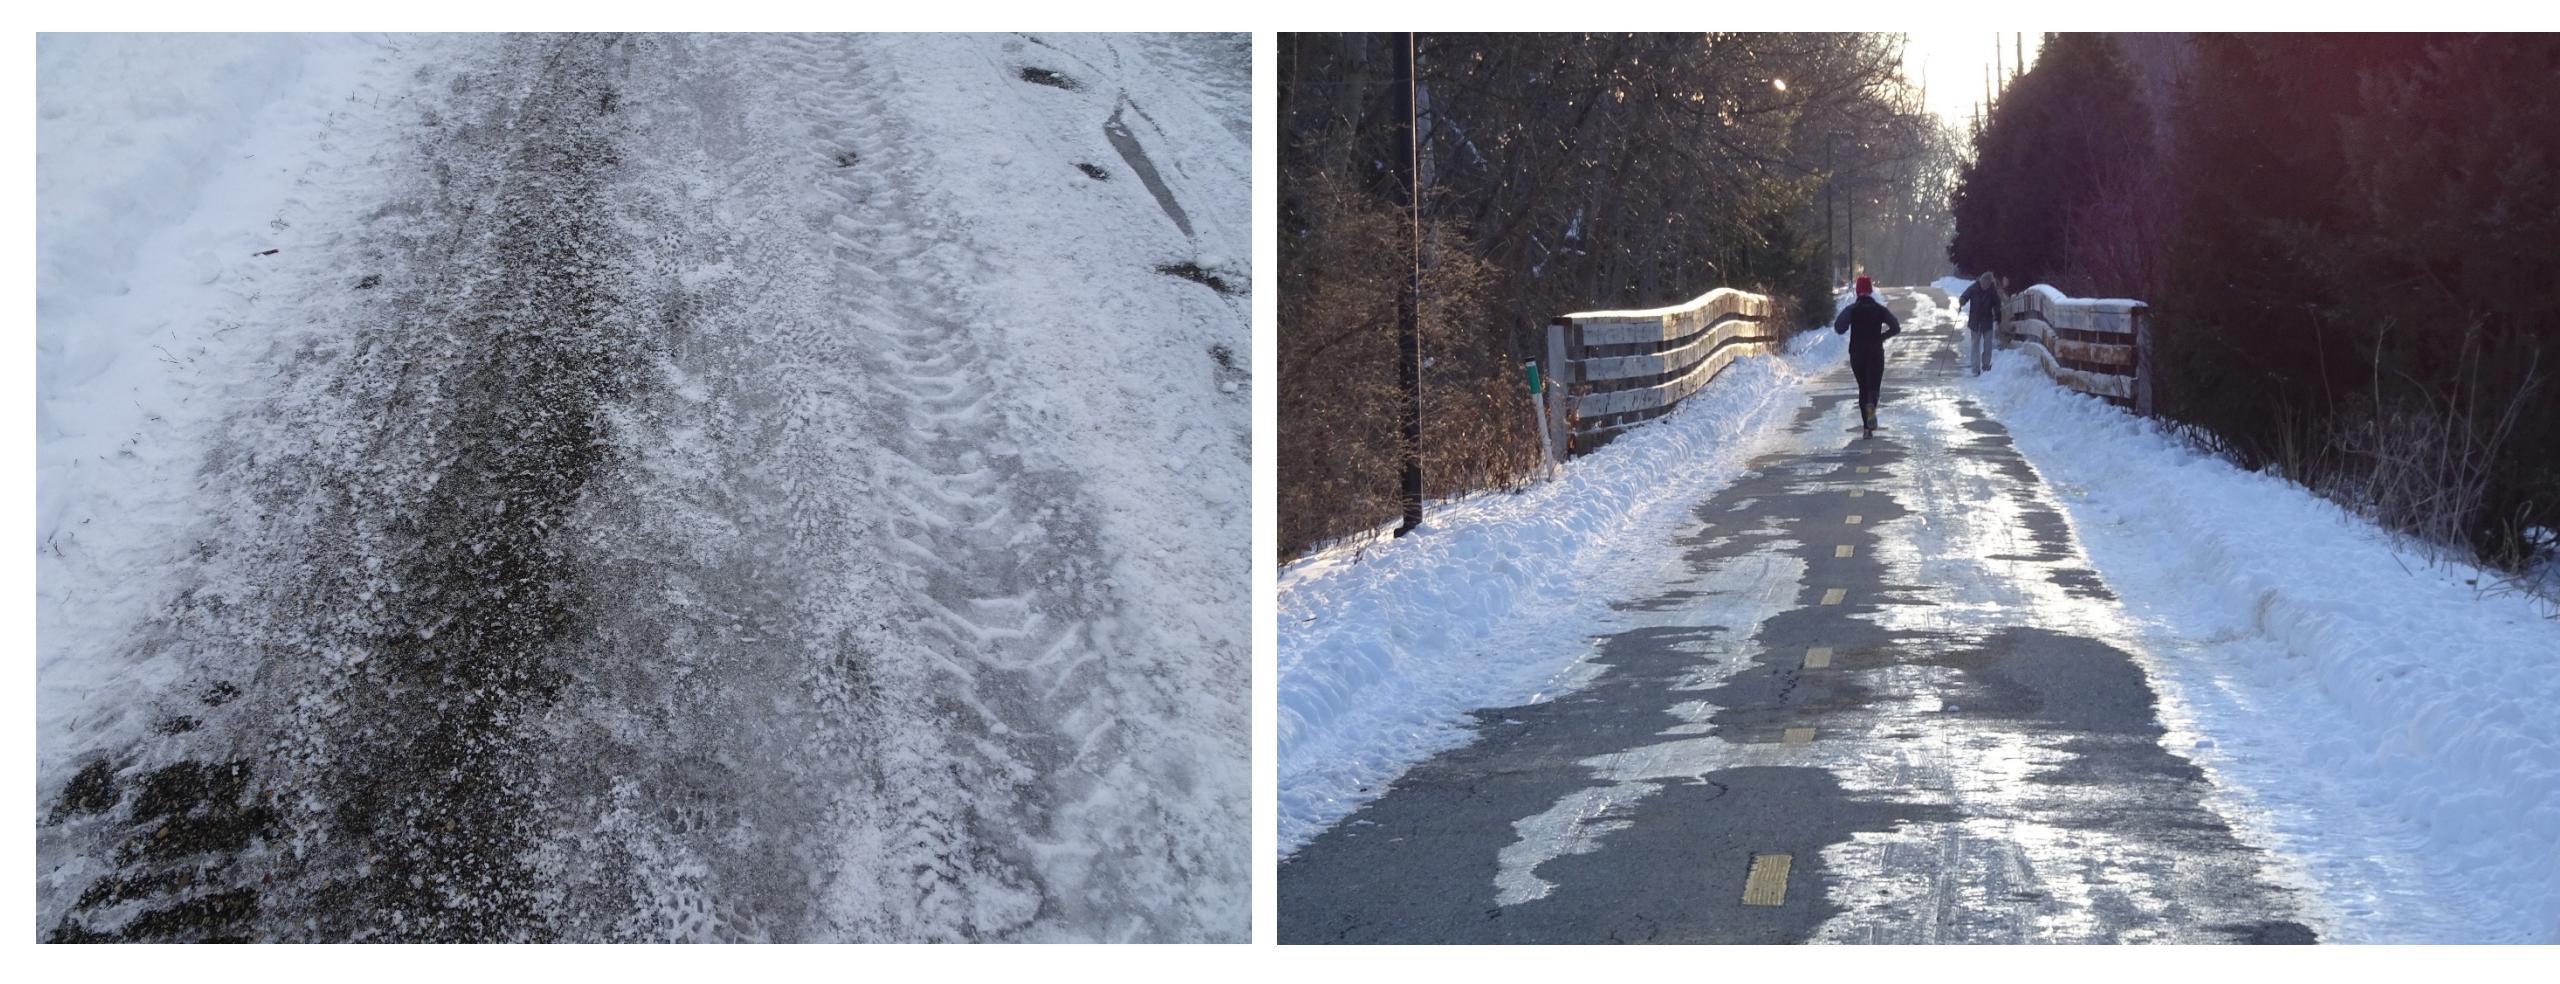
Glare ice from salt-brine pre-treatment- Dec 2015

Salt brine sprayed on 12/28 from Commonwealth to Beltline prior to 5" of wet snow Created unprecedented glare-ice for over a week throughout treated area.

Dec 30- Frozen slush in brine-treated area

Dec 31- Treacherous glare ice on entire brine-treated span

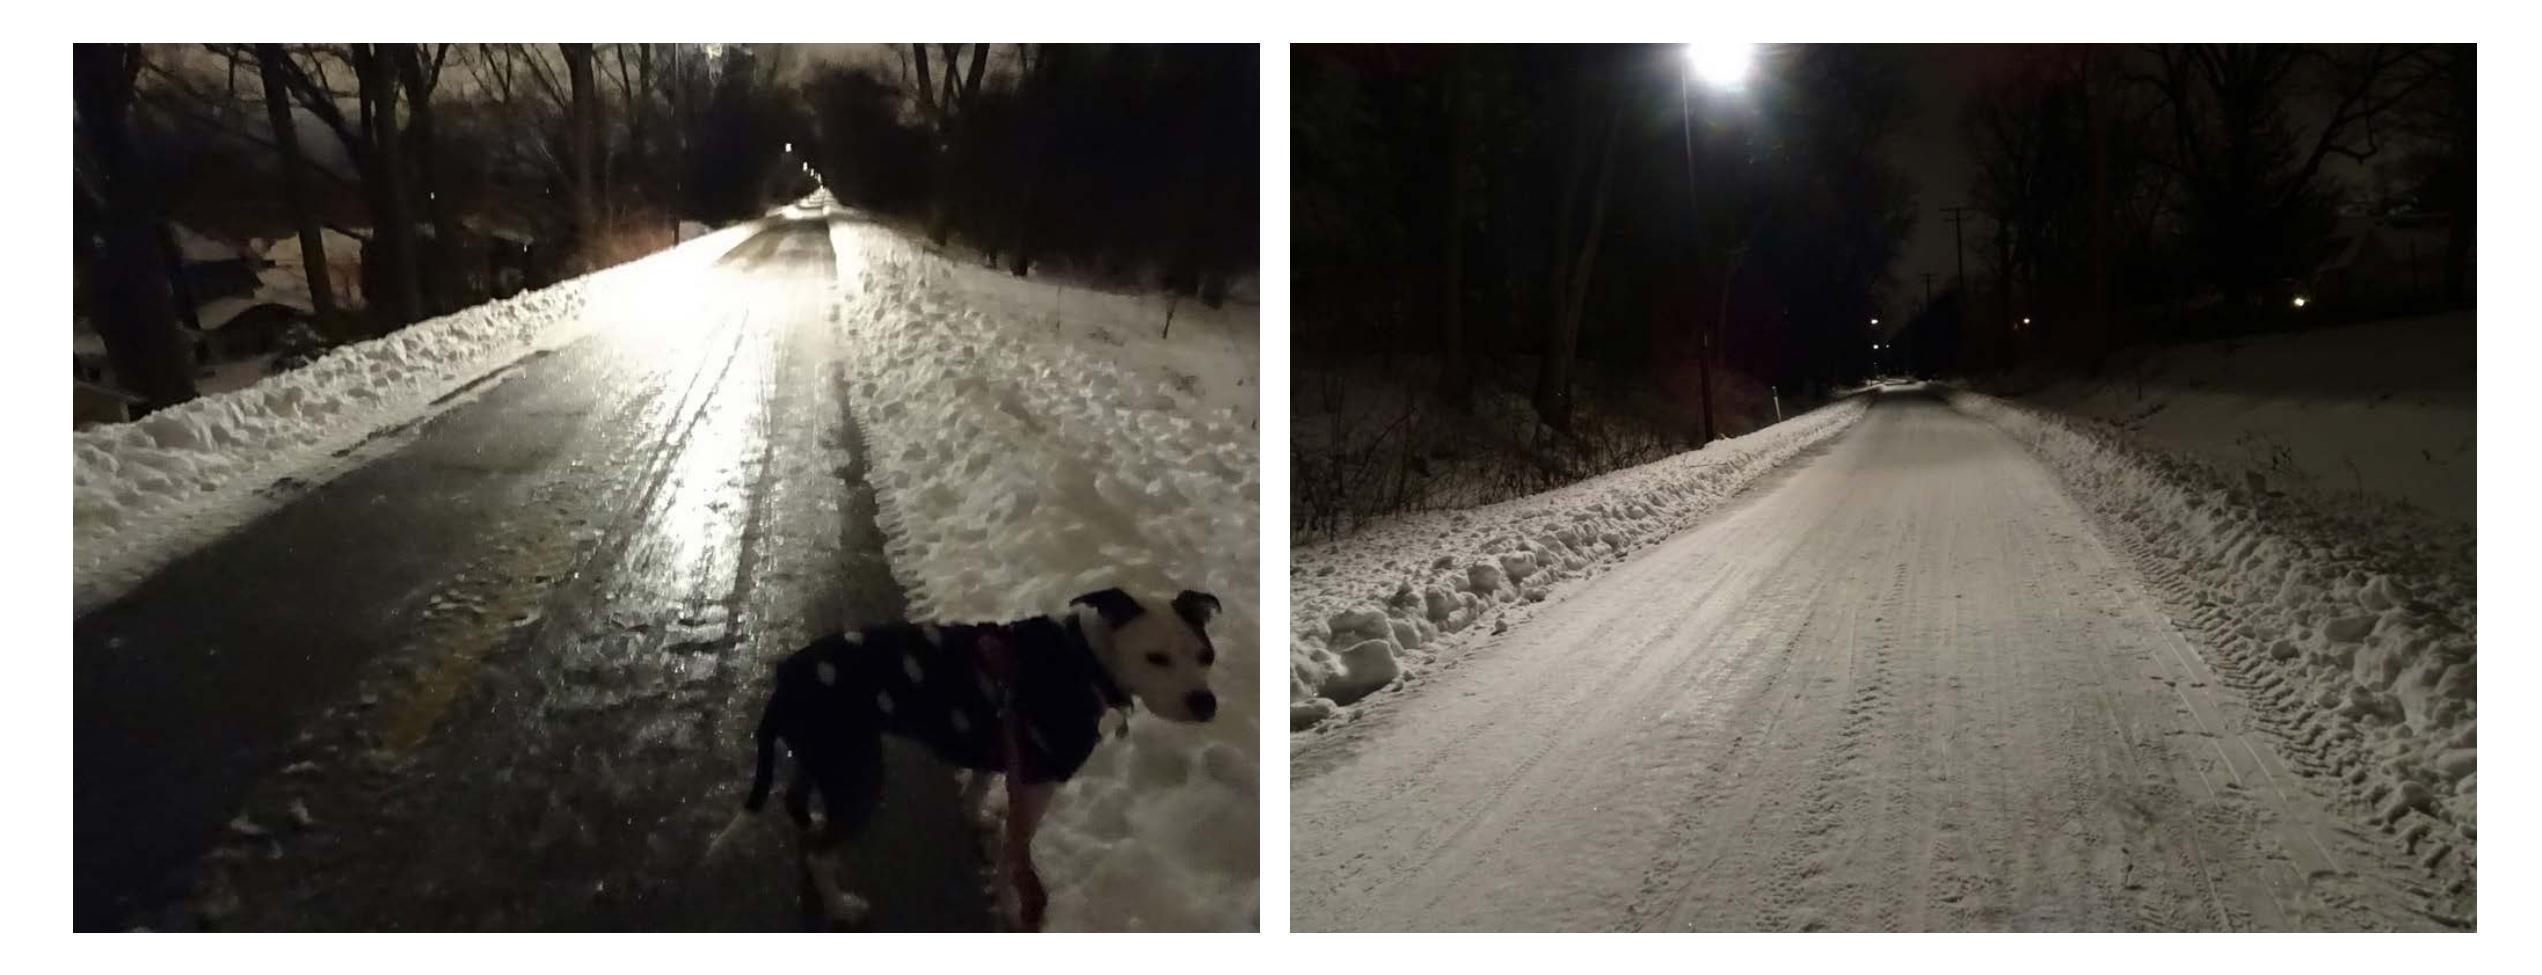
Brine treated vs. untreated sections after one day:

Brine treated section: Barely passable with glare ice and corrosive slush Untreated section: Safe surface for walking, running biking

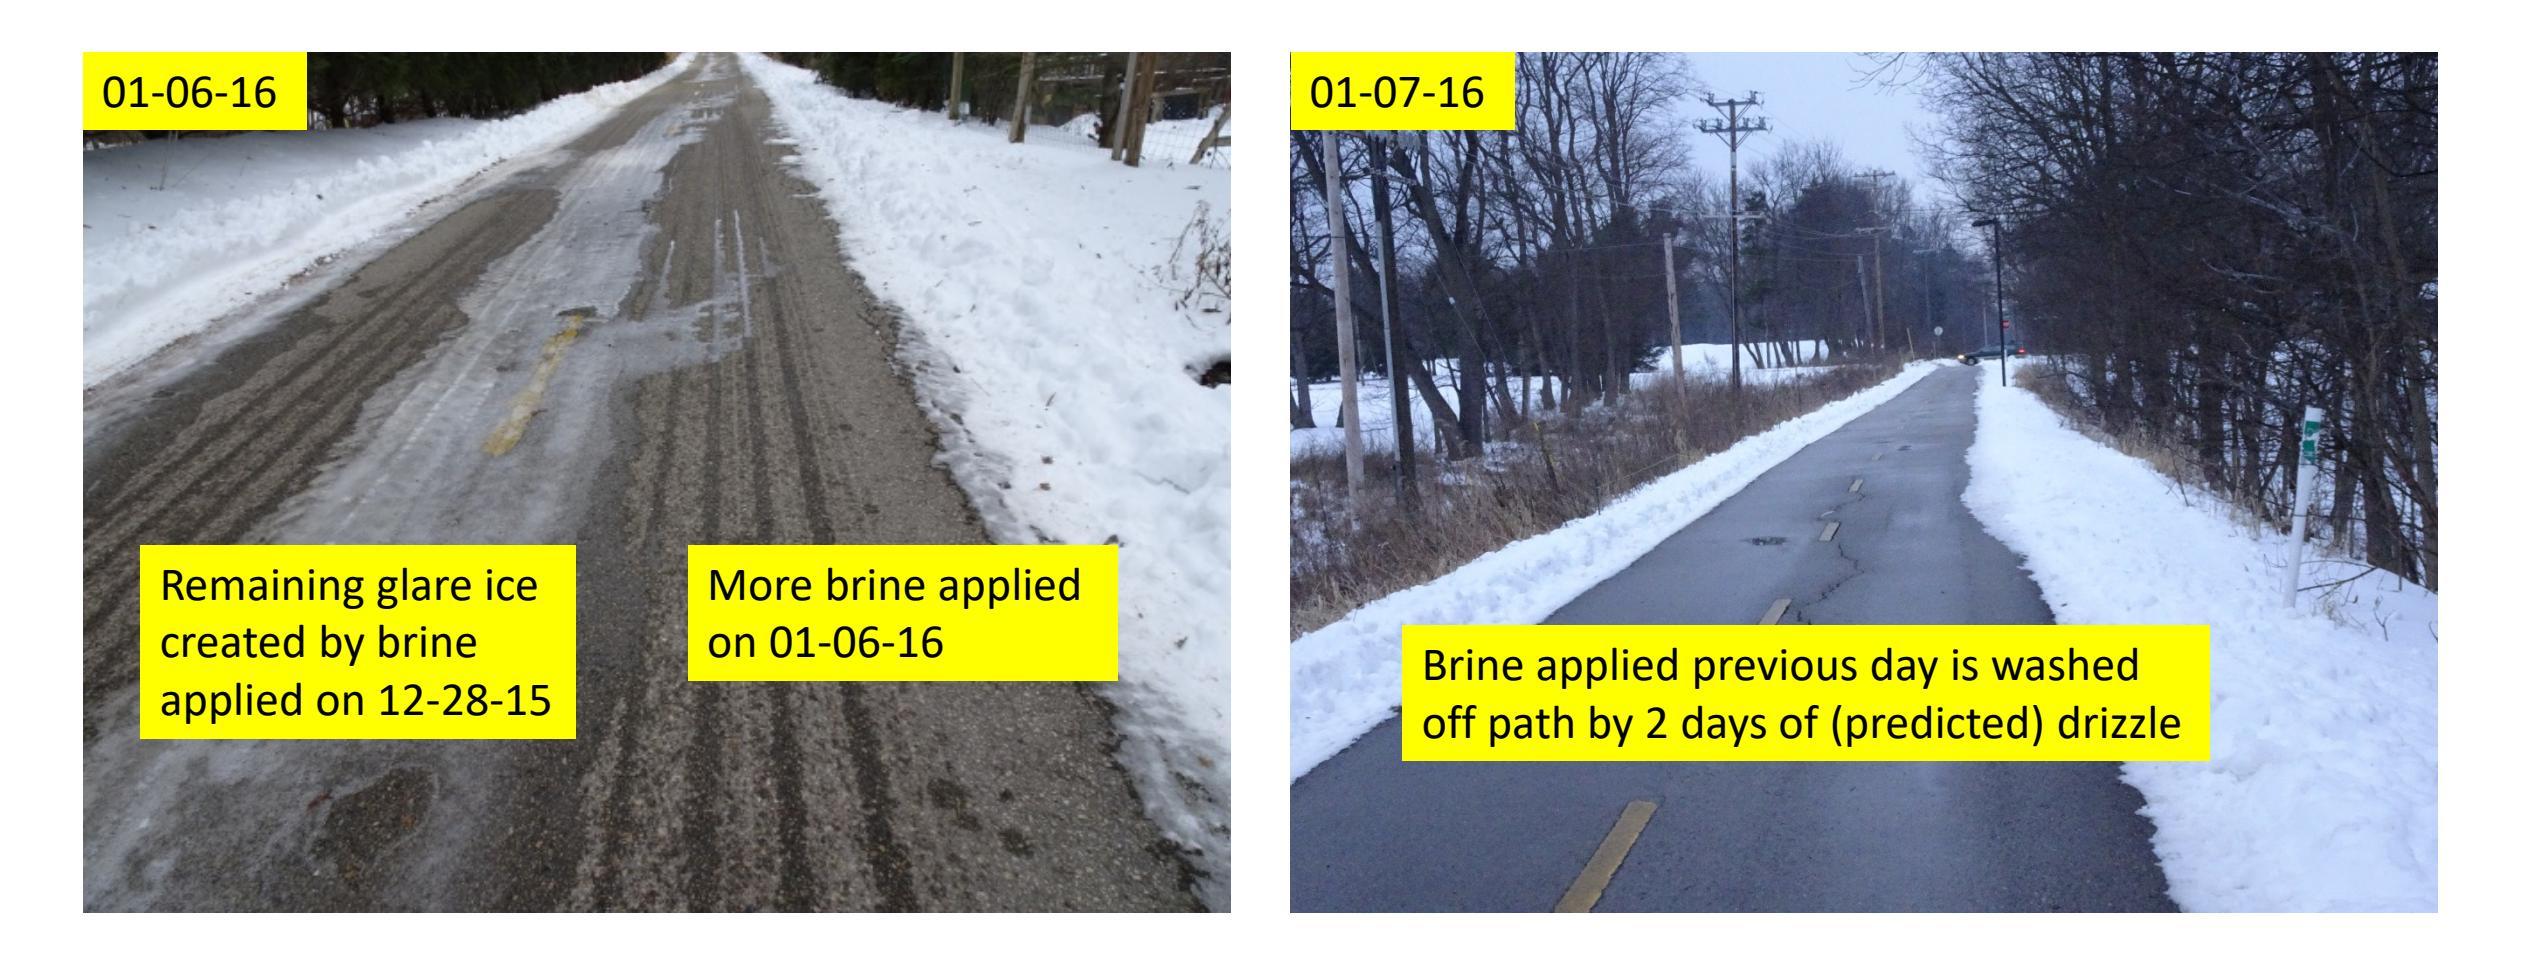
Brine use creates ice and poisons greenspace

Even if brine was somehow effective, its use in a greenspace is not justifiable when traction agents like course sand or organic matter can be used instead.

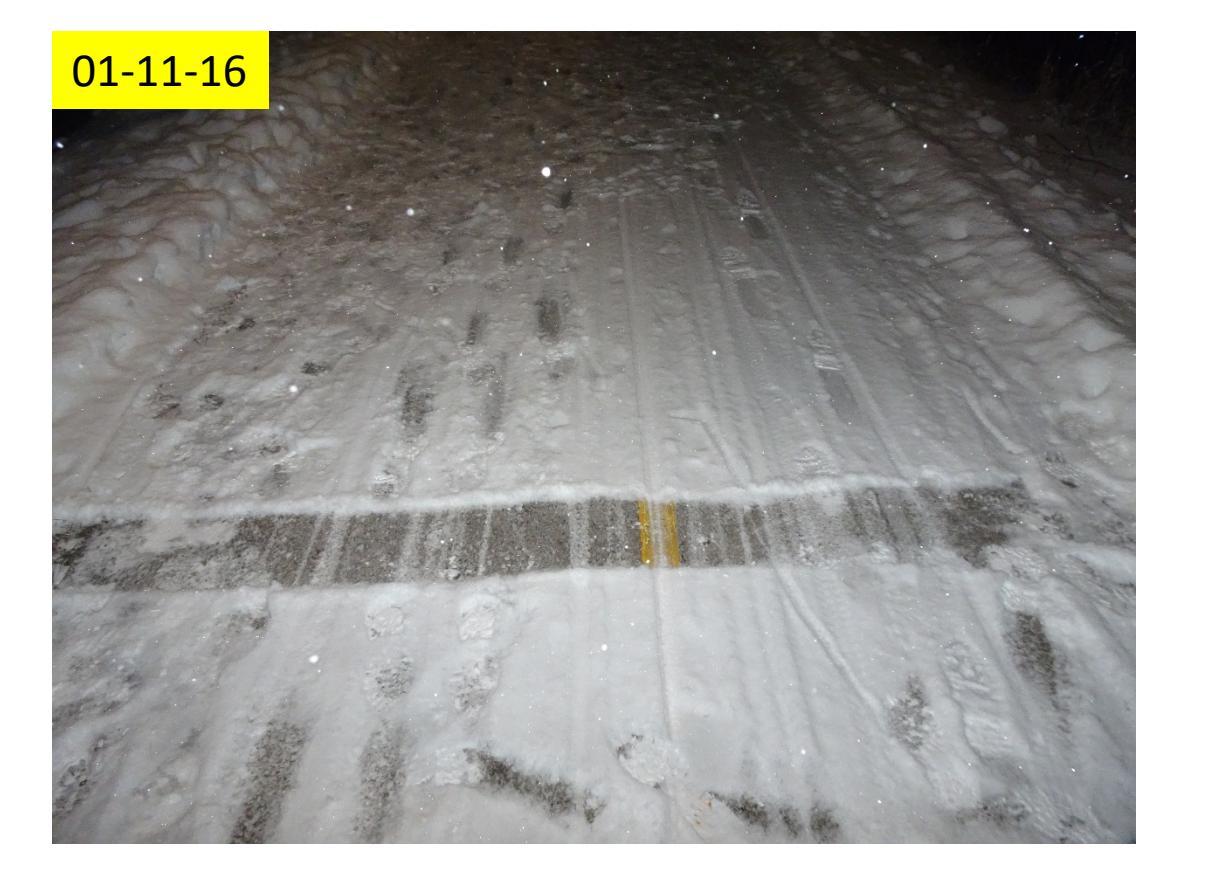
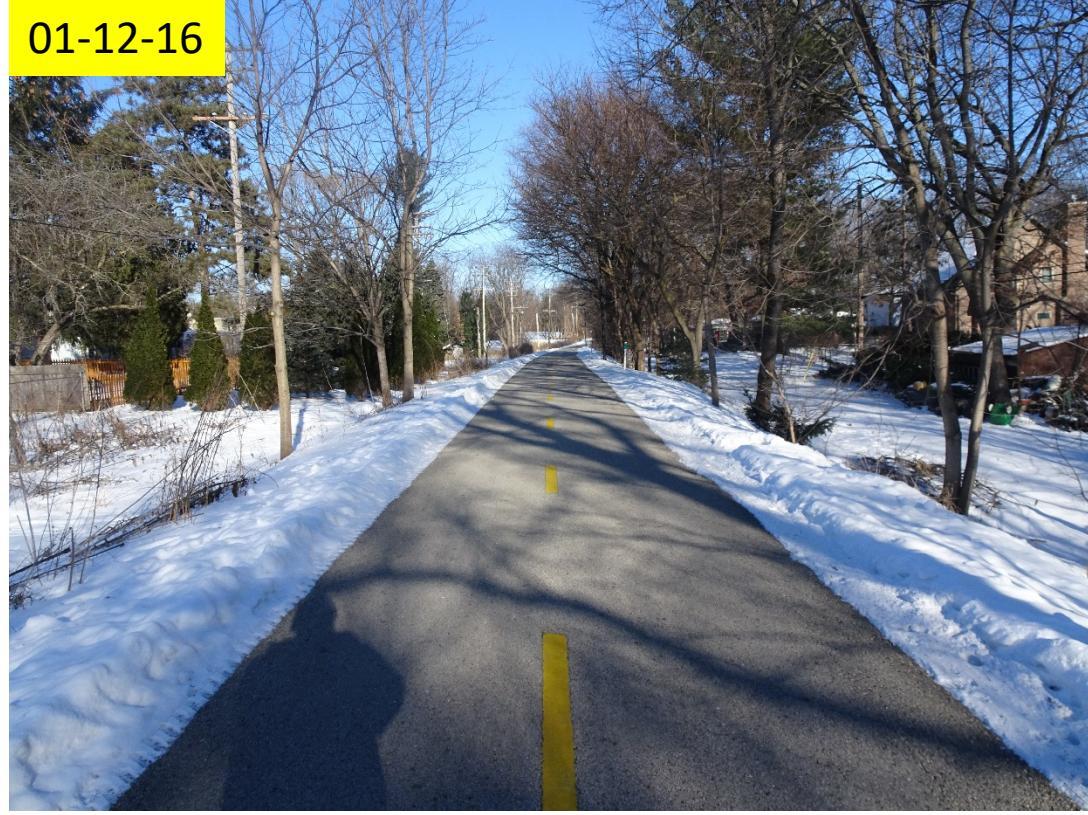
New brush works great without using brine

Same location on path after brushing with NO BRINE USED Excellent results achieved by "brush only" on 02-15-16, 03-01-16 and other dates.

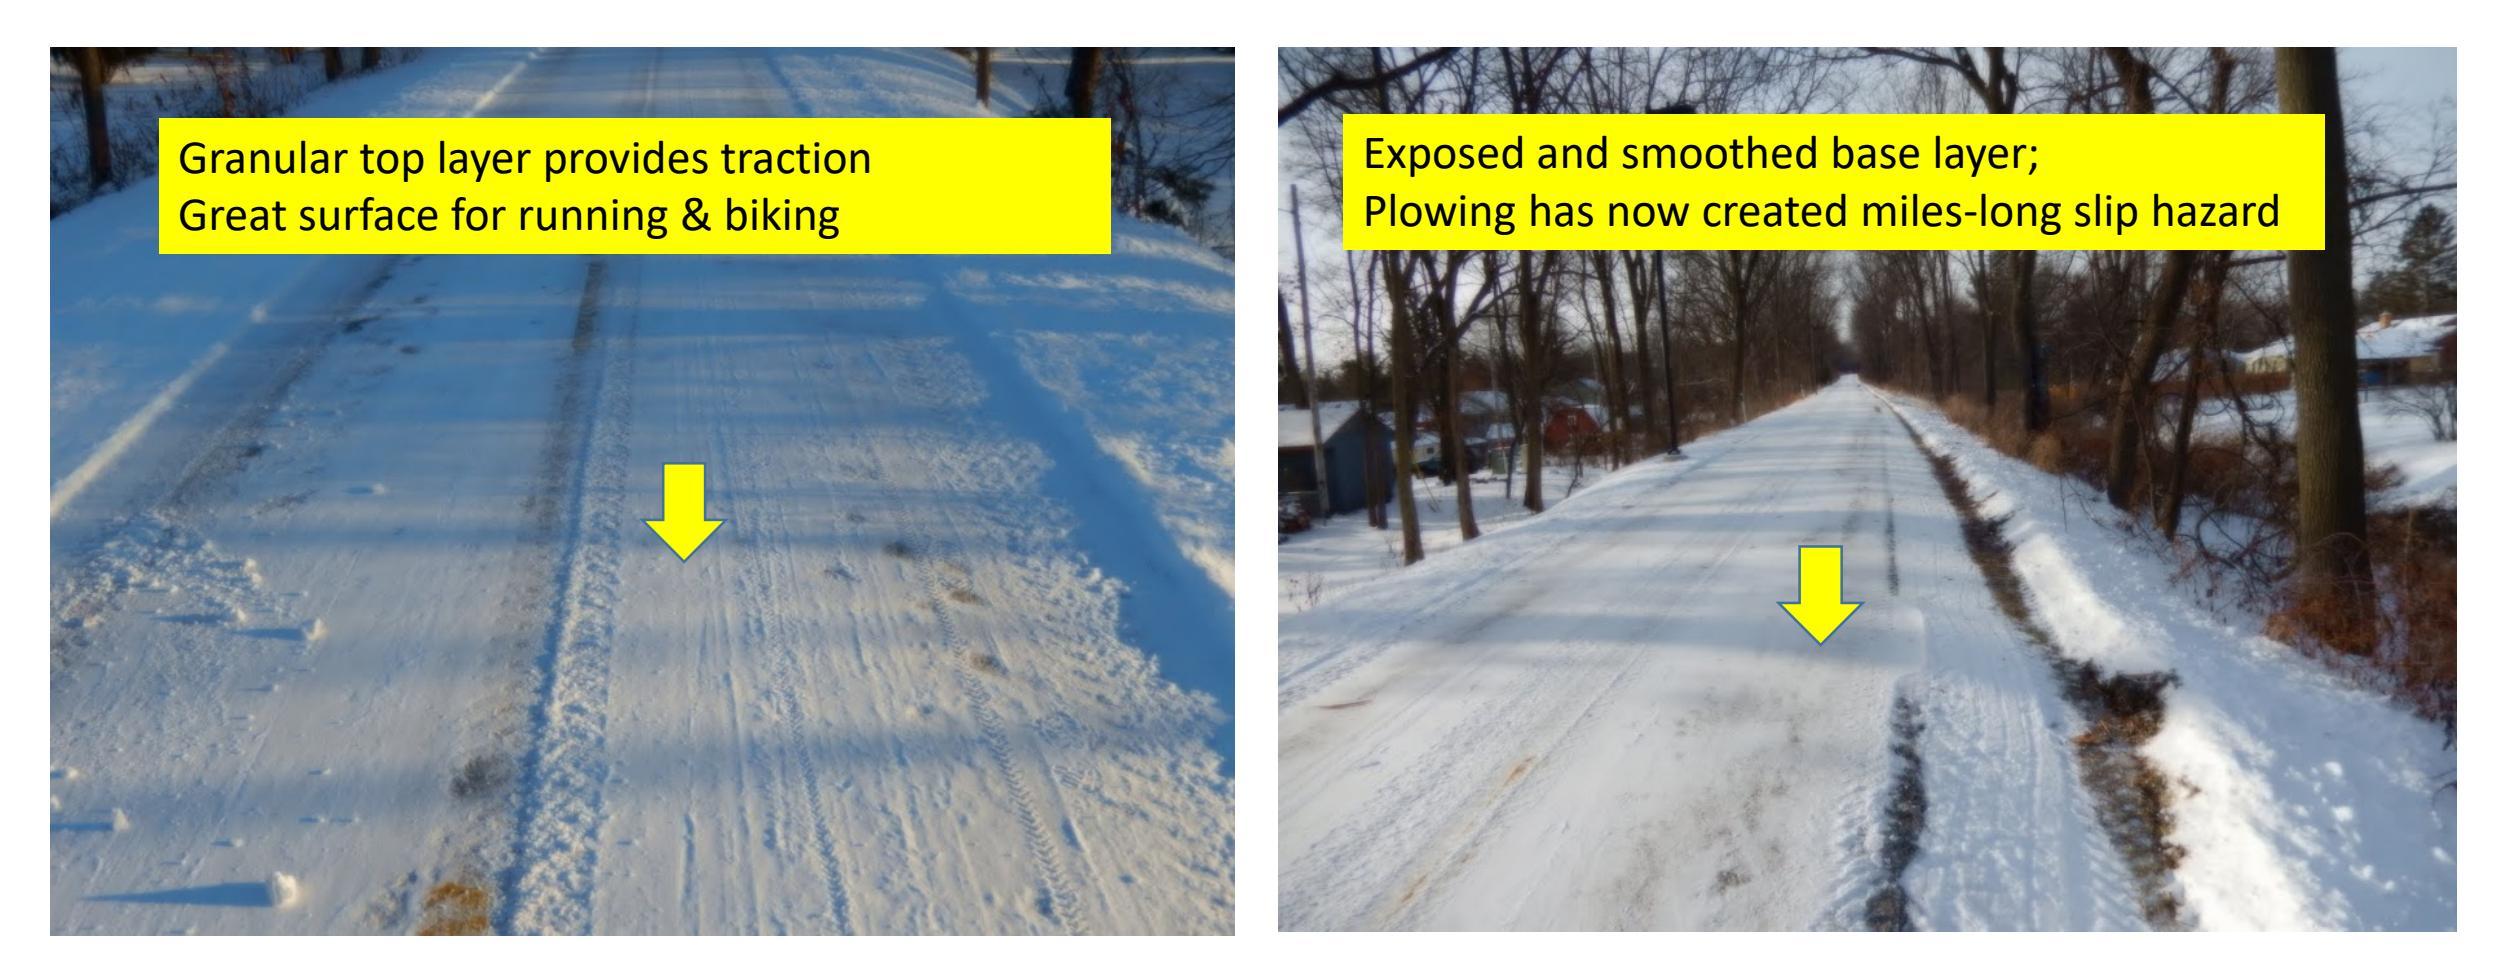
Overplowing: Stripping top fluff converts ideal surface to "unsafe"

Photos taken 10 minutes apart; before and after a "scraping" plow pass When base layer exists, grooming is preferable to trying to scrape down to pavement

Slip hazard created by over-plowing (Zamboni effect)

Bare pavement is never achieved scraping with plow anyways.

- Use brush for lighter snows and minimize vehicle travel on path
- Plow only after substantial accumulation instead of every small flurry
- Abandon unrealistic and unnecessary goal of "bare pavement"
- Raise blade off surface (set skid shoes) when plowing; groom granular top layer

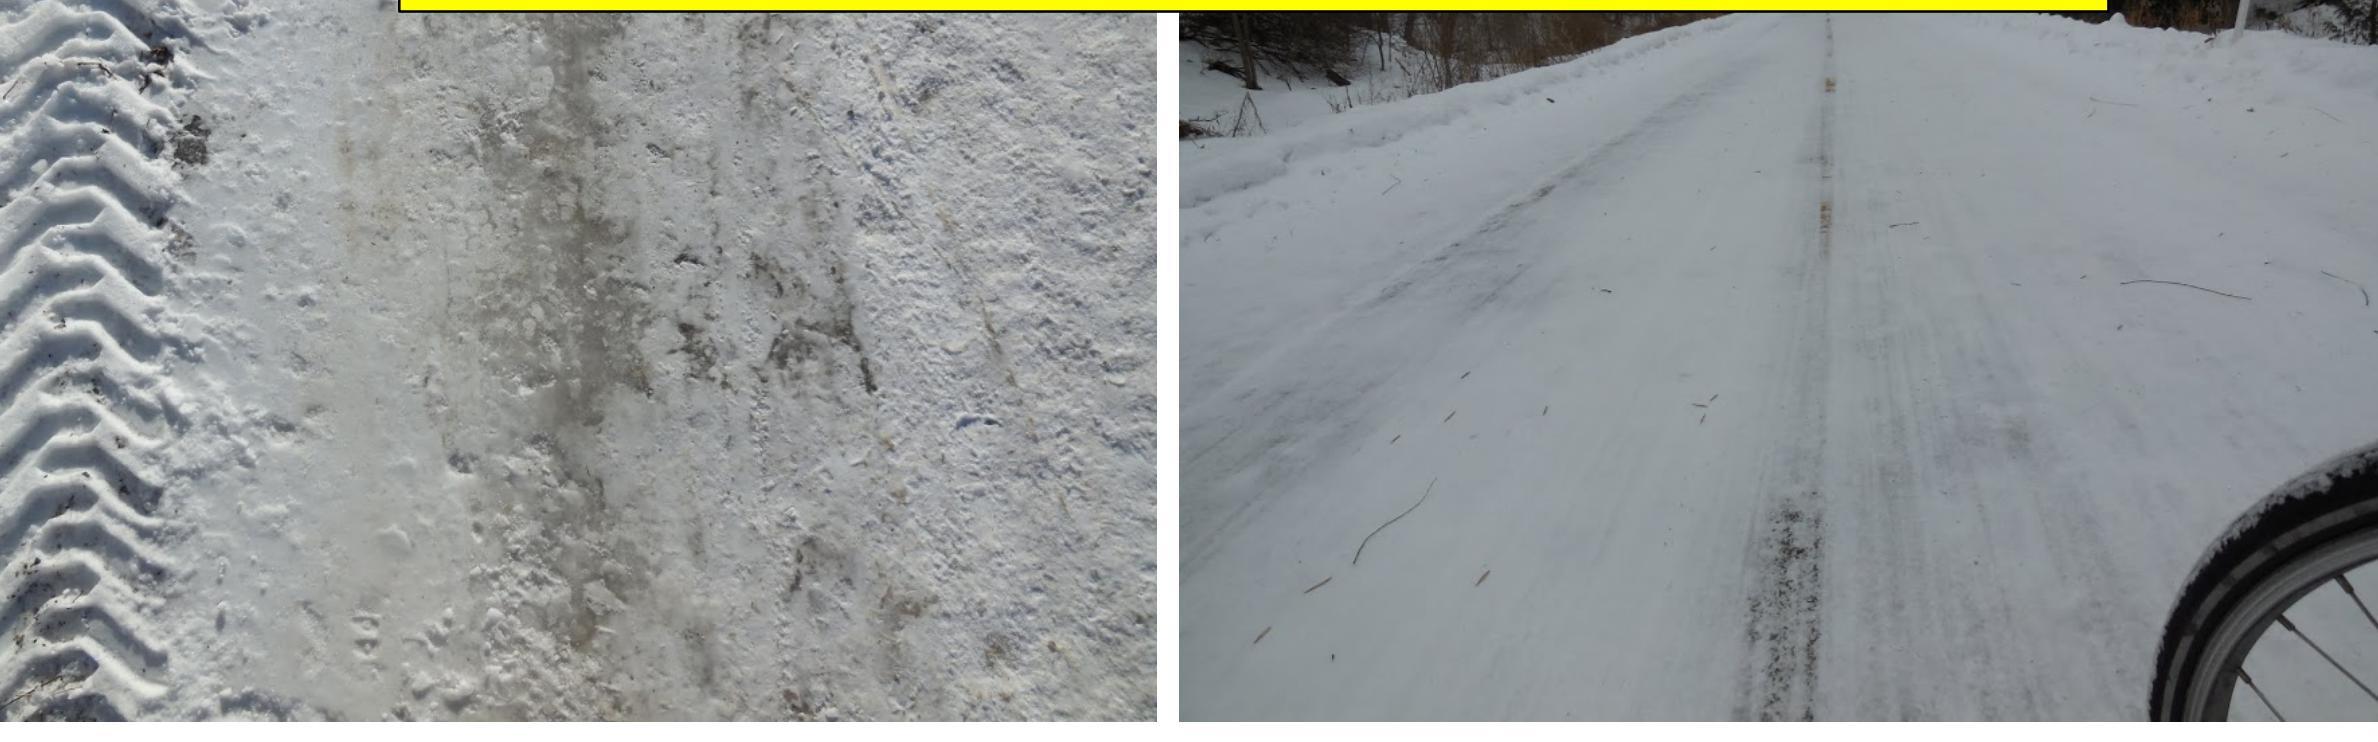
Slip hazard from flooding and re-freeze

- **Brine** will not prevent this!
- Sand can help after formation
- **Prevent** by removing slush during thaw cycles

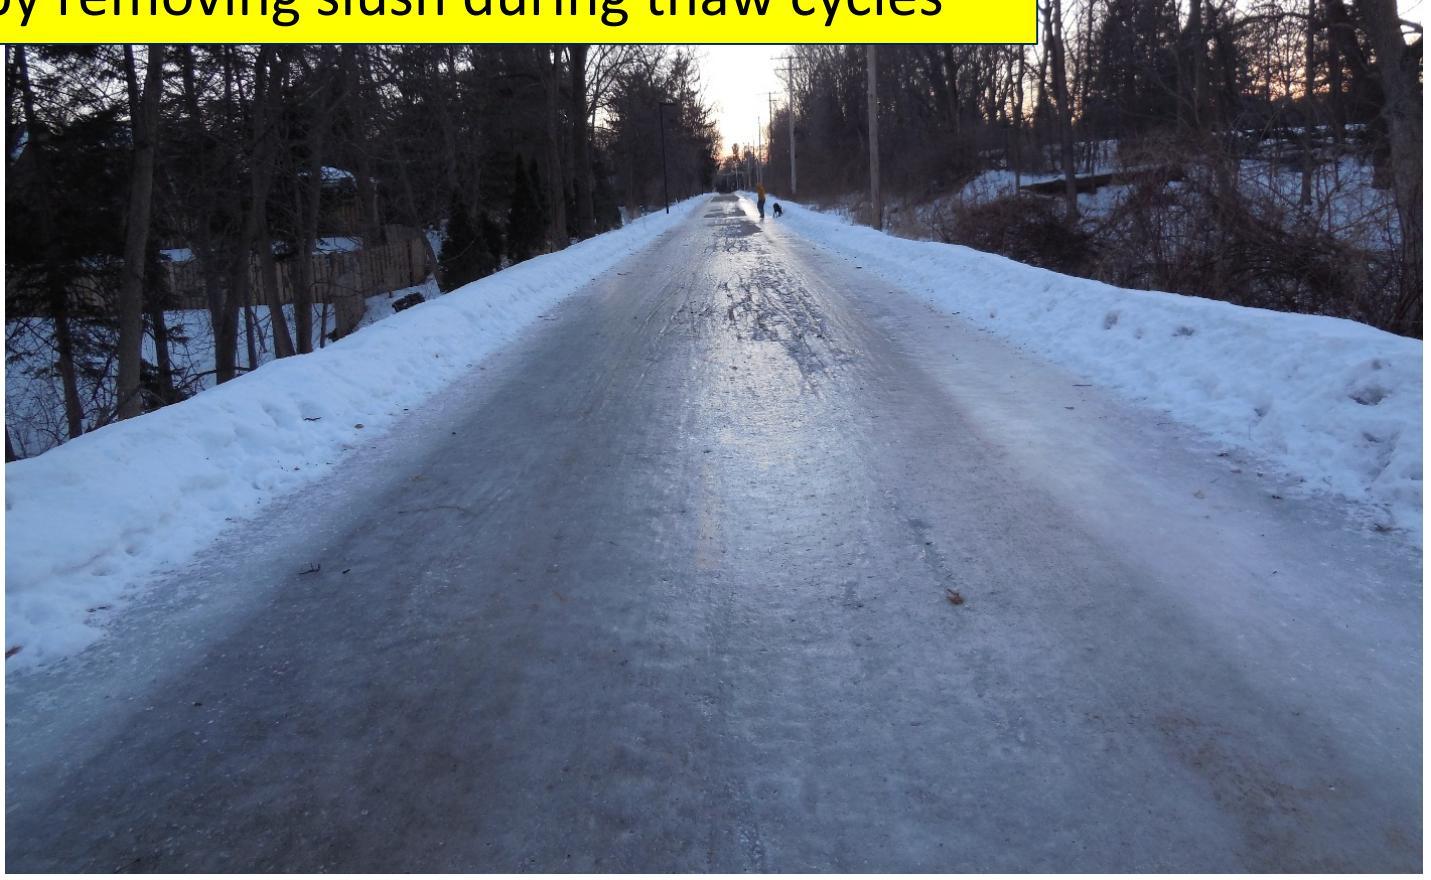
Possible tweaks to EQUIPMENT

- Use rotary brush to clean to bare pavement when feasible
- Leave groomed surface behind whenever plowing is done
 - 1) Use skid shoes to raise blade ~ ¼" ½" to retain some fluff, and/or
 - 2) Try grooming granular surface layer with drag bar or chain loop

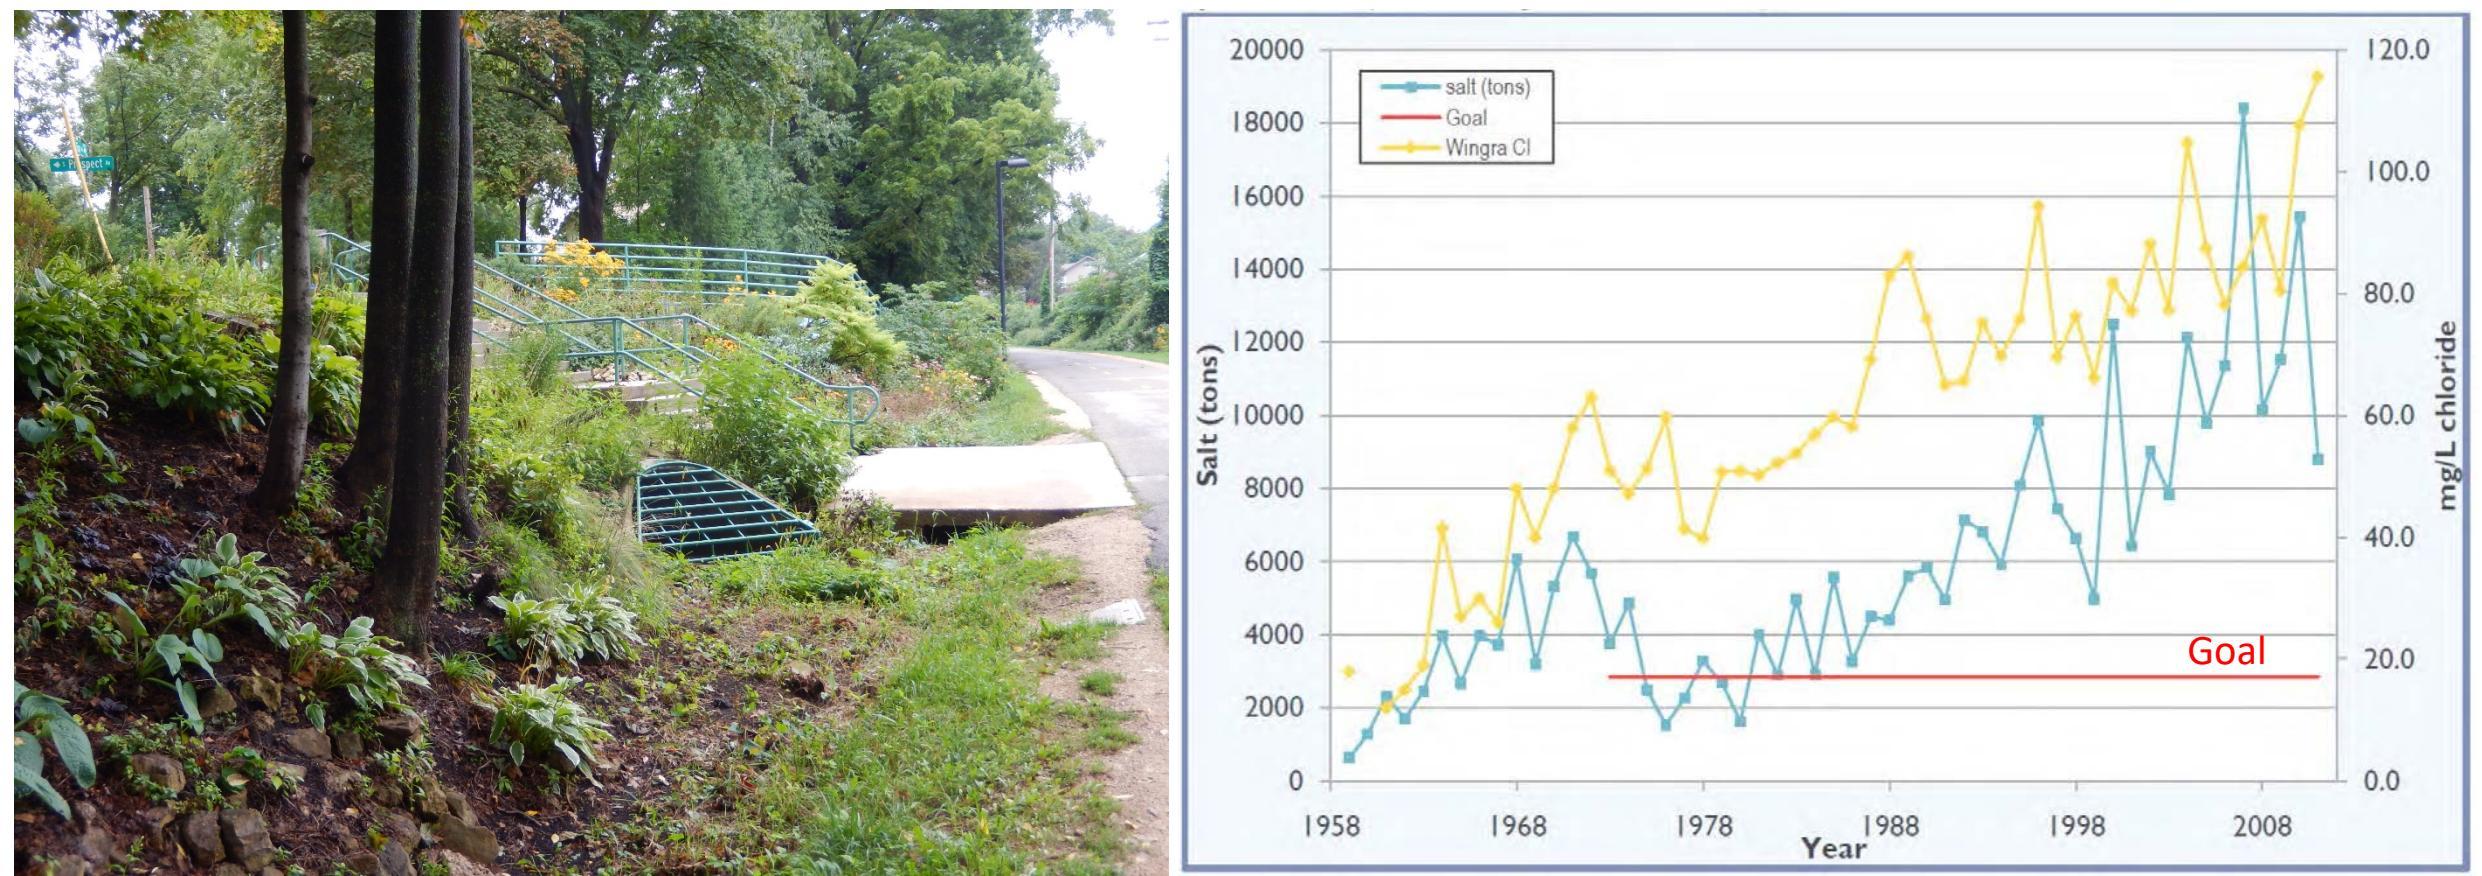
Thaws send salt brine plumes with acute toxicity into Wingra Brine applications also contribute to near-toxic levels of cumulative chloride

One of the many drains which line the path (These flow downhill directly into Lake Wingra)
