Building Condition Report

4316 Monona Drive, Madison WI
4217 Jerome Street, Madison WI
4221 Jerome Street, Madison WI

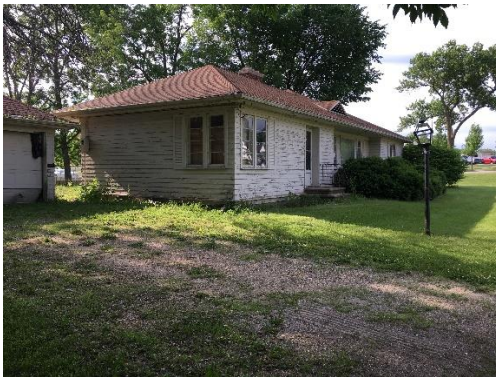
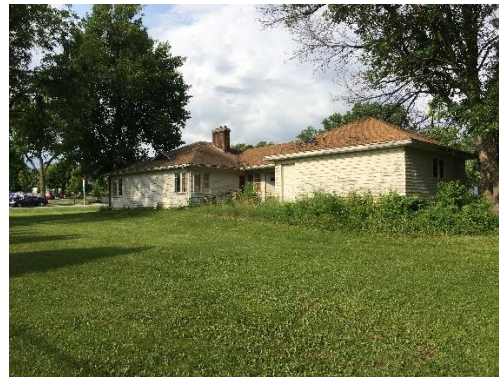
4316 Monona Drive

It is a wood framed building on a cast-in-place concrete foundation with full basement. Wood siding and casement windows appear to be original. There is a gravel driveway that is overgrown with weeds. While the building appears to be basically sound structurally, it has significant condition issues.

The roof shingles are completely deteriorated. The paint on the wood siding is peeling heavily and the storm gutters, while intact, have plants growing in them. An environmental survey has concluded that asbestos is present in widow glazing and flooring materials.

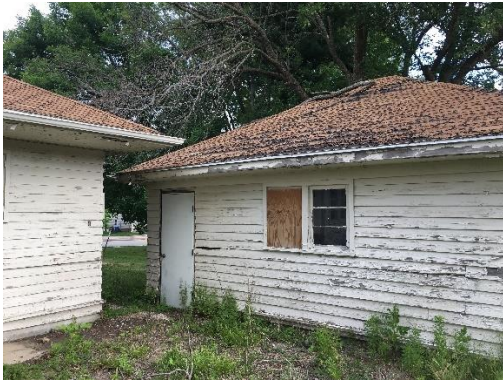
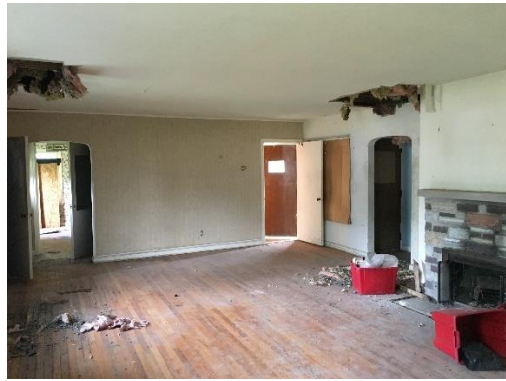
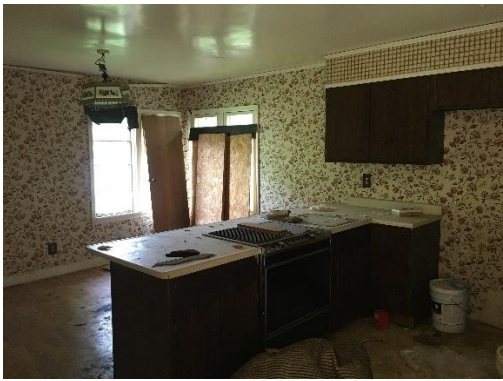
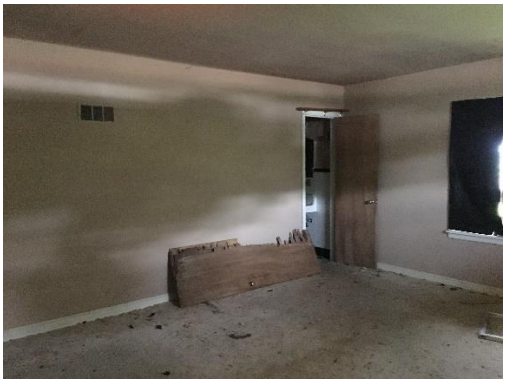
The interior of the building is not habitable and has suffered damage. There are numerous holes in the walls and ceilings, and most interior doors are missing or non-functional. Heating and main electrical equipment are obsolete. Because the utilities have been disconnected, equipment could not be tested to determine whether they are operational. In its present condition, the house is in need of a complete rehabilitation, remodeling and refurbishment. This includes siding, windows, roofing, HVAC, insulation, bathrooms, kitchen and finishes.
