Chapter 18: Lead-Based Paint and Historic Preservation

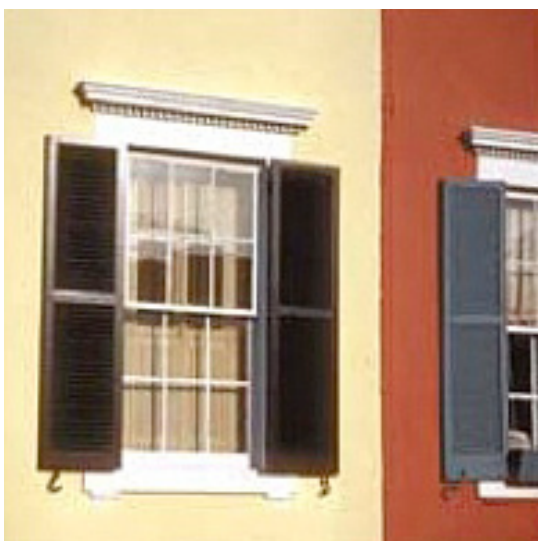
FIGURE 18.1 Delicate muntins and multi-pane sash on early 19th century row houses. Photo Courtesy National Park Service.

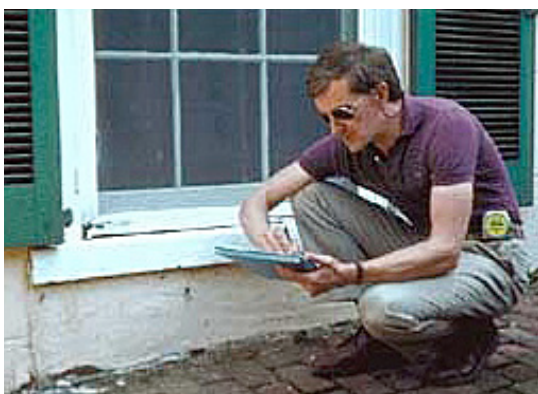
FIGURE 18.2 Historic properties should have a window condition assessment preceding work. Photo Courtesy National Park Service.

Identifying, retaining, and preserving windows – and their functional and decorative features – is an important step in preserving the overall historic character of the building. Such features can include frames, sash, muntins, glazing, sills, heads, hoodmolds, paneled or decorated jambs and moldings, and interior and exterior shutters and blinds. An in-depth survey of the interior and exterior features and condition of existing windows will provide the basis for evaluating possible rehabilitation or replacement options to make the windows lead-safe. The exterior portion of a window assessment is shown in Figure 18.2.

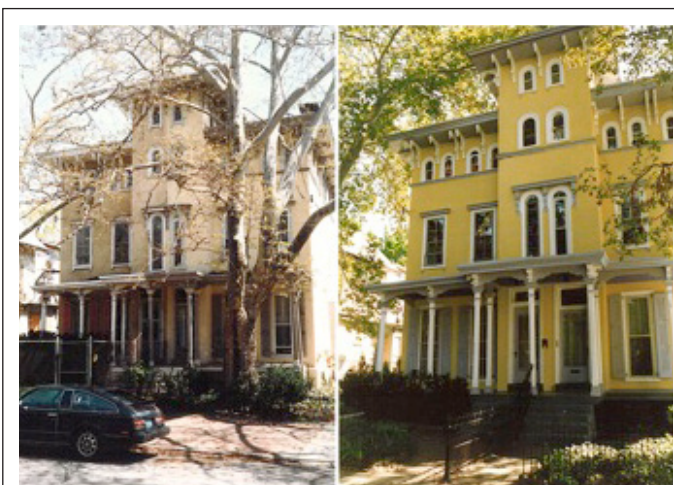
FIGURES 18.3a and 18.3b

Historic property before and after rehabilitation.

The significance of historic elements also affects priorities for intervention. (Figure 18.3.) Historic components should be treated with great care when physical intervention is considered as part of a lead hazard control plan. If the element is extremely significant (e.g., a carved mantel) and is in good condition, it should be disturbed as little as possible while still ensuring that lead hazards will be controlled. In this case interim controls are generally preferred (see Chapter 11). If the element is not particularly significant (e.g., a simple baseboard) and is in poor condition, then it may be acceptable to remove the entire feature and replace it with a duplicate or similar baseboard. If the element is significant, but in deteriorated condition, then preservation measures should ensure that in the process of rebuilding or repairing the element, it is not further damaged. Careful paint removal and thorough cleaning of substrates is very time consuming, but may be appropriate for highly significant elements.

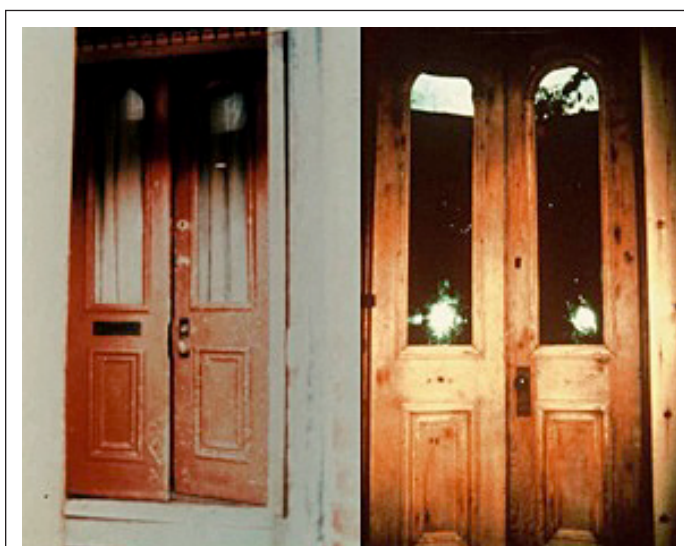
FIGURE 18.5a and 18.5b

Doors to historic property before and after off-site stripping.

Off-Site: A potentially more damaging paint removal treatment involves the removal of items for off-site stripping. Only companies experienced in treating historic building parts should be used to conduct paint stripping. If the items are easily removed (e.g., doors, shutters, or windows), they can be carefully treated off-site and then reinstalled. (See Figure 18.5). Caution is advised when considering this method because trim, mantels, banisters, newel posts, or other carved elements constructed in sections may be firmly attached and may be damaged when removed, thus requiring repair or reconstruction. Hardware should be removed and labeled before paint is removed.

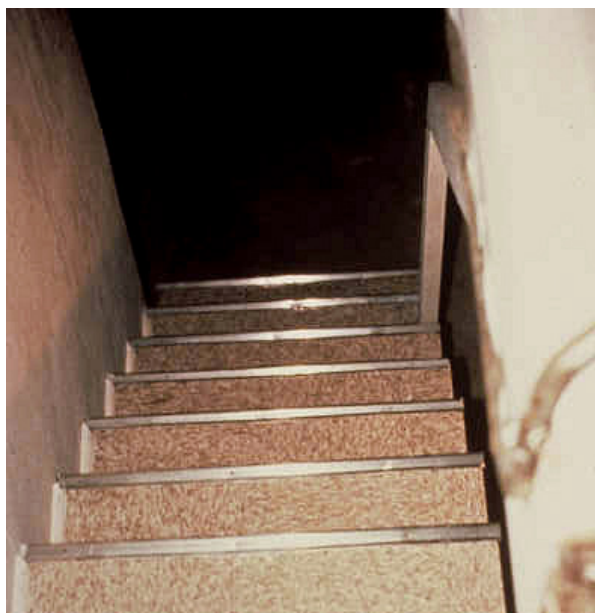
FIGURE 18.6 Enclosure of stairs in this manner is generally not appropriate in a historic property.

Enclosing a decorative feature may be appropriate if doing so does not damage the structure beyond a minimal amount (see Figure 18.6). For example, a projecting mantel might be enclosed if the fireplace is not to be used in the interim, and the decorative finishes are to be enclosed behind drywall finishes. While this is a serious loss of historic character, if it is a temporary solution and no harm is done to the feature, it might be an appropriate treatment. The use of artificial siding over painted and otherwise sound historic exteriors often results in a removal of projecting historic elements, such as roof brackets, and conceals the historic trim. The use of these artificial sidings is not recommended.
