UW-Madison University Club Advance Planning Study

May 26, 2022

INTRODUCTION

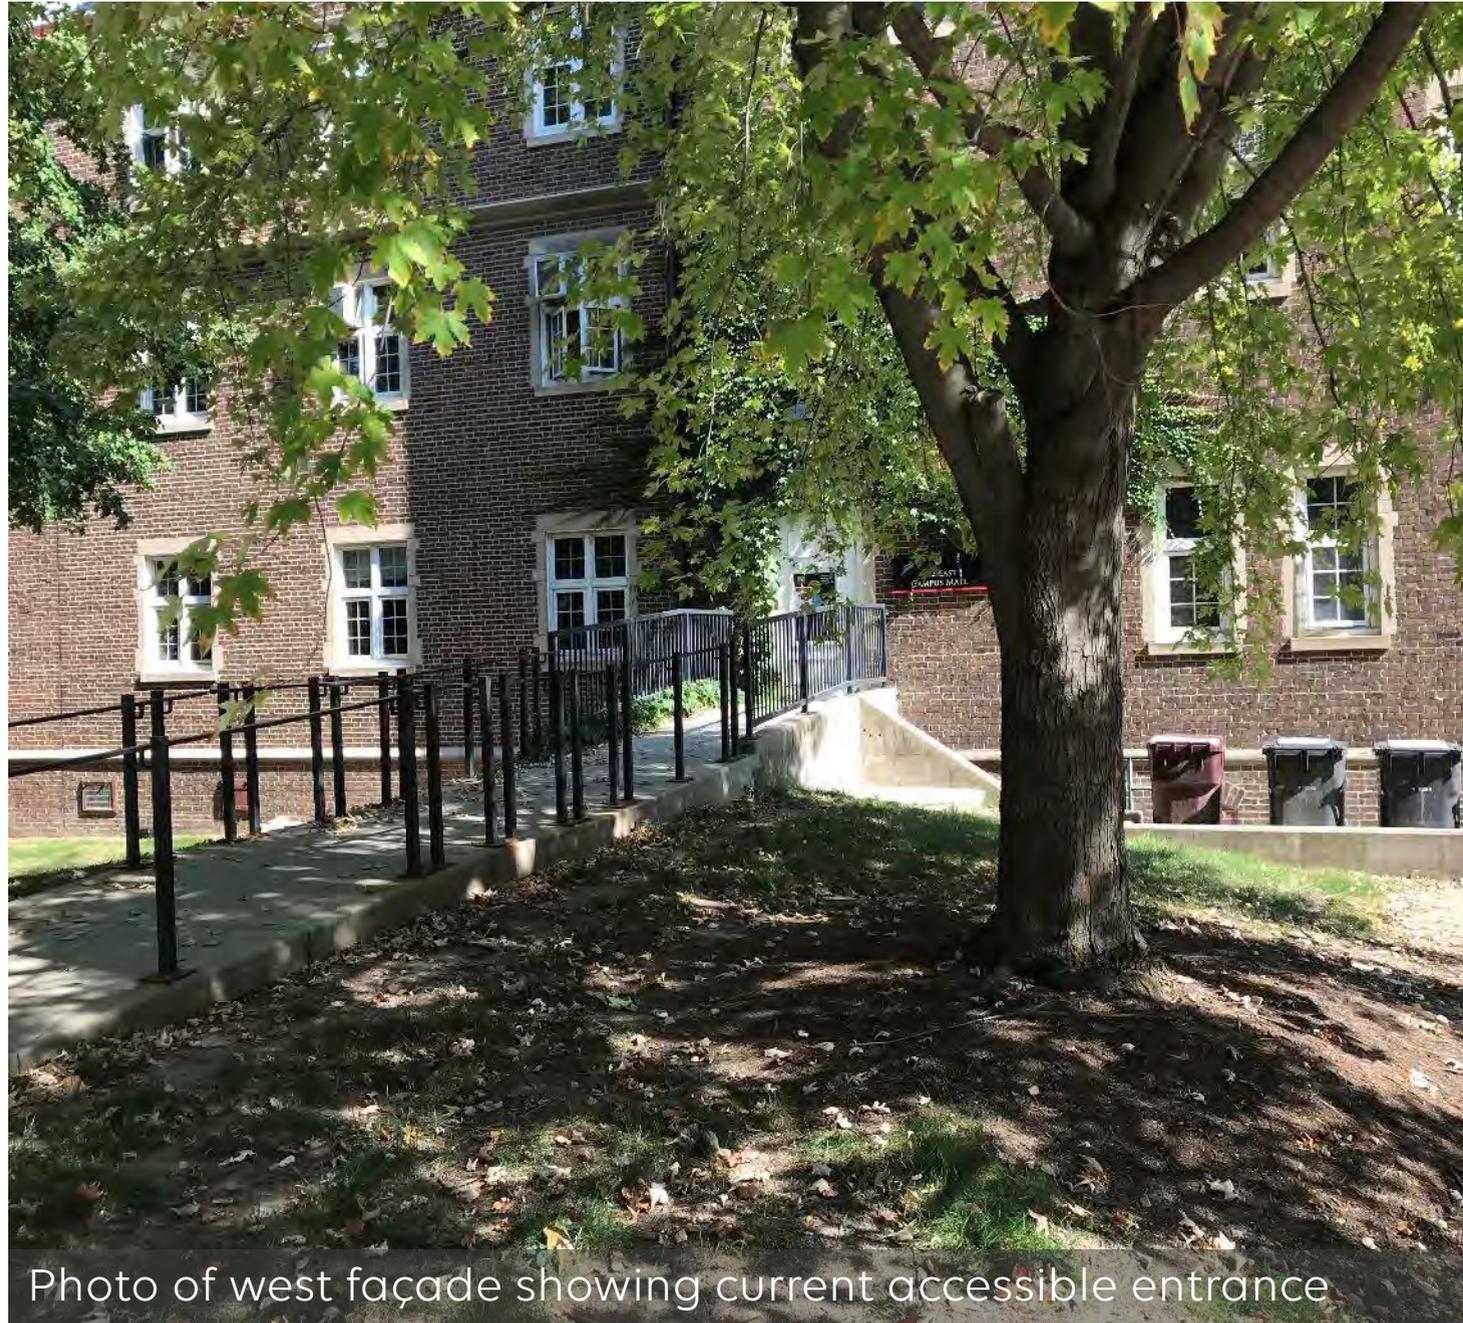
Photo of west façade showing current accessible entrance

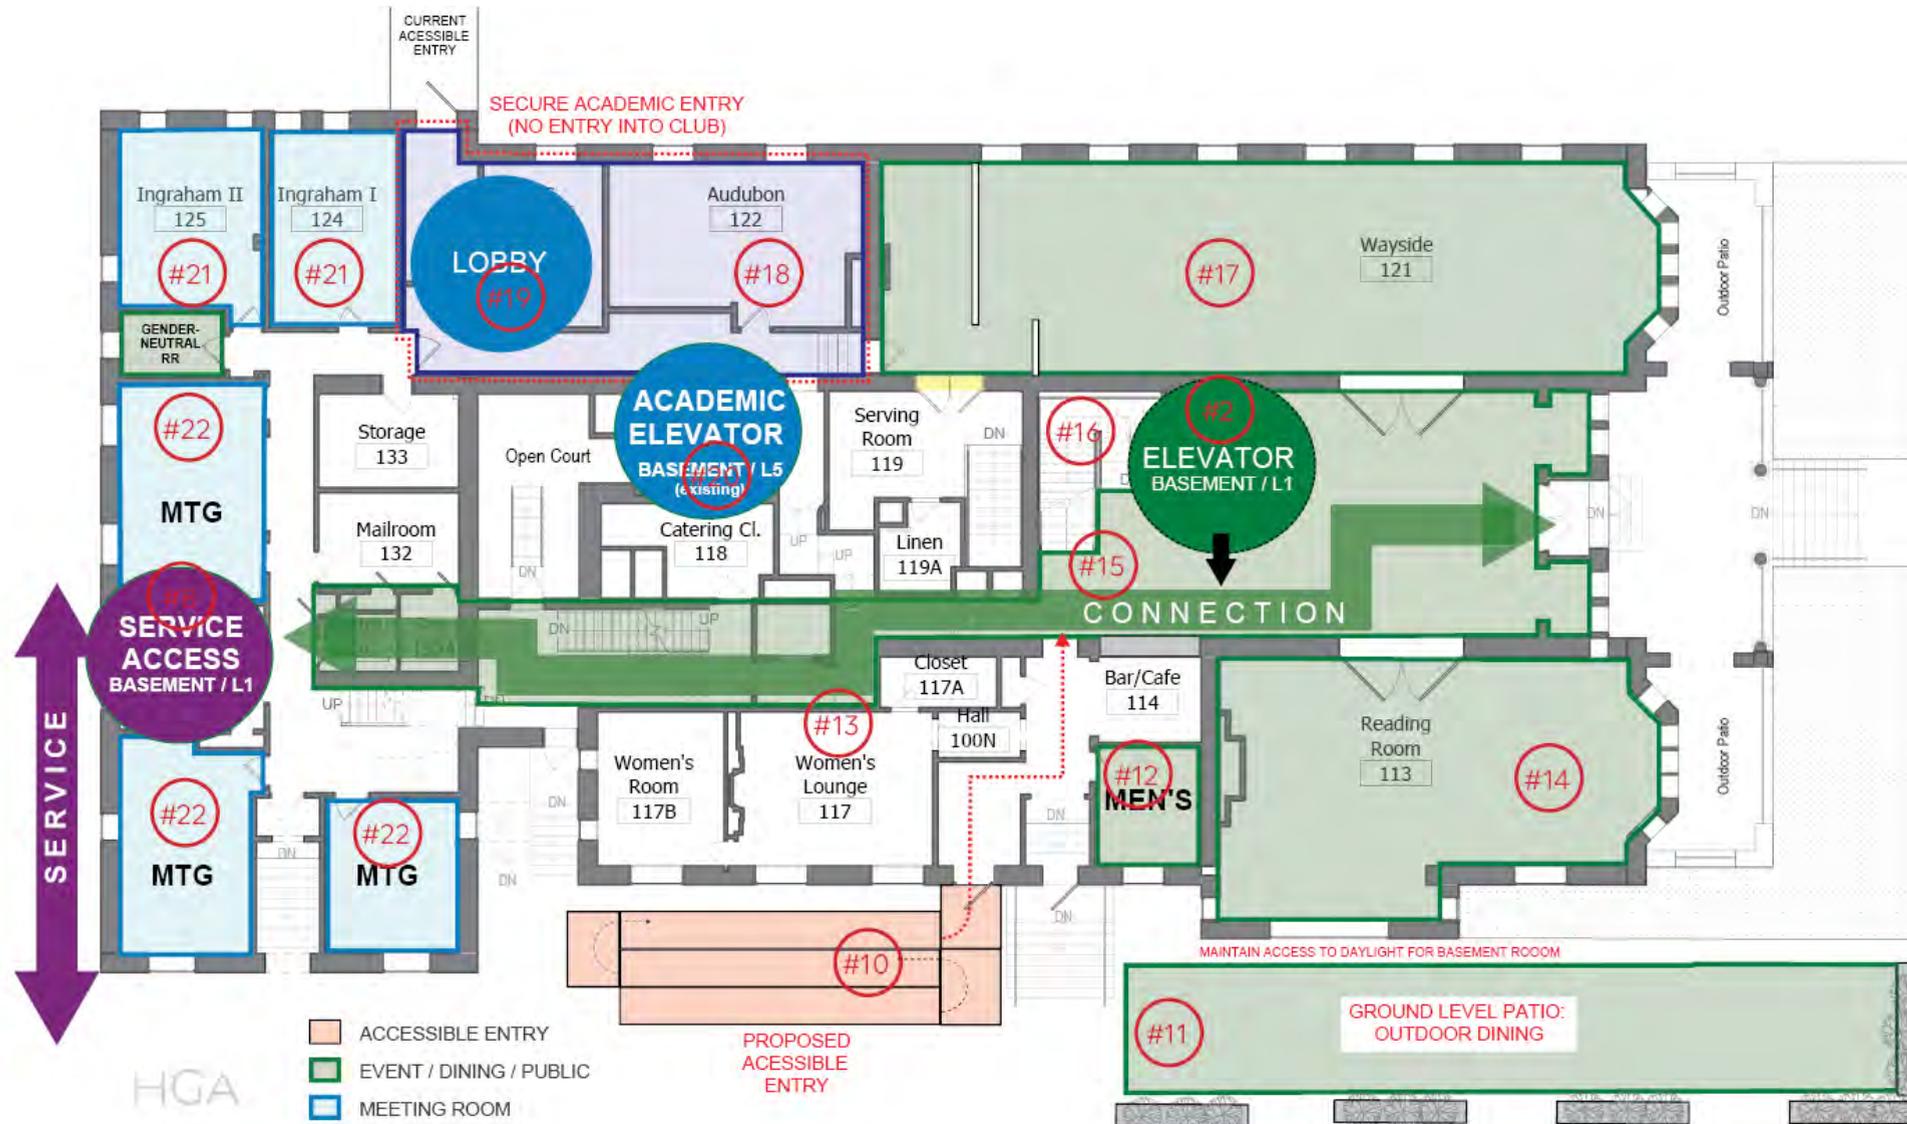
KEY PLAN FOR MAJOR WORK AREAS

10. New Accessible Entry Ramp to Level 1
11. New Patio Seating Area
12. New Men's Restroom on Level 1
13. Women's Lounge/ Restroom receives new finishes
14. Reading Room receives new finishes
15. New major corridor is created to Meeting Rooms
16. Existing Stairs from above retrofitted w/ access control to restrict cross traffic
17. Wayside Room receives new finishes
- 18-20. Area converted to entry/ reception/ meeting room for academic use only.
21. Elevator controls modified to access 1-4
22. Renovated Meeting Room / Office Space Converted to Meeting Rooms

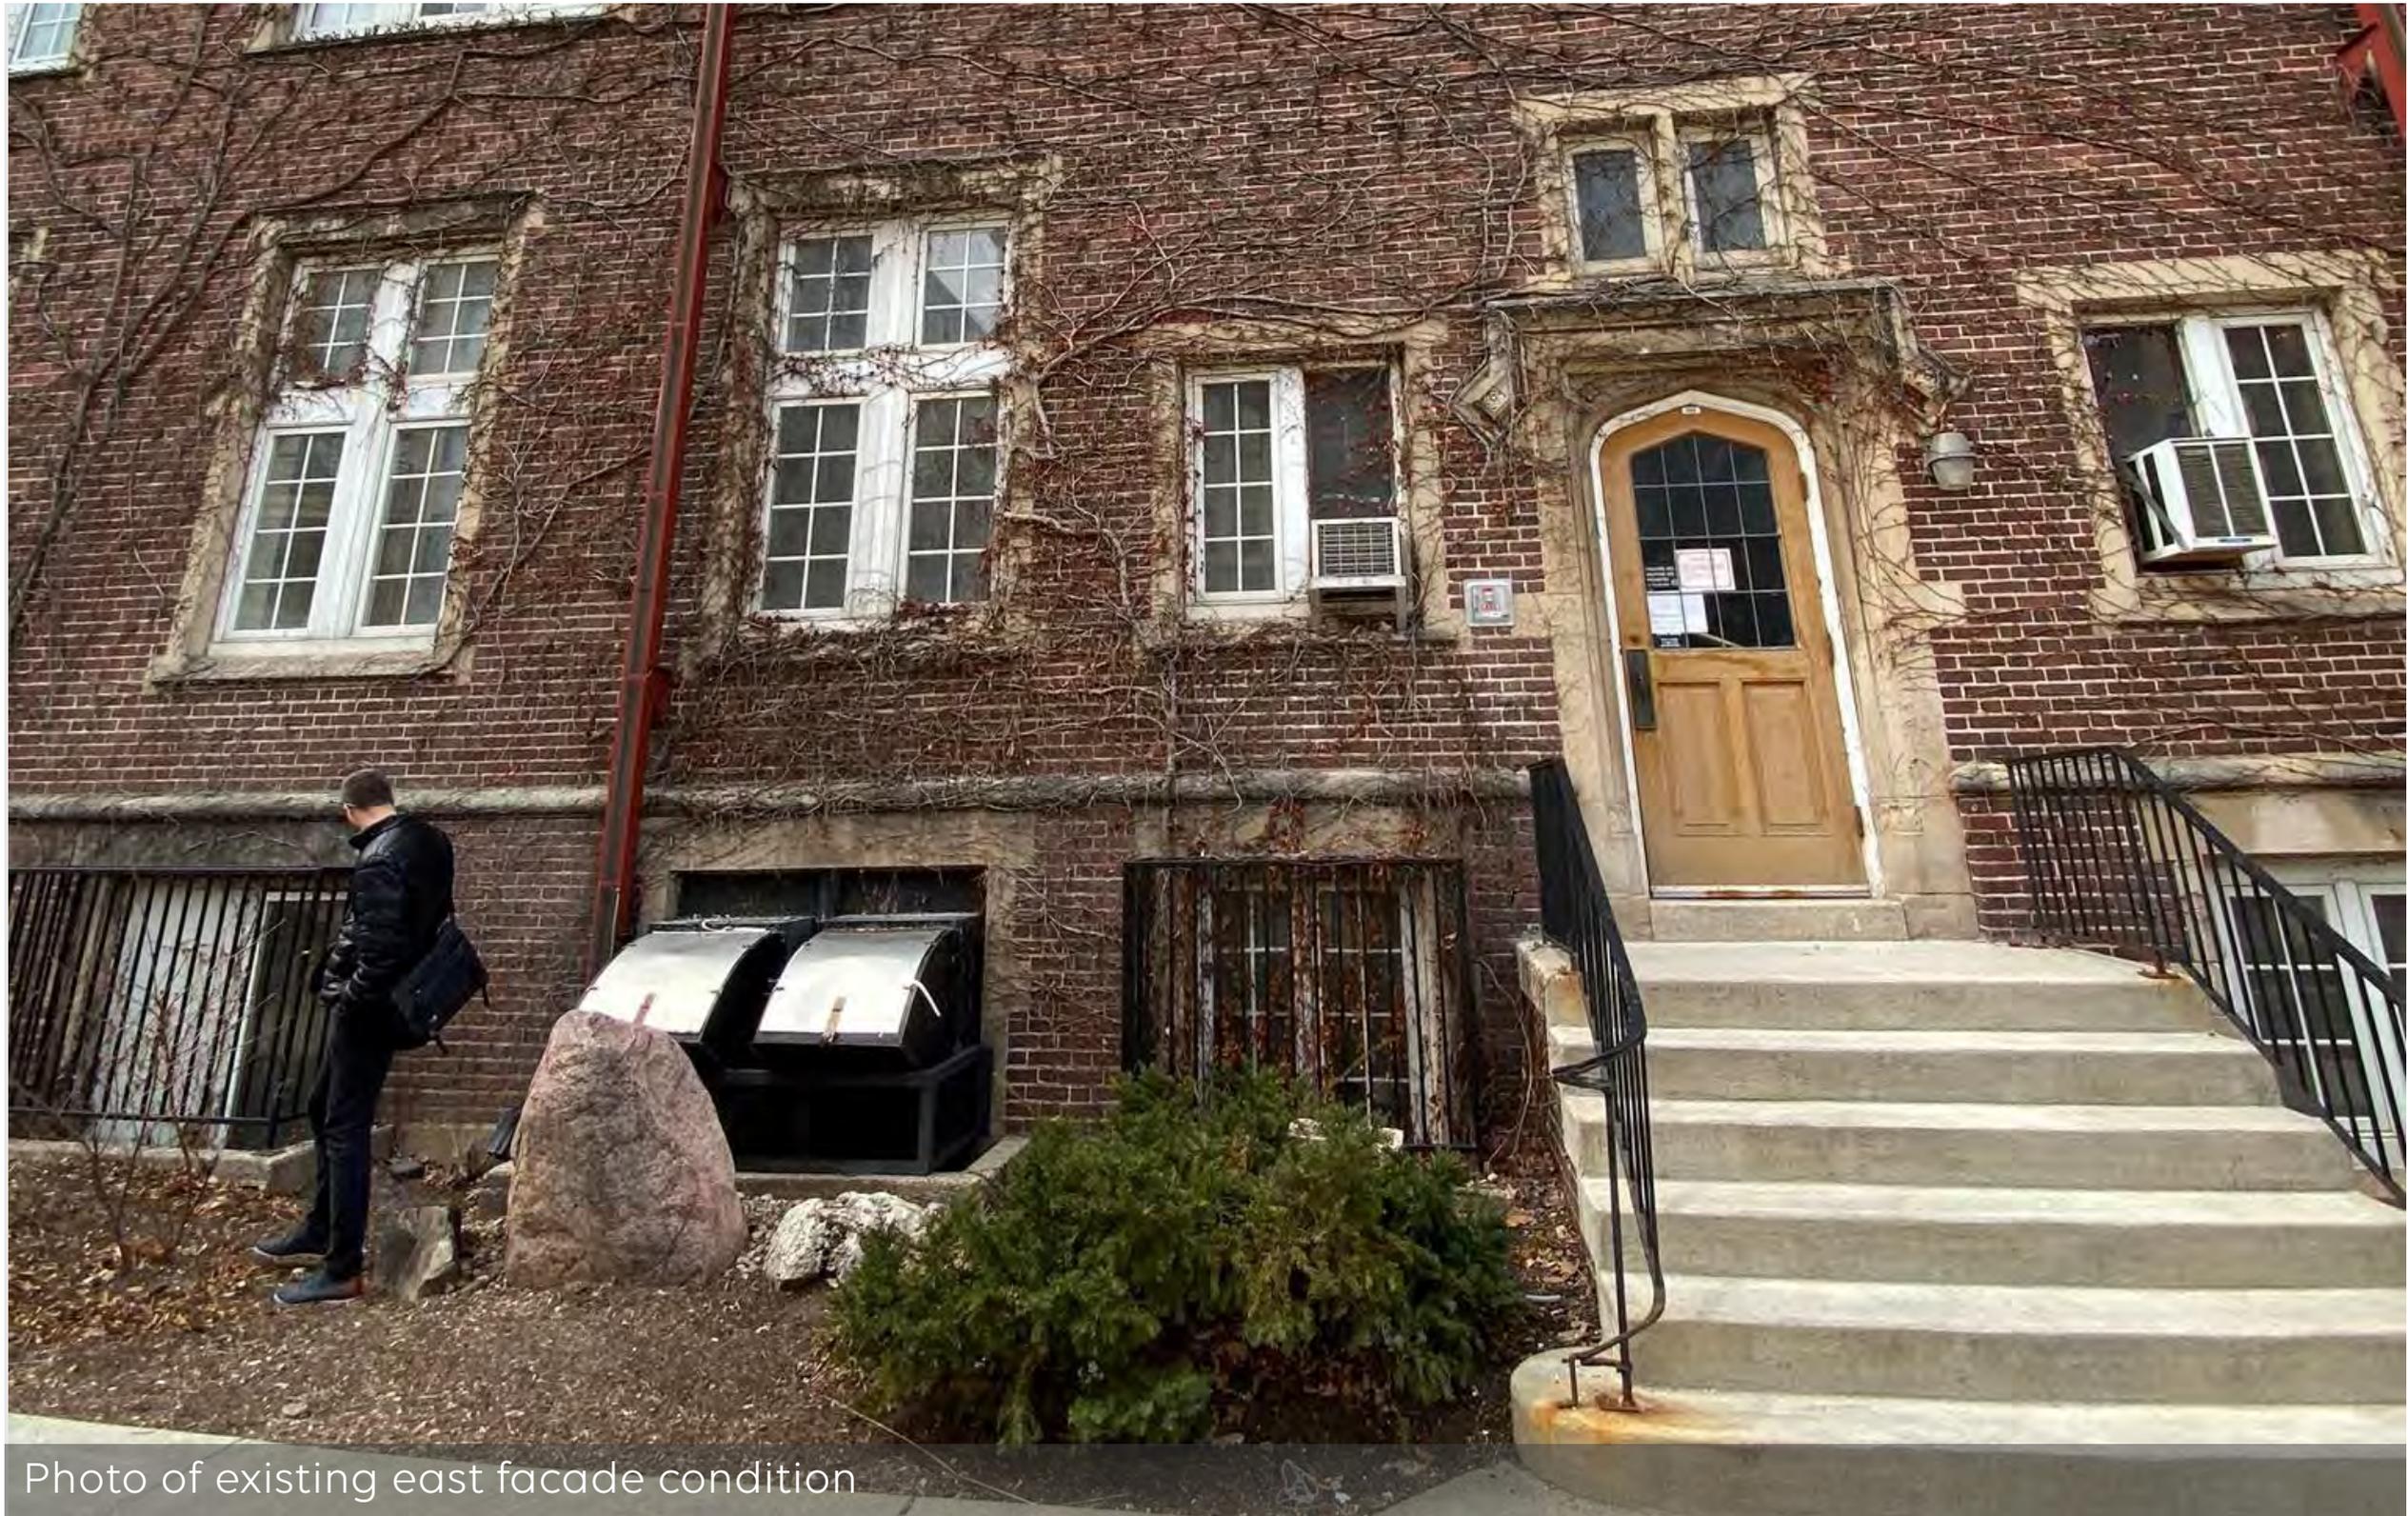
Photo of existing east facade condition

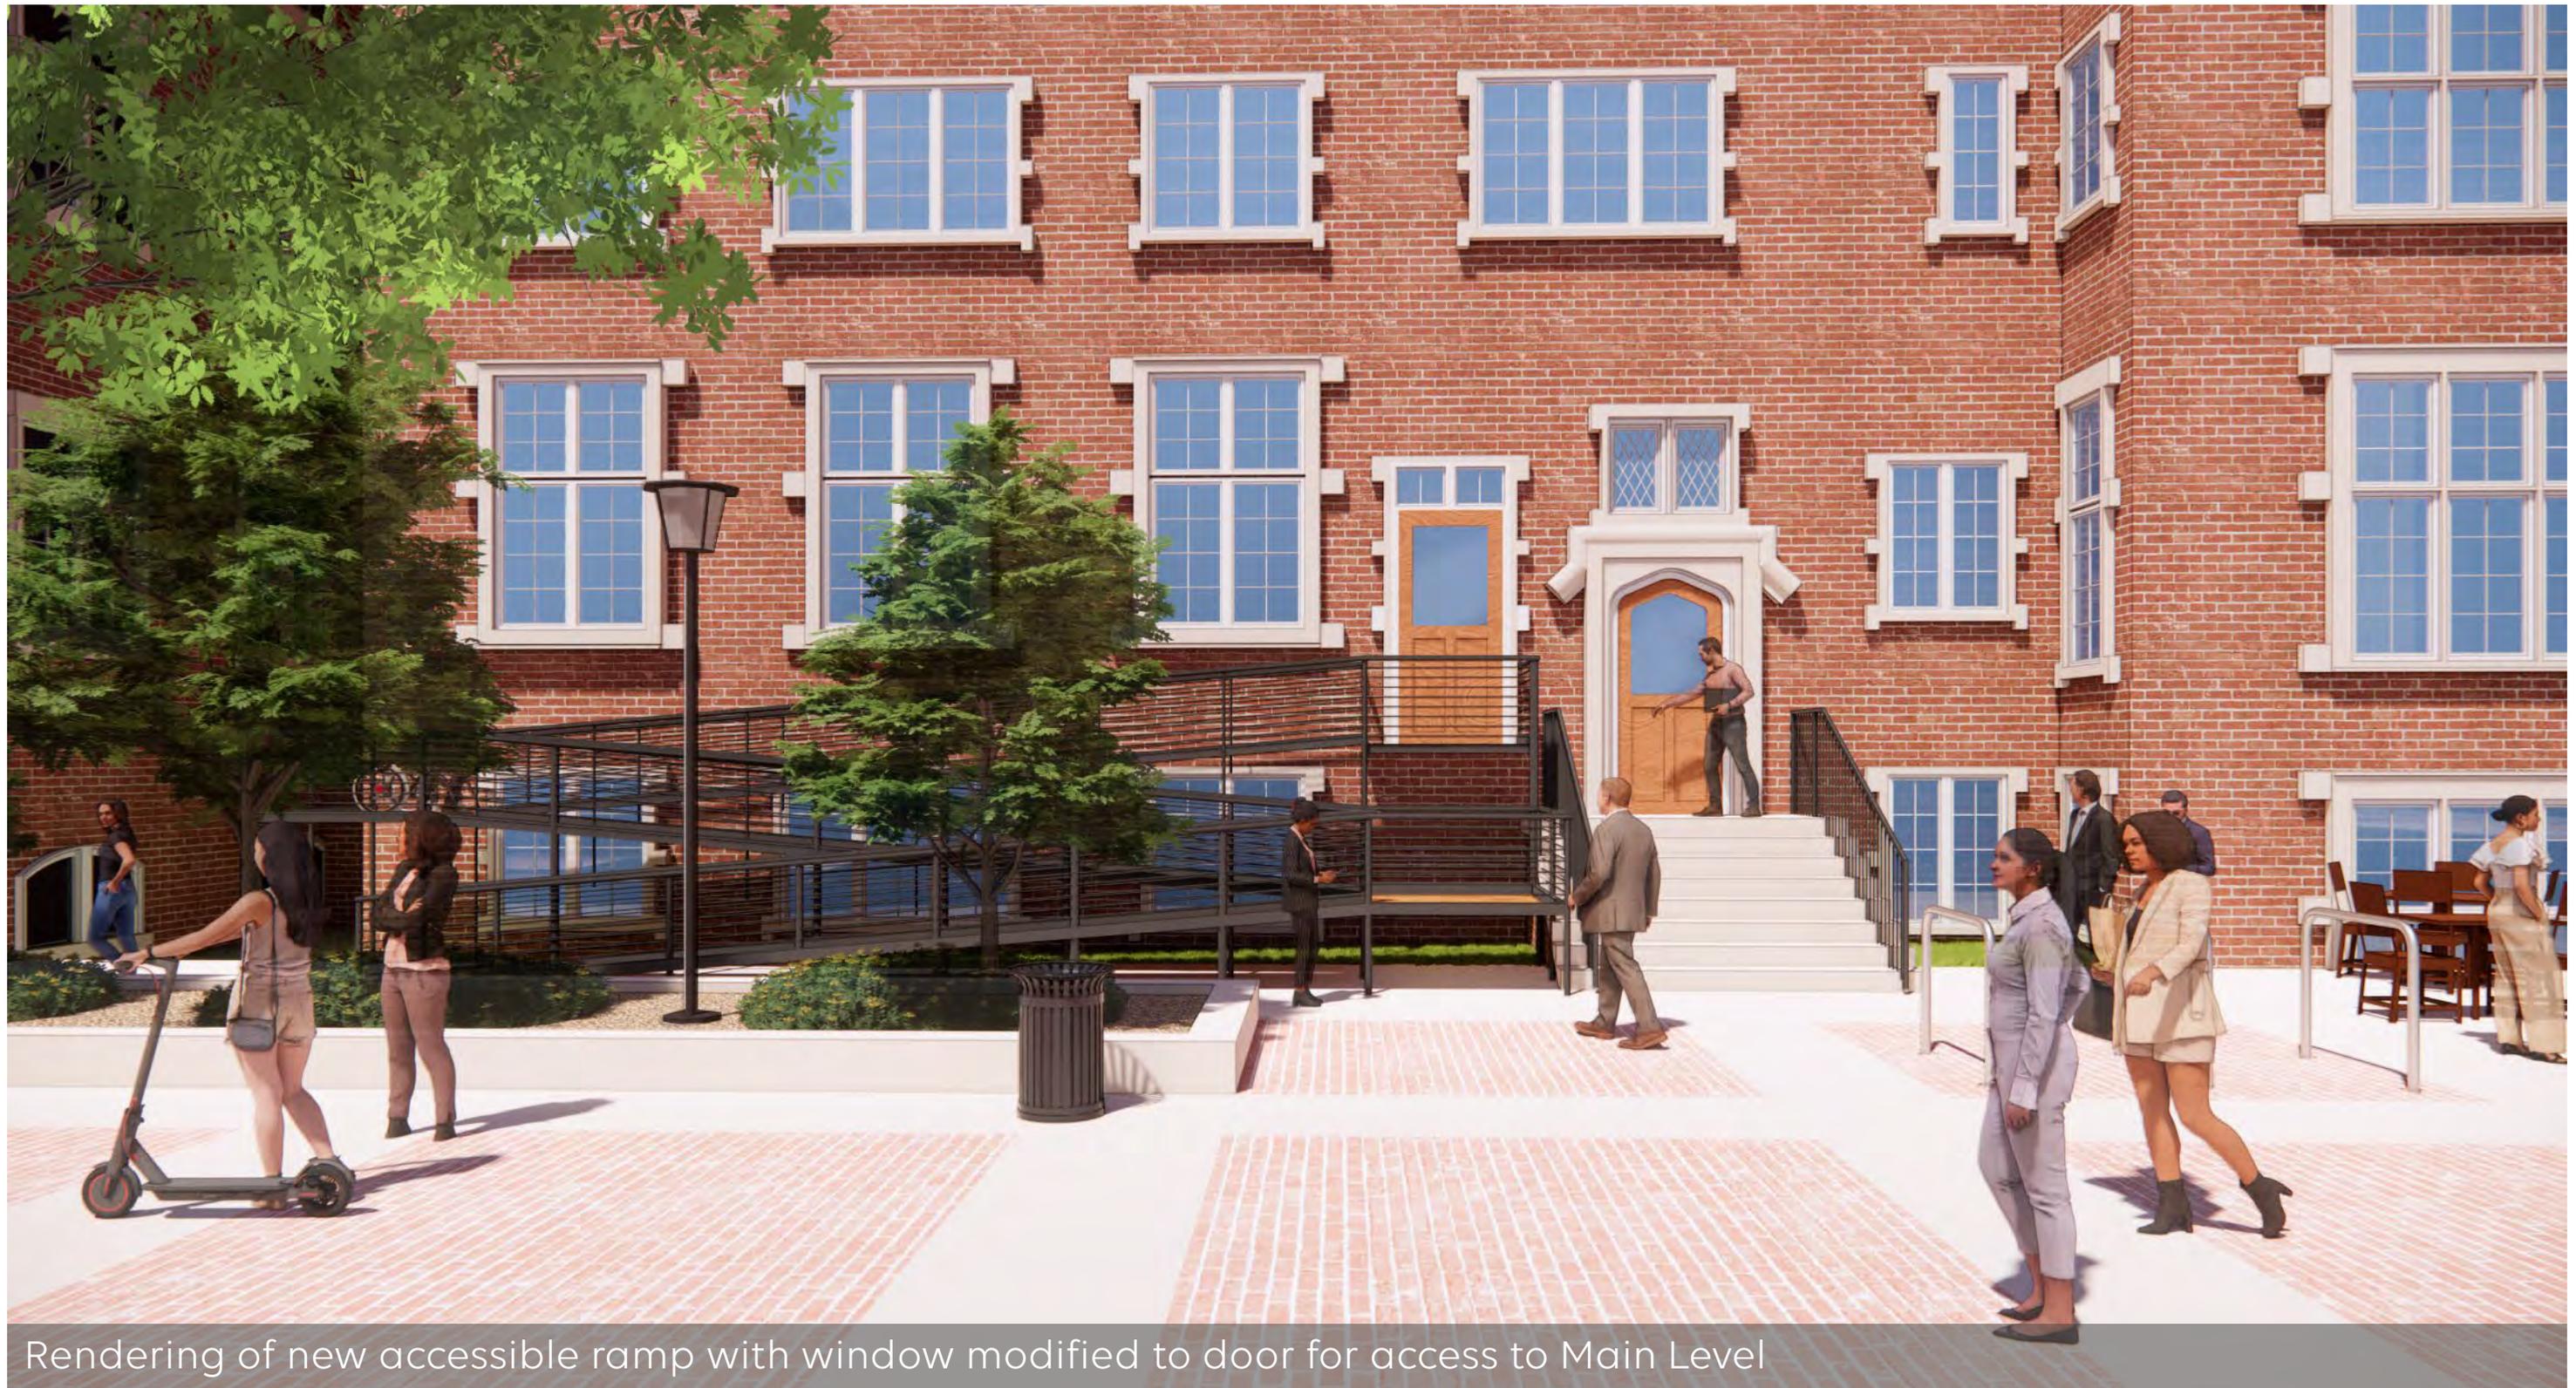
Rendering of new accessible ramp with window modified to door for access to Main Level

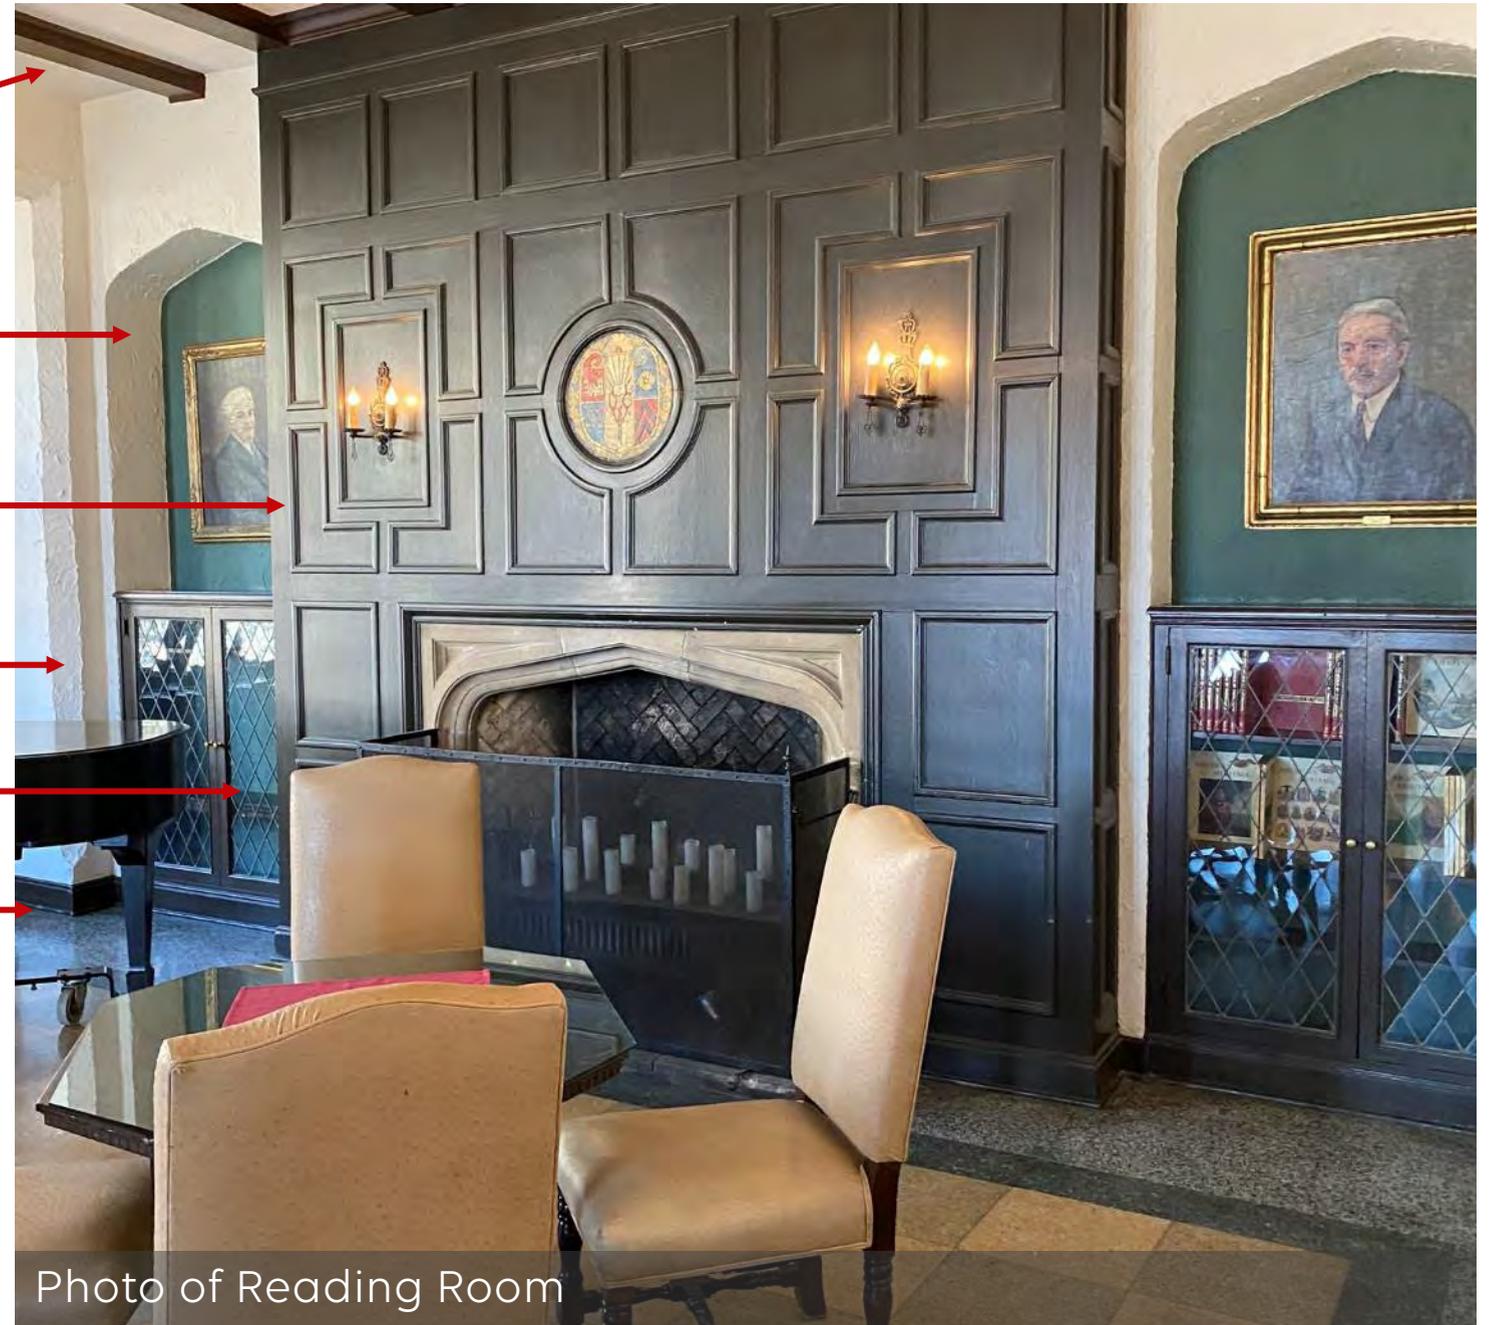
EXISTING LEVEL 1 READING ROOM

Existing beams to remain (repair – touch-up finish as required)

Existing plaster niches to remain

Existing fire place and wood wall paneling to remain (repainted)

Existing plaster walls and ceiling to remain (repaired and repainted)

Existing wood/glass cabinets to remain

Existing terrazzo floors to remain

Existing windows to remain

All exposed conduit to be removed

Photo of Reading Room

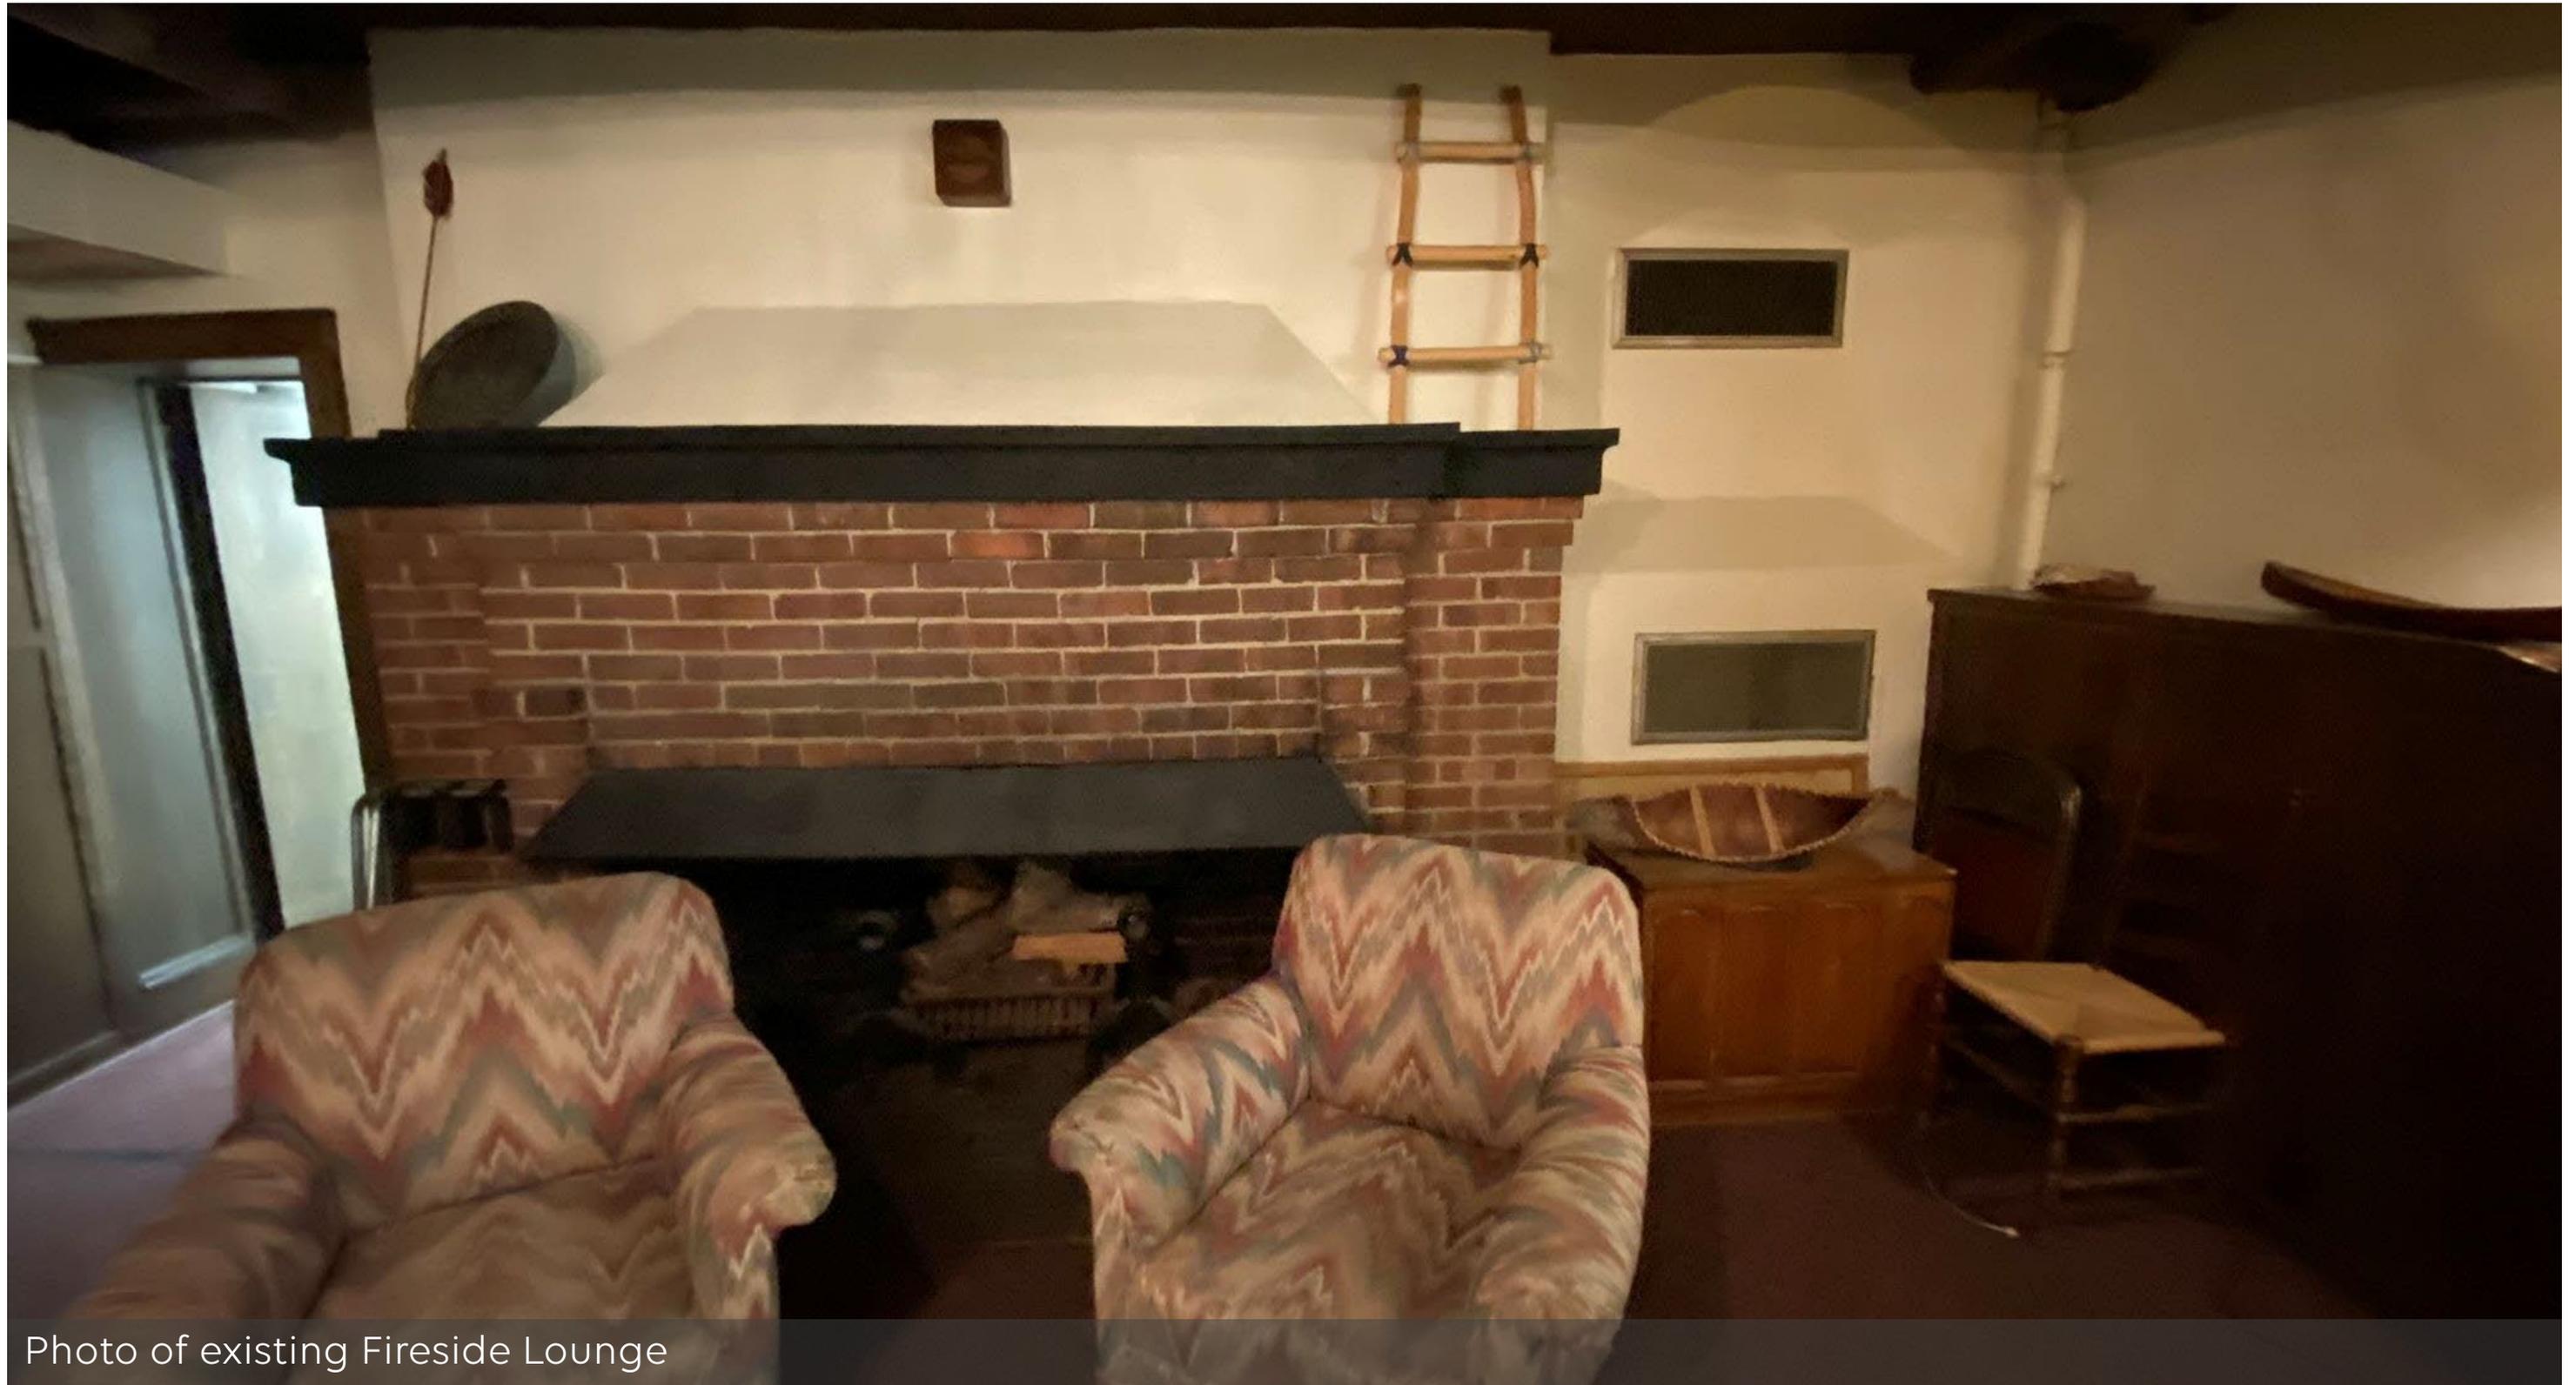
Photo of existing Fireside Lounge

LOWER -LEVEL FIRESIDE LOUNGE

Existing plaster wrapped beams to remain (repainted)

Existing stained-glass windows to remain (restored)

Existing wood paneling to remain (refinished)

Existing fireplace + mantel to remain

Existing carpet to be removed and replaced with wood-look LVT

New ceiling light fixtures / existing wall scones to remain

Existing bar restored / relocated

All exposed conduit to be removed

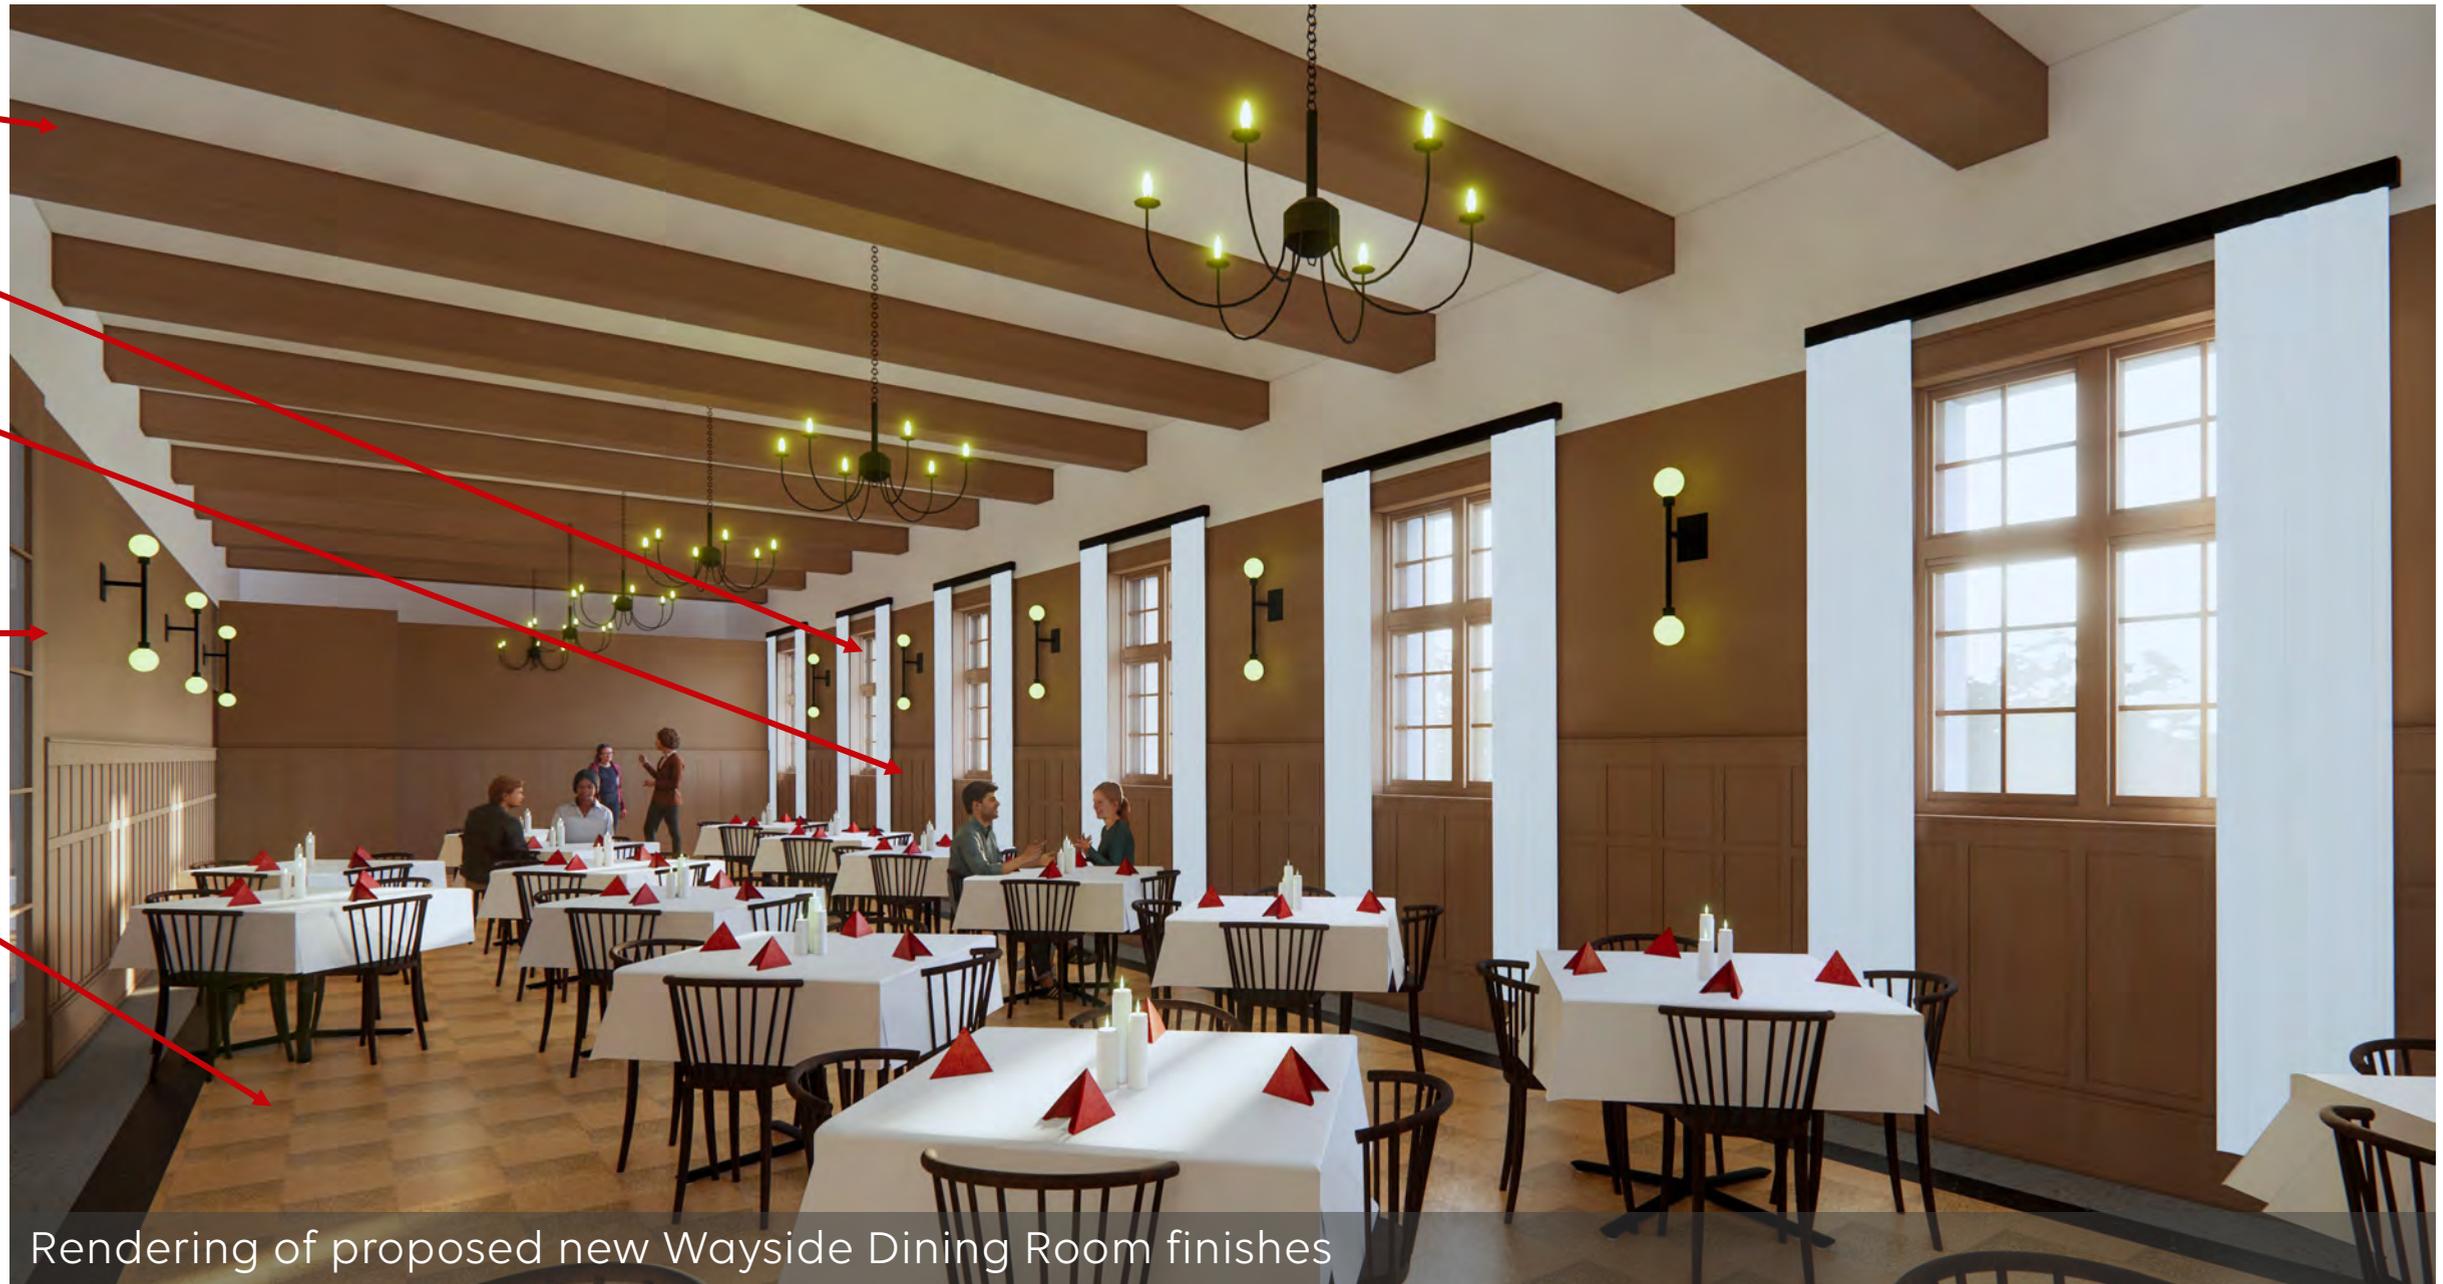
LEVEL 1 –WAYSIDE DINING ROOM

Existing beams to remain (refinished)

Existing windows to remain (refinished)

Existing wood wall paneling to remain (refinished)

Existing plaster walls and ceiling to remain (repaired)

Existing terrazzo floors to remain

New light fixtures

All exposed conduit to be removed

Rendering of proposed new Wayside Dining Room finishes
