1123 Jenifer St
Certificate of Appropriateness
July 31, 2023

Proposed Work

- Replace double-hung bathroom window with fixed window
- Staff administratively approved other requested windows due to positive lead tests, per the standards

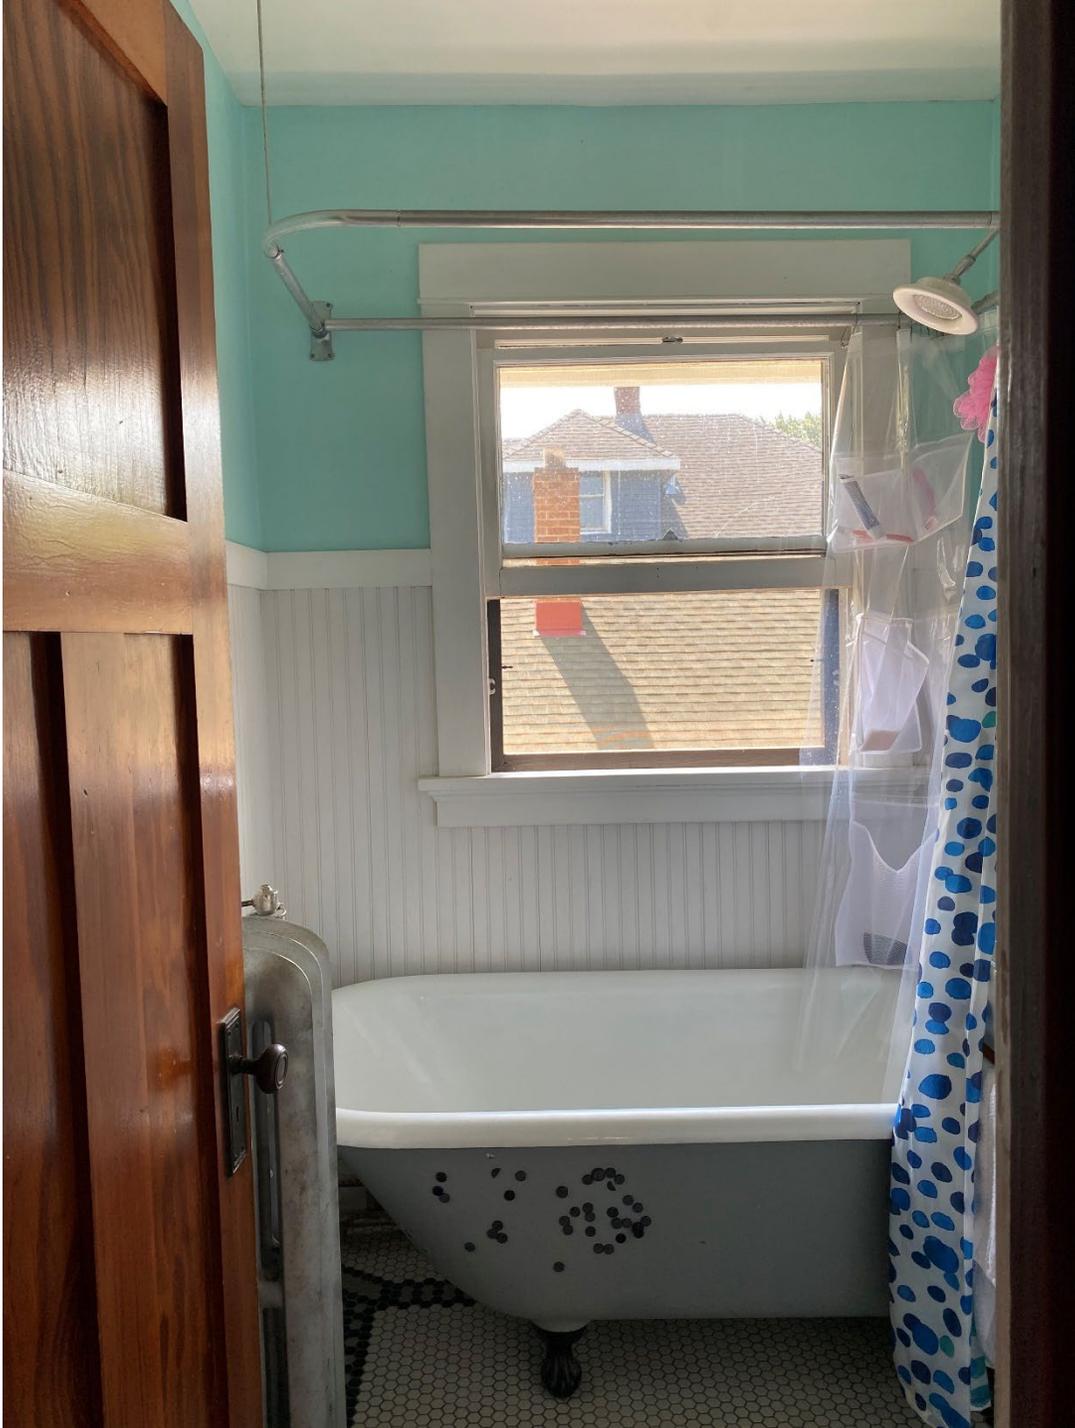
Commissioner David McClain's bathroom window

- 1914 wood window
- Painted 15-20 years ago

1. A replacement double-hung window, to match the other replacement windows recently approved, with an interior storm.
