REINDAHL PARK - UTILITY STRUCTURE IMPROVEMENTS

FOR THE CITY OF MADISON MADISON, WISCONSIN

75% SUBMITTAL, 3/8/2019

ELEVATIONS
REINDAHL - UTILITY STRUCTURE IMPROVEMENTS
CITY OF MADISON
MADISON, WISCONSIN

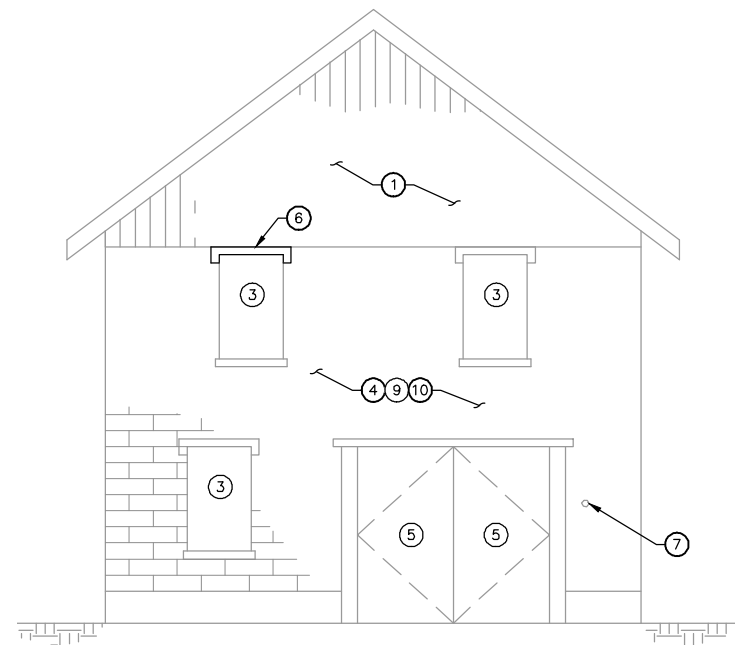
SOUTH ELEVATION
0 2' 4' 8' 16'

- KEY NOTES:**
- ① EXISTING WOOD SIDING.
 - ② EXISTING ASPHALT SHINGLES.
 - ③ EXISTING BOARDED-UP WINDOW OR DOOR OPENING.
 - ④ EXISTING MASONRY WALL.
 - ⑤ EXISTING STEEL DOOR.
 - ⑥ NEW CONCRETE LINTEL.
 - ⑦ PATCH HOLE IN WALL W/MORTAR.
 - ⑧ PATCH GAP IN MASONRY W/MORTAR.
 - ⑨ REPOINT EXISTING DETERIORATED MORTAR JOINTS. SEE REPOINTING SPECIAL PROVISION.
 - ⑩ REPAIR CRACKED MASONRY UNITS USING EPOXY CRACK INJECTION. SEE MASONRY UNIT RESTORATION SPECIAL PROVISION.
