**Madison Landmarks Commission
APPLICATION**

Project Address: 1335 Rutledge St Aldermanic District: _____

Project Title / Description: Installation of Replacement Windows

Window World Milwaukee LLC, proposing work at 1335 Rutledge street Madison W.I. 53703

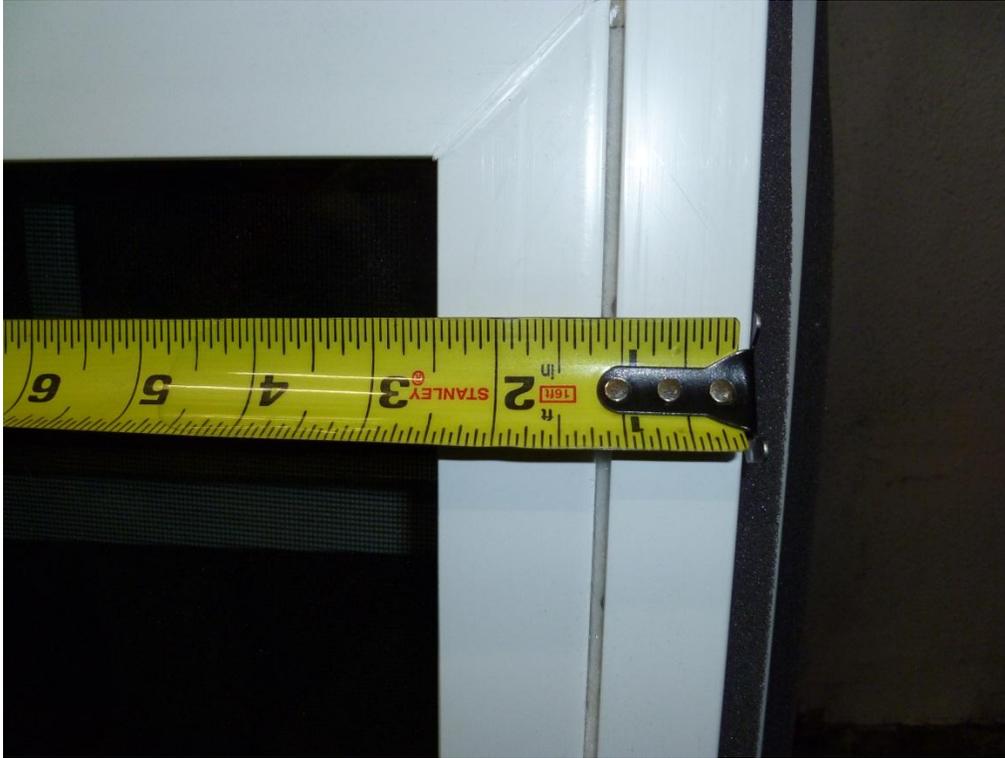
(Picture #1) 4000 SERIES DOUBLE HUNG SIDE PROFILE:

This is a side profile of our 4000 series double hung window. This picture shows the thickness of the mainframe and sash. The 4000 series window better replicates the existing windows at the 1335 Rutledge street address. As you can see on the 6000 series pictures, that the 6000 series mainframe and sashes are much more larger, thus shrinking the glass down a significant amount.

We feel that the 4000 series window provides the least amount of change to the windows. The glass lines on the 4000 are slim and provide the most light and replicate the sash profile better than the 6000 series which has a much wider sash profile. On the 6000 series frame, the frame is designed with a much bigger sash profile that cuts the glass size down at least an inch all around.

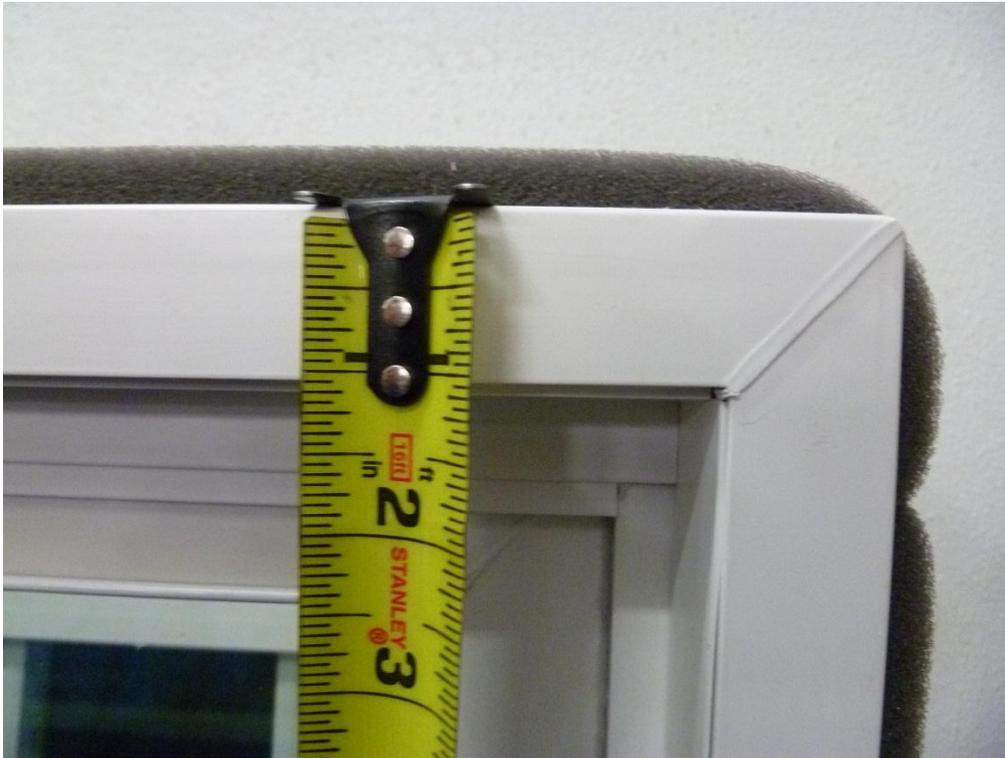
(Picture #2) 4000 SERIES DOUBLE HUNG TOP PROFILE:

This is a top profile of our 4000 series double hung window. This picture shows the thickness of the mainframe and sash.

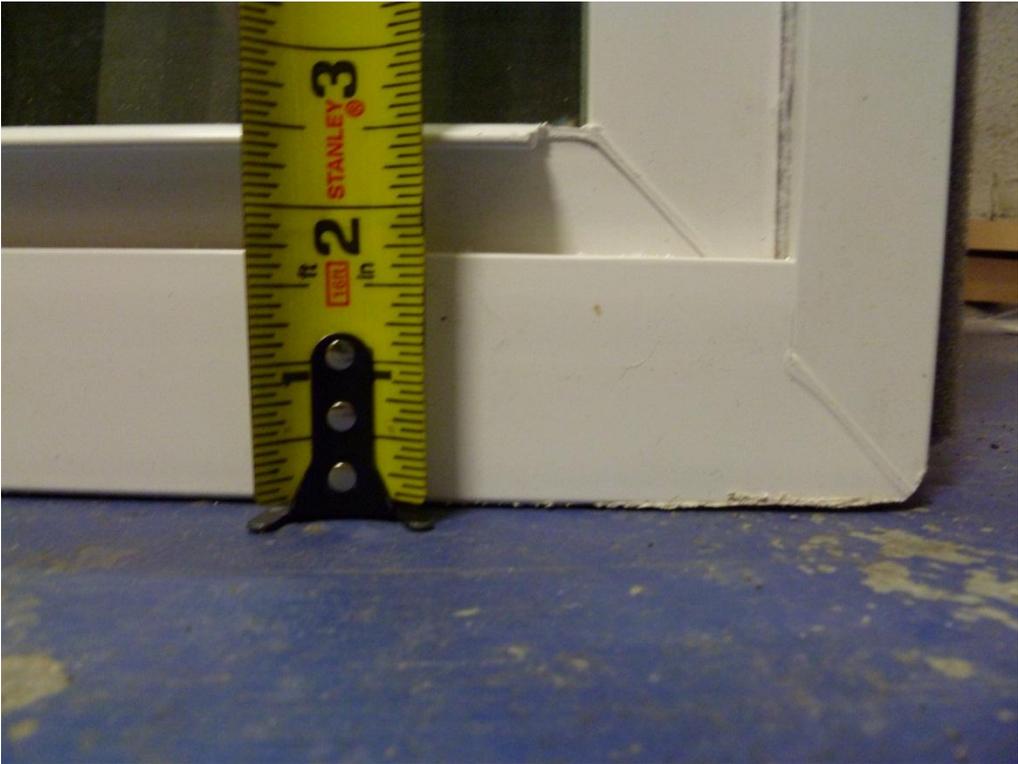
(Picture #3) 4000 SERIES DOUBLE HUNG BOTTOM PROFILE:

This is a bottom profile of our 4000 series double hung window. This picture shows the thickness of the mainframe and sash.

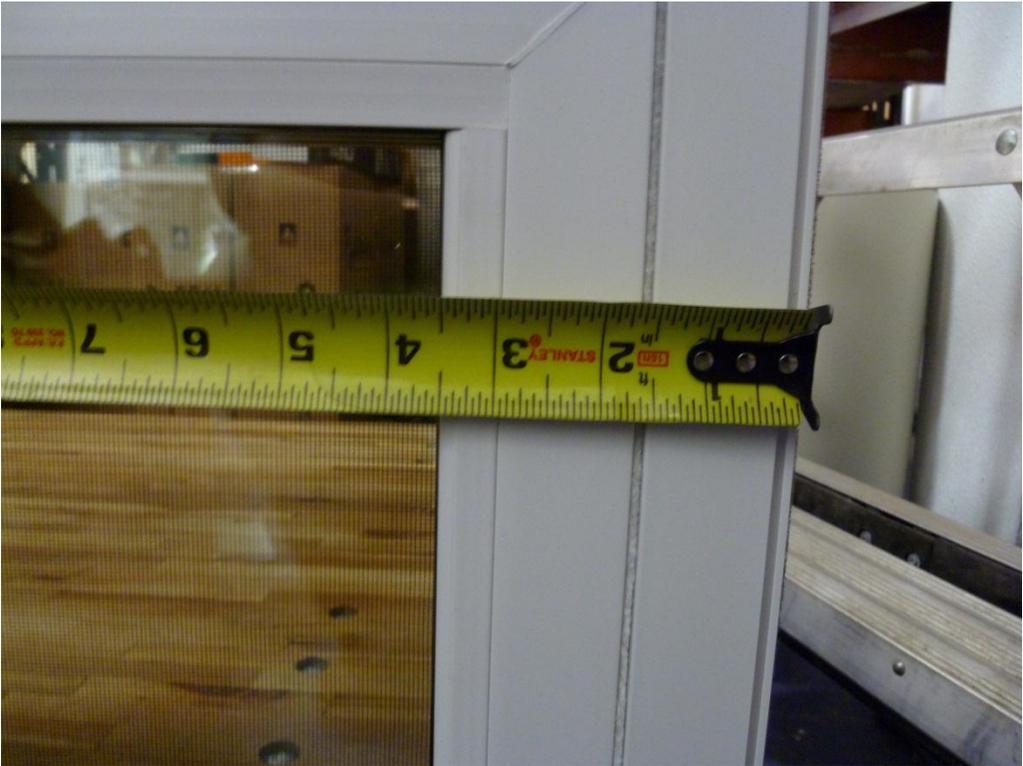
(Picture #4) 6000 SERIES DOUBLE HUNG SIDE PROFILE:

This is a side profile of our 6000 series double hung window. This picture shows the thickness of the mainframe and sash.

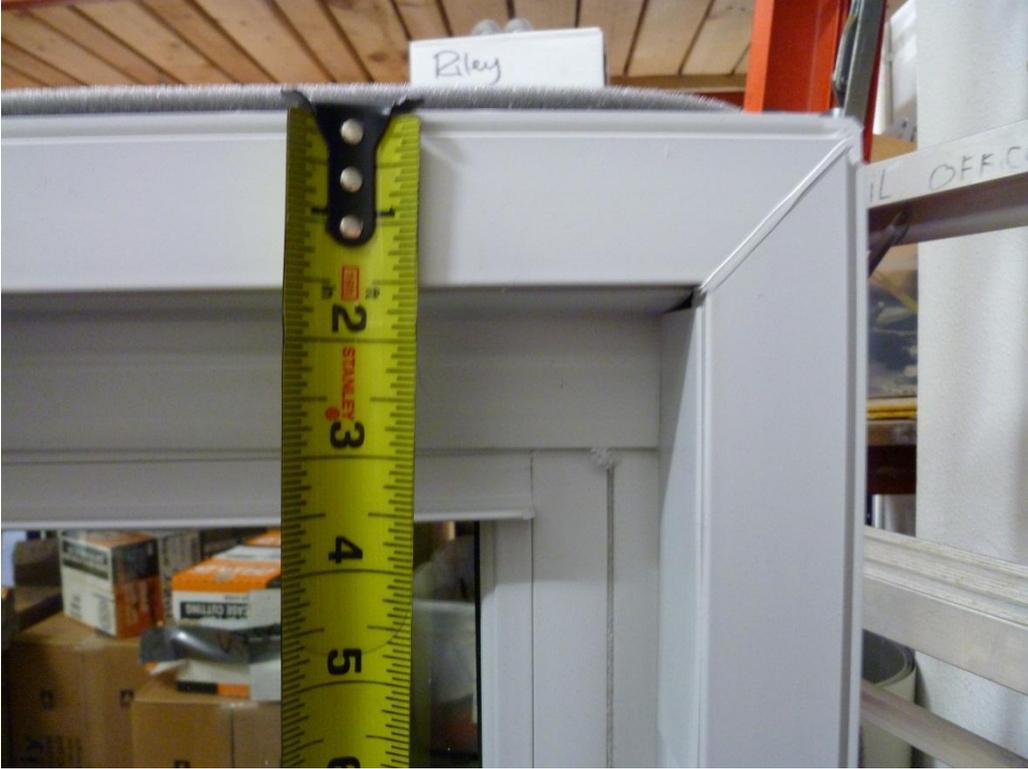
(Picture #5) 6000 SERIES DOUBLE HUNG TOP PROFILE:

This is a top profile of our 6000 series double hung window. This picture shows the thickness of the mainframe and sash.

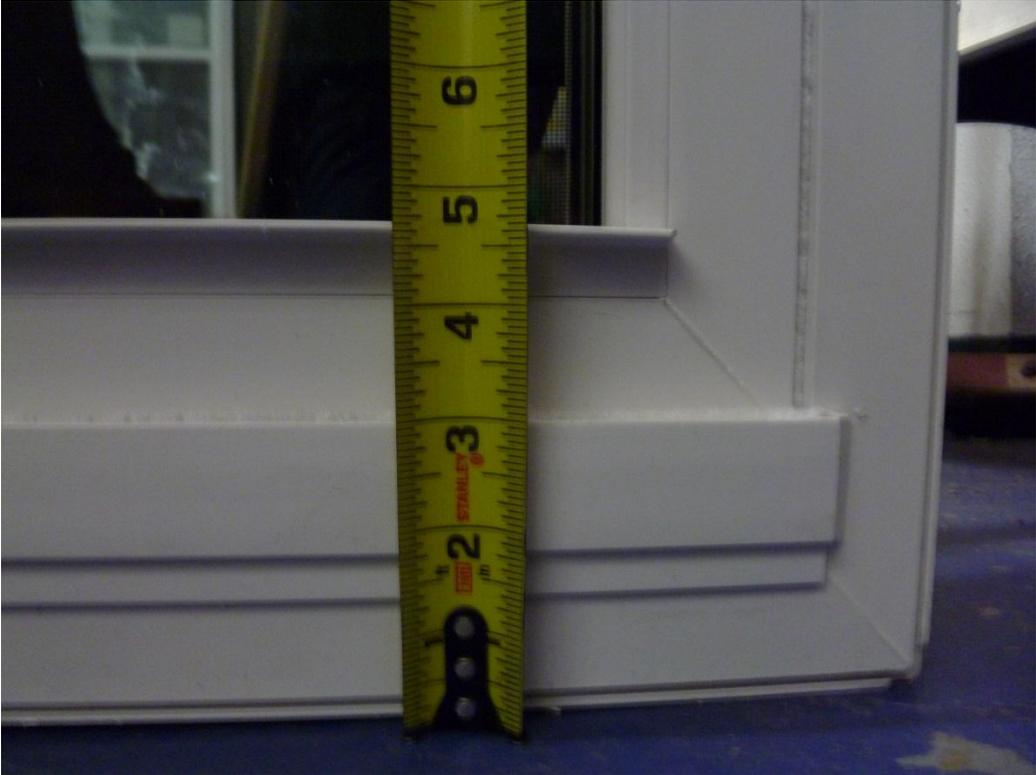
(Picture #6) 6000 SERIES DOUBLE HUNG BOTTOM PROFILE:

This is a bottom profile of our 6000 series double hung window. This picture shows the thickness of the mainframe and sash.

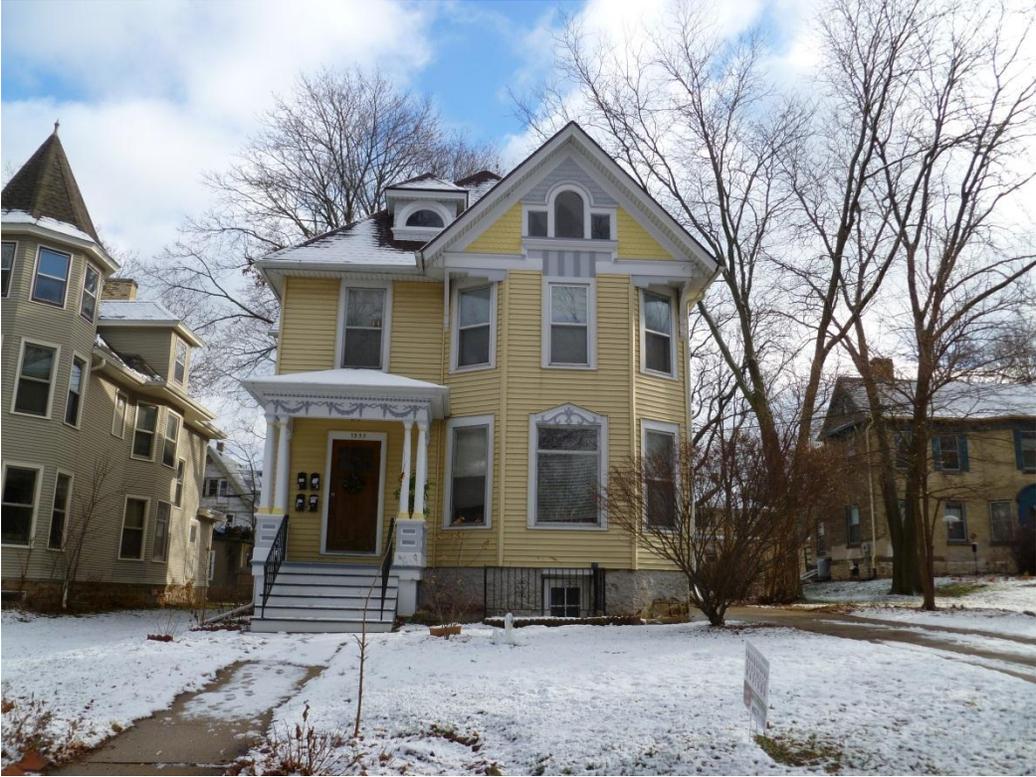
(Picture #7) 1335 RUTLEDGE STREET MADISON W.I. 53703:

This is a picture of the home at 1335 Rutledge Street. This picture shows the front of the home.

As you can see in all of the pictures of the home at 1335 Rutledge street, there is currently vinyl siding on the home, aluminum trim around all of the windows, and aluminum soffit , fascia, and porch ceiling.

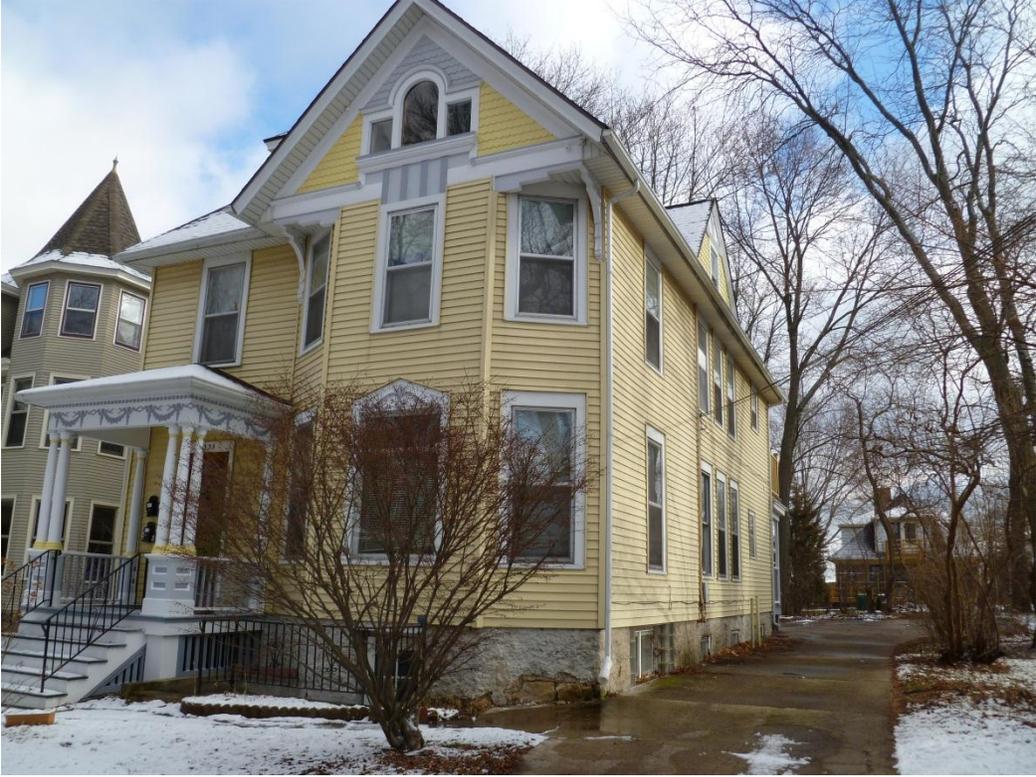
(Picture #8) 1335 RUTLEDGE STREET MADISON W.I. 53703:

This is a picture of the home at 1335 Rutledge Street. This picture shows the front of the home, and the side of the home.

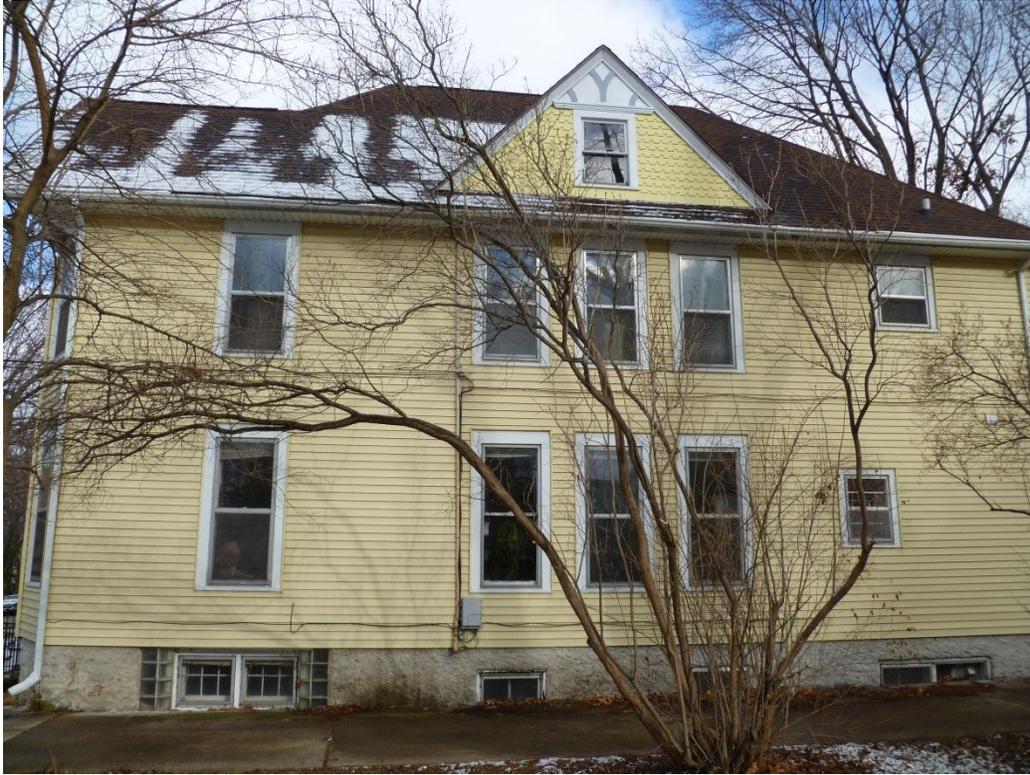
(Picture #9) 1335 RUTLEDGE STREET MADISON W.I. 53703:

This is a picture of the home at 1335 Rutledge Street. This picture shows the side of the home.

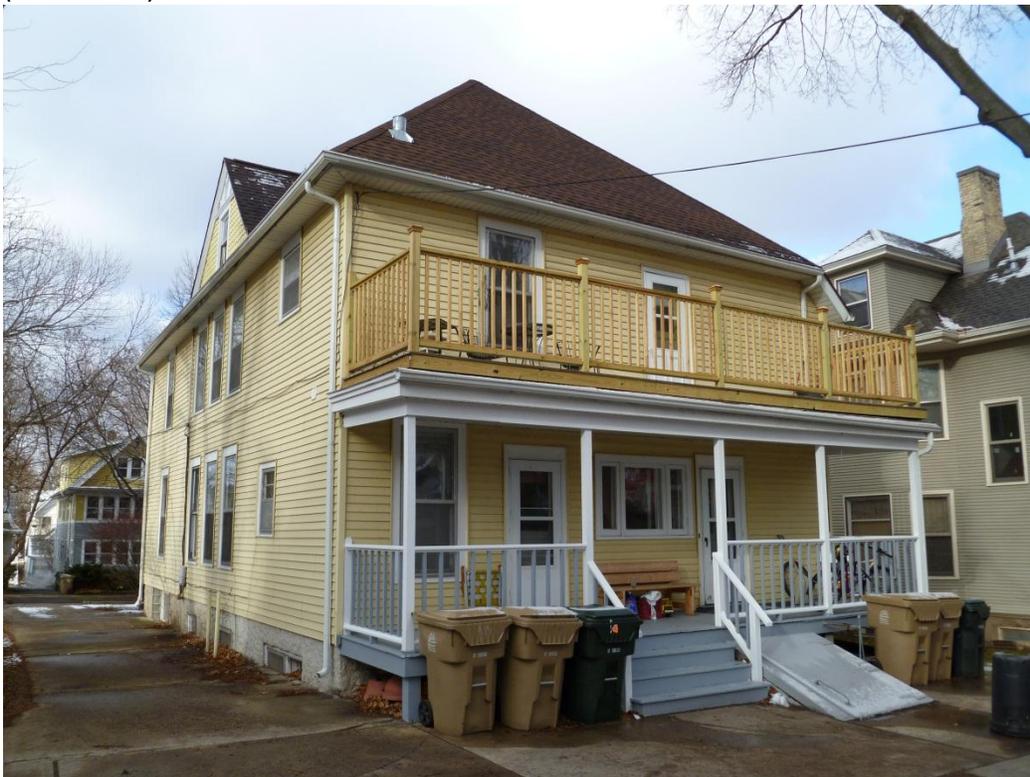
(Picture #10) 1335 RUTLEDGE STREET MADISON W.I. 53703:

This is a picture of the home at 1335 Rutledge Street. This picture shows the side of the home, and the back of the home.

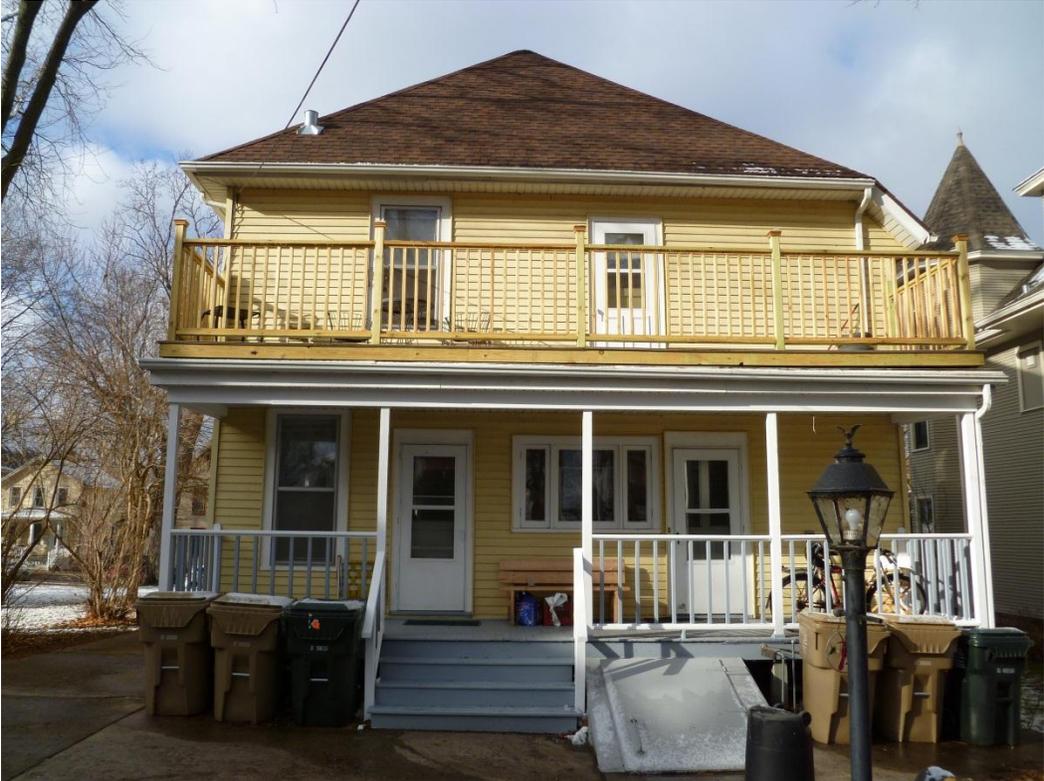
(Picture #11) 1335 RUTLEDGE STREET MADISON W.I. 53703:

This is a picture of the home at 1335 Rutledge Street. This Picture shows the back of the home.

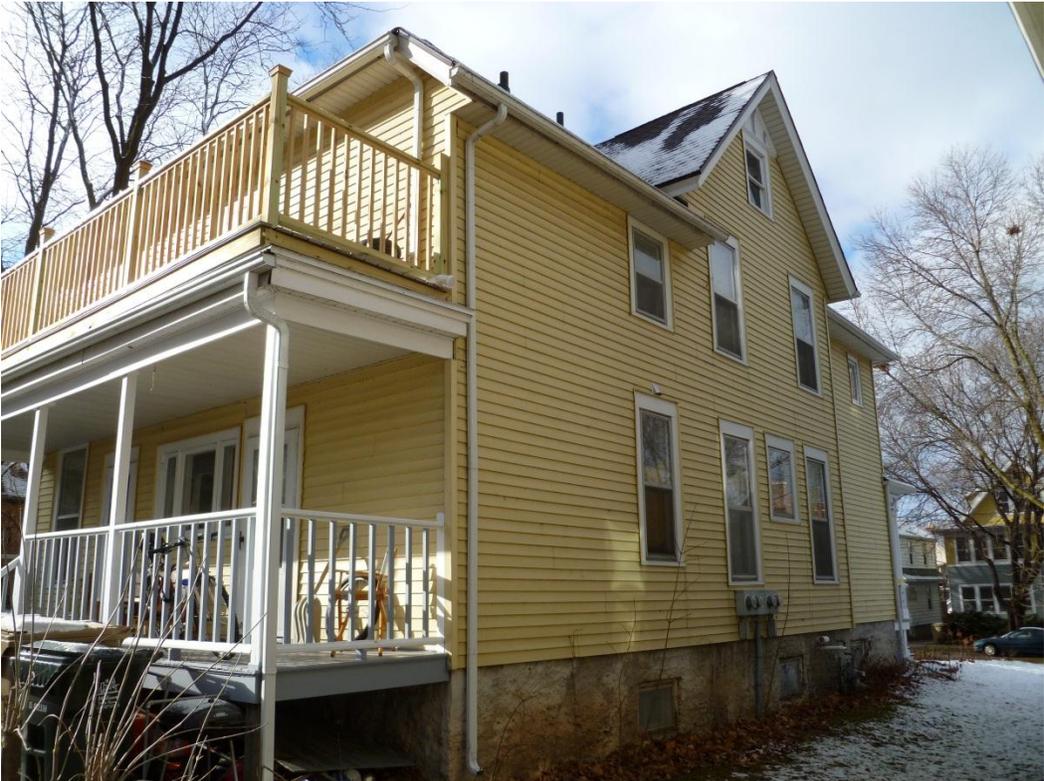
(Picture #12) 1335 RUTLEDGE STREET MADISON W.I. 53703:

This is a picture of the home at 1335 Rutledge Street. This picture shows the side of the home.

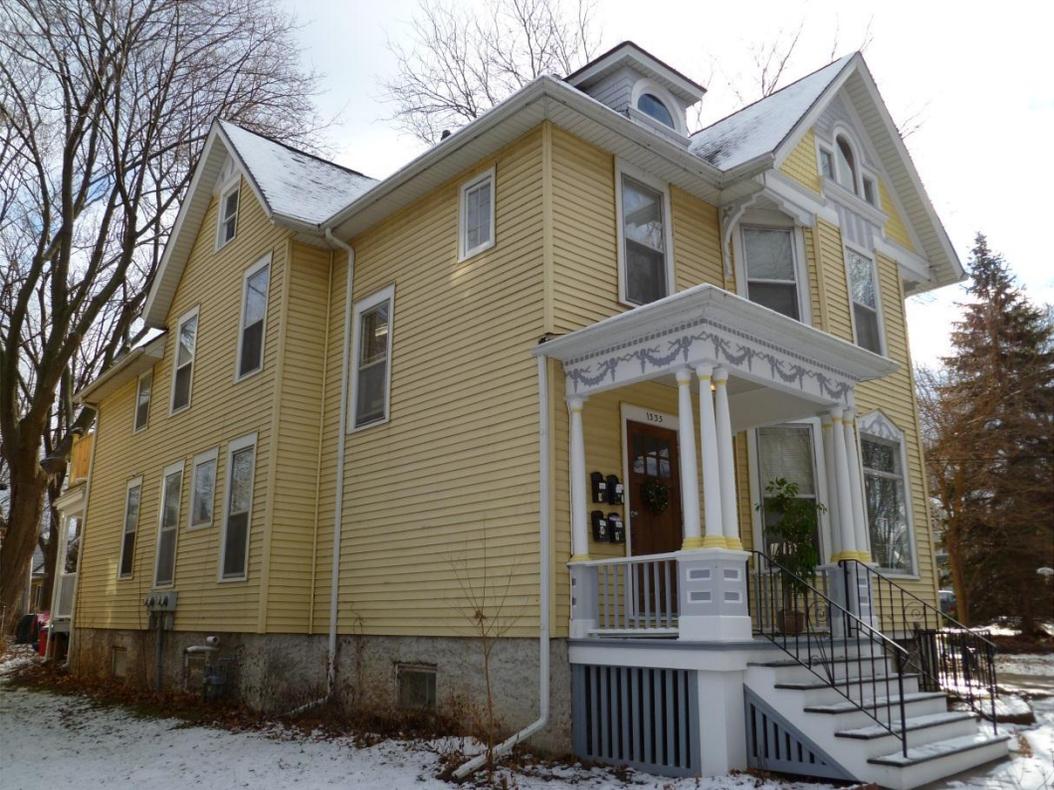
(Picture #13) 1335 RUTLEDGE STREET MADISON W.I. 53703:

This is a picture of the home at 1335 Rutledge Street. This picture shows the side of the home.

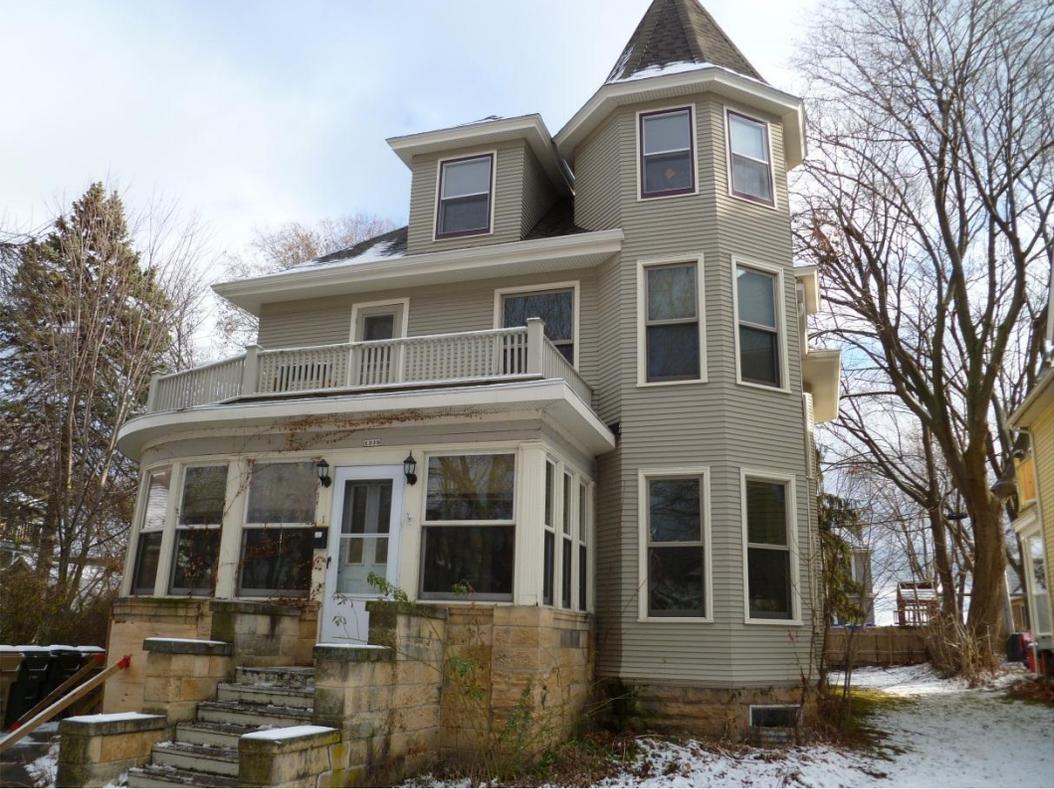
(Picture #14) SURROUNDING PROPERTY:

This is a picture of a surrounding home that has had vinyl siding installed and some of the windows were replaced.

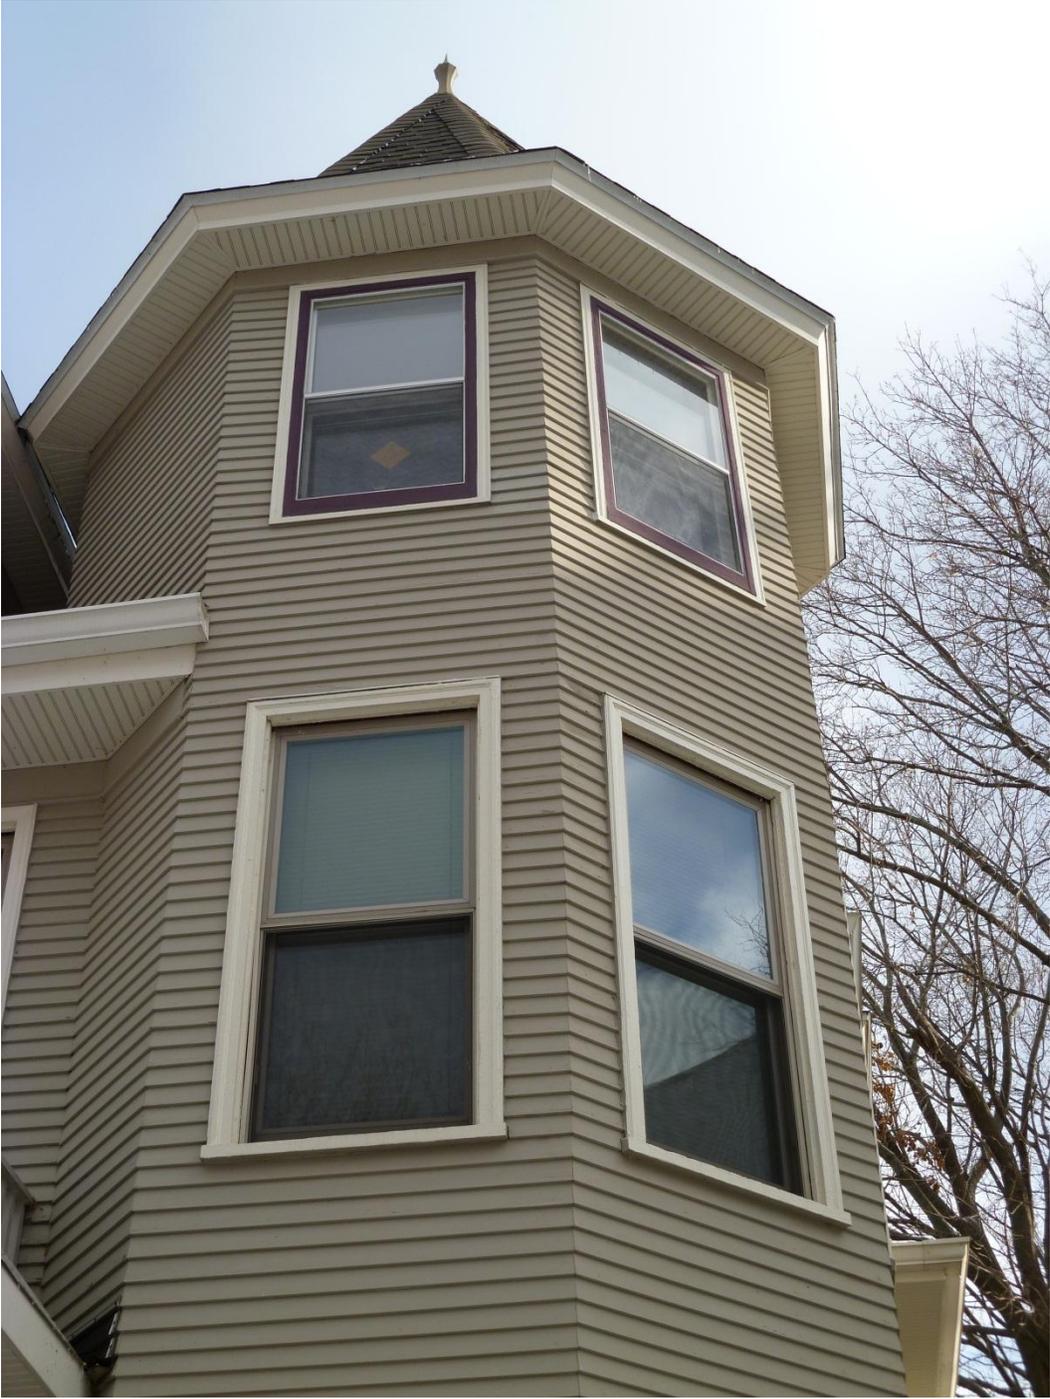
(Picture #15) SURROUNDING PROPERTY:

This is a picture of a surrounding home showing that some of the windows were replaced, and some that were not replaced. From the pictures you can see that the ones that were not replaced still have the burgundy wood storm windows.

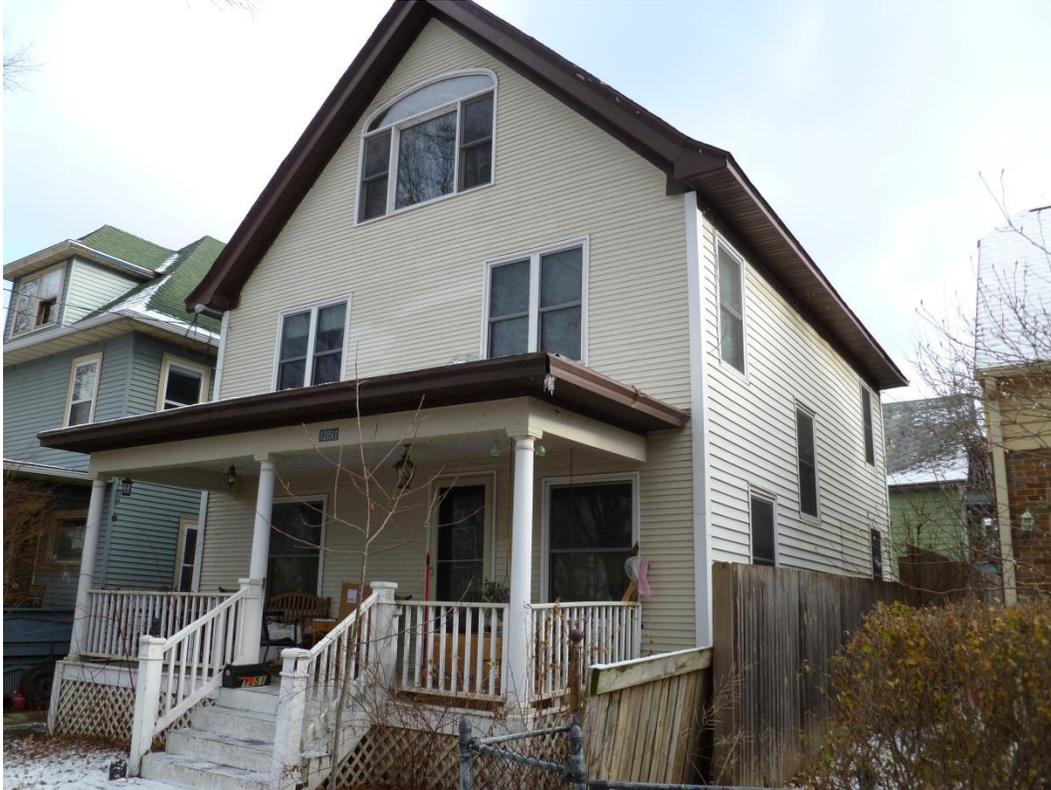
(Picture #16) SURROUNDING PROPERTY:

This is a picture of a surrounding home that has had vinyl windows installed, exterior aluminum trim around the windows done, and vinyl siding installed.

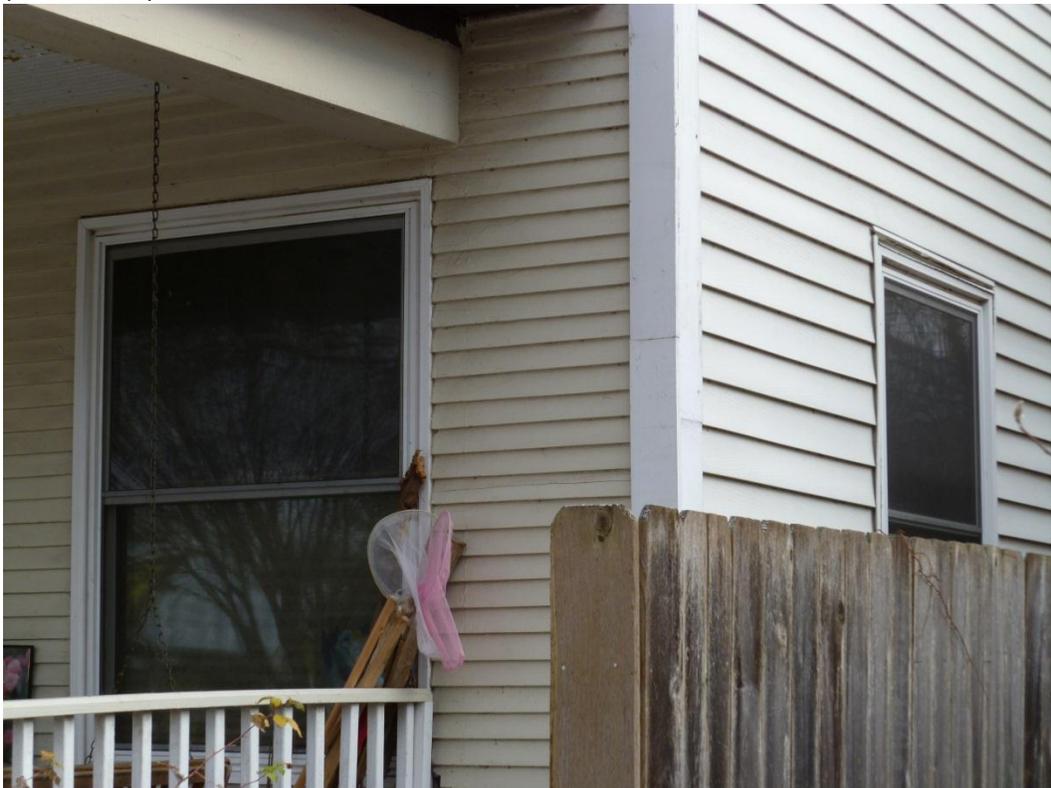
(Picture #17) SURROUNDING PROPERTY:

This is just a close up of picture #16.

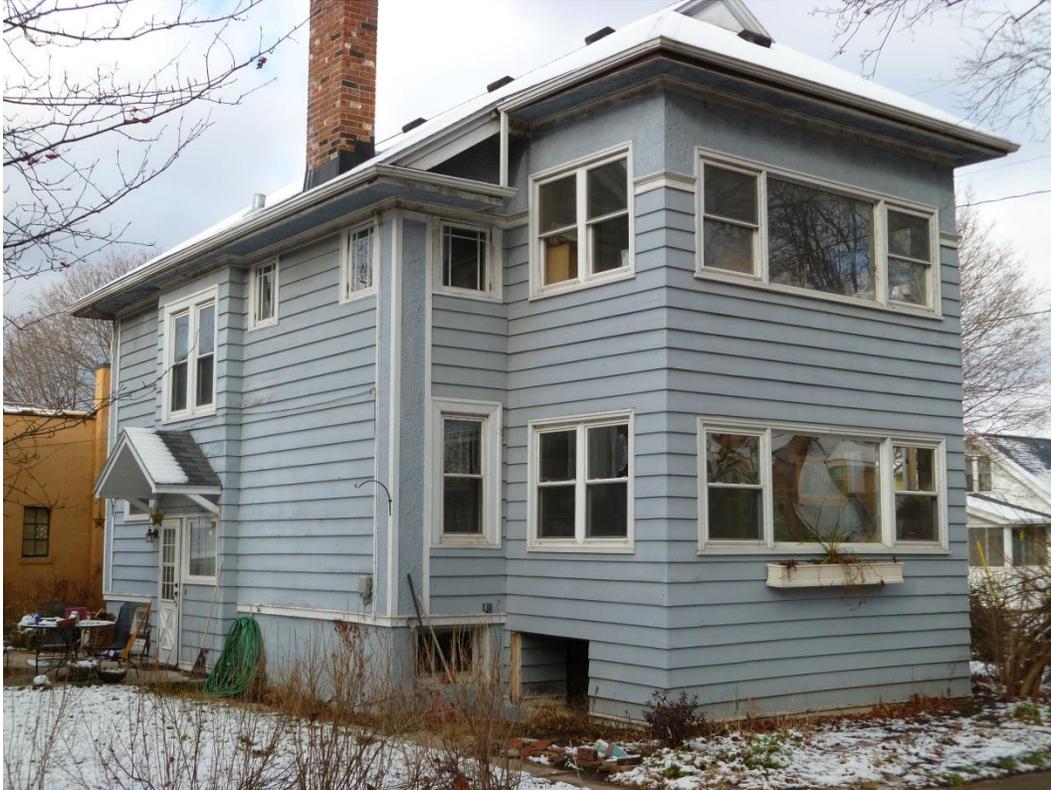
(Picture #18) SURROUNDING PROPERTY:

This is a picture of a surrounding home that had vinyl windows installed, and exterior aluminum trim around the windows done.

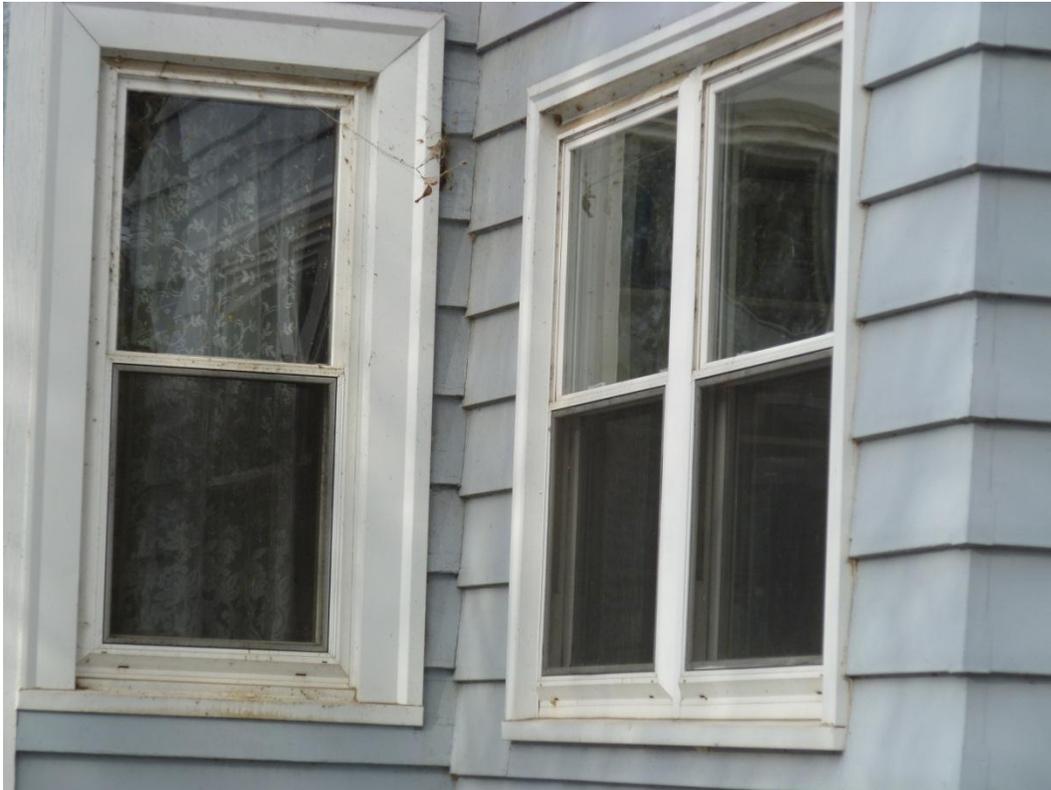
(Picture #19) SURROUNDING PROPERTY:

This is just a close up of picture #18.

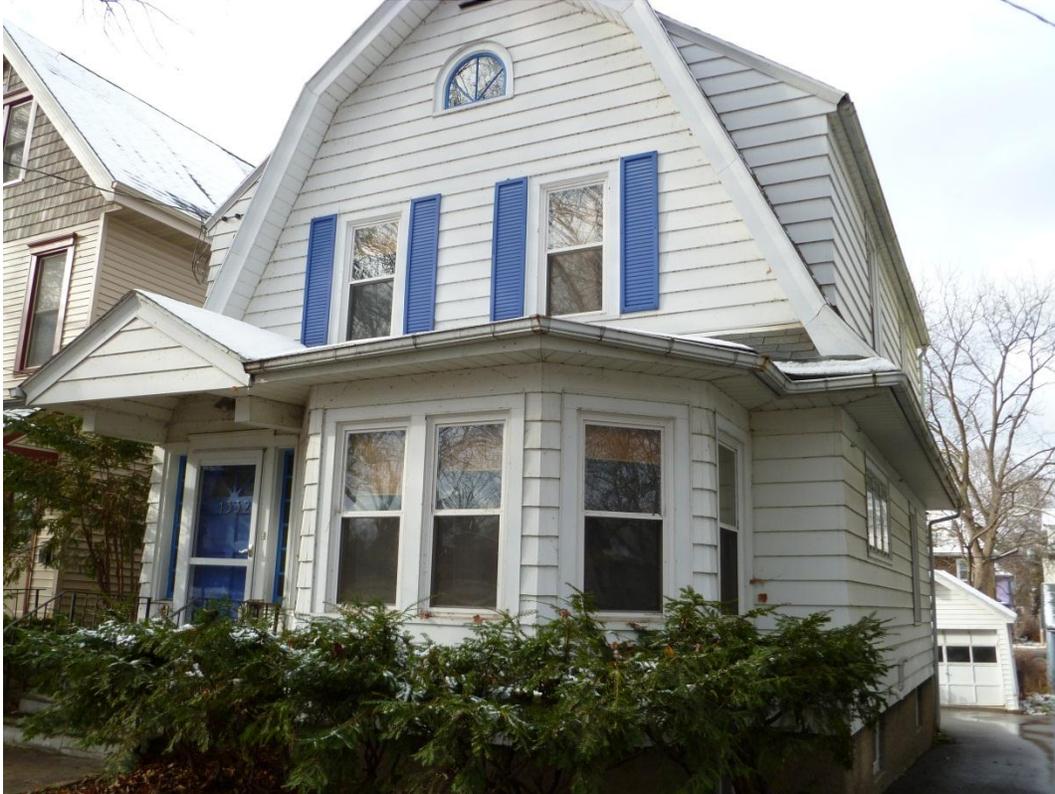
(Picture #20) SURROUNDING PROPERTY:

This is a picture of a surrounding home that has had vinyl windows installed, and exterior aluminum trim around the windows done.

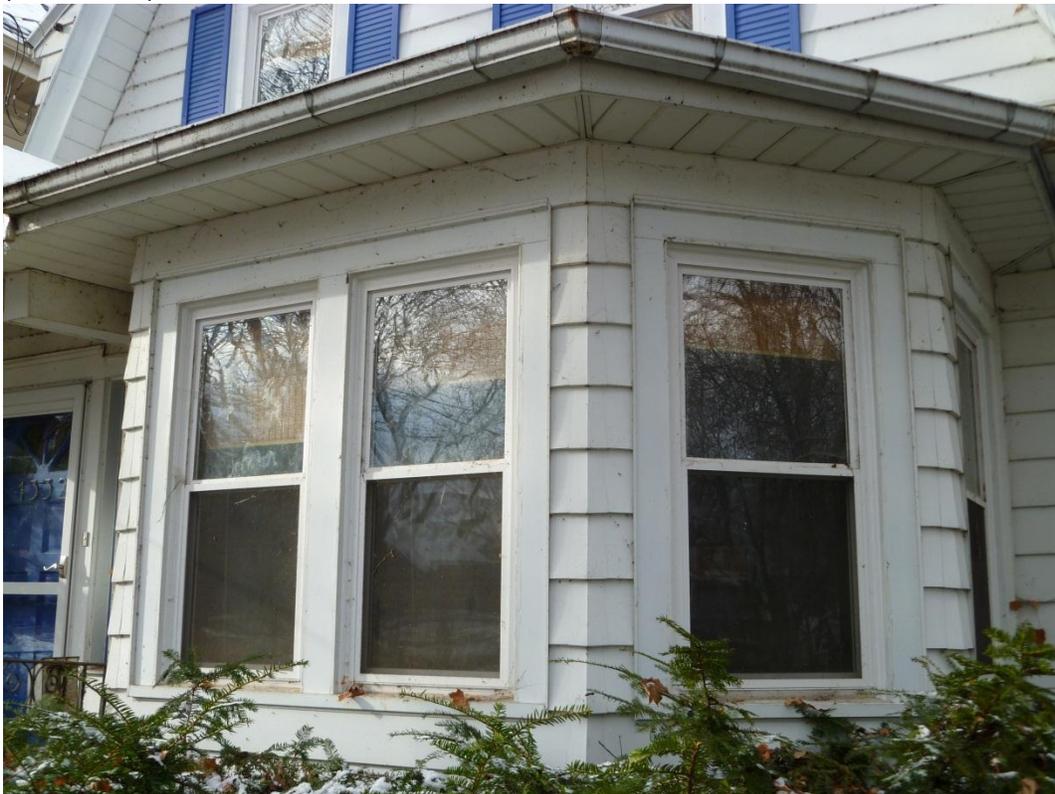
(Picture #21) SURROUNDING PROPERTY:

This is just a close up of picture #20.

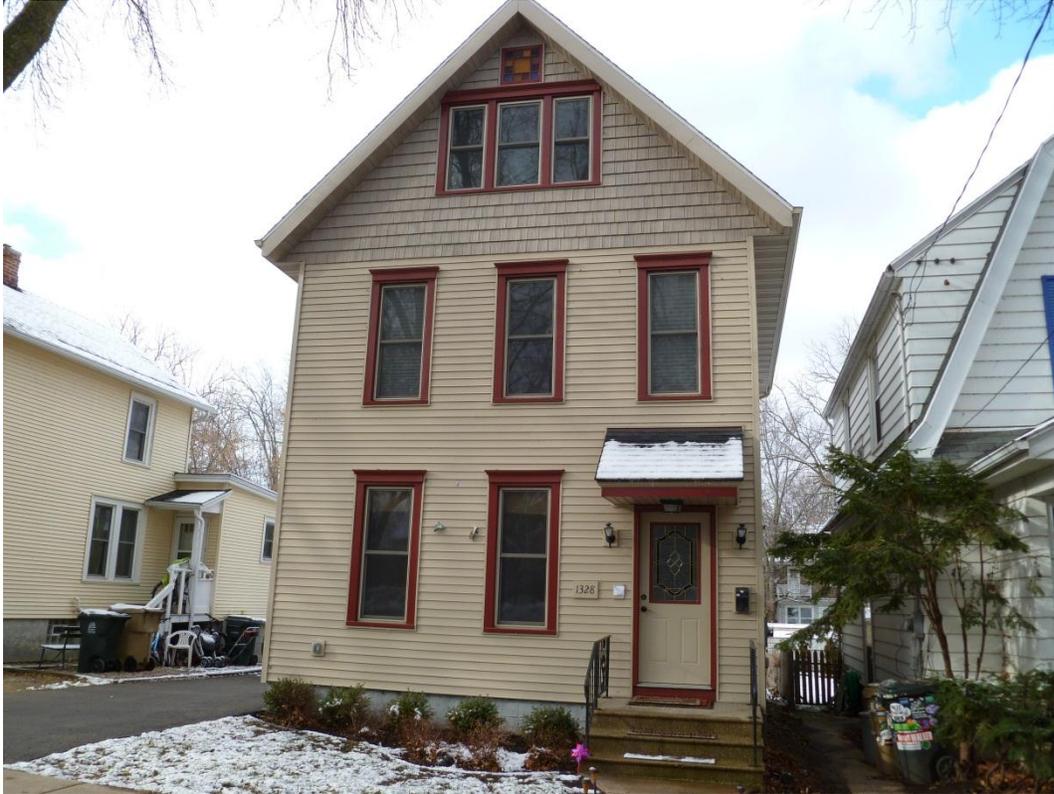
(Picture #22) SURROUNDING PROPERTY:

This is a picture of a surrounding home that has had vinyl windows installed, and exterior aluminum trim around the windows done.

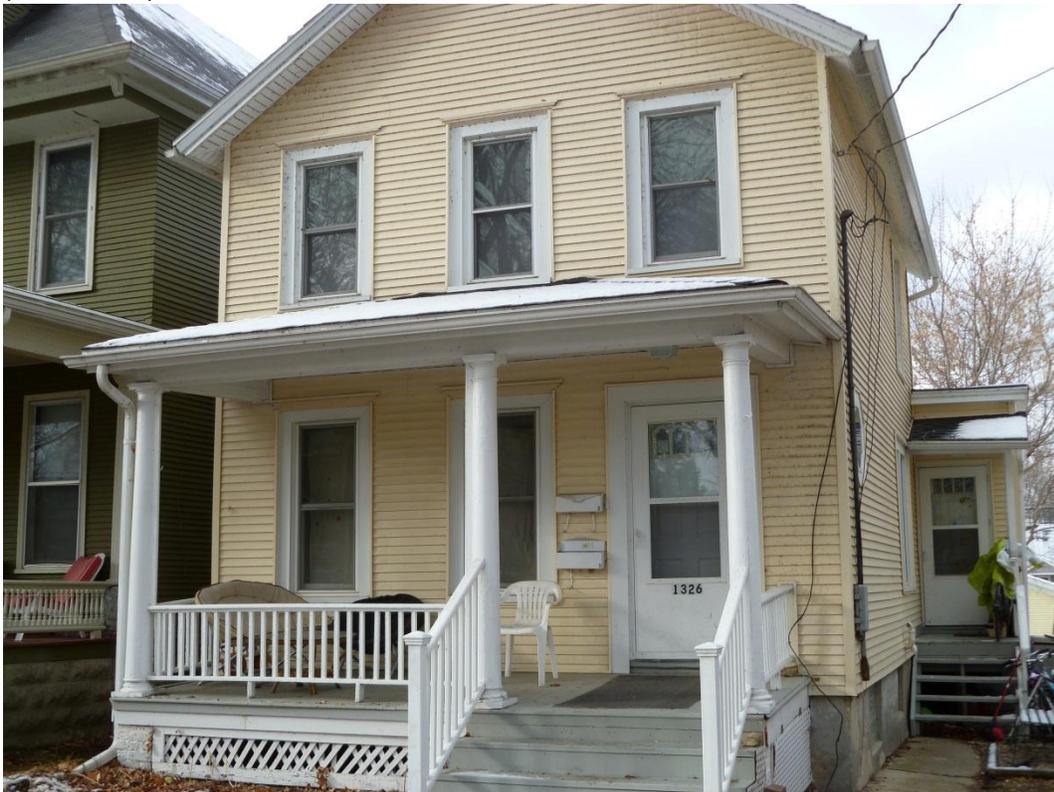
(Picture #23) SURROUNDING PROPERTY:

This is a picture of a surrounding home that has had vinyl windows installed, and exterior aluminum trim around the windows done.

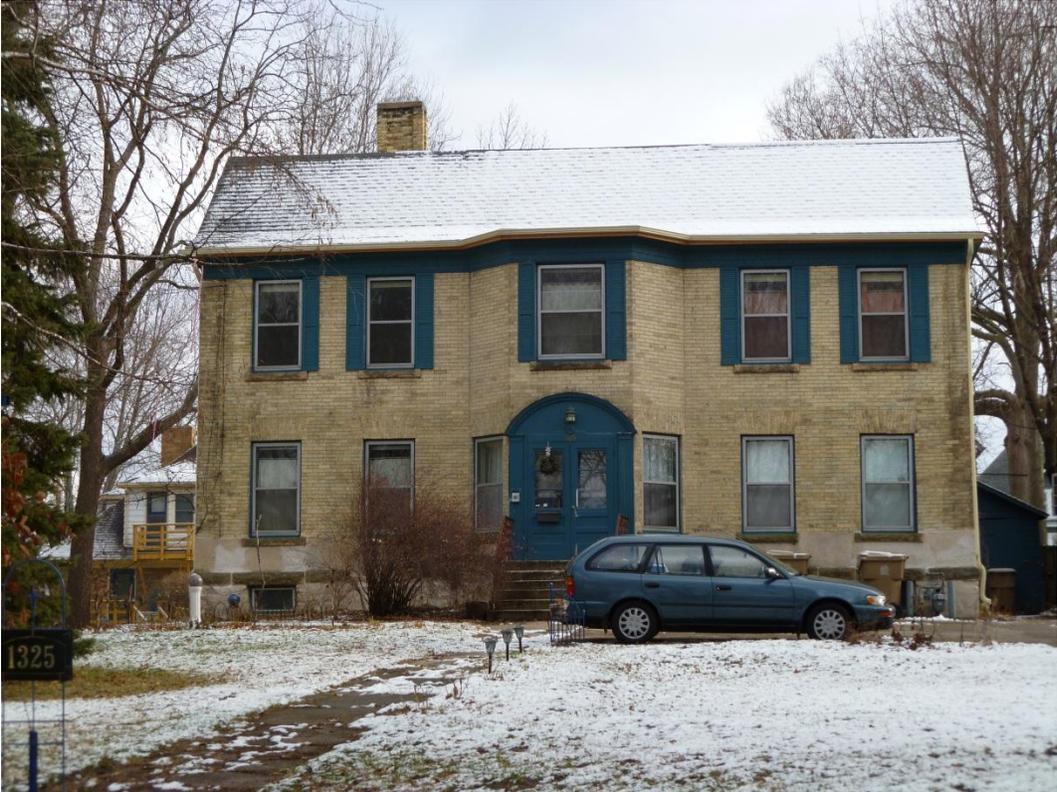
(Picture #24) SURROUNDING PROPERTY:

This is a picture of a surrounding home that has nothing done. Everything looks original.

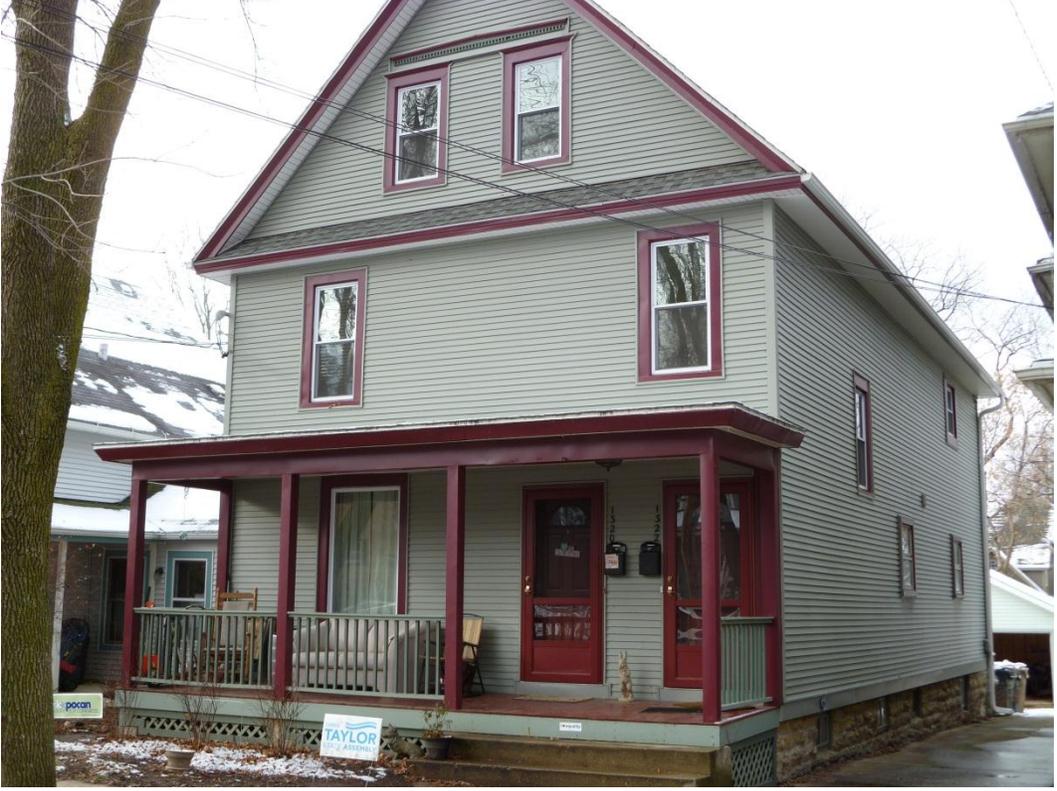
(Picture #25) SURROUNDING PROPERTY:

This is a picture of a surrounding home that has had vinyl windows installed, exterior aluminum trim around the windows done, and vinyl siding installed.
