Madison Metro Transit Building

Executive Summary and Recommendations

City of Madison – Metro Transit
Madison, Wisconsin

March 9, 2018

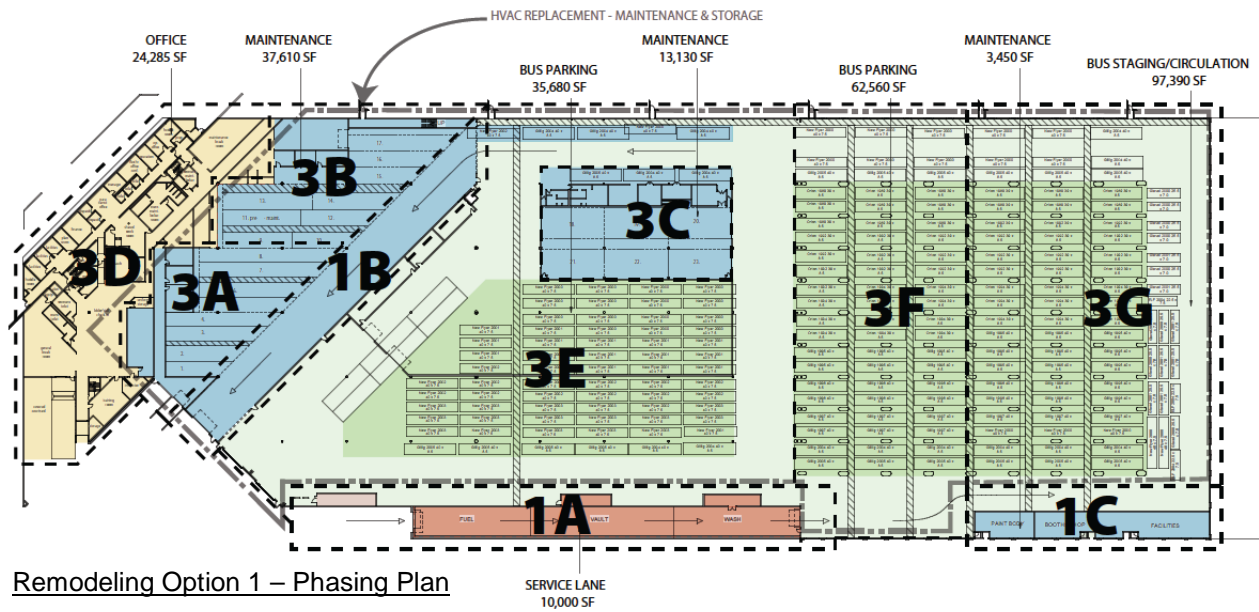
Remodeling Option 1 – Phasing Plan

- Phase 1, 2019 – The new service lane addition and remodeling allows for the continued use of the existing lanes until the new lanes are operational. This eliminates any downtime or suspension of service activities for daily bus maintenance and cleaning. The resultant reclamation of the area of the old service lane provides extra area for bus maintenance and starts the separation for internal zoning of Mechanical ventilation systems. This construction project is estimated to require 9 months.

- Phase 2, 2020 - New mechanical distribution system upgrades to support the existing maintenance areas and bus storage areas, exclusive of the administrative support area. This upgrade would also include the creation of physical separations between work area activities, such as maintenance and the administration and bus storage, to support individual area ventilation requirements and vastly improve air quality within the existing building. This construction project is estimated to require 12 months.

- Phase 3, 2021 - Remodeling of the existing Maintenance, Driver Dispatch, and support areas, will reconfigure to the building to the Remodeling Option 1 layout. This construction activity requires temporary relocation of Maintenance bays, bus storage, and Driver Dispatch/support areas to other off-site facilities or on-site mobile facilities. The sequencing of this construction activity is more critical to maintaining Metro Transit Operations. This construction project is estimated to require 18 months.

- Phase 4, 2022 - On-going Building Maintenance is for the restoration of the existing building envelope, such as metal wall panel replacement and masonry tuckpointing and possible “Gisholt” clerestory roof replacement in the bus storage area. This also would provide for miscellaneous mechanical and electrical system upgrades not addressed in previous projects. This construction project is estimated to require 12 months.
