## Building Condition Report

**4316 Monona Drive, Madison WI**  
**4217 Jerome Street, Madison WI**  
**4221 Jerome Street, Madison WI**

The Monona Grove School District owns three single family houses in the City of Madison, across Coldspring Avenue from Monona Grove High School to the south. 4316 Monona drive was purchased in 1996, 4221 Jerome Drive in 1997 and 4217 Jerome Drive in 1999. The houses have been vacant for most of that time.

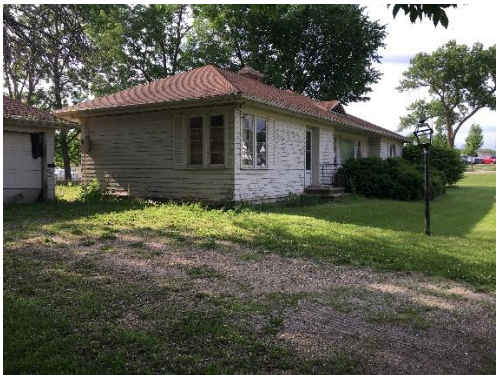
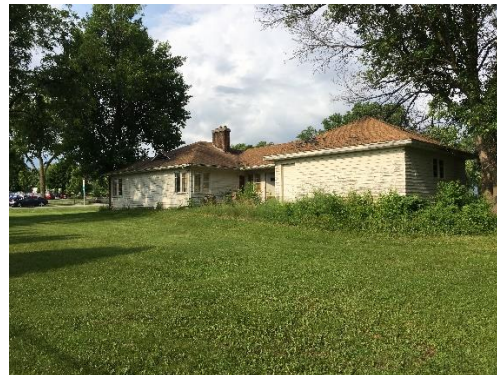
It is a wood framed building on a cast-in-place concrete foundation with full basement. Wood siding and casement windows appear to be original. There is a gravel driveway that is overgrown with weeds. While the building appears to be basically sound structurally, it has significant condition issues.

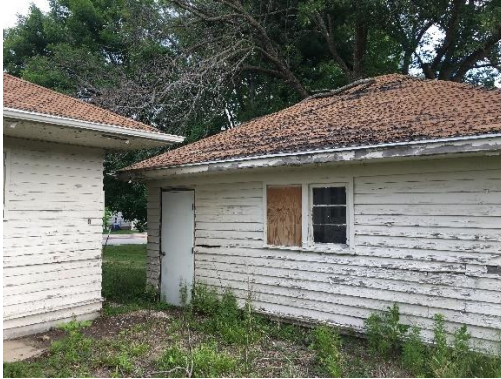
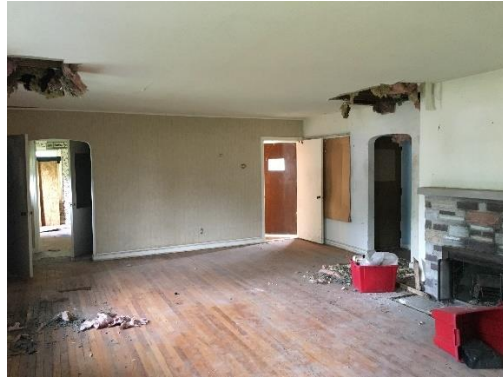
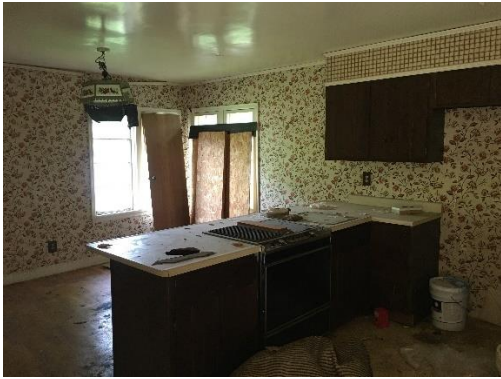
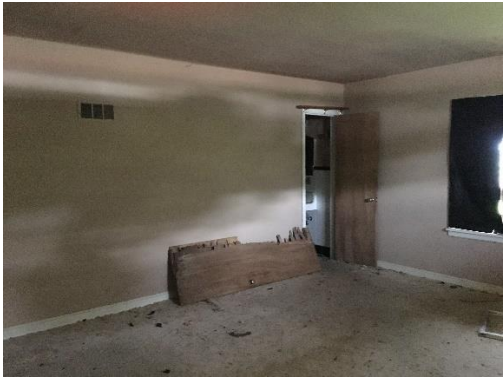
The roof shingles are completely deteriorated. The paint on the wood siding is peeling heavily and the storm gutters, while intact, have plants growing in them. An environmental survey has concluded that asbestos is present in widow glazing and flooring materials.

The interior of the building is not habitable and has suffered damage. There are numerous holes in the walls and ceilings, and most interior doors are missing or non-functional. Heating and main electrical equipment are obsolete. Because the utilities have been disconnected, equipment could not be tested to determine whether they are operational. In its present condition, the house is in need of a complete rehabilitation, remodeling and refurbishment. This includes siding, windows, roofing, HVAC, insulation, bathrooms, kitchen and finishes.

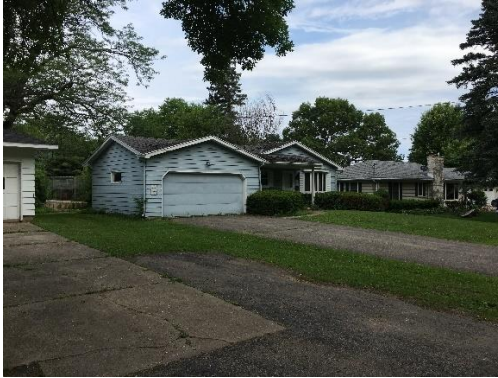
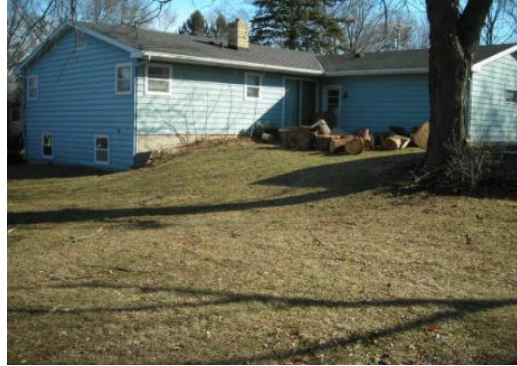
It is a wood framed building on a cast-in-place concrete foundation with full basement. aluminum siding and wood windows appear to be original. There is an asphalt driveway that is in fair condition and the roof shingles are deteriorated and in poor condition. While the building appears to be basically sound structurally, it has significant condition issues.

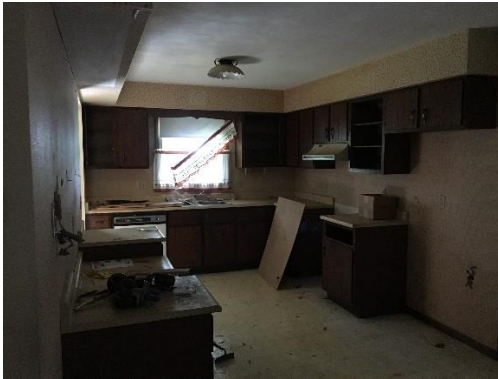
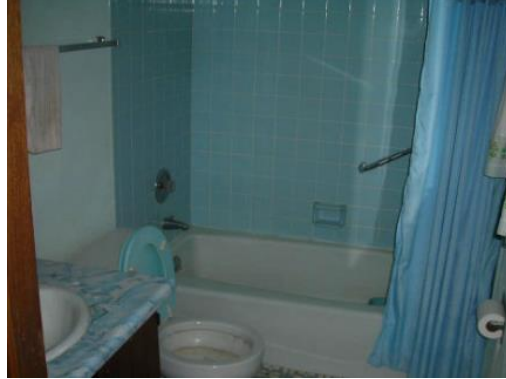
An environmental survey has concluded that asbestos is present in flooring materials.

The interior of the building is not habitable and has been vacant for nearly 20 years. Because the utilities have been disconnected, equipment could not be tested to determine whether they are operational. In its present condition, the house is in need of a complete rehabilitation, remodeling and refurbishment. This includes windows, roofing, HVAC, insulation, bathrooms, kitchen and finishes.

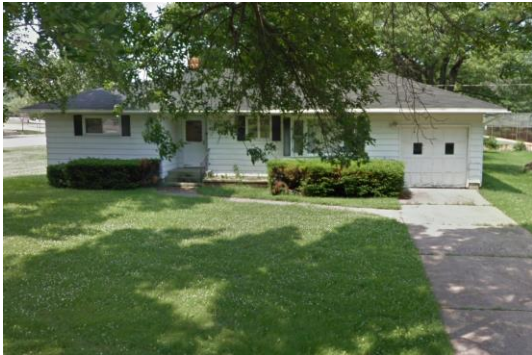
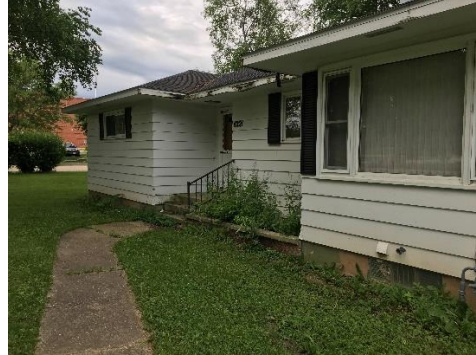
It is a wood framed building on a cast-in-place concrete foundation with full basement. Wood siding and windows appear to be original. There is a concrete/asphalt driveway that is in poor condition and the roof shingles are deteriorated and in poor condition. While the building appears to be basically sound structurally, it has significant condition issues.

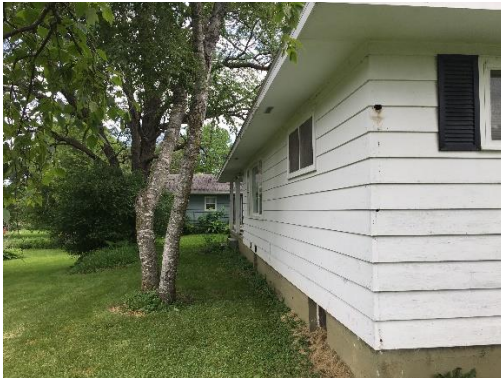
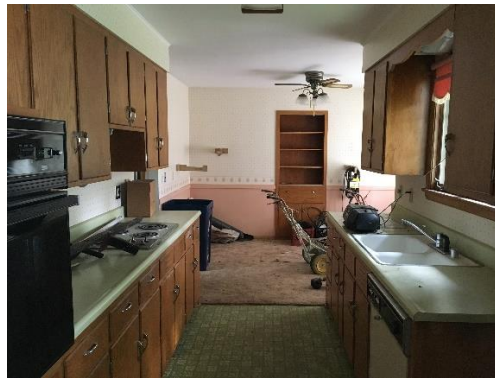
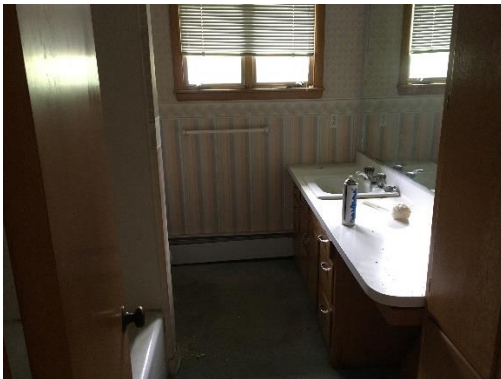
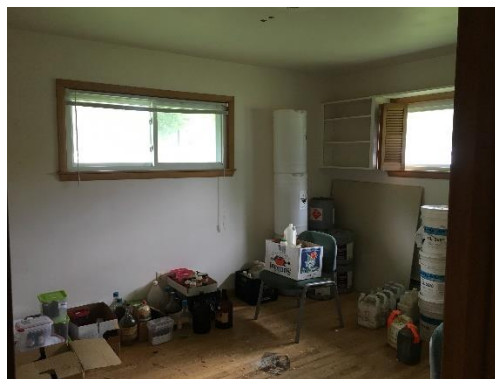
The exterior roof fascia is rotted and falling off in places. It was noted that birds have broken through the siding and are nesting within the exterior walls. An environmental survey has concluded that asbestos is present in widow glazing, flooring materials and the boiler.

The interior of the building is not habitable and has been vacant for nearly 20 years. Because the utilities have been disconnected, equipment could not be tested to determine whether they are operational. In its present condition, the house is in need of a complete rehabilitation, remodeling and refurbishment. This includes siding, soffits, windows, roofing, HVAC, insulation, bathrooms, kitchen and finishes.
