LANDMARKS COMMISSION APPLICATION

Project Title/Description: EXTERIOR REPAIR - 121 LANGDON

RE: Letter of Intent – 121 Langdon Street

The owner of the registered landmarks building (John Suhr Residence) at 121 Langdon was issued a notice for needed repair work on the building. Attached is that repair notice and drawings addressing the repairs.

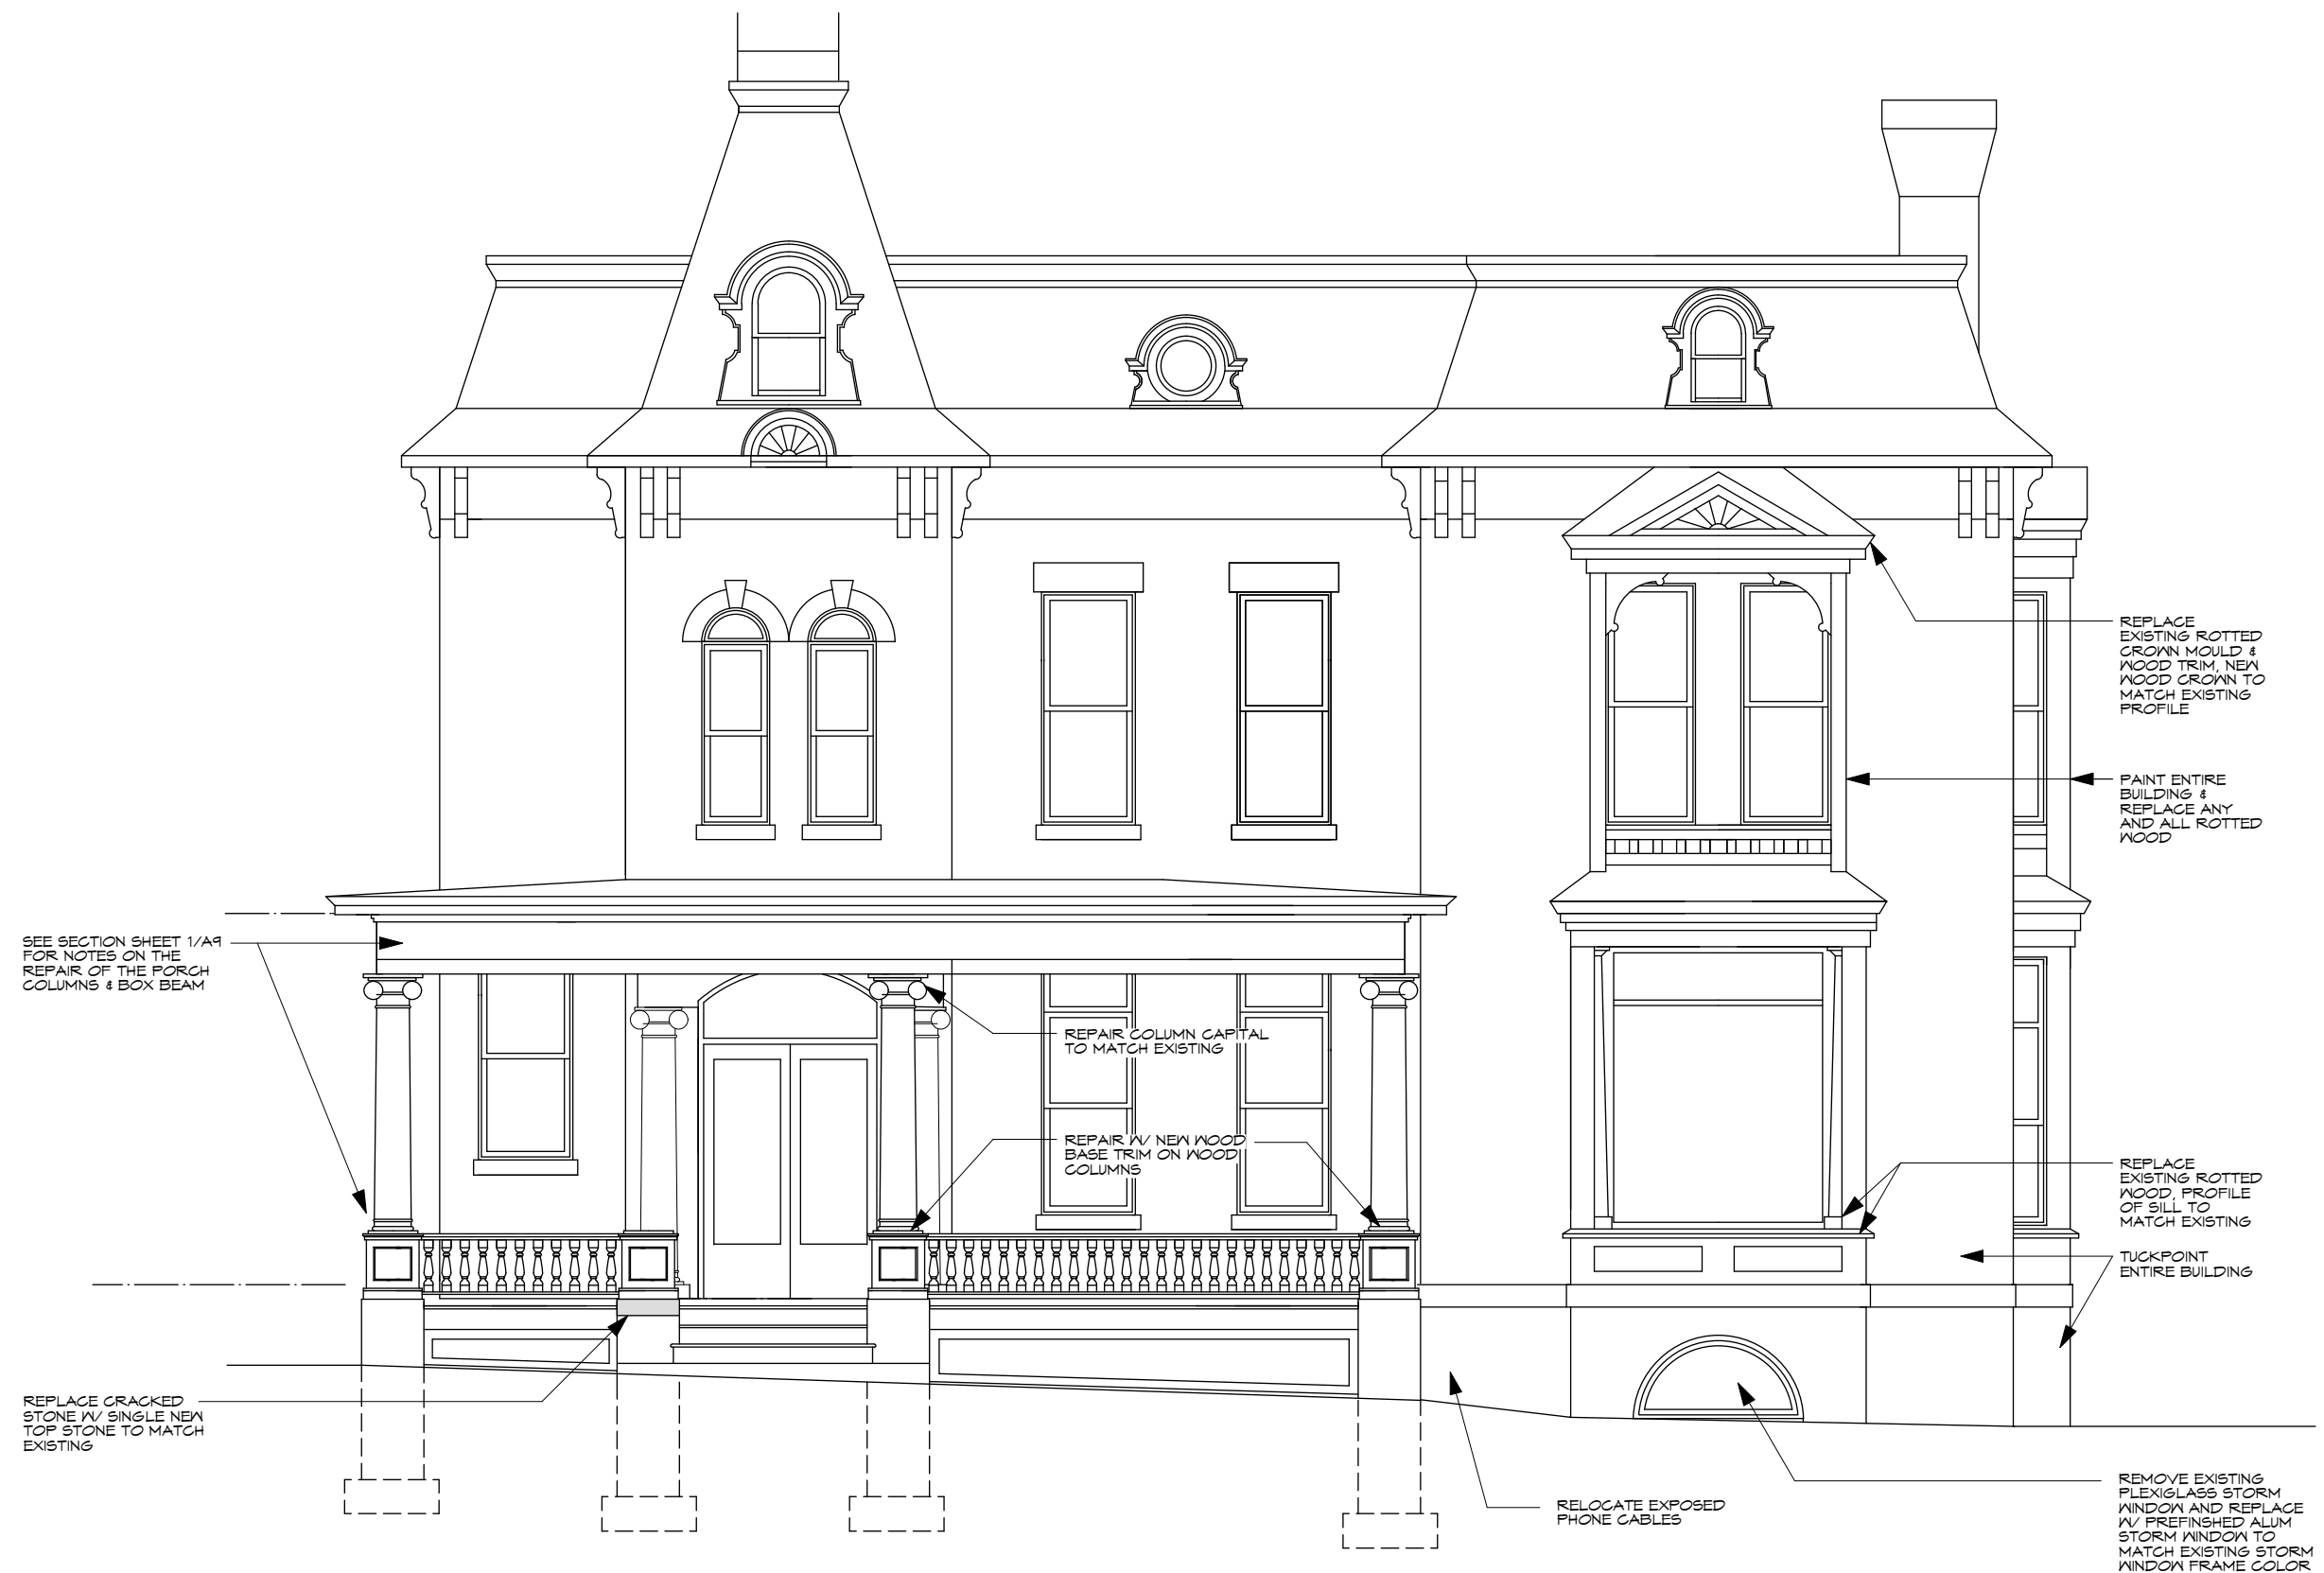
FRONT ELEVATION

GENERAL NOTE: REPAIR BUILDING WOOD TRIM, BRICK & STONE AND PAINT PER CITY INSPECTION REPORT.

2. I have proposed replacing the metal roof on the front porch with a rubber roof membrane.
3. South side porch will be restored to the original building design. I have relocated the required exit stair to the rear of the building and have proposed using the same baluster design of the south porch on the stair guardrails.

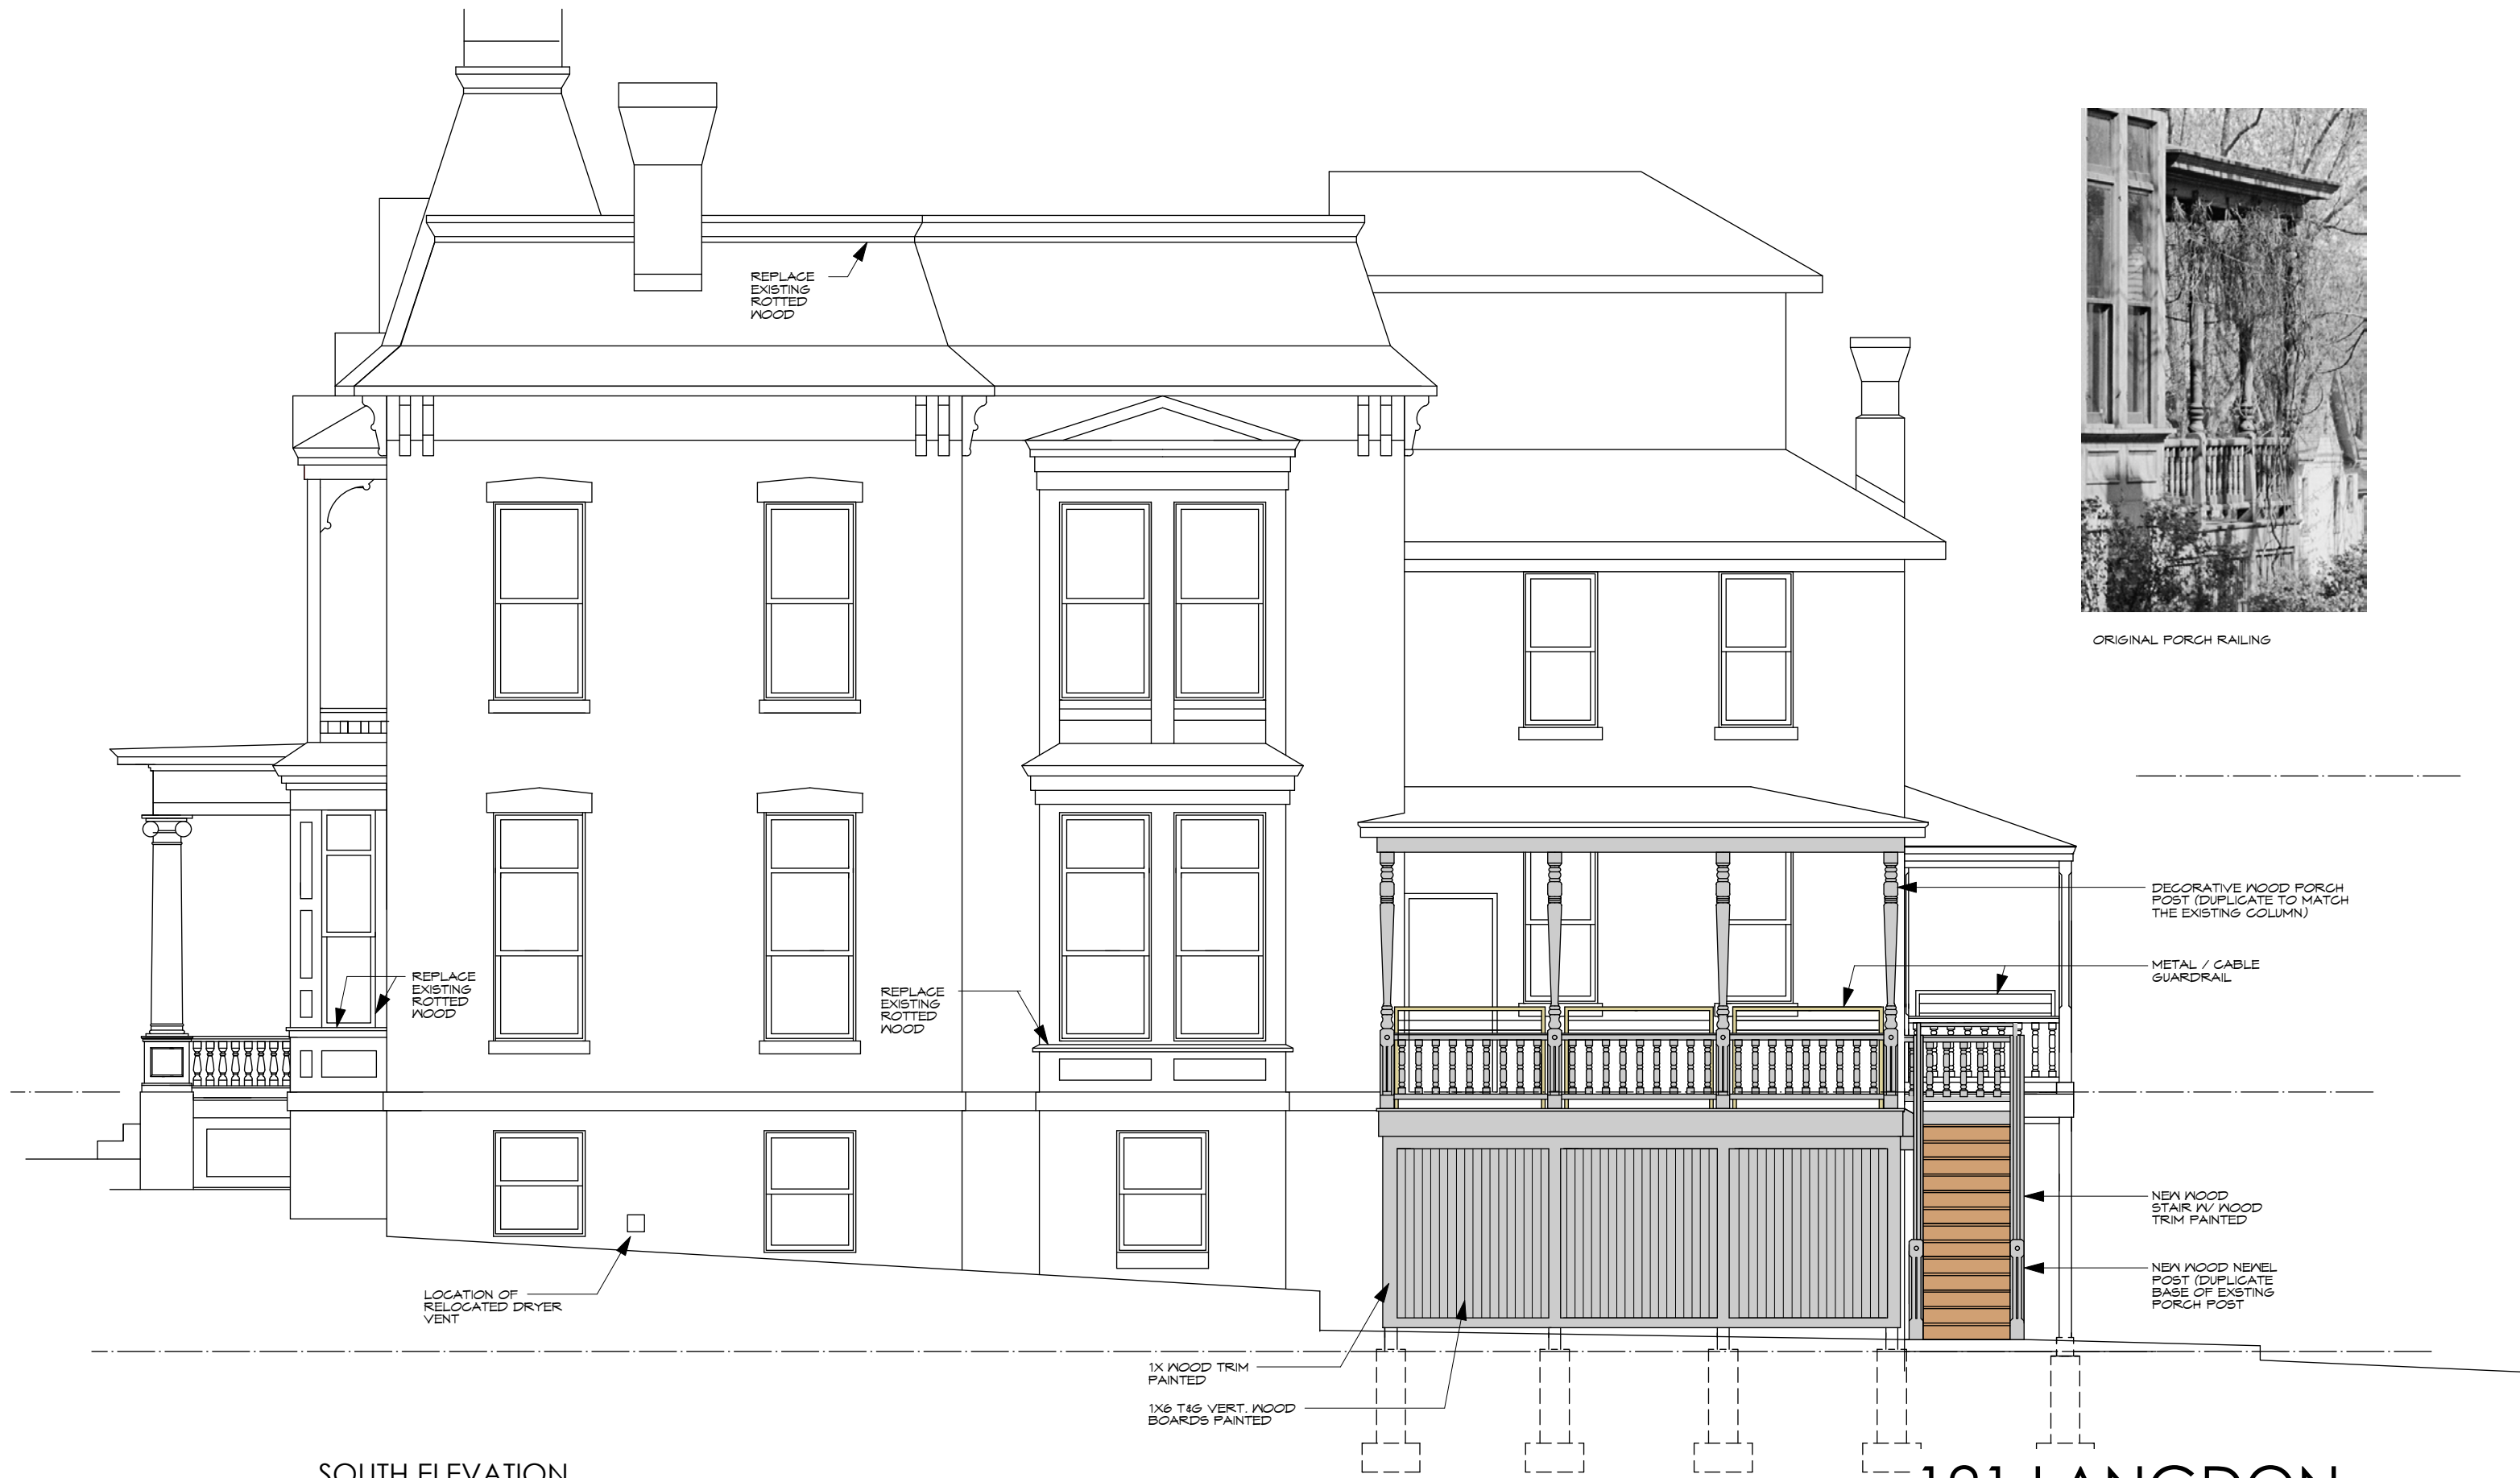
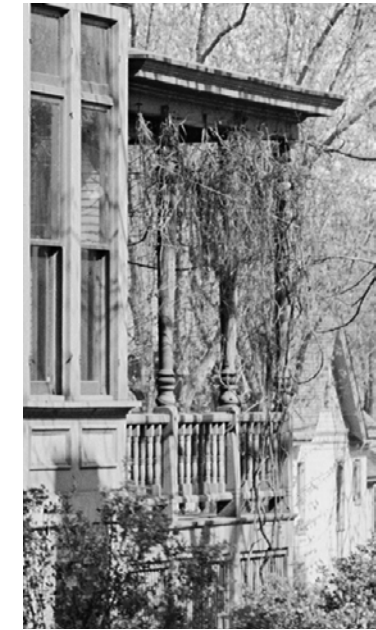
SOUTH ELEVATION

ORIGINAL PORCH RAILING

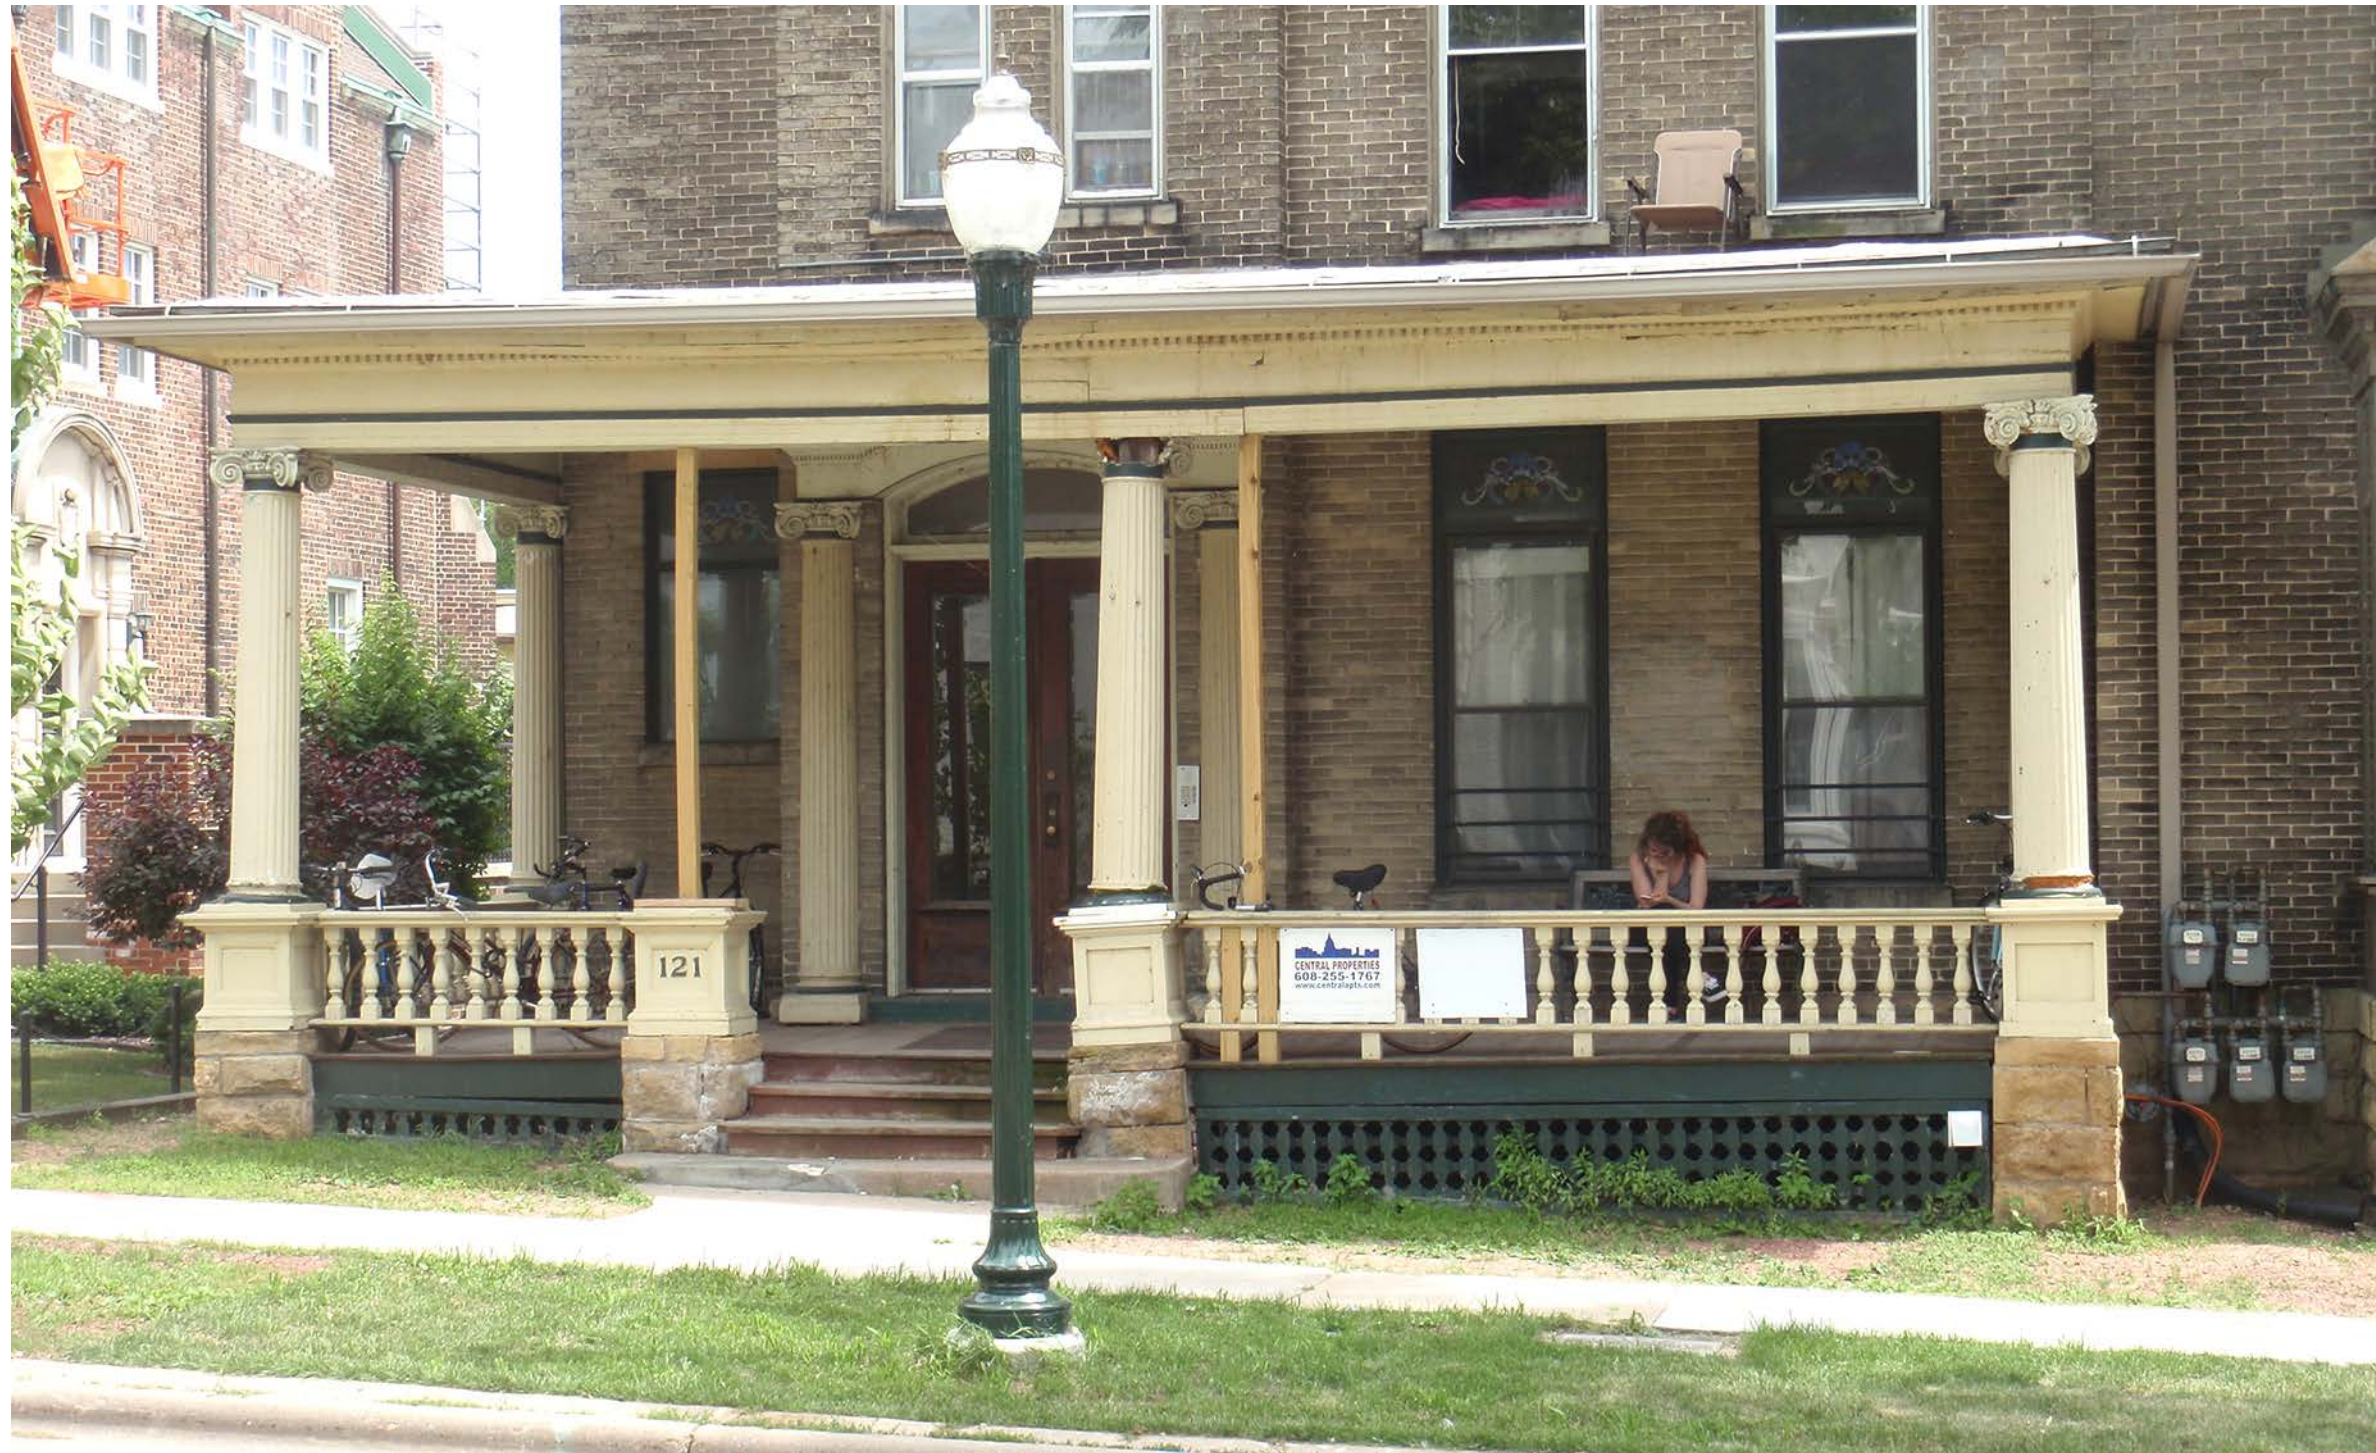
FRONT PORCH PHOTO

Obtain the required building permit and inspections and repair or rebuild the front porch and roof assembly to a safe and substantial condition. This includes, but is not limited to:

- Repair or replace the damaged and out of plumb masonry piers supporting the front porch roof columns, tuck point the columns as needed, and replace any missing material. Ensure all piers are returned to plumb condition and can support all loads applied to them
- Repair or replace the porch columns - the columns are deteriorating and out of plumb - ensure all columns are returned to plumb condition and can support all loads applied to them
- Repair or replace any deteriorated beams and framing in the front porch roof assembly and return them to a level condition.
- Replace any rotted, missing, or damaged fascia, soffit, trim, or decorative members on the front porch assembly

- Eliminate all holes, gaps, and cracks, and repair the crushed areas where the support columns meet the beams
- Ensure that the roof system is weatherproof, rodent proof, and in proper repair

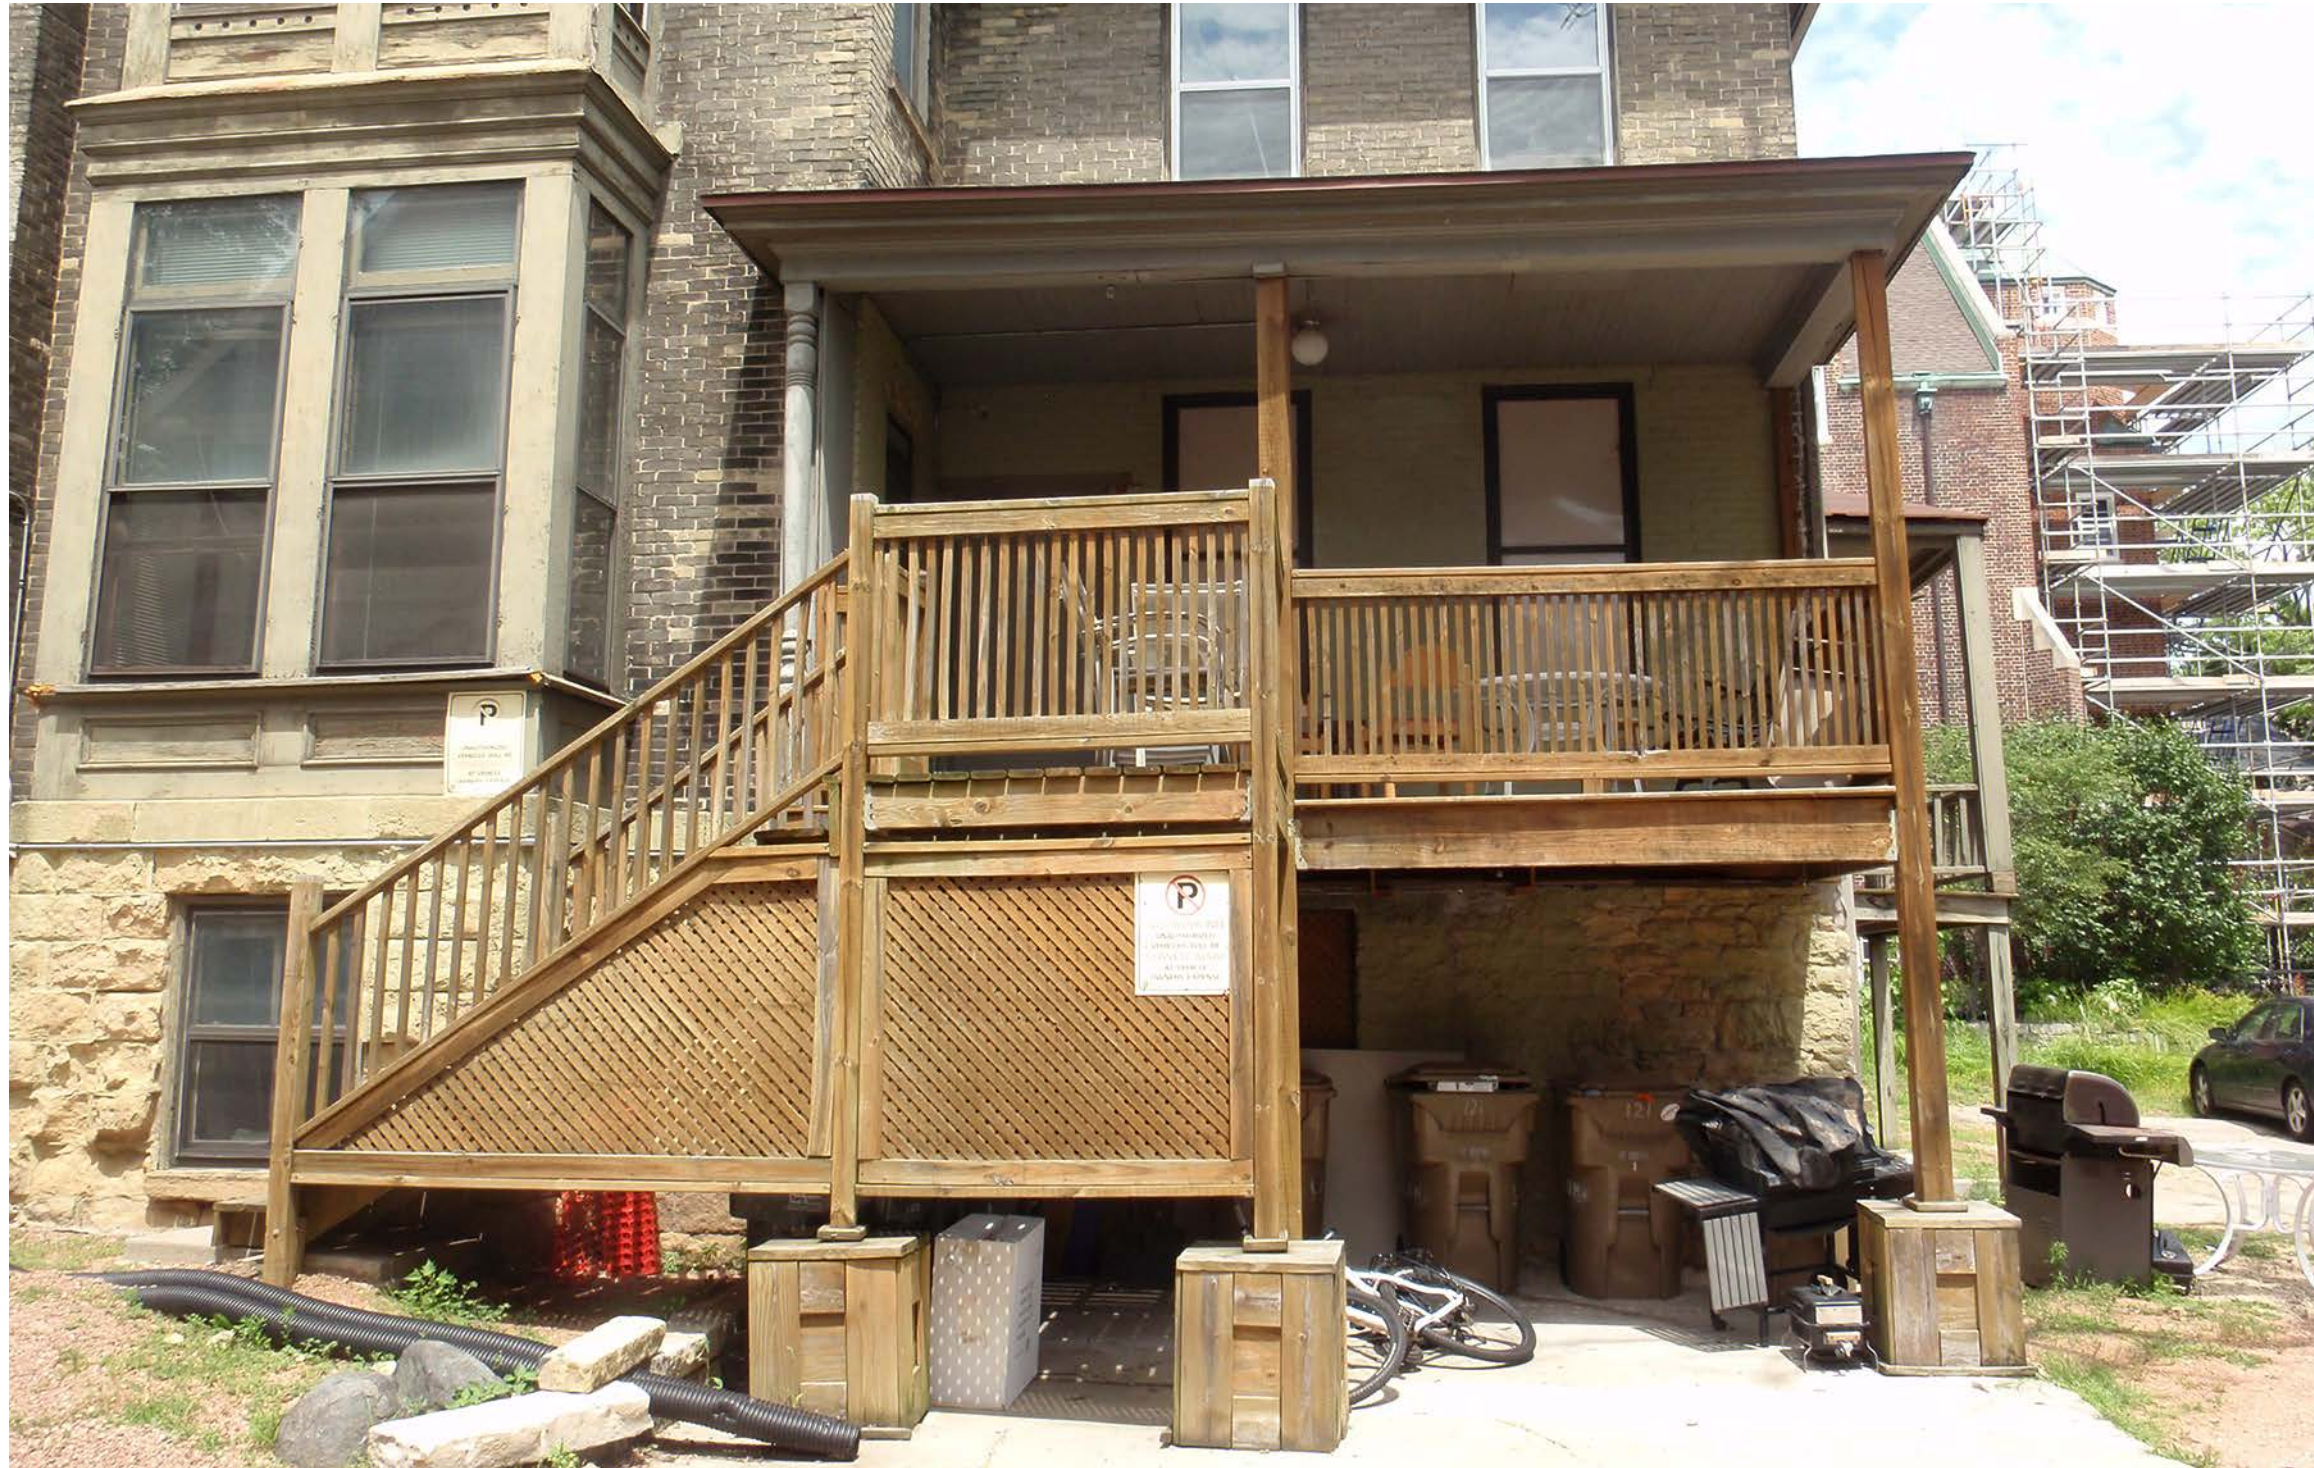
SIDE PORCH PHOTO

Obtain the required building permit and inspections for the right side porch stairway that was installed without approvals or return the area to its original condition. An inspection found that a non-code complaint right side porch stairway was installed without a building permit or approvals. Some items observed that do not comply with the building code are as follows:

- Use of a 2x4 as top of handrail
- Handrail does not extend to the bottom landing
- Unknown construction of support post footings
- Stair stringers not properly attached to the top beam
- Existing box beam supporting roof system crushed/rotted
- Beam connections not resting on top of support posts
- Drywall screws used in post to footing connection
- Foundation window not safety glass at base of stairs

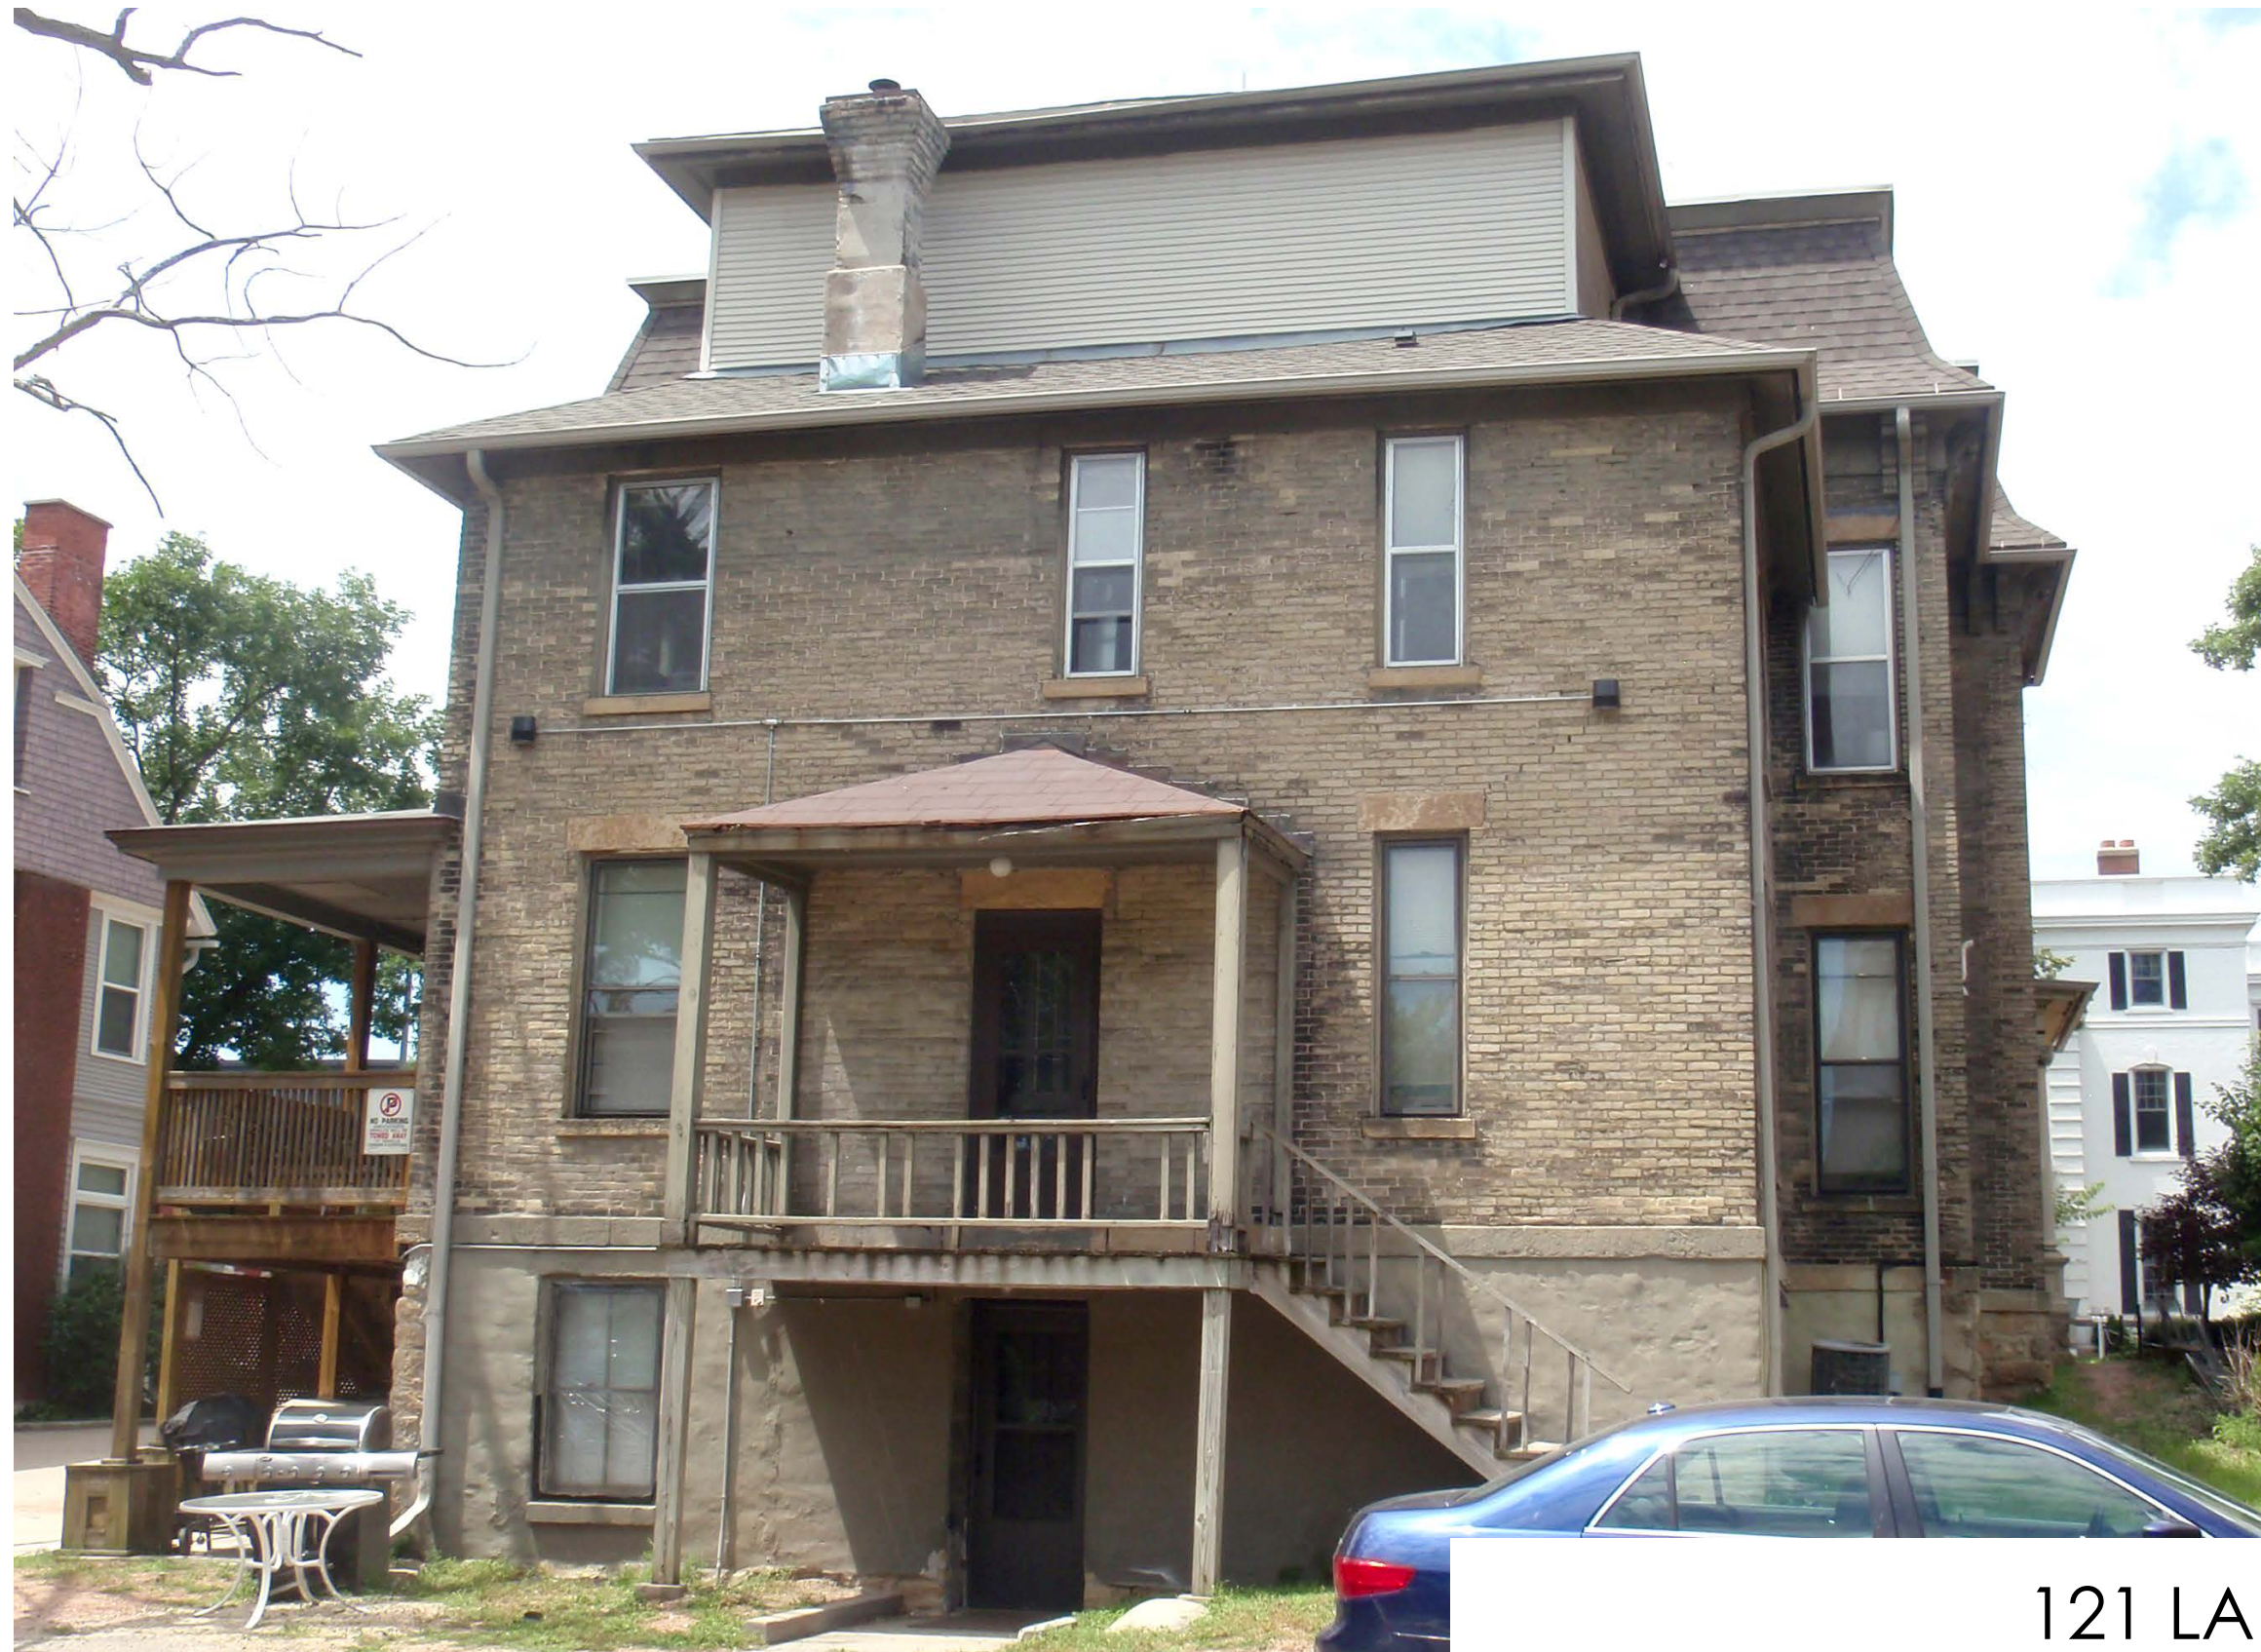
REAR PORCH PHOTO

Obtain the required building permit and inspections for the work done to repair the rear porch assembly and return the rear porch assembly to a safe and code compliant condition. An inspection found that incorrect rear porch repairs were made without a building permit or approvals. Some items observed that do not comply with the building code are as follows:

- Open stair risers
- Over span of deck support beams
- Unknown construction and use of "cookie" support post footings
- Missing beam/support post connections
- Loose, rotted, and/or missing balusters
- Rotted wood in the roof support columns
- Rotted/animal damaged wood roof fascias/soffits/trim
