## Chapter 18: Lead-Based Paint and Historic Preservation

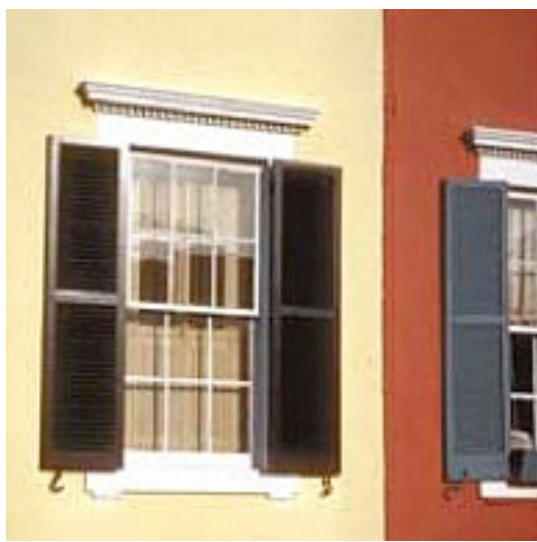
**FIGURE 18.1** Delicate muntins and multi-pane sash on early 19th century row houses. Photo Courtesy National Park Service.

The quality of a building's architecture and craftsmanship must be considered when evaluating the significance of a property. Buildings that exhibit distinctive characteristics of architectural design represent work by skilled craftsmen, or have high artistic value may require a greater sensitivity on the part of a responsible entity when undertaking alterations or modifications to that structure (see Figure 18.1). Worker housing in an industrial mill town was often constructed with heavy timber post and beam construction or balloon frame wooden systems, but may have very simple decorative or trim work on the interior. The significance of these properties is more closely tied to social movements within our cultural history than to architectural design. A property designed by a prominent architect using master craftsmen and artistic painters will be noted for its architectural appearance and design.

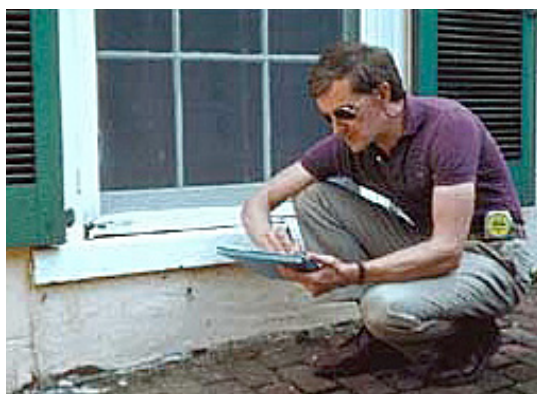
**FIGURE 18.2** Historic properties should have a window condition assessment preceding work. Photo Courtesy National Park Service.

Identifying, retaining, and preserving windows – and their functional and decorative features – is an important step in preserving the overall historic character of the building. Such features can include frames, sash, muntins, glazing, sills, heads, hoodmolds, paneled or decorated jambs and moldings, and interior and exterior shutters and blinds. An in-depth survey of the interior and exterior features and condition of existing windows will provide the basis for evaluating possible rehabilitation or replacement options to make the windows lead-safe. The exterior portion of a window assessment is shown in Figure 18.2.

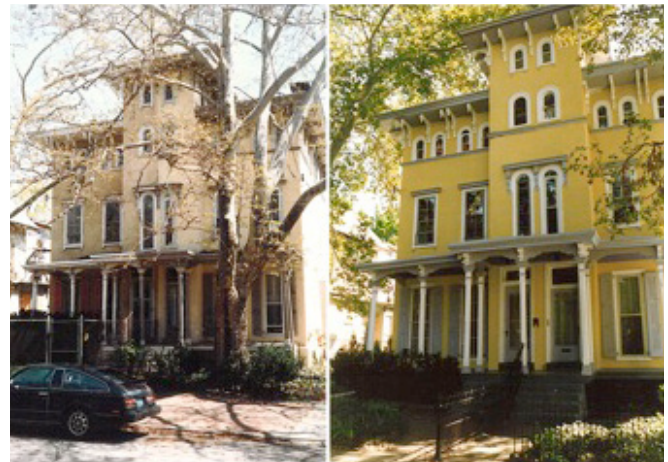
FIGURES 18.3a and 18.3b

Historic property before and after rehabilitation.

The significance of historic elements also affects priorities for intervention. (Figure 18.3.) Historic components should be treated with great care when physical intervention is considered as part of a lead hazard control plan. If the element is extremely significant (e.g., a carved mantel) and is in good condition, it should be disturbed as little as possible while still ensuring that lead hazards will be controlled. In this case interim controls are generally preferred (see Chapter 11). If the element is not particularly significant (e.g., a simple baseboard) and is in poor condition, then it may be acceptable to remove the entire feature and replace it with a duplicate or similar baseboard. If the element is significant, but in deteriorated condition, then preservation measures should ensure that in the process of rebuilding or repairing the element, it is not further damaged. Careful paint removal and thorough cleaning of substrates is very time consuming, but may be appropriate for highly significant elements.

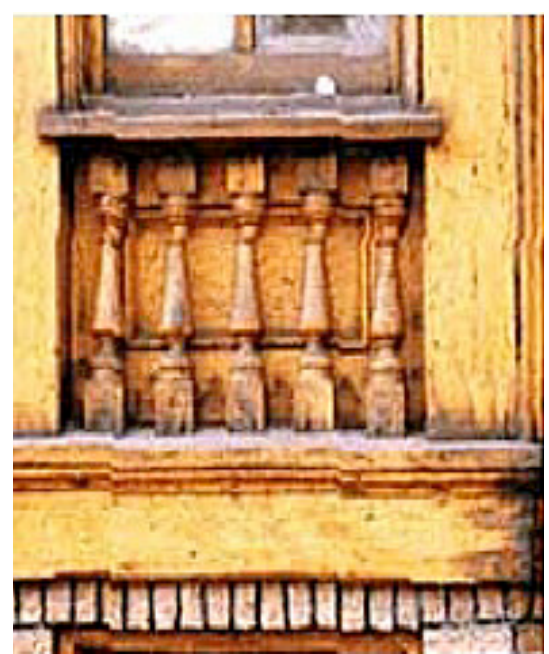
**FIGURE 18.4** Wood features on historic properties. Sometimes they can be stabilized instead of stripped of traditional painted finish as in this photo. Photo courtesy of National Park Service.

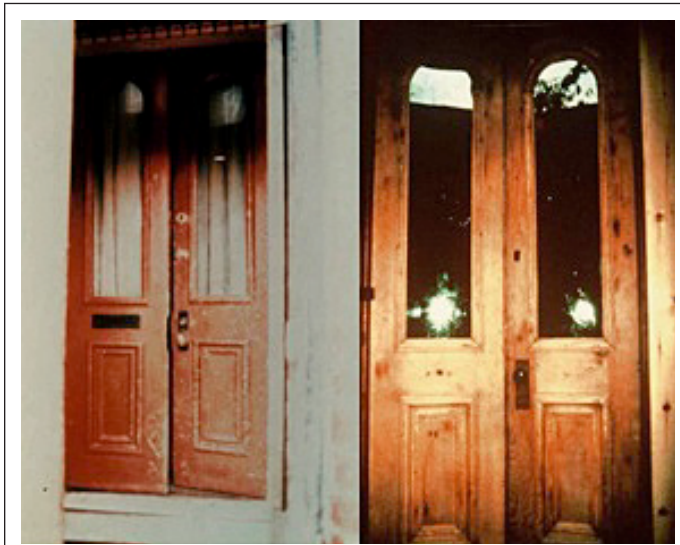
FIGURE 18.5a and 18.5b

Doors to historic property before and after off-site stripping.

**Off-Site:** A potentially more damaging paint removal treatment involves the removal of items for off-site stripping. Only companies experienced in treating historic building parts should be used to conduct paint stripping. If the items are easily removed (e.g., doors, shutters, or windows), they can be carefully treated off-site and then reinstalled. (See Figure 18.5). Caution is advised when considering this method because trim, mantels, banisters, newel posts, or other carved elements constructed in sections may be firmly attached and may be damaged when removed, thus requiring repair or reconstruction. Hardware should be removed and labeled before paint is removed.

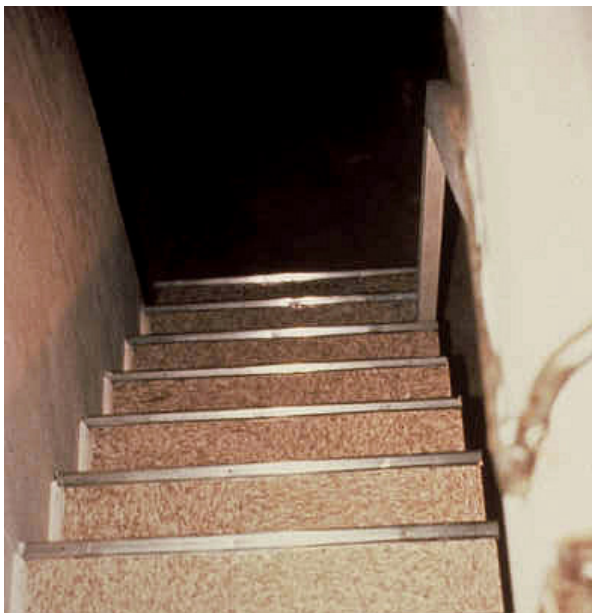
**FIGURE 18.6** Enclosure of stairs in this manner is generally not appropriate in a historic property.

Enclosing a decorative feature may be appropriate if doing so does not damage the structure beyond a minimal amount (see Figure 18.6). For example, a projecting mantel might be enclosed if the fireplace is not to be used in the interim, and the decorative finishes are to be enclosed behind drywall finishes. While this is a serious loss of historic character, if it is a temporary solution and no harm is done to the feature, it might be an appropriate treatment. The use of artificial siding over painted and otherwise sound historic exteriors often results in a removal of projecting historic elements, such as roof brackets, and conceals the historic trim. The use of these artificial sidings is not recommended.
