From: [Punt, Colin](#)
To: [Plan Commission Comments](#)
Subject: FW: Oscar Mayer Health Assessment - Final
Date: Wednesday, December 7, 2022 10:14:28 AM
Attachments: [image001.png](#)
[image002.png](#)
[image003.png](#)
[image004.png](#)
[image005.png](#)

Overview of Oscar Mayer (OM) and Hartmeyer Sites

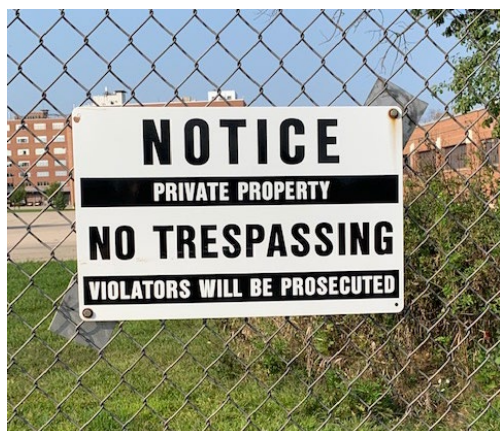
Figure 7. Trespassing sign on the central Oscar Mayer Property near back of Bodgery building.

Bodgery, there is a “garage door” type entrance to the building and a side door. Both appeared to not be in use (Figure 6). The fencing right outside this area does have a “No Trespassing” sign (Figure 7). A building at the back of the lot did appear to be in use with cars parked in the parking lot but it appeared to be for the building labeled “Nine-Ten” which is being leased out by a third party company. Upon further

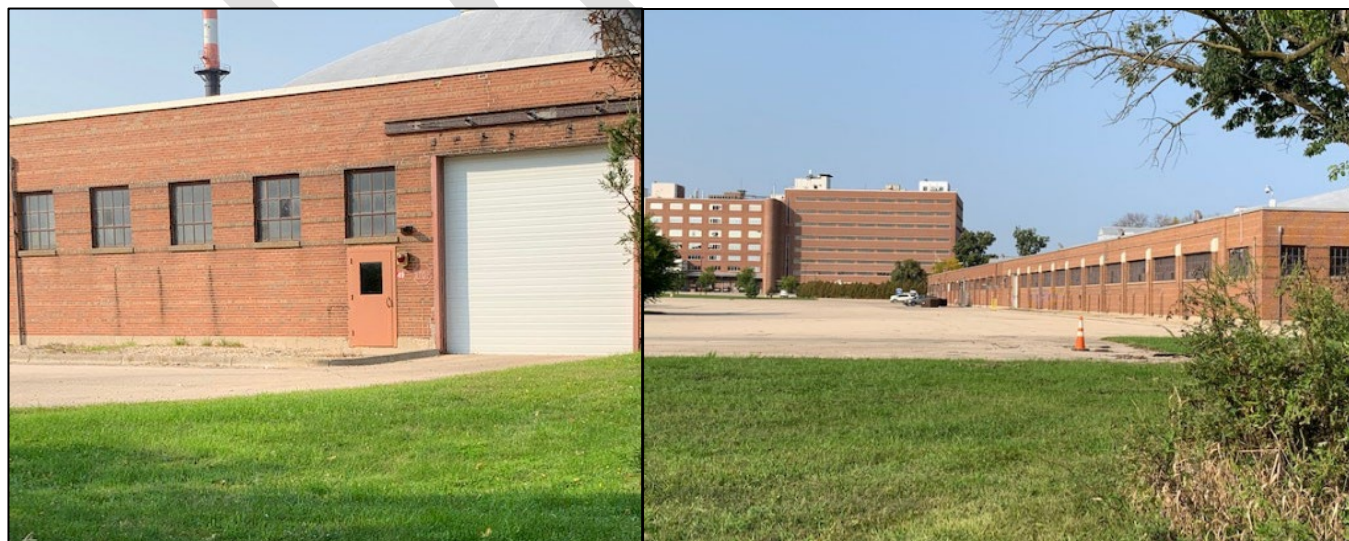
Figure 8. The south side of the Bodgery building adjacent to the former 1,2-DCA tank site

- 1) Deed restrictions that require a surface barrier over the remaining soil contamination in order to prevent contamination from impacting human health through direct contact and to prevent contamination from impacting groundwater due to the infiltration of precipitation. The deed restriction also requires the property owner to investigate the degree and extent of residual contamination that is currently inaccessible if and when structural impediments that currently exist on the property are removed.
- 2) If contamination remains, all current and future owners and occupants of the property need to be aware that excavation of the contaminated soil may pose an inhalation or other direct contact

hazard at the time of excavation. Special precautions may need to be taken during excavation activities to prevent a direct contact health threat to humans.

As part of the deed restriction, the pavement barrier is required to be inspected annually and documentation kept noting said annual inspection. **Therefore, these sites have no apparent public health hazard at this time.** Future changes that impact or remove the existing barriers would require DNR approval, which would include an evaluation of potential health hazards by DHS.

In the interim, DHS also recommends that general precautions be taken for workers handling any soil in order to limit dermal exposure and incidental ingestion of soil. This includes:

- Wearing gloves when handling soil or site material during the remediation process
- Proper hand washing and hygiene prior to handling, preparing, and/or eating food
- Changing boots and/or clothing between the worksite and home to avoid cross contamination from the site and the home environment.

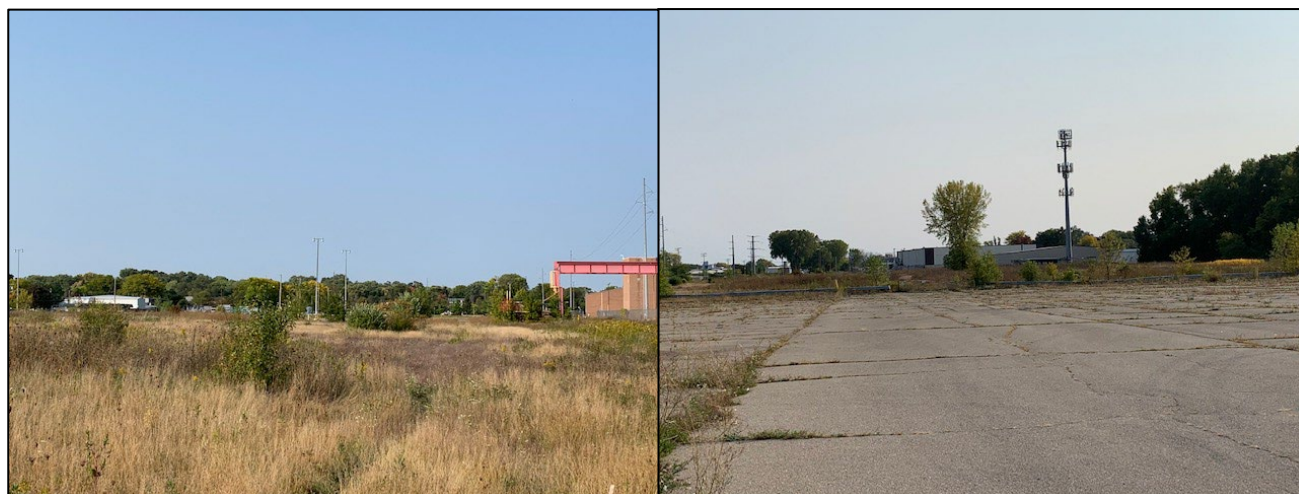
Figure 10. Hartmeyer site looking South to North (left photo) and looking north to South (right photo).

Currently, this site is easily accessible to the general public, is not enclosed by a fence, and there is no signage on the property. It also sits adjacent to businesses with parking lots. The northwestern portion of the site is partially capped with pavement. The site is also covered with dense vegetation (Figure 10 and 11) and there are railroad tracks to the east of the site that would limit access in that direction. As long as these features ensure sub-surface soils remain inaccessible, ingestion or dermal exposure to contaminated soil is unlikely and the exposure pathway for contaminated soil at the site is considered to be incomplete
