Winter Maintenance on the Shared-Use Southwest Path

*Possibilities for
Improving Safety
and
Eliminating
Salt & Brine Use*

*Compiled from the experiences
of daily wintertime users of
the Southwest Path*

*Southwest Path Alliance
Madison, WI*

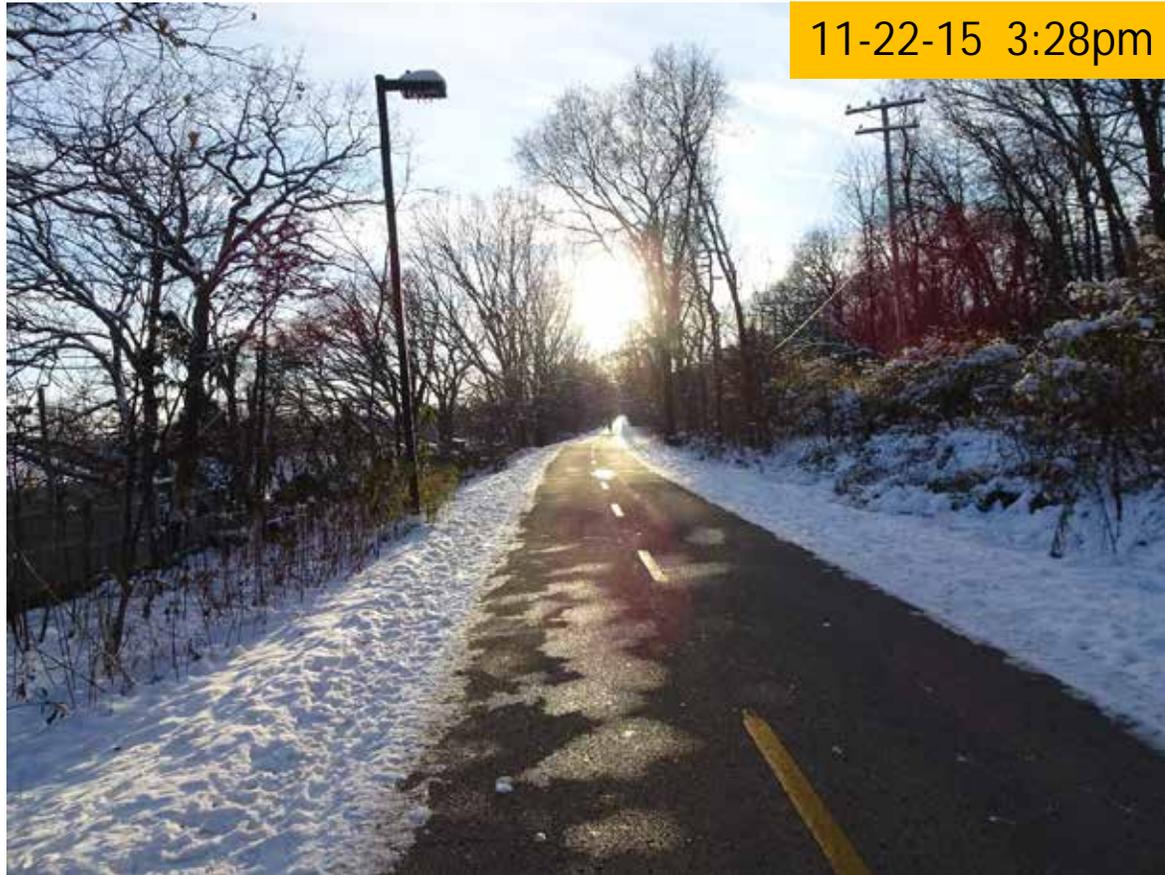
Section of path with NO BRINE
(Clean pavement emerging)

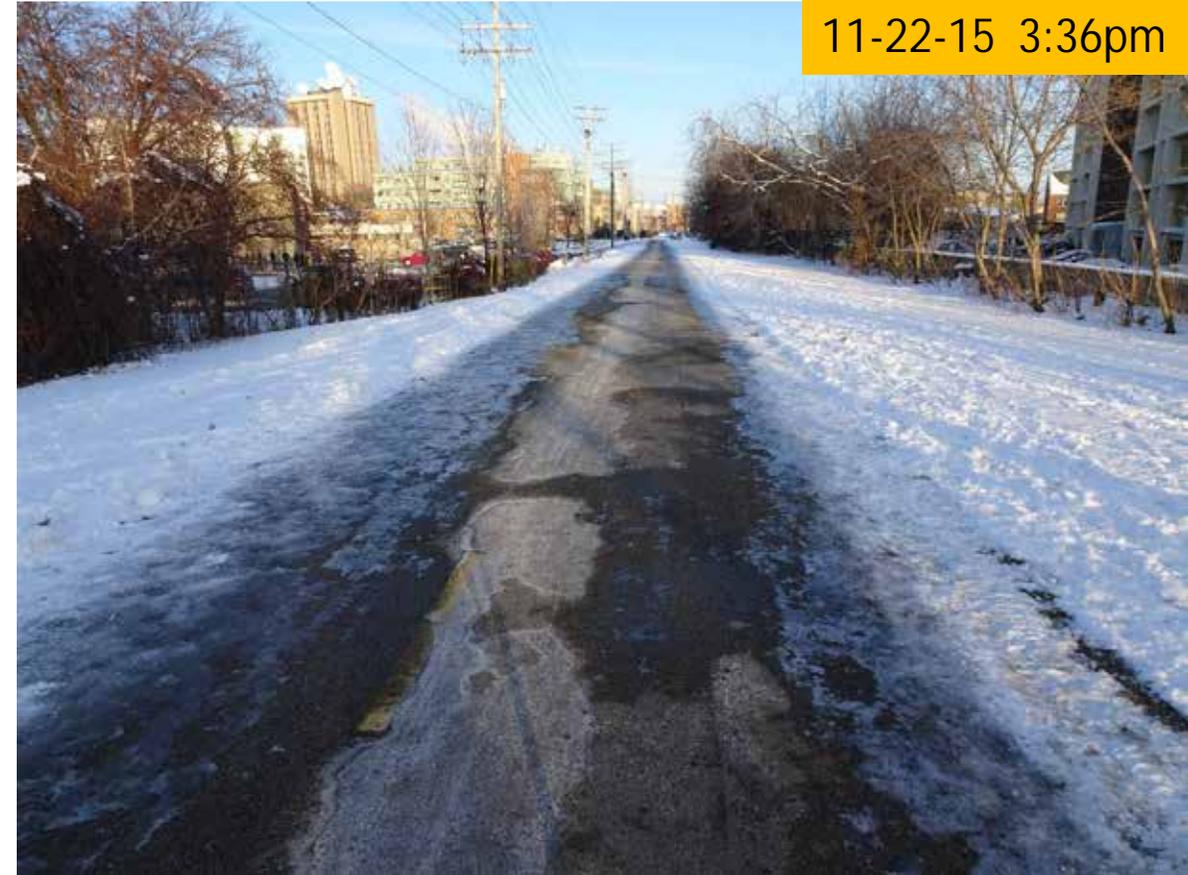
Section of path with BRINE PRE-TREAT
(Corrosive residue emerging)

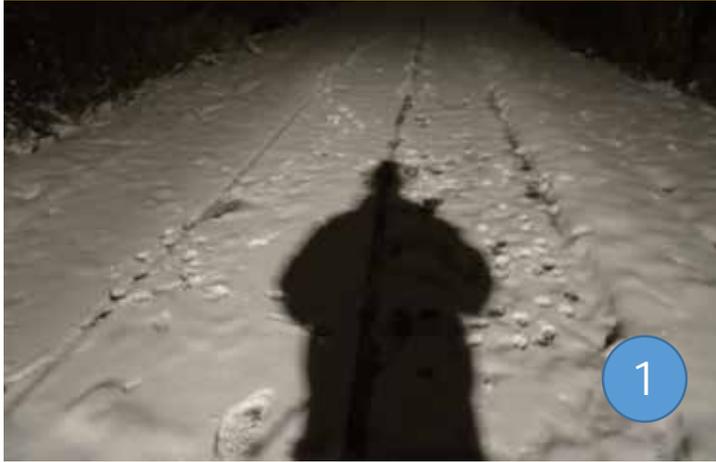
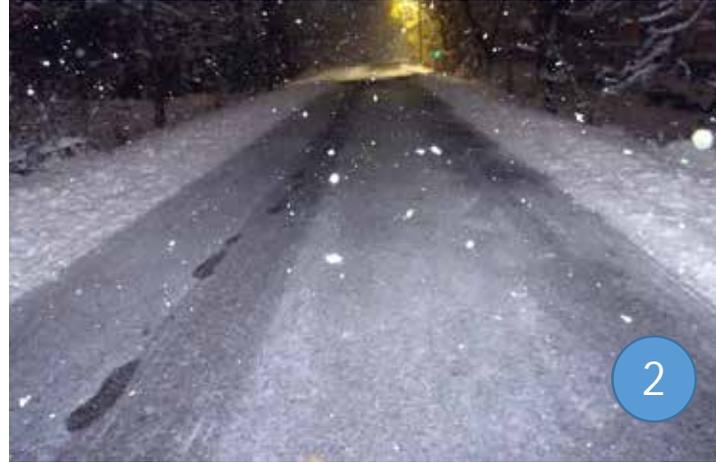
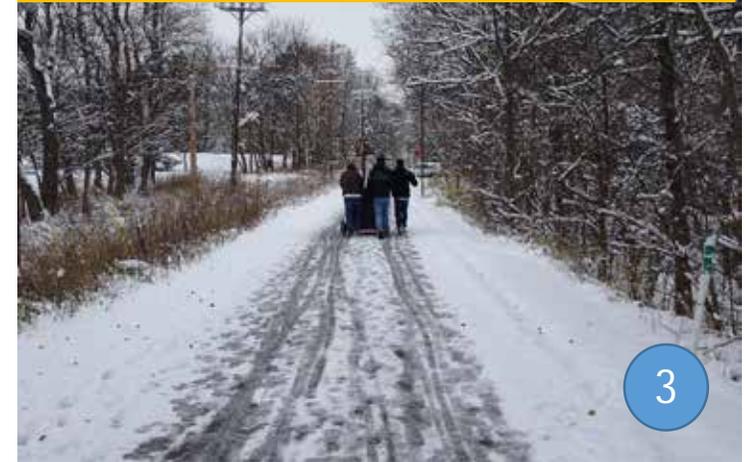
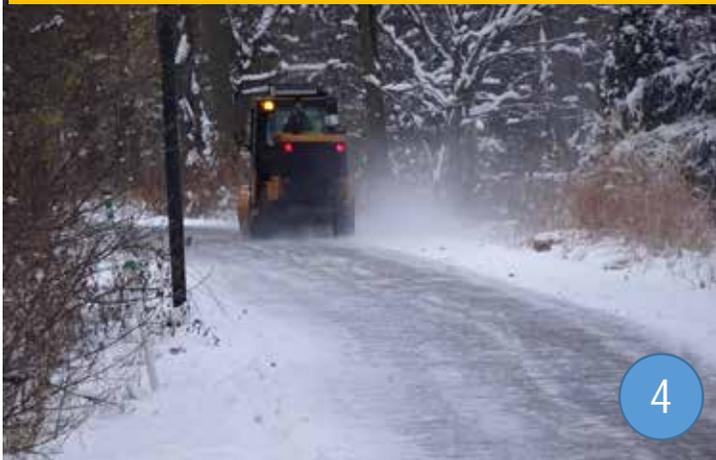
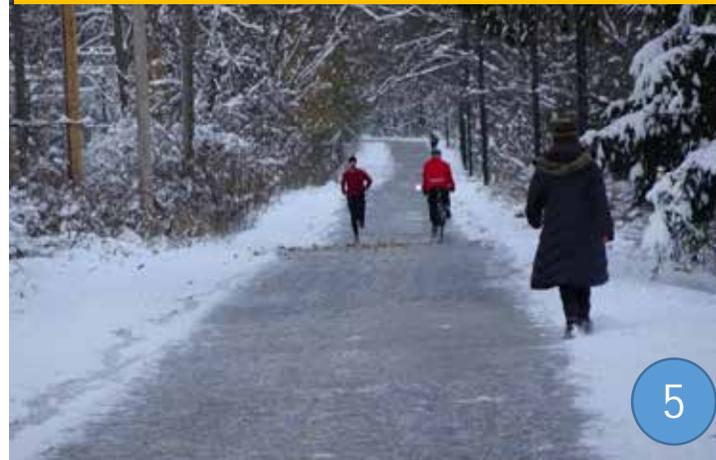
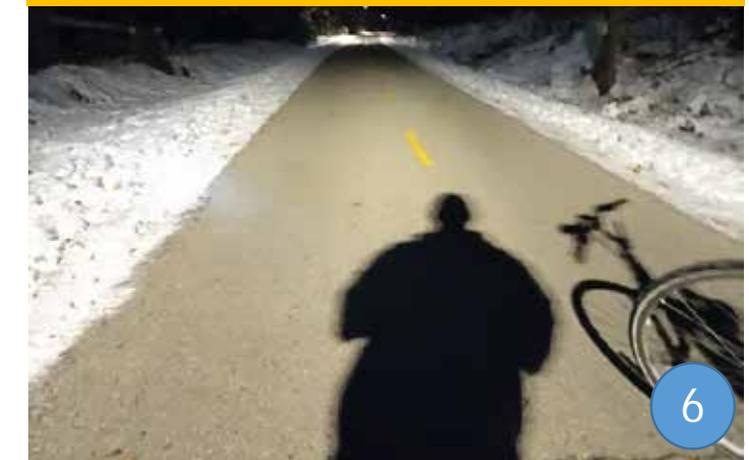
Bare Pavement via sublimation -No brine or salt

Plowing in (3) might have avoided ice in (4,5), but still achieved bare pavement without using salt

5am First snow of 2015

6am First plow-pass

12pm Wet snow left unplowed

8am Re-frozen snow scraped

4pm People using still icy path

8pm Bare surface by sublimation

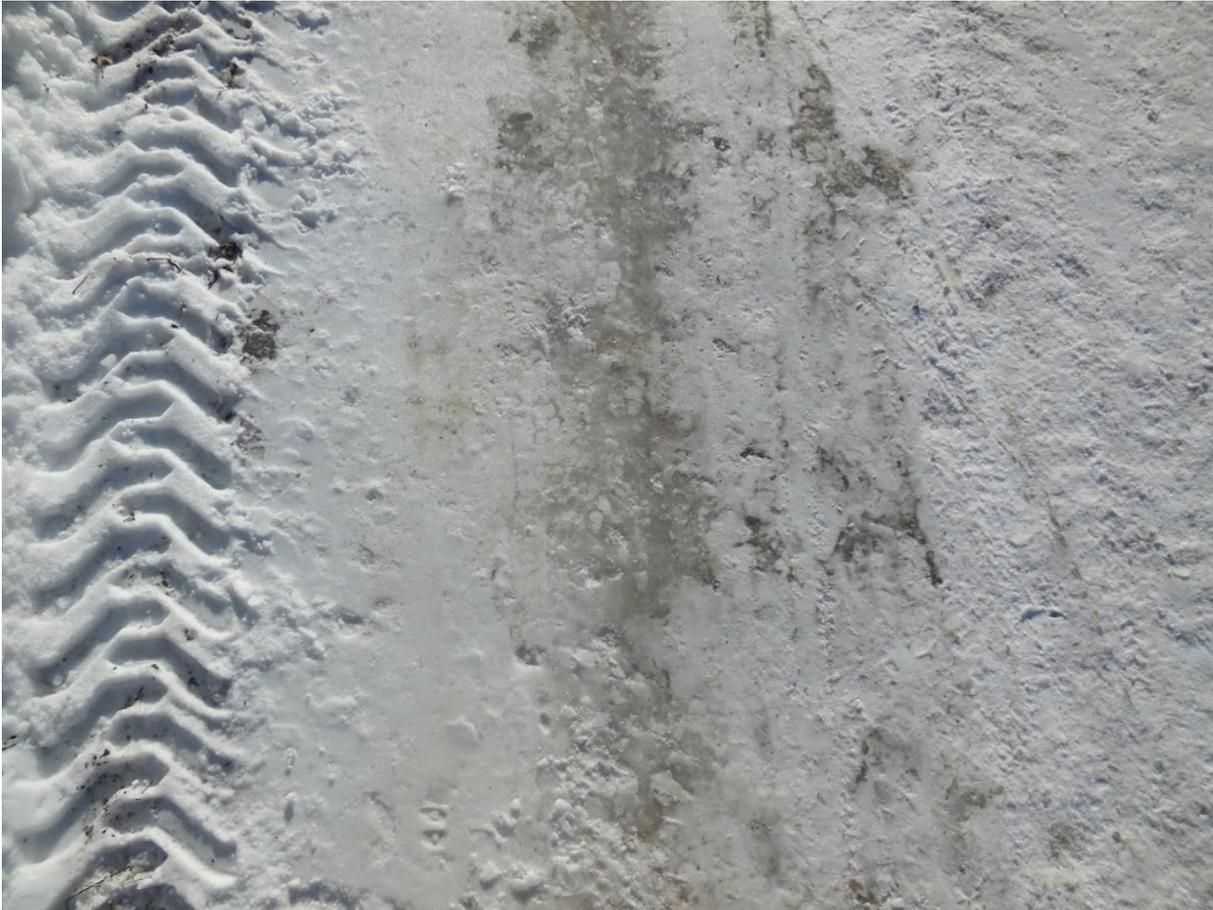
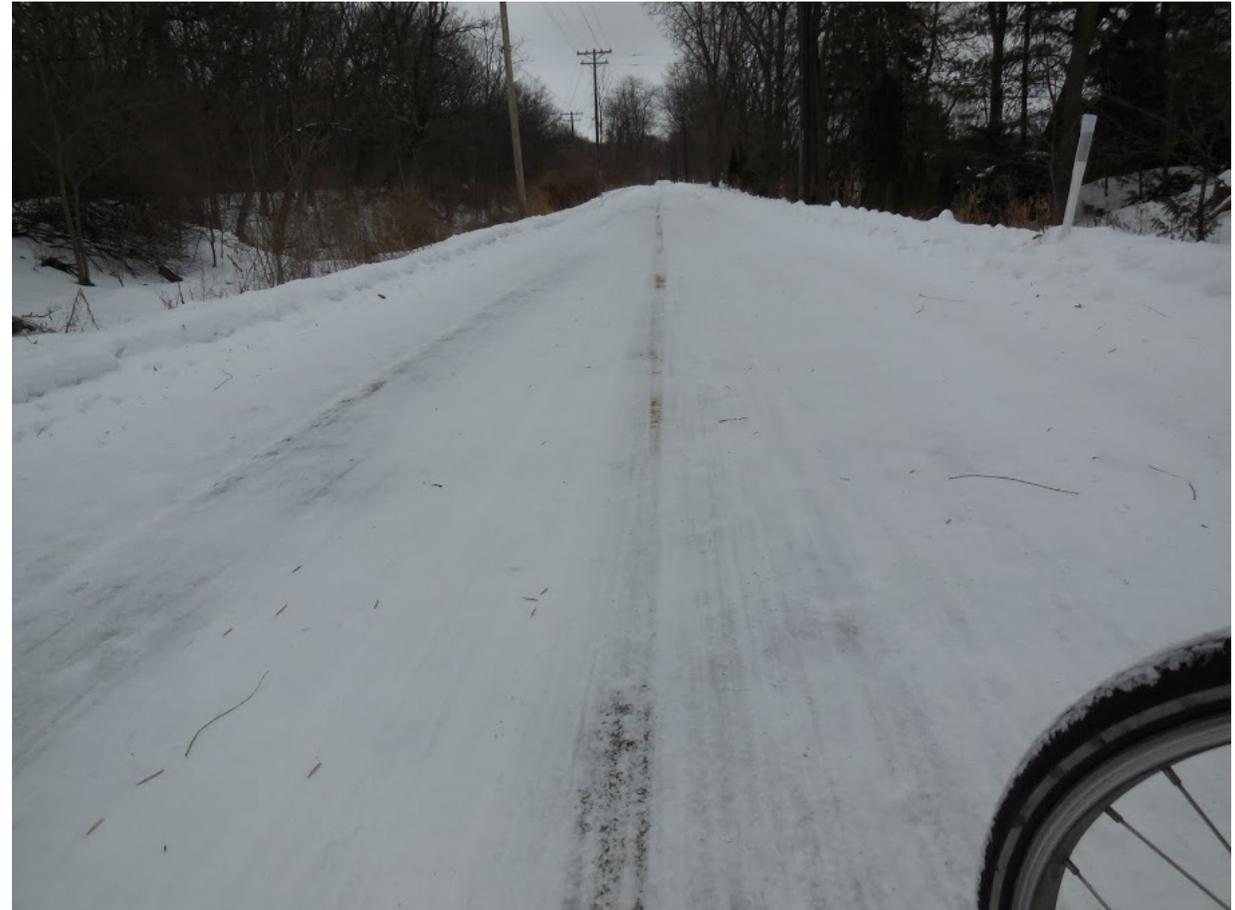
Compaction/smoothing by equipment (Zamboni effect)

*Bare pavement is never achieved directly from plowing & scraping.
Accumulation-based protocol and grooming avoids this*

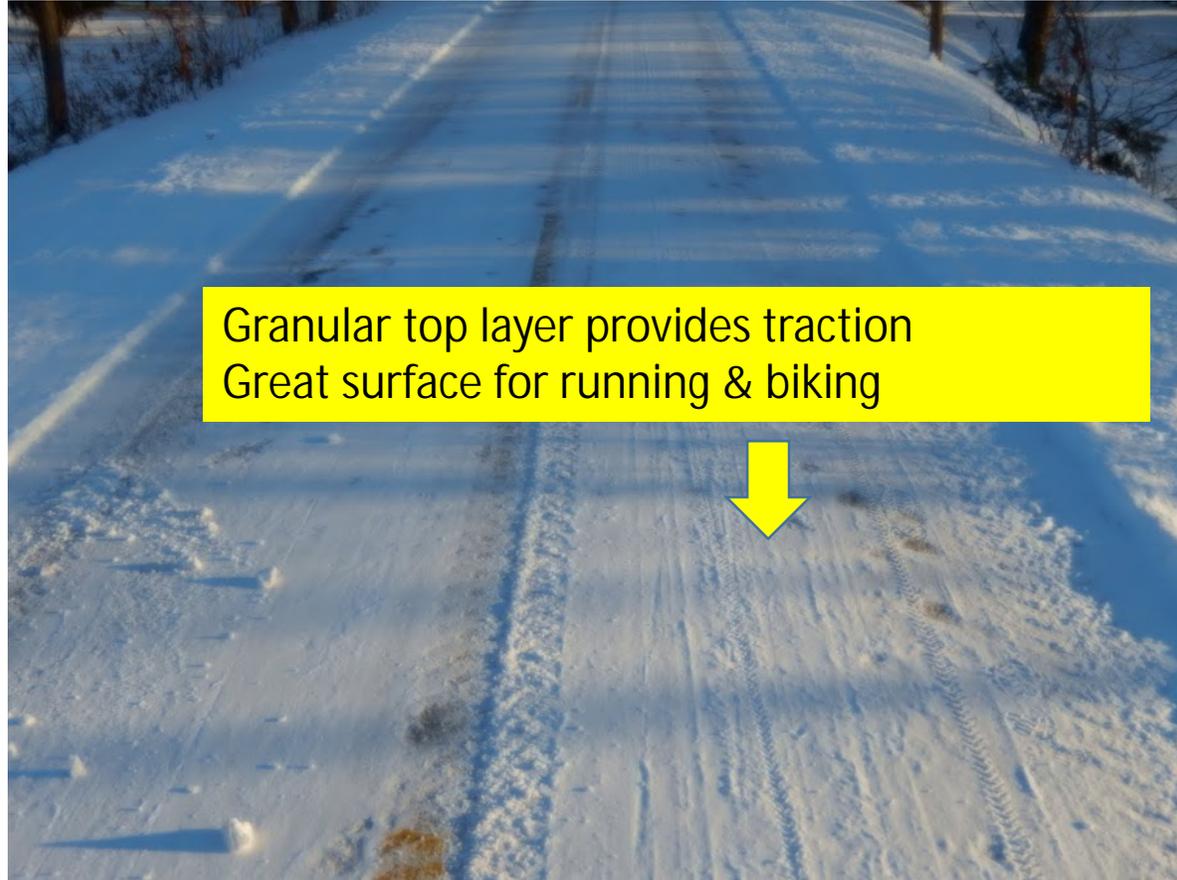
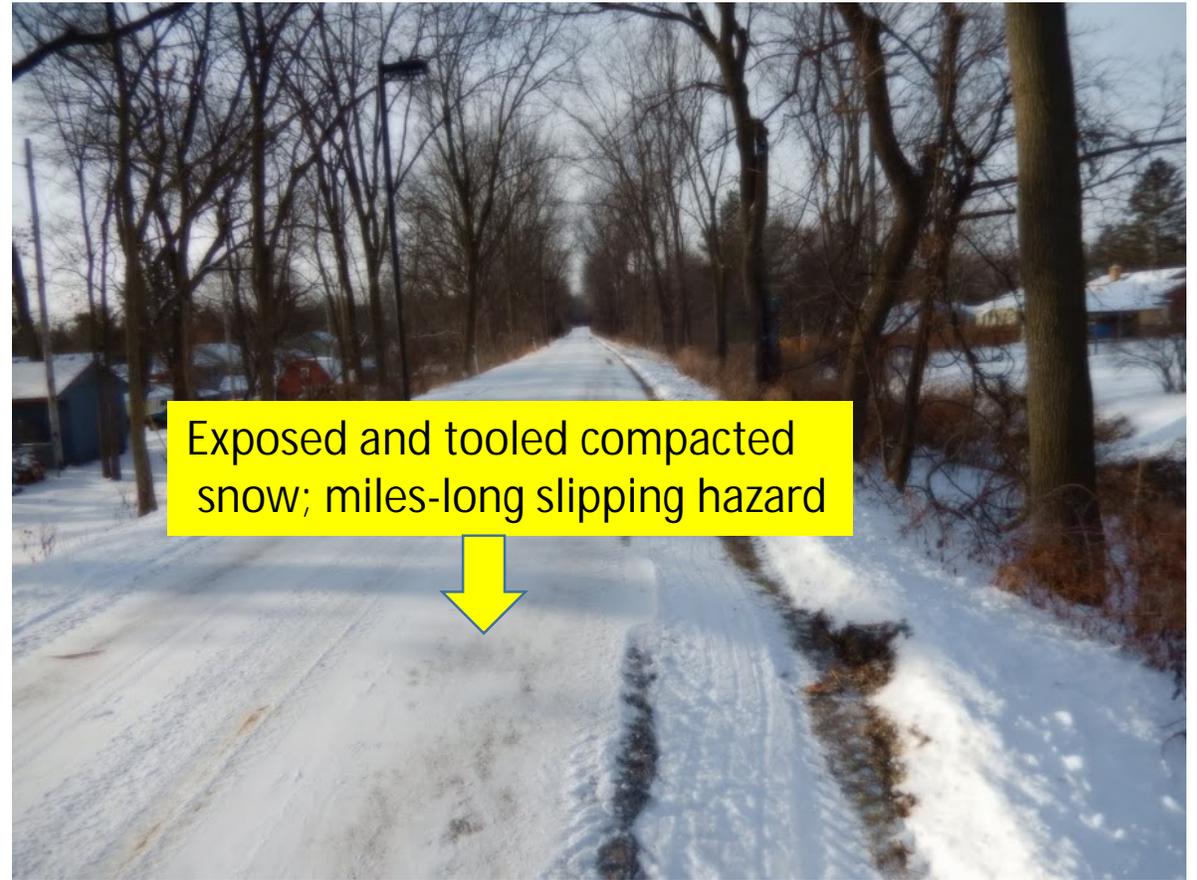
Stripping top fluff turns ideal surface to "unsafe"

*Photos taken 10 minutes apart; before and after a "scraping" plow pass
Grooming after scraping adds traction when a base layer exists*

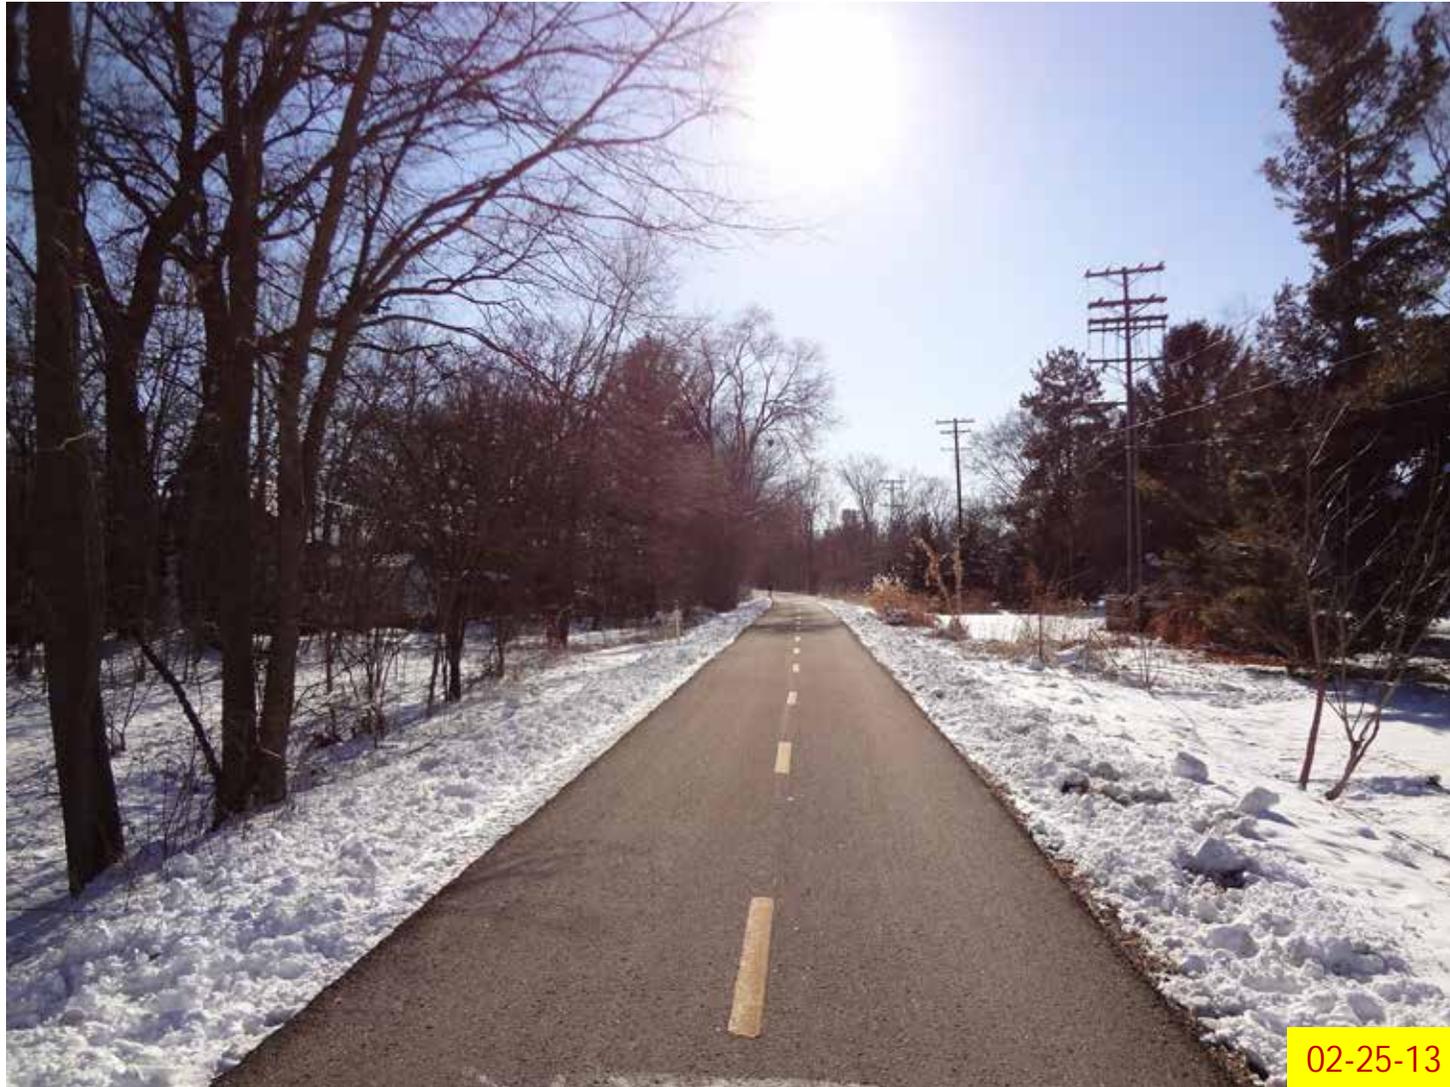
Bare Pavement – No slip hazards

Created during cold mainly by:

- Plowing/brushing by equipment
- Sublimation by sun and wind

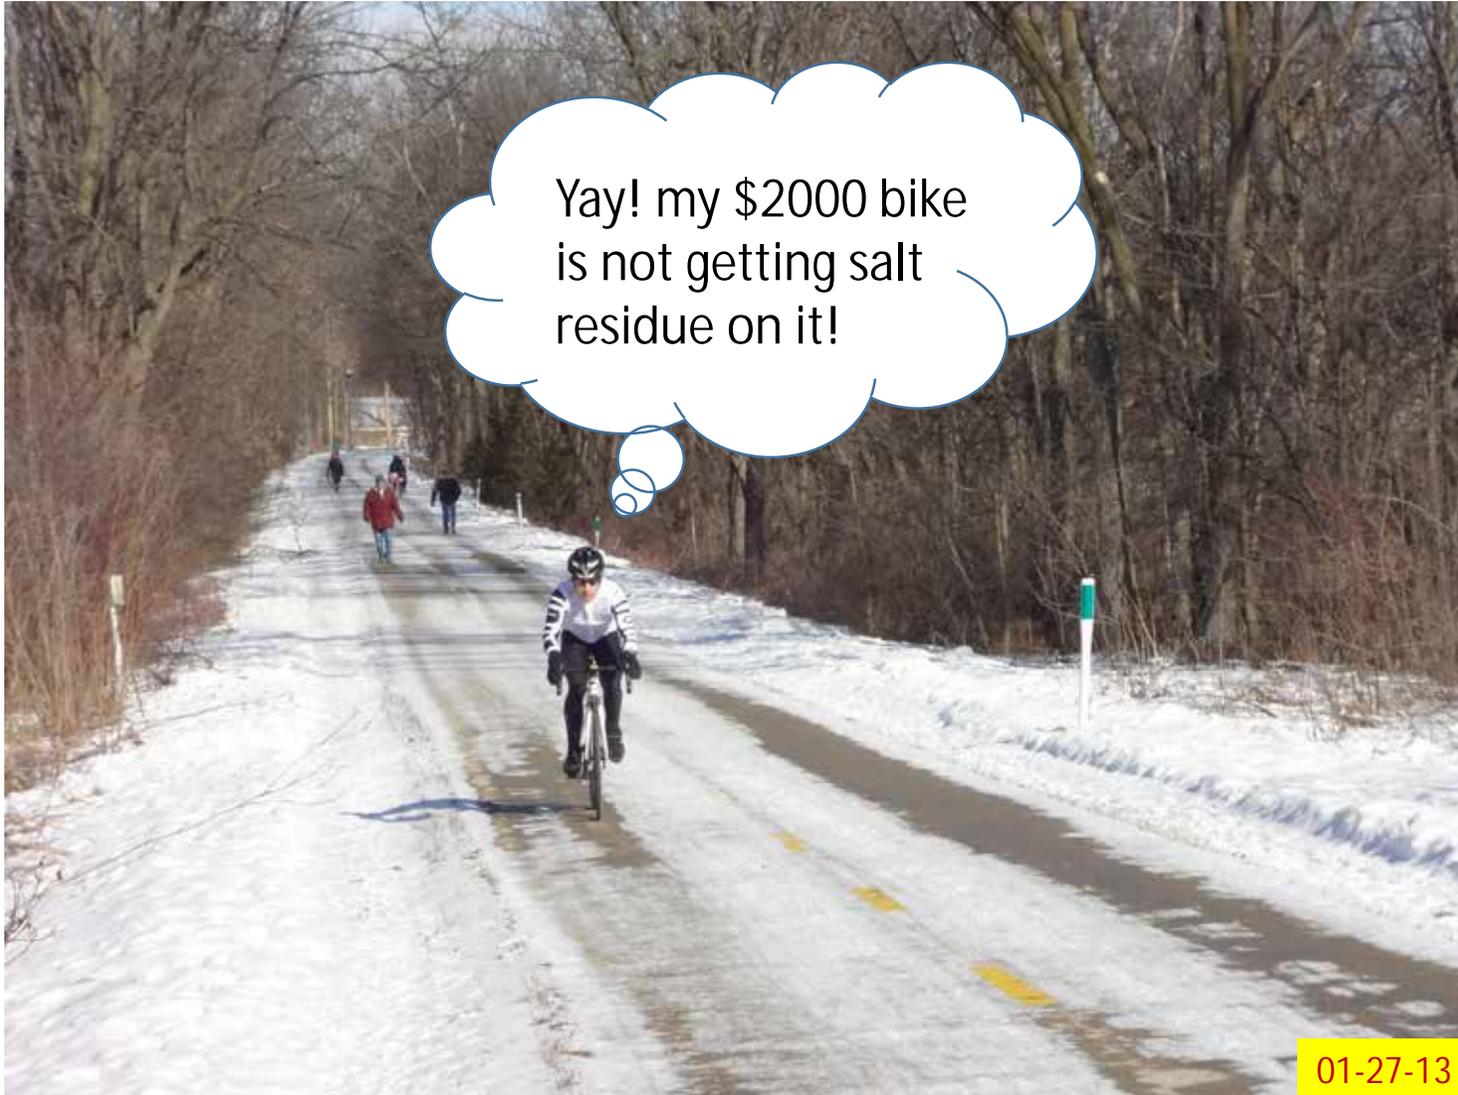
Scraped with snow + ice patches– slightly hazardous

Sublimates to bare pavement
In a day or two
without use of salt

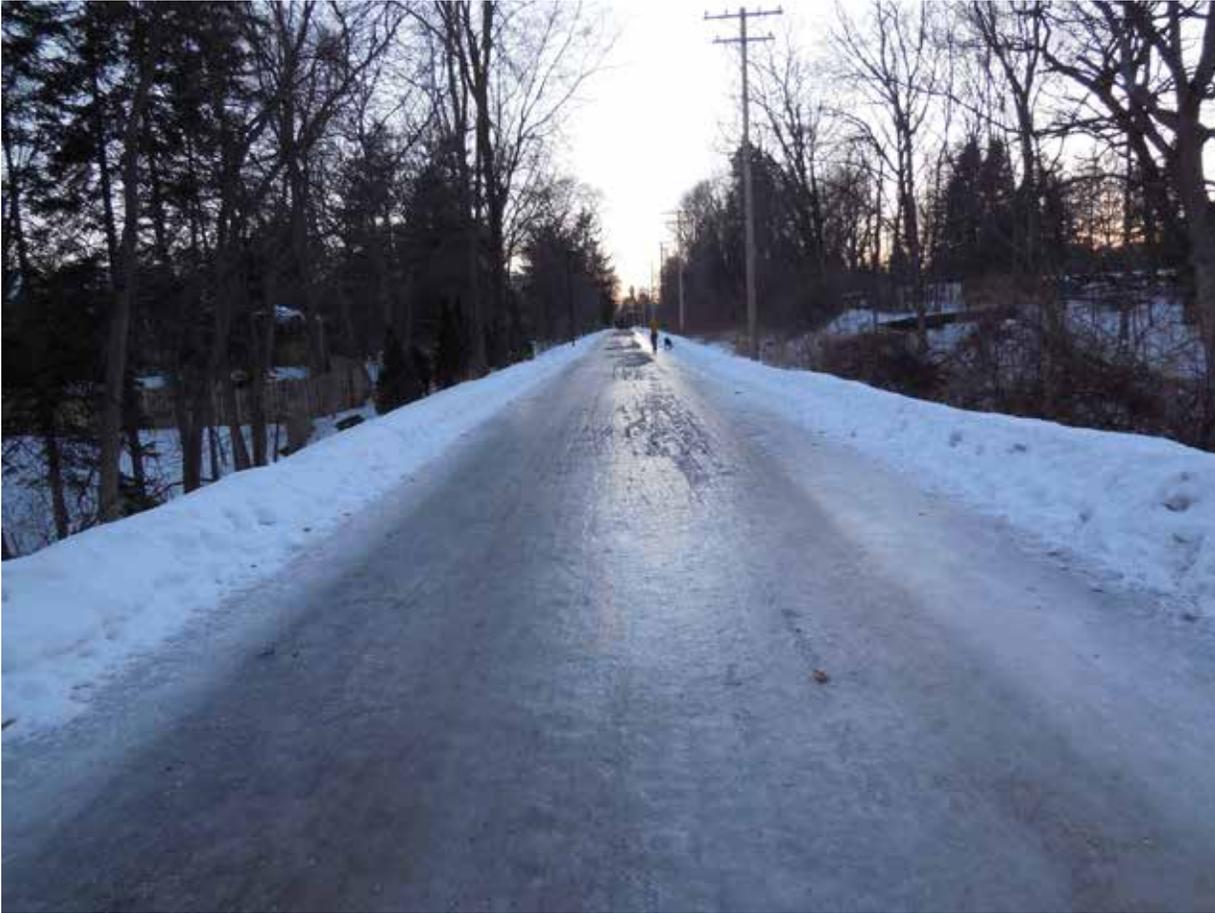
Snowmelt/flooding and re-freeze - hazardous

*This spot is located above
the tree shown in next slide:*

- Brine will not prevent this
- Prevent by plowing in thaw

- Sand is possible fix
- Rock salt "fix" creates:
 - Slush
 - Slippery conditions
 - High salinity drainage

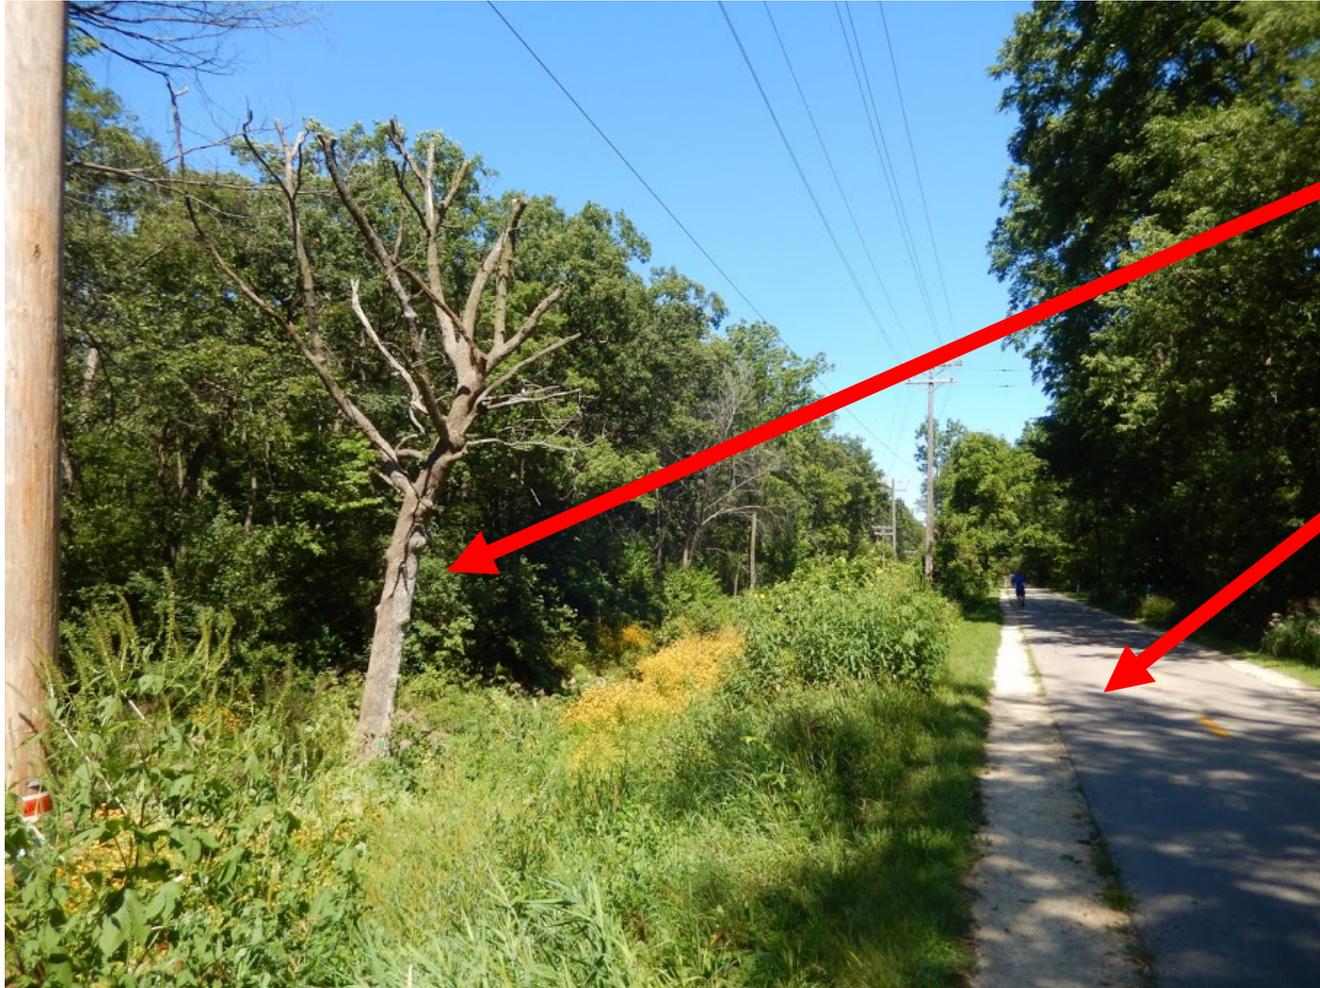
White oak that died in 2011-2012 season

- Healthy 150+ year tree died in a single season
- Possibly killed by salt poisoning

- Lowest spot on path for ~1/4 mile
- Ice Puddles here "fixed" with rock salt
- Brine tunnels observed through snow bank
- Brine observed pooled at base of tree

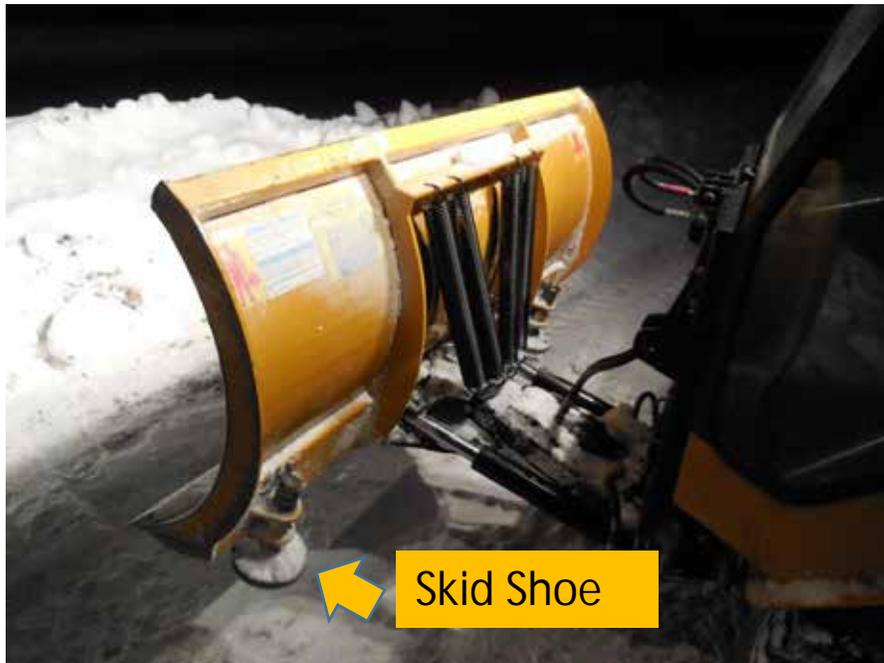
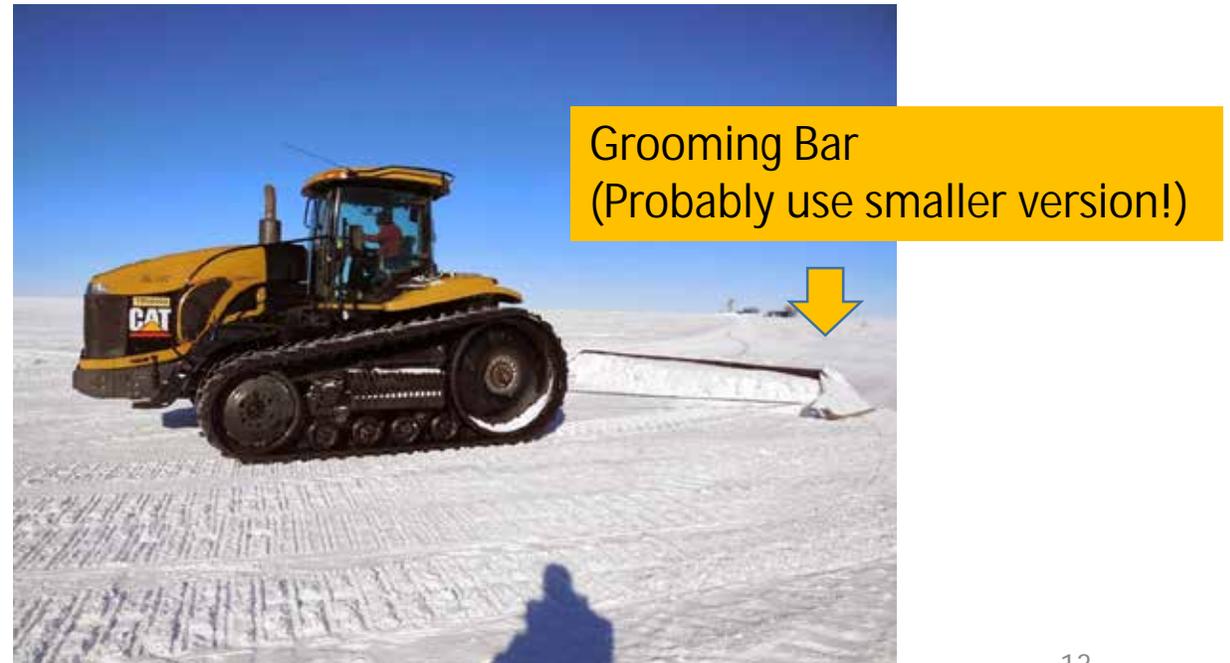
Possible modification to EQUIPMENT

- Use rotary brush to clean to bare pavement when feasible
- Leave groomed surface behind whenever plowing/scraping is done
 - Use skid shoes to raise blade ~1/4 to retain some fluff, or
 - Try drag bar or chain loop behind plow; leaves light snow layer for traction

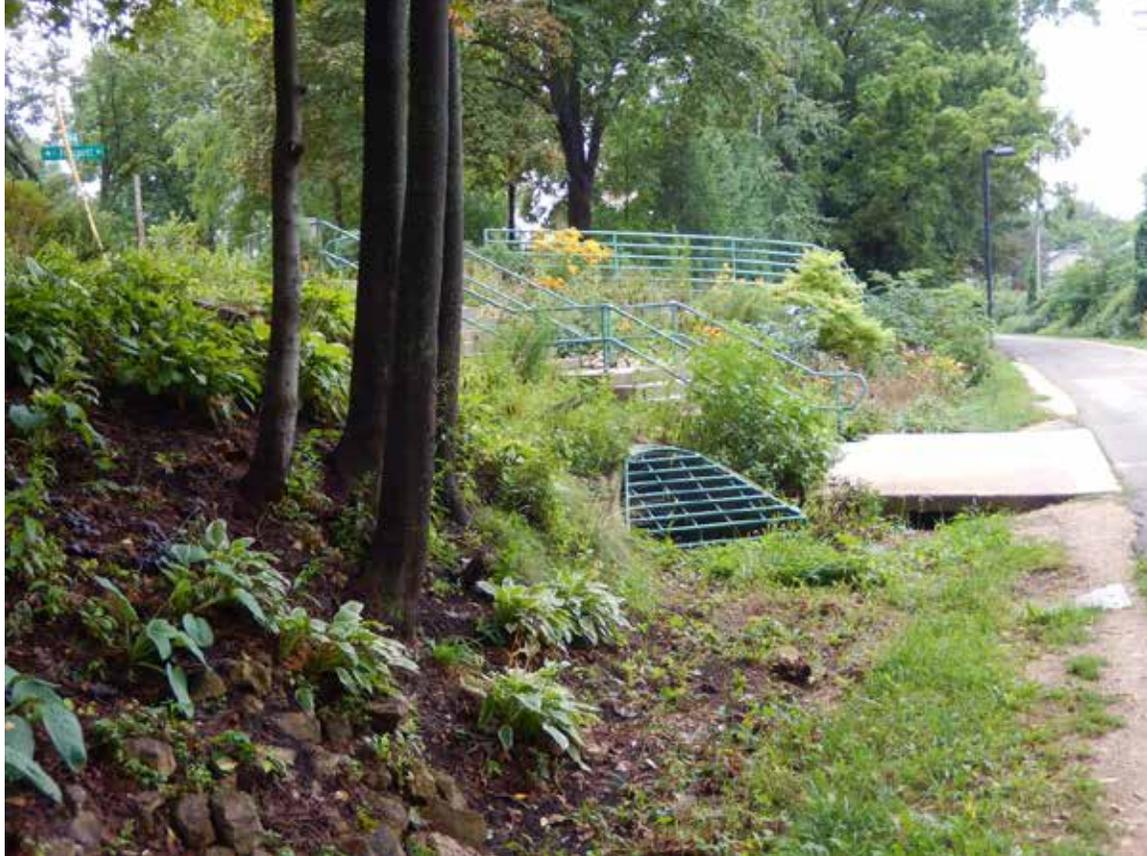
Thaws send brine plumes with high toxicity into Wingra

One of the many drains which line the path
(These flow downhill directly into Lake Wingra)

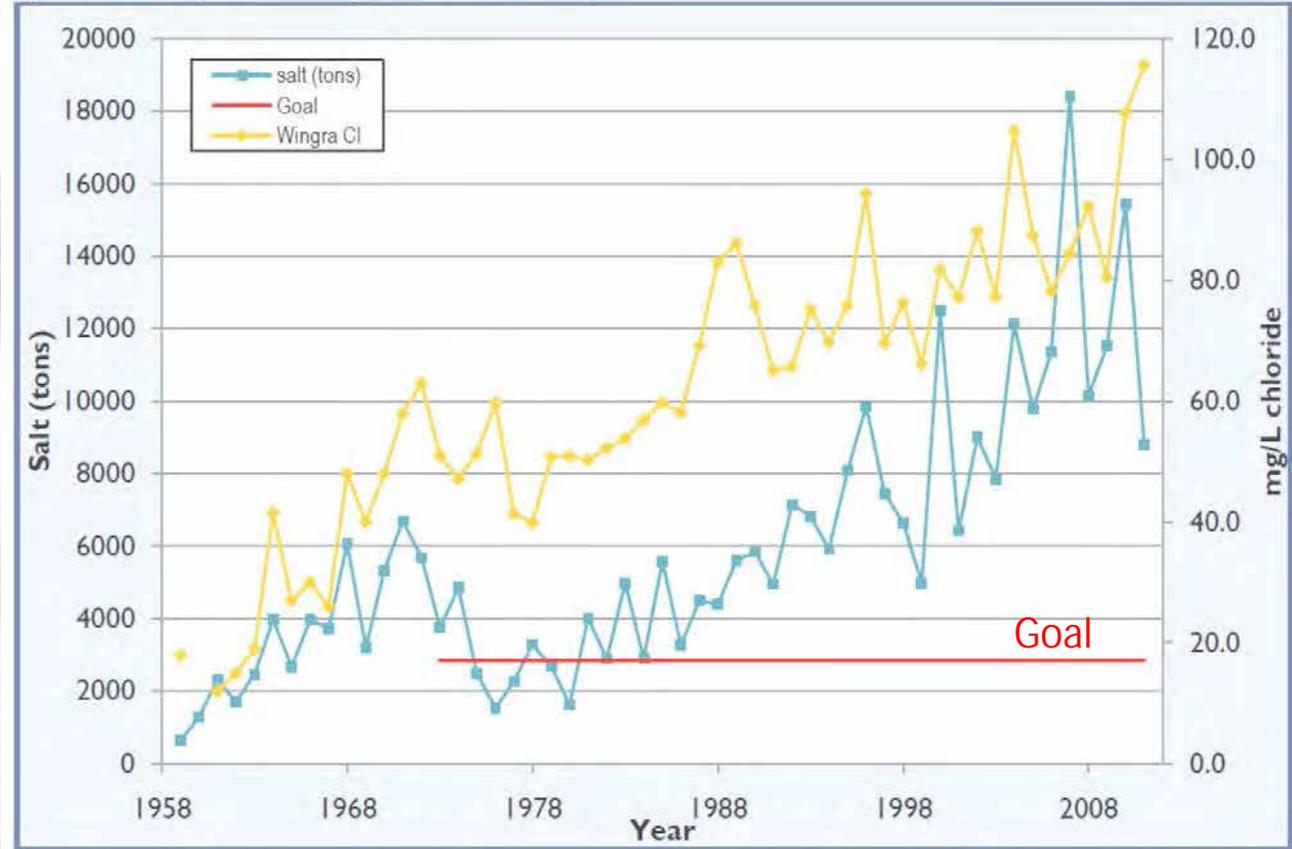
Rock salt on SW Path also contributes to near-toxic levels of cumulative chloride in lake

Madison Salt Use Compared with Lake Wingra Chloride Levels
(from *City of Madison 2012 Salt Report*)

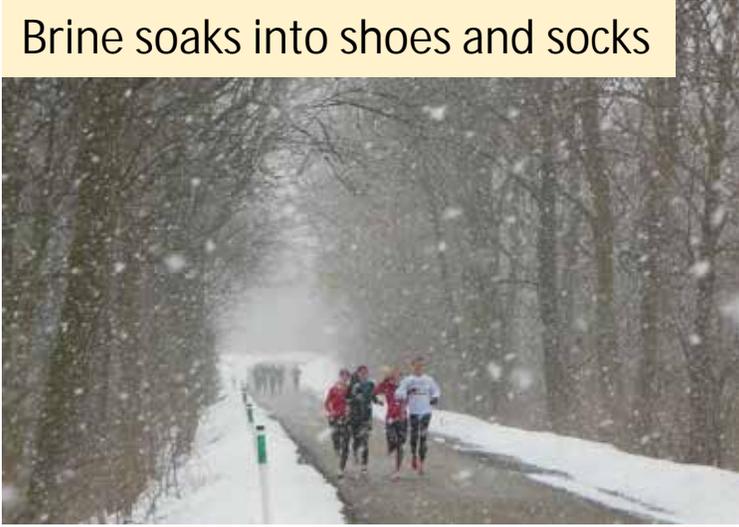
Brine soaks into shoes and socks

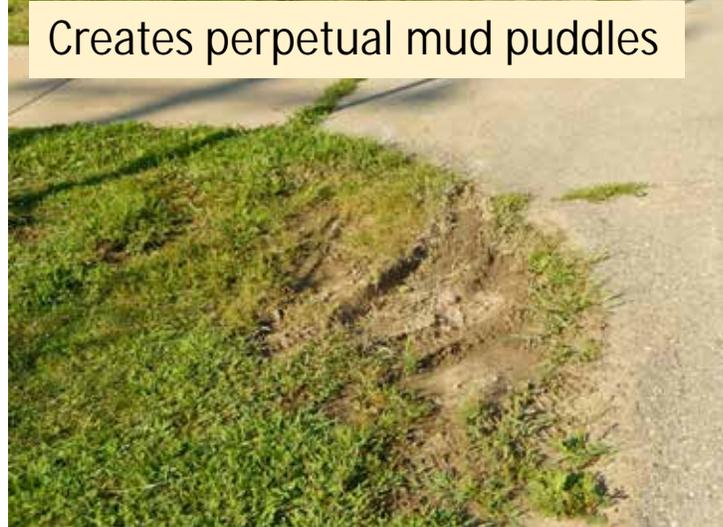
Creates perpetual mud puddles

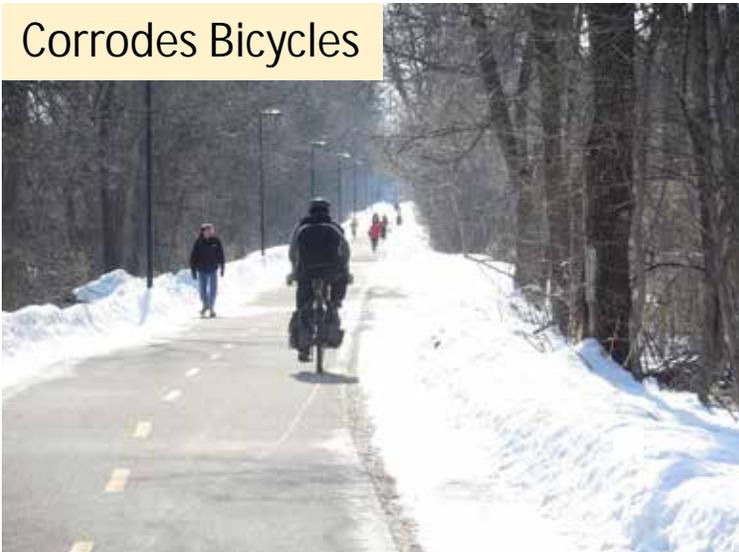
Corrodes Bicycles

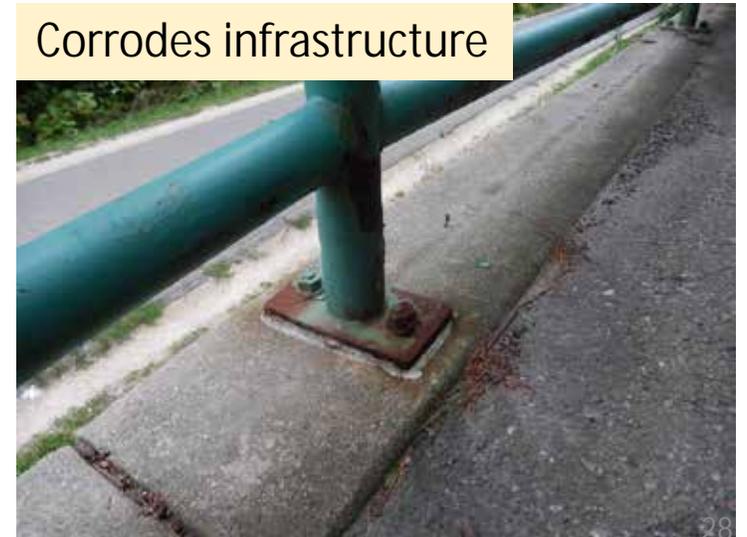
Corrodes infrastructure
