## Traffic Engineering Division

## SUMMARY OF STAFF RECOMMENDATIONS TO TRANSPORTATION COMMISSION

March 19, 2025

## **2024 TRAFFIC SIGNAL PRIORITY LIST SPECIAL STUDIES FOR TRANSPORTATION COMMISSION SELECT INTERSECTIONS**

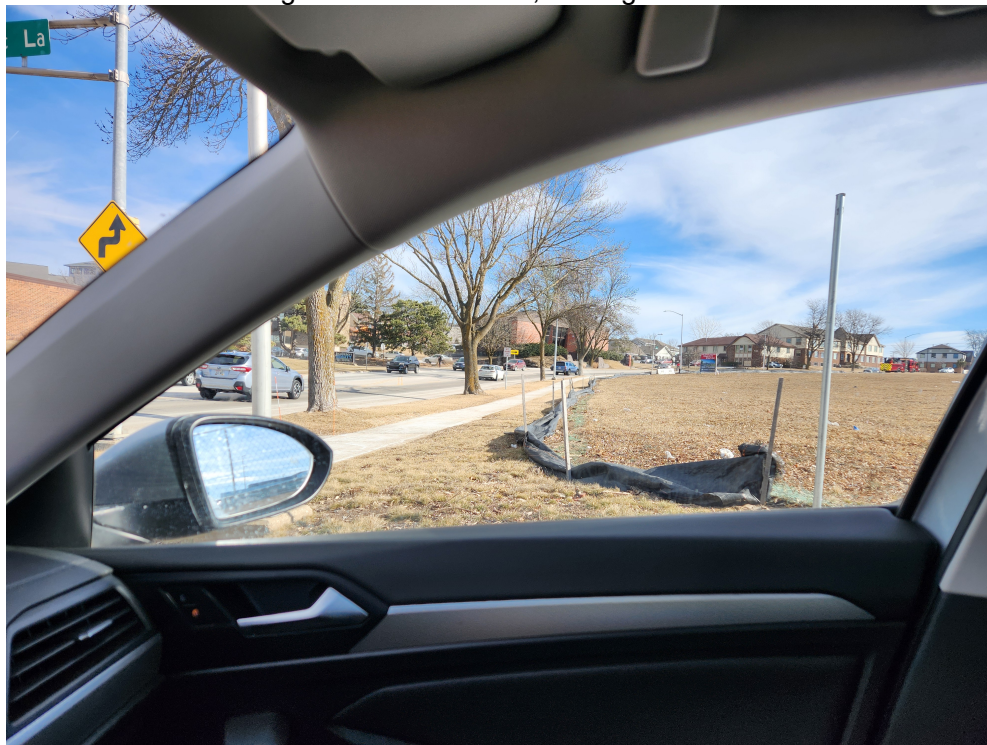
Figure 1: NB Potomac, looking east

- An automated hose count indicates this intersection does not currently meet traffic signal warrants 1-A, 1-B, or peak hour warrants.
  - Current redevelopment on the south side of the intersection is expected to bring this intersection closer to meeting traffic signal warrant.
- The signal spacing between this intersection and adjacent intersections is near equal distance between Research Park Boulevard and Grand Canyon Drive. This location may allow for platoon management when running in coordination.
- Visibility coming from the south side of the intersection is currently roughly 350 feet to the east, and approximately 250 feet to the west. At the posted speed limit, this is approximately 7-9 seconds down the road. At the 85<sup>th</sup> percentile speed measured, this approximately 5-7 seconds down the road. See figures 1 and 2 below.
