## OLBRICH COTTAGE ROOF REPLACEMENT PROJECT 10/8/18

The Cottage Building is part of the Garver Feed Mill building complex and is part of a locally designated landmark site and is listed on the National Register of Historic Places. This project will be reviewed by the State Historic Preservation Office and the Landmarks Commission.

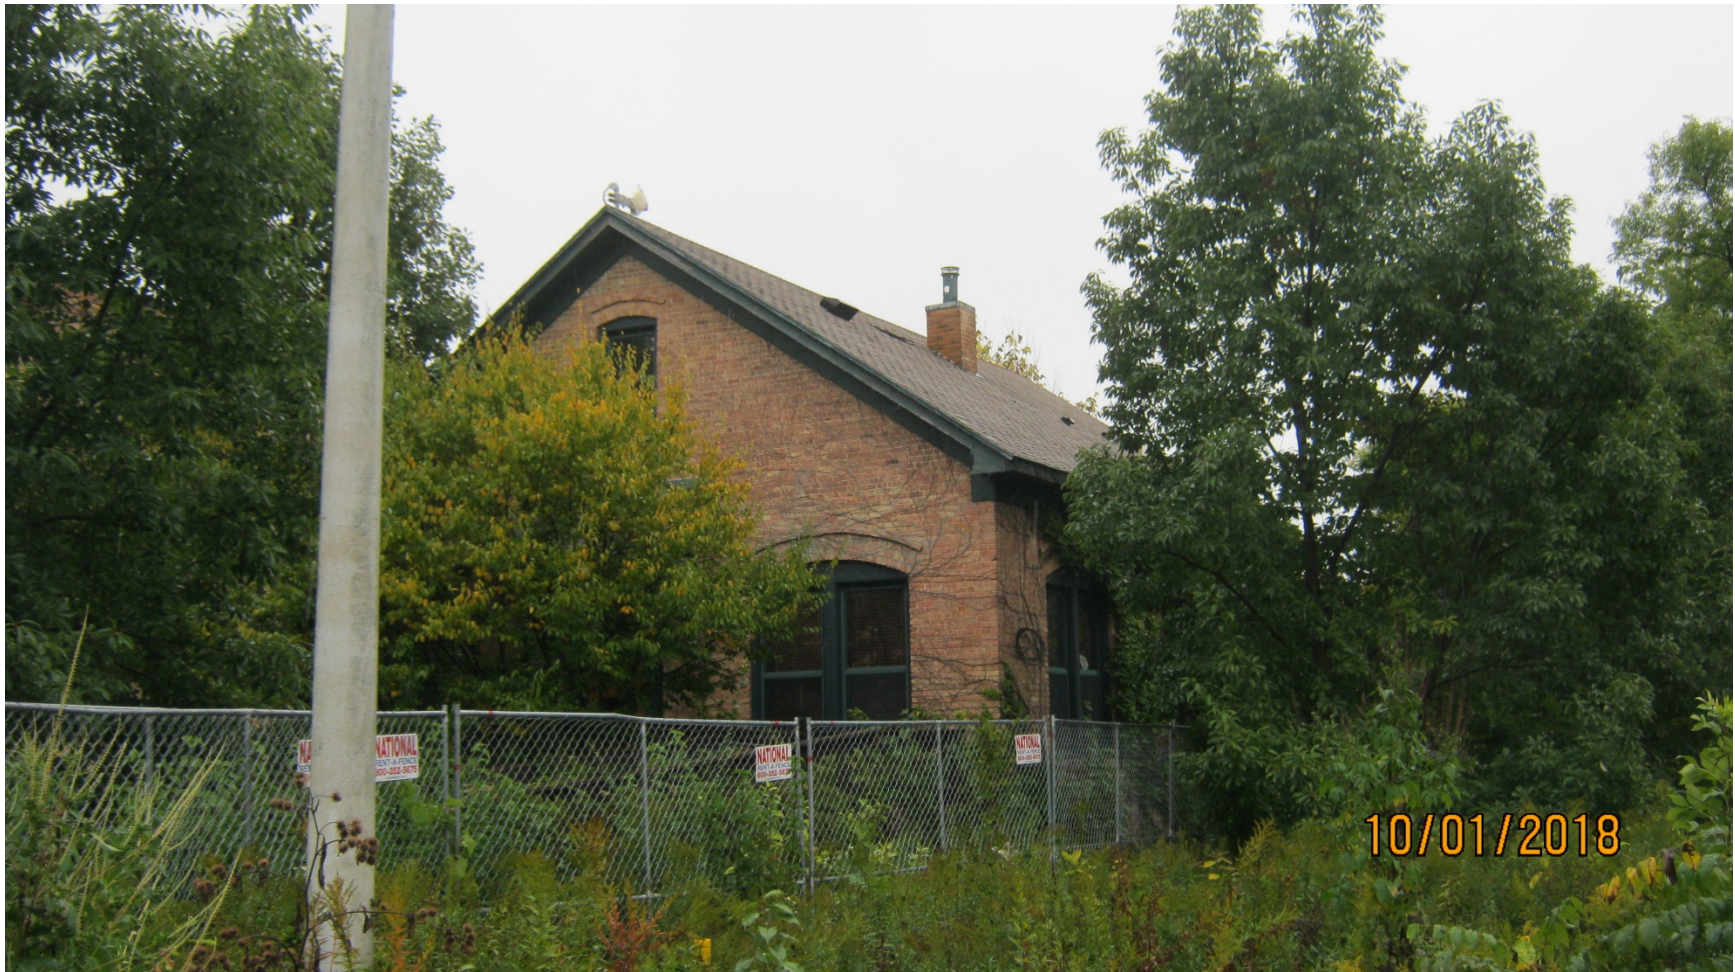
View of simple gable roof with 3 tab asphalt shingles and typical eave and rake conditions.

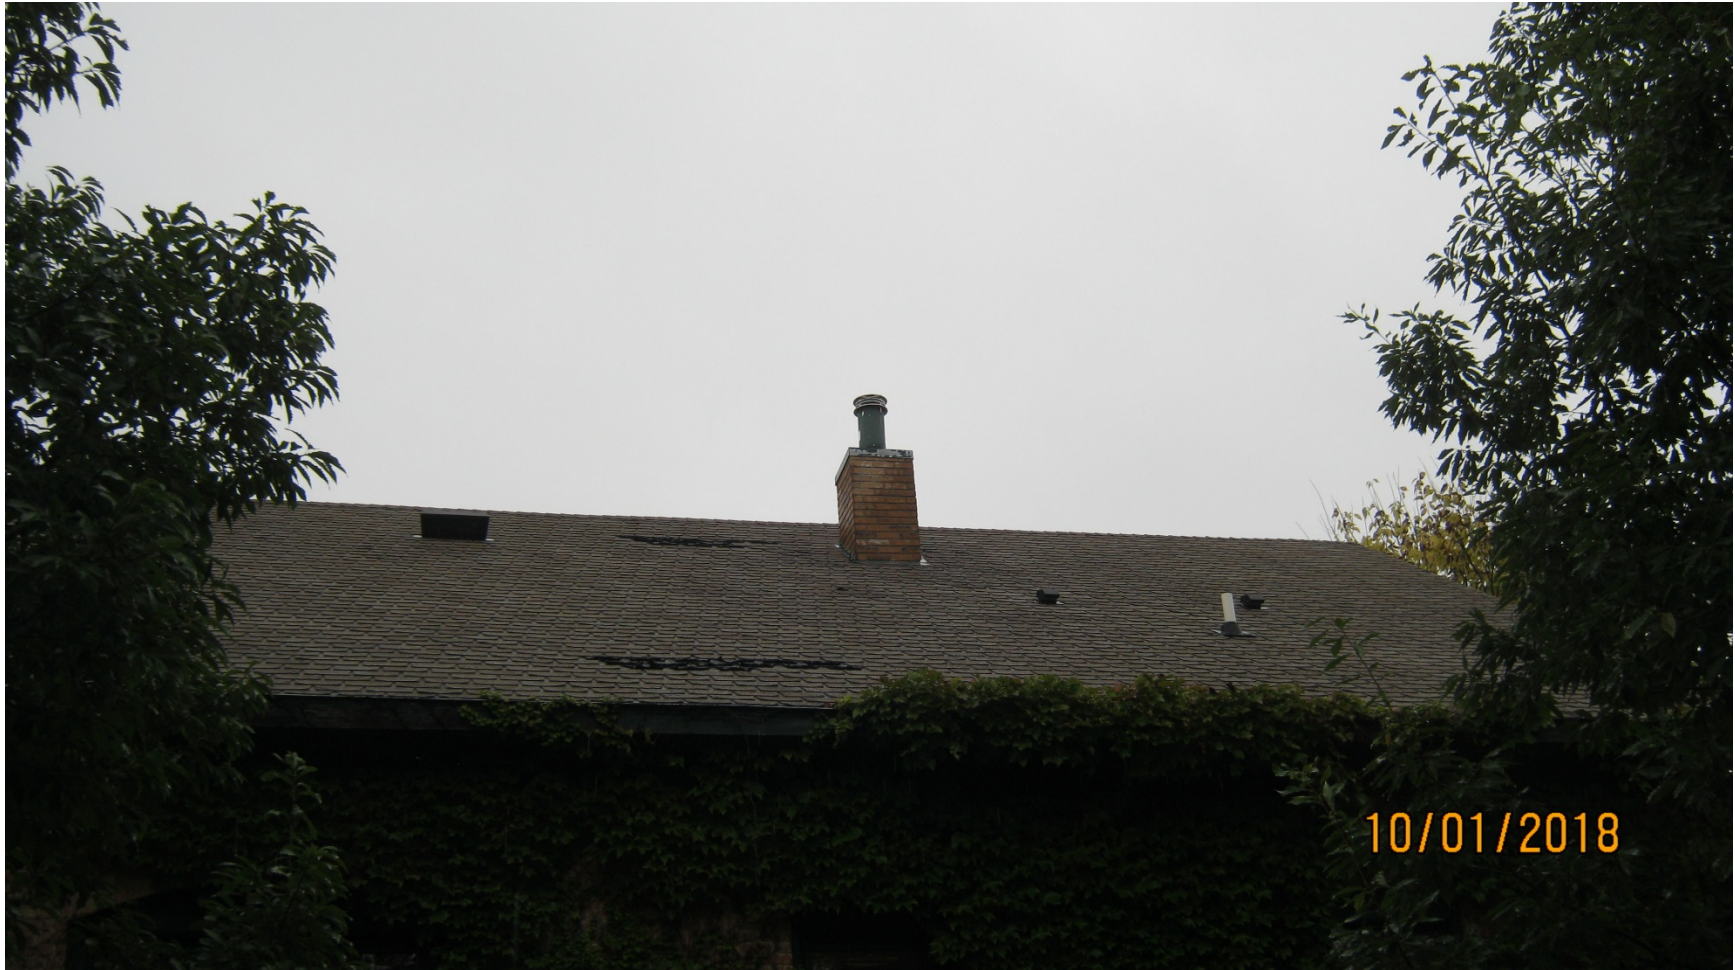
The existing roof is showing wear and areas of failure. The lower level is getting water on the interior. To remedy these issues, the following project scope has been prepared:

View of simple gable roof with 3 tab asphalt shingles and typical penetrations. Please note the areas of shingle failure.

Tear off existing roof covering.

Replace deteriorated areas of sheathing.

Install ice and water shield at lower 6 feet from eave and roof paper on entire roof

Install new asphalt 3 tab shingles.
