Lake Mendota Drive Turtle Rain Garden

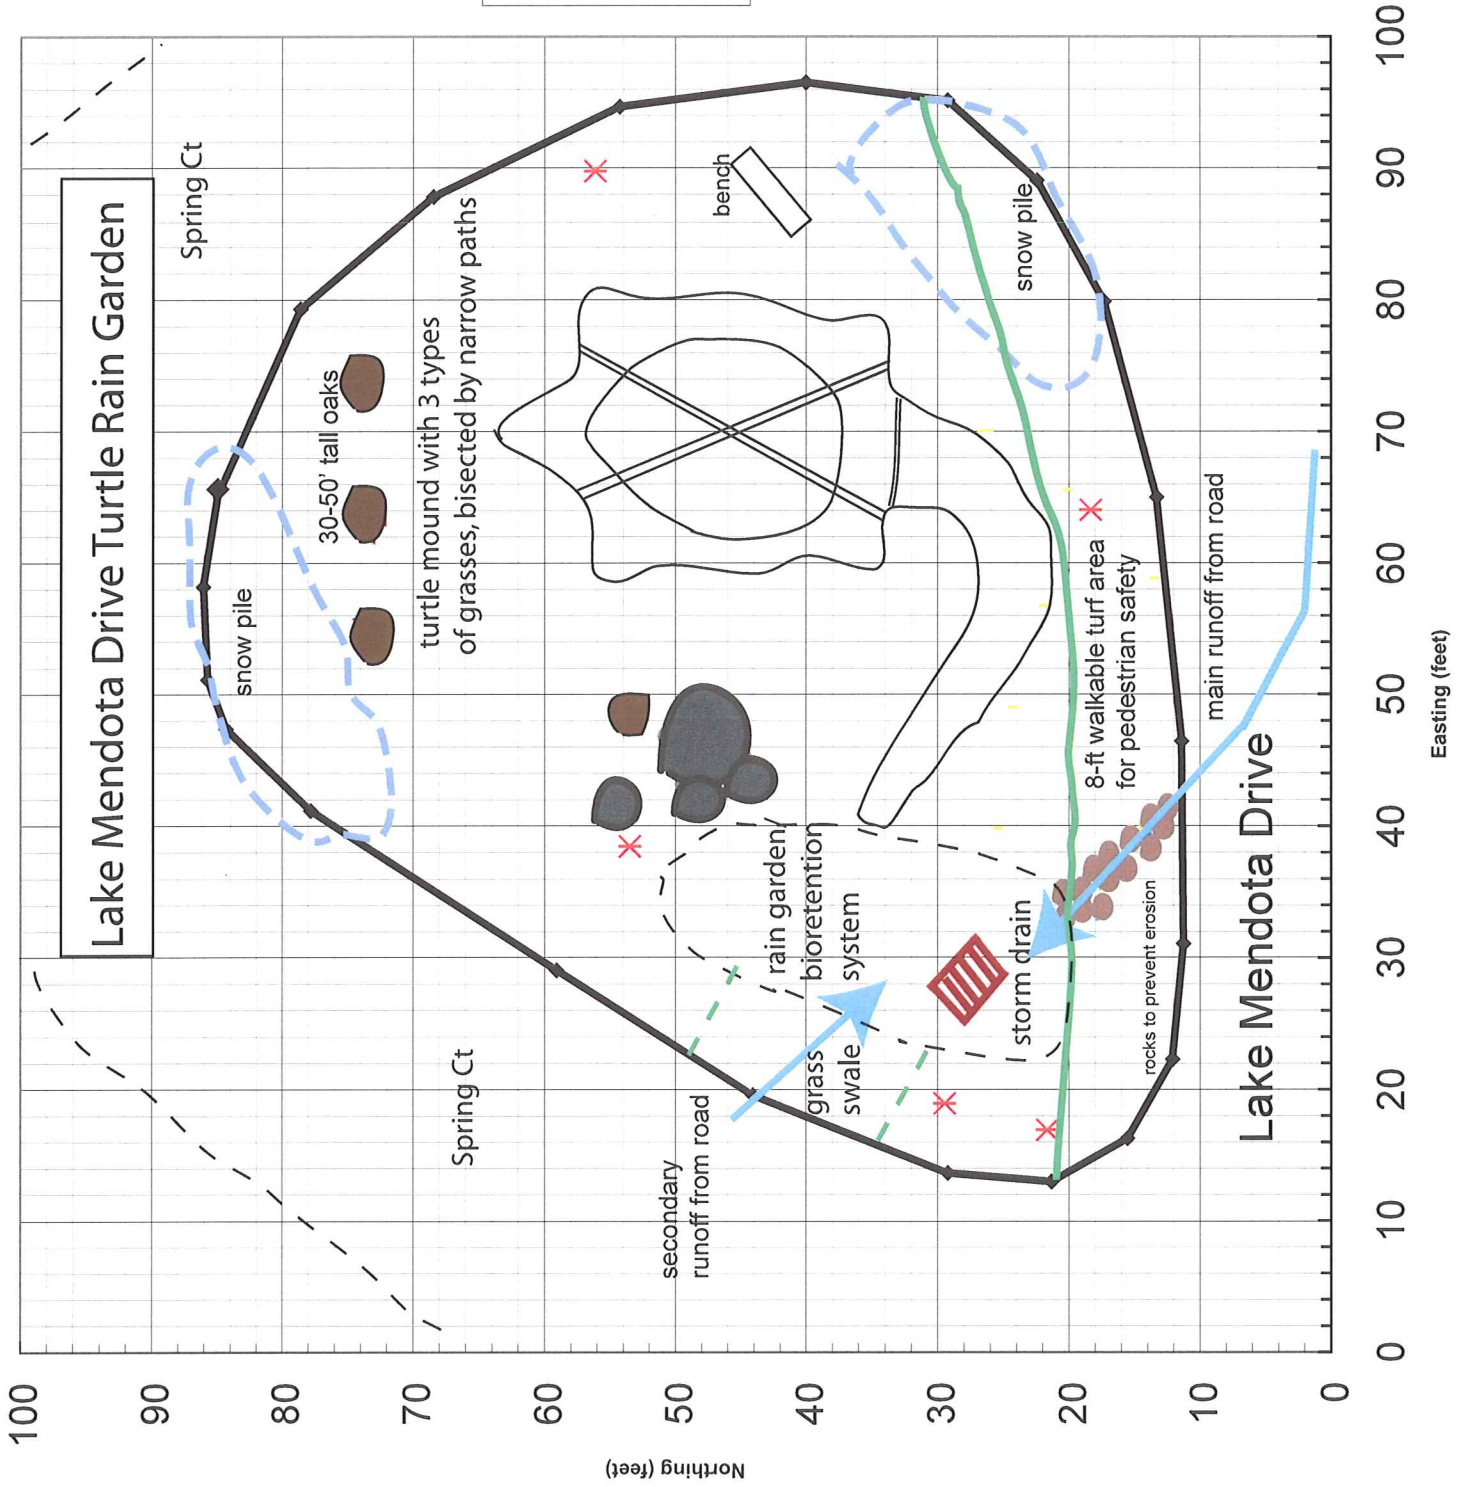
- edge of street
- 8-ft setback from street
- existing oak trees
- rocks
- signs/electrical poles
- runoff

turtle mound with 3 types of grasses, bisected by narrow paths

secondary runoff from road

grass swale

rain garden/bioretention system

storm drain

rocks to prevent erosion

8-ft walkable turf area for pedestrian safety

main runoff from road
