Dayton Hotel

Land Use Application - Historical Resources

11 April 2022

Historical Resources

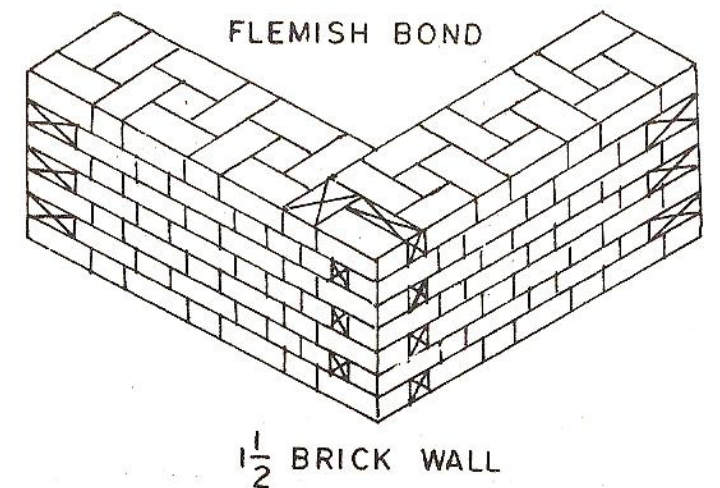
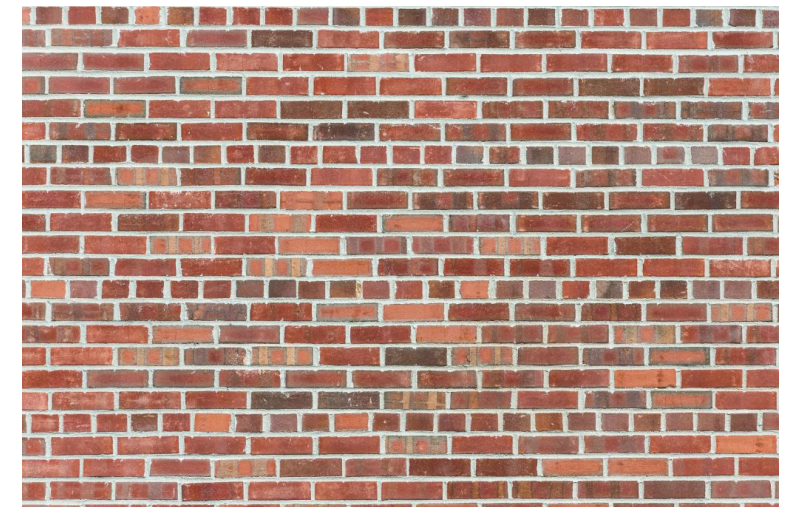
Relocating Existing Warehouse Facade

“In regards to the facade at the front of 615 E Dayton St with head course construction which was typical construction for the time, this will be a very hard demolition and the amount that can be salvaged will not amount to much.”

- 16” Flemish bond wall every 6th header coarse is tied back. Makes deconstruction of the brick extremely difficult.
- Bricks of this era/vintage are brittle and loss due to damage during deconstruction would be high.
- Salvaging limestone pieces is feasible and loss to damage would be minimal.
- Relocating the facade is not feasible.

- The Reynolds House (616 E Mifflin) will be retained, renovated and incorporated into the hotel.
- We evaluated retaining and incorporating the Dayton St warehouse into the facade as well as relocating it on-site.
- Retaining the facade in its current location was not feasible due to its location on the property and how that impacted the overall project design. A summary of the design impacts are outlined in the following pages.
- Relocating the facade on-site was found to not be feasible due to the construction methods used to originally construct the wall/facade and the difficulty of disassembling it. Details on the wall construction are outlined in the following pages.
- Limestone pieces and salvaged brick from Dayton St. facade will be incorporated into the common area / cafe interior design

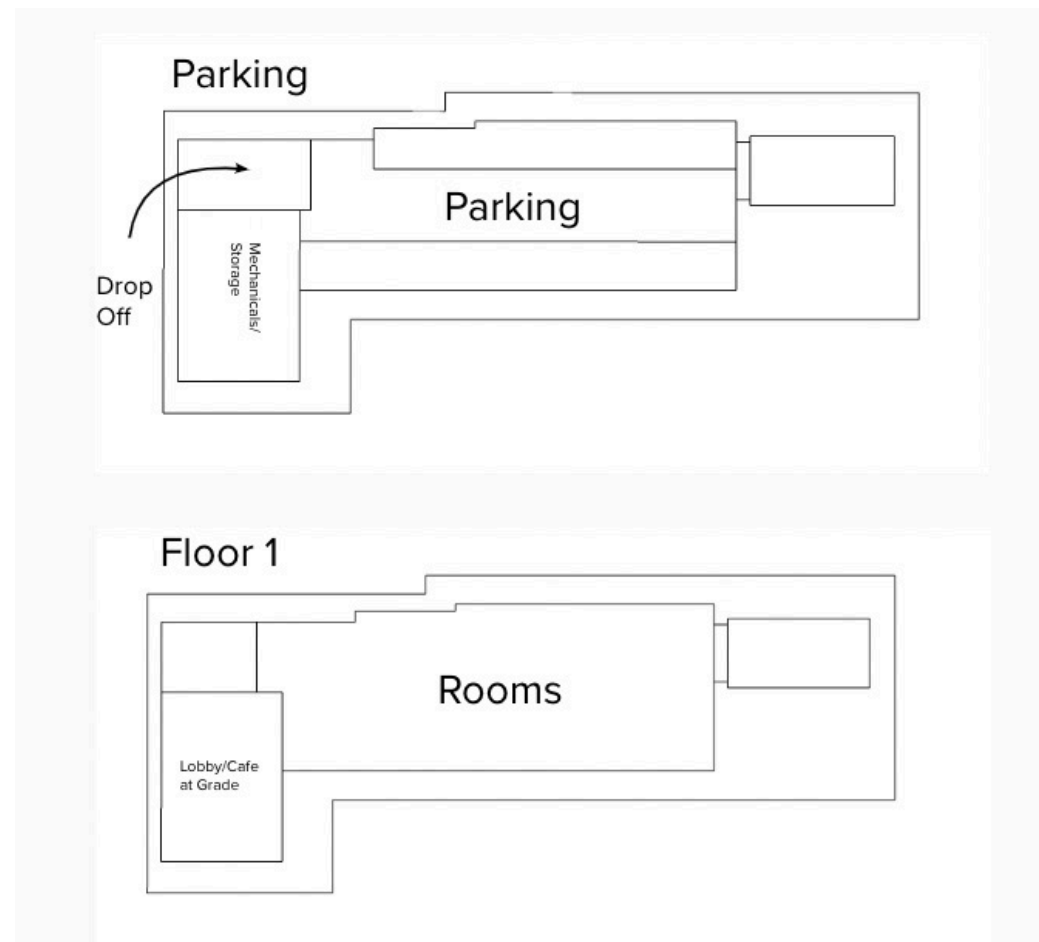
Proposed Design

- Natural flow for building entry and access to parking garage
- Green space/BCycle station on E. Mifflin St.
- Cafe/Lobby (~2,300 sf) on E. Dayton St.
- 2nd floor rooms on Dayton St. have windows
- Outdoor space behind cafe remains
- Retains Reynolds House (616 E. Mifflin)
- Reduces traffic on E. Mifflin St.
- Raised entry door elevation mitigates flood risk to property

- Loss of existing Dayton St. facade

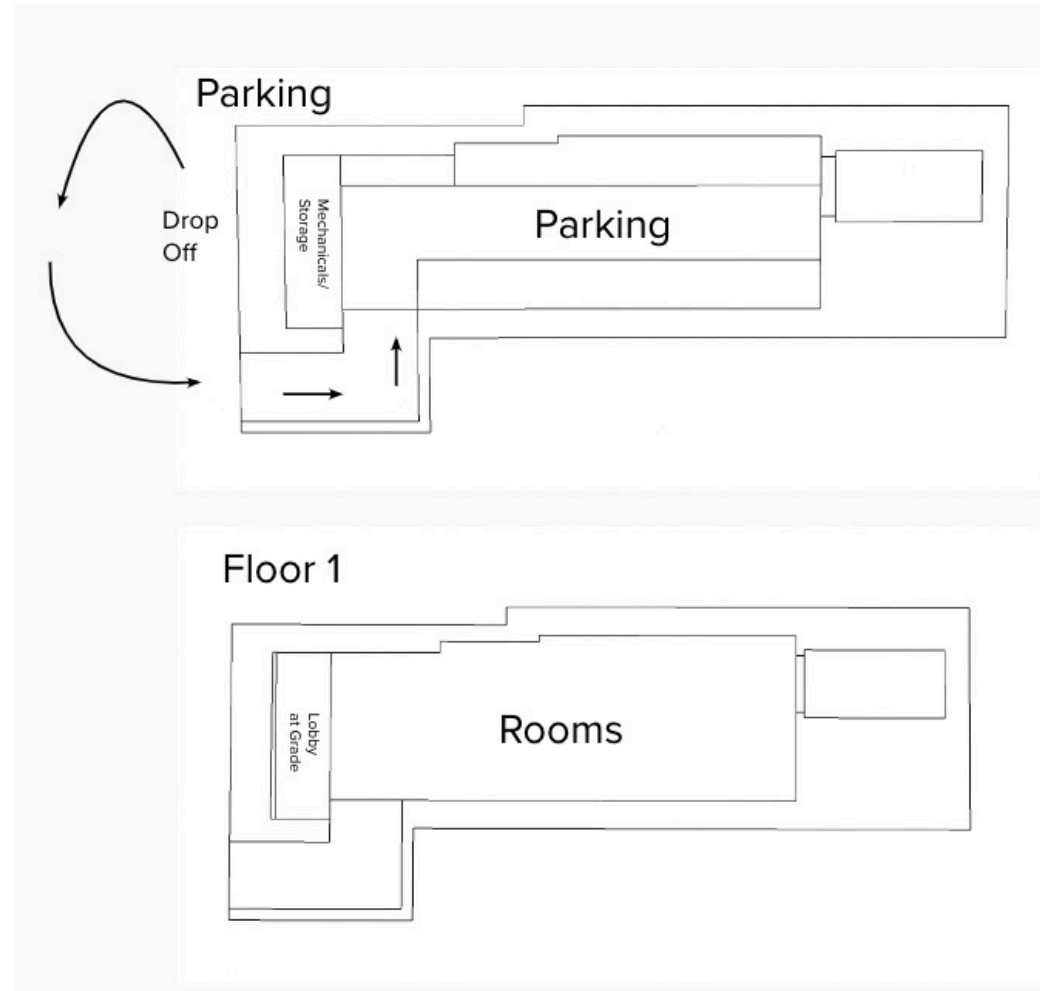
Leave Existing Facade in Place

Parking Entrance From Dayton St.

- Saves the existing Dayton St. facade
- Maintains greens space/BCycle station on E. Mifflin St.
- Reduces traffic on E. Mifflin St.
- Retains Reynolds House (616 E. Mifflin)

- Entry flow reversed likely leading to “U” turns and increased traffic on Dayton St.
- Depth of Lobby reduced to ~18 feet
- Lobby area reduced to ~1,100 sf - no space for cafe
- Loss of outdoor space in rear yard setback
- Cost to stabilize/underpin wall during construction
- Occupiable building square footage reduced by 15%
- 2nd floor of hotel rooms on Dayton St. blocked by facade
- Flooding concerns due to low entry door elevation

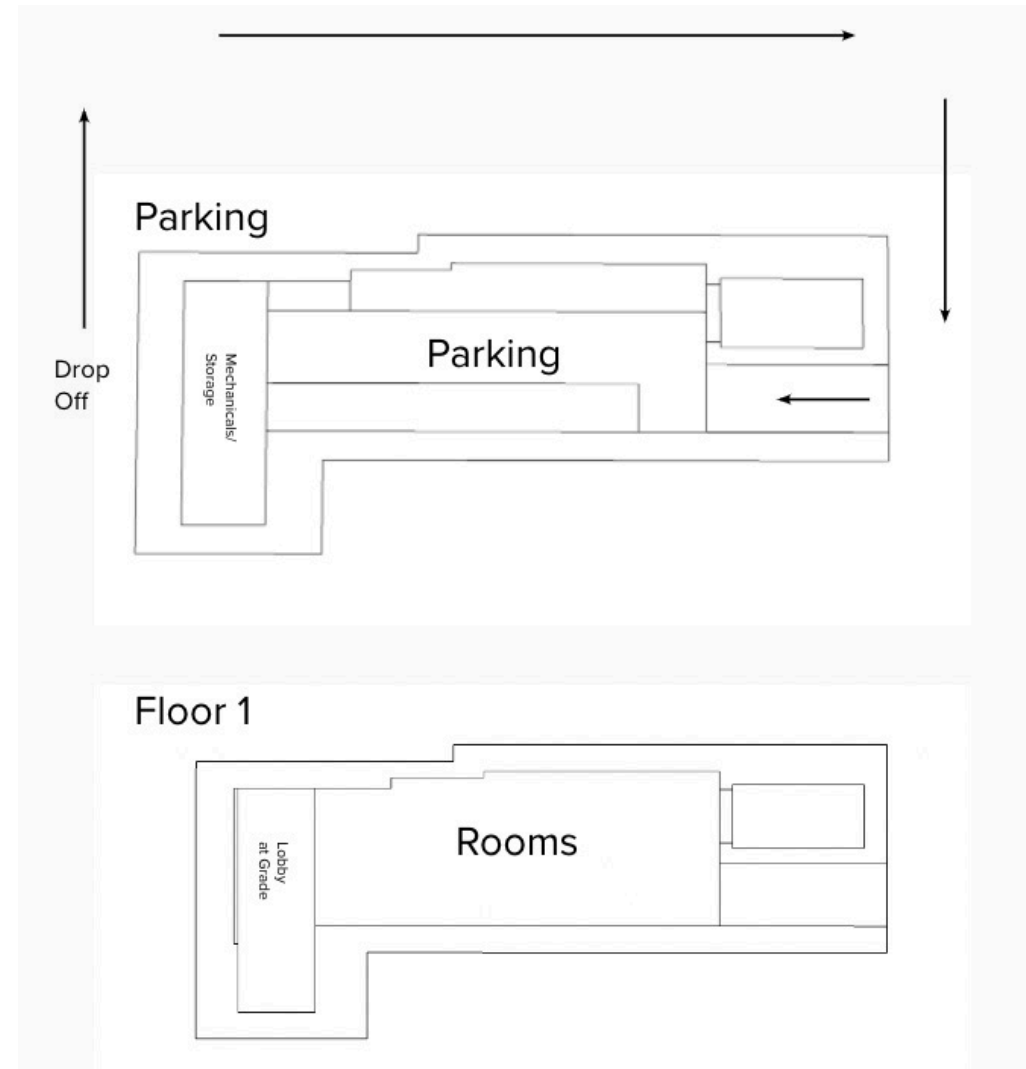
Leave Existing Facade in Place

Parking Entrance from Mifflin St.

- Saves the existing facade
- Lobby/Cafe space is adequate (~2, 550 sf)
- Retains Reynolds House (616 E. Mifflin)

- Parking access entry from Mifflin St.
- Confusion finding underground parking with main entry on Dayton St.
- Cost to stabilize/underpin wall during construction
- Occupiable building square footage reduced by 9.5%
- 2nd floor of hotel rooms on Dayton St blocked by facade
- Eliminates green space/BCycle statipon on Mifflin St.
- Flooding concerns due to low entry door elevation
