## Traffic Engineering Division

## SUMMARY OF STAFF RECOMMENDATIONS TO TRANSPORTATION COMMISSION

## **2024 TRAFFIC SIGNAL PRIORITY LIST SPECIAL STUDIES FOR TRANSPORTATION COMISSION SELECT INTERSECTIONS**

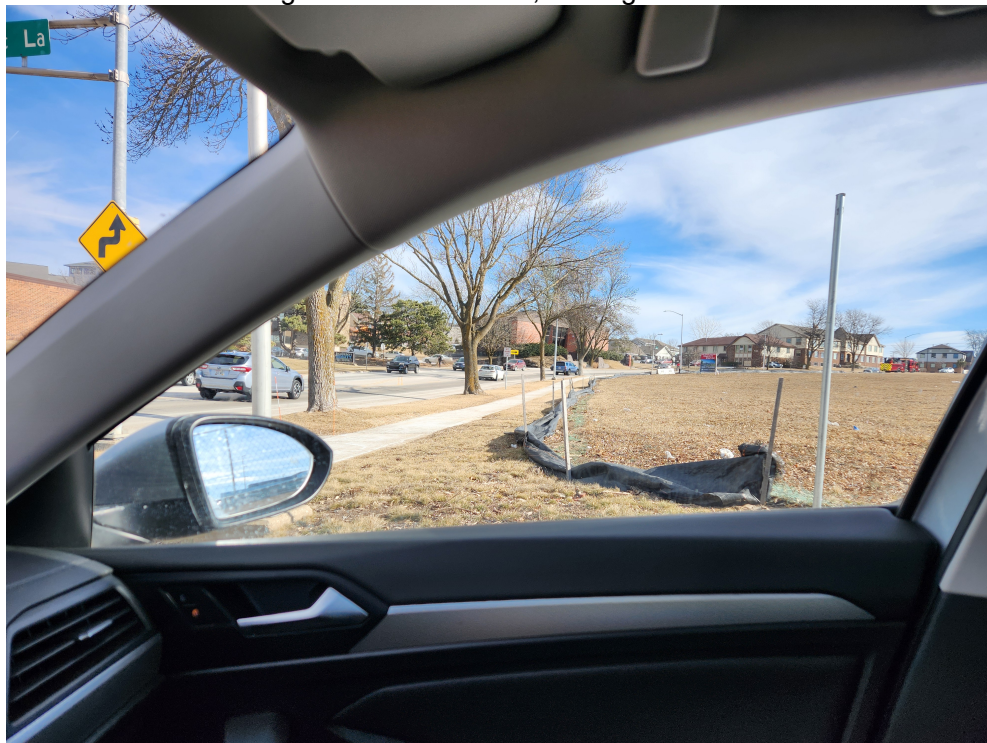
Figure 1: NB Potomac, looking east

- An automated hose count indicates this intersection does not currently meet traffic signal warrants 1-A, 1-B, or peak hour warrants.
  - Current redevelopment on the south side of the intersection is expected to bring this intersection closer to meeting traffic signal warrant.
- The signal spacing between this intersection and adjacent intersections is near equal distance between Research Park Boulevard and Grand Canyon Drive. This location may allow for platoon management when running in coordination.
- Visibility coming from the south side of the intersection is currently roughly 350 feet to the east, and approximately 250 feet to the west. At the posted speed limit, this is approximately 7-9 seconds down the road. At the 85<sup>th</sup> percentile speed measured, this approximately 5-7 seconds down the road. See figures 1 and 2 below.
