## Chapter 18: Lead-Based Paint and Historic Preservation

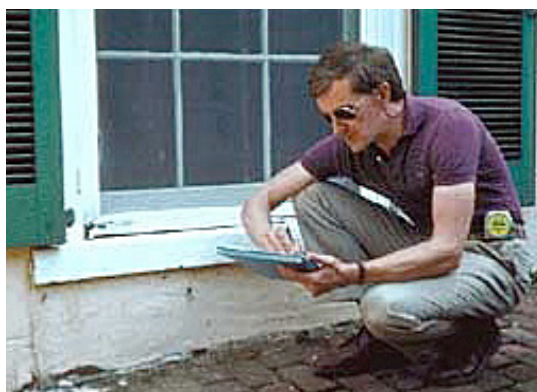
**FIGURE 18.2** Historic properties should have a window condition assessment preceding work. Photo Courtesy National Park Service.

Identifying, retaining, and preserving windows – and their functional and decorative features – is an important step in preserving the overall historic character of the building. Such features can include frames, sash, muntins, glazing, sills, heads, hoodmolds, paneled or decorated jambs and moldings, and interior and exterior shutters and blinds. An in-depth survey of the interior and exterior features and condition of existing windows will provide the basis for evaluating possible rehabilitation or replacement options to make the windows lead-safe. The exterior portion of a window assessment is shown in Figure 18.2.

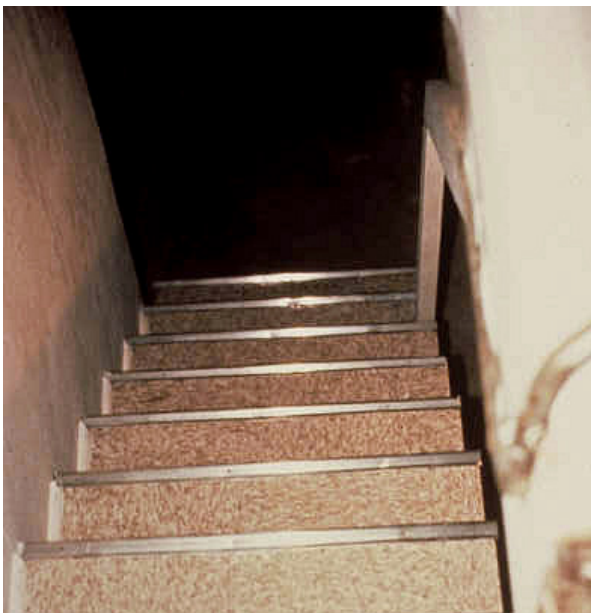
**FIGURE 18.6** Enclosure of stairs in this manner is generally not appropriate in a historic property.

Enclosing a decorative feature may be appropriate if doing so does not damage the structure beyond a minimal amount (see Figure 18.6). For example, a projecting mantel might be enclosed if the fireplace is not to be used in the interim, and the decorative finishes are to be enclosed behind drywall finishes. While this is a serious loss of historic character, if it is a temporary solution and no harm is done to the feature, it might be an appropriate treatment. The use of artificial siding over painted and otherwise sound historic exteriors often results in a removal of projecting historic elements, such as roof brackets, and conceals the historic trim. The use of these artificial sidings is not recommended.
