Chapter 18: Lead-Based Paint and Historic Preservation

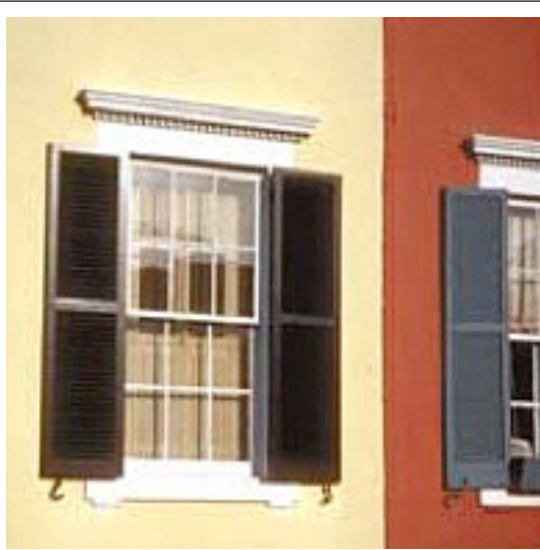
FIGURE 18.1 Delicate muntins and multi-pane sash on early 19th century row houses. Photo Courtesy National Park Service.

The quality of a building’s architecture and craftsmanship must be considered when evaluating the significance of a property. Buildings that exhibit distinctive characteristics of architectural design represent work by skilled craftsmen, or have high artistic value may require a greater sensitivity on the part of a responsible entity when undertaking alterations or modifications to that structure (see Figure 18.1). Worker housing in an industrial mill town was often constructed with heavy timber post and beam construction or balloon frame wooden systems, but may have very simple decorative or trim work on the interior. The significance of these properties is more closely tied to social movements within our cultural history than to architectural design. A property designed by a prominent architect using master craftsmen and artistic painters will be noted for its architectural appearance and design.

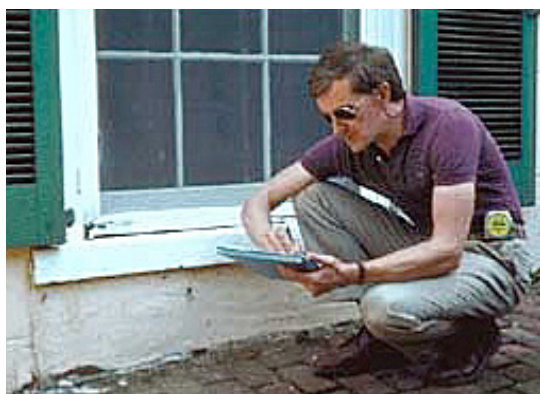
FIGURE 18.2 Historic properties should have a window condition assessment preceding work. Photo Courtesy National Park Service.

Identifying, retaining, and preserving windows – and their functional and decorative features – is an important step in preserving the overall historic character of the building. Such features can include frames, sash, muntins, glazing, sills, heads, hoodmolds, paneled or decorated jambs and moldings, and interior and exterior shutters and blinds. An in-depth survey of the interior and exterior features and condition of existing windows will provide the basis for evaluating possible rehabilitation or replacement options to make the windows lead-safe. The exterior portion of a window assessment is shown in Figure 18.2.

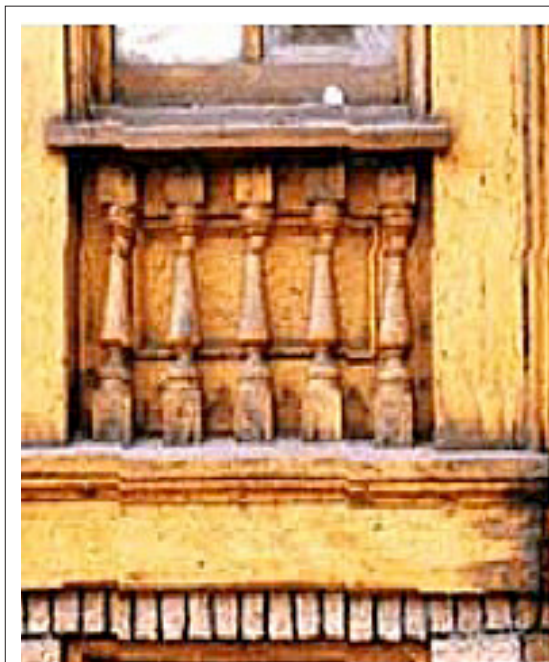
FIGURE 18.4 Wood features on historic properties. Sometimes they can be stabilized instead of stripped of traditional painted finish as in this photo. Photo courtesy of National Park Service.

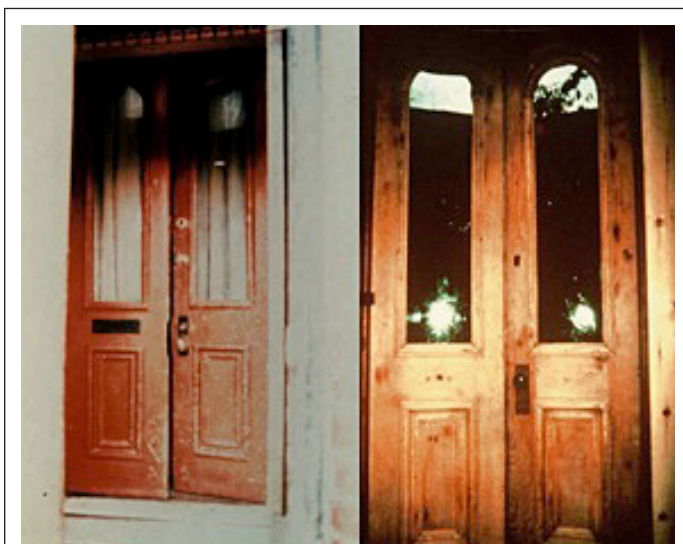
FIGURE 18.5a and 18.5b

Doors to historic property before and after off-site stripping.

Off-Site: A potentially more damaging paint removal treatment involves the removal of items for off-site stripping. Only companies experienced in treating historic building parts should be used to conduct paint stripping. If the items are easily removed (e.g., doors, shutters, or windows), they can be carefully treated off-site and then reinstalled. (See Figure 18.5). Caution is advised when considering this method because trim, mantels, banisters, newel posts, or other carved elements constructed in sections may be firmly attached and may be damaged when removed, thus requiring repair or reconstruction. Hardware should be removed and labeled before paint is removed.
